# Observations From The Design, Construction And Drone Monitoring Of A Geotextile Sand Container (GSC) Seawall

C Drummond<sup>1</sup>, J Carley<sup>1</sup>, A Harrison<sup>1</sup>, W Brown<sup>2</sup> and P Roberts<sup>3</sup>

<sup>1</sup> Water Research Laboratory, School of Civil & Environmental Engineering, UNSW Sydney, NSW, Australia.;  
[c.drummond@wrl.unsw.edu.au](mailto:c.drummond@wrl.unsw.edu.au)

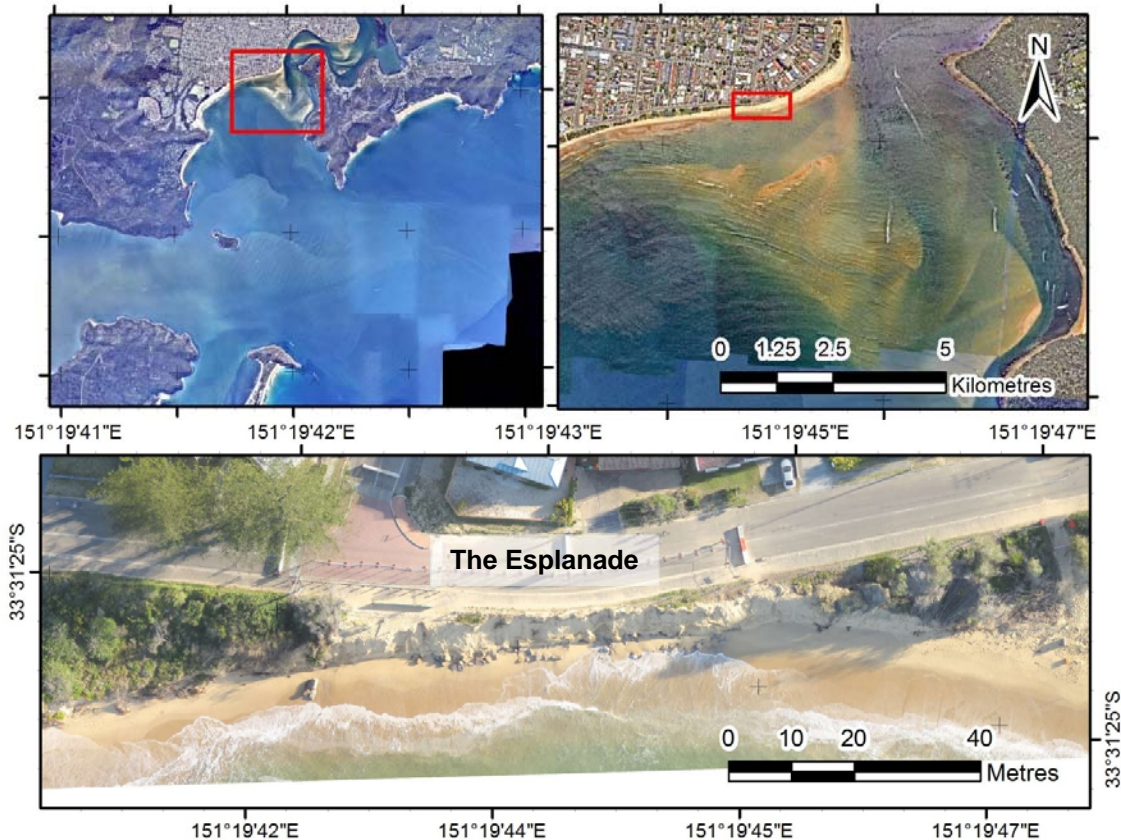
In mid-2015 following a major storm event, Council identified coastal erosion was causing an immediate threat to The Esplanade despite substantial beach scraping (Figure 1 and Figure 4). The Esplanade was deemed to be at imminent threat of collapse into the ocean and this necessitated the closure of this beachfront road. The Water Research Laboratory (WRL) of UNSW Sydney proposed the design of an interim geotextile sand container (GSC) seawall to mitigate further erosion. This paper presents the design of this seawall followed by details of its construction. Ongoing monitoring, using UAS

Figure 1 Clockwise from top left: site location showing semi-protected orientation with exposure to swell from the south east, Ettalong Point and the Brisbane Water estuary shoal, UAS-derived orthomosaic taken on 14<sup>th</sup> August 2015 showing proximity of erosion scarp to The Esplanade before construction of the GSC seawall.

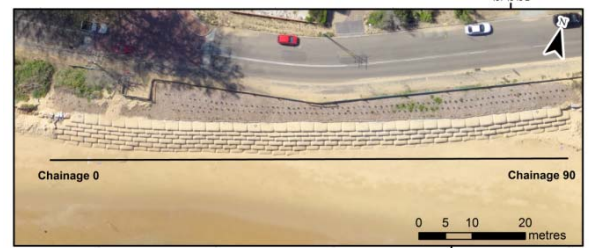
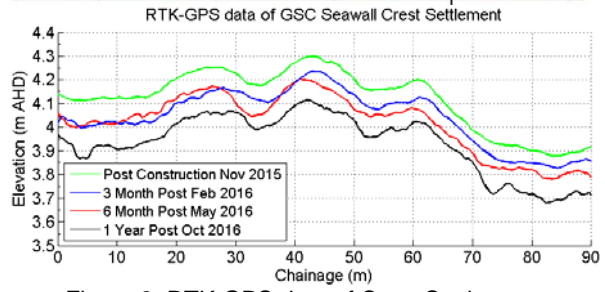
RTK-GPS ground surveys were sampled in a continuous profile along the crest centreline to assess potential settlement or slumping. The data shows that the crest experienced settlement of approximately 0.05 - 0.1 m in the first three months following construction (Figure 3). The western half of the wall maintained its elevation between February 2016 and May 2016, while the eastern portion of the wall settled a further 0.05 m. The October 2016 survey shows a consistent total settlement of 0.2 m since construction. The cause of this settlement is difficult to ascertain. Possible causes are settlement of sand foundation due to the weight of the seawall, rotation along the slip plane of the structure, or most likely due to settlement of the sand within individual containers. This dataset provides a valuable insight into the settlement of GSC structures and the potential for

Figure 3: RTK-GPS data of Crest Settlement

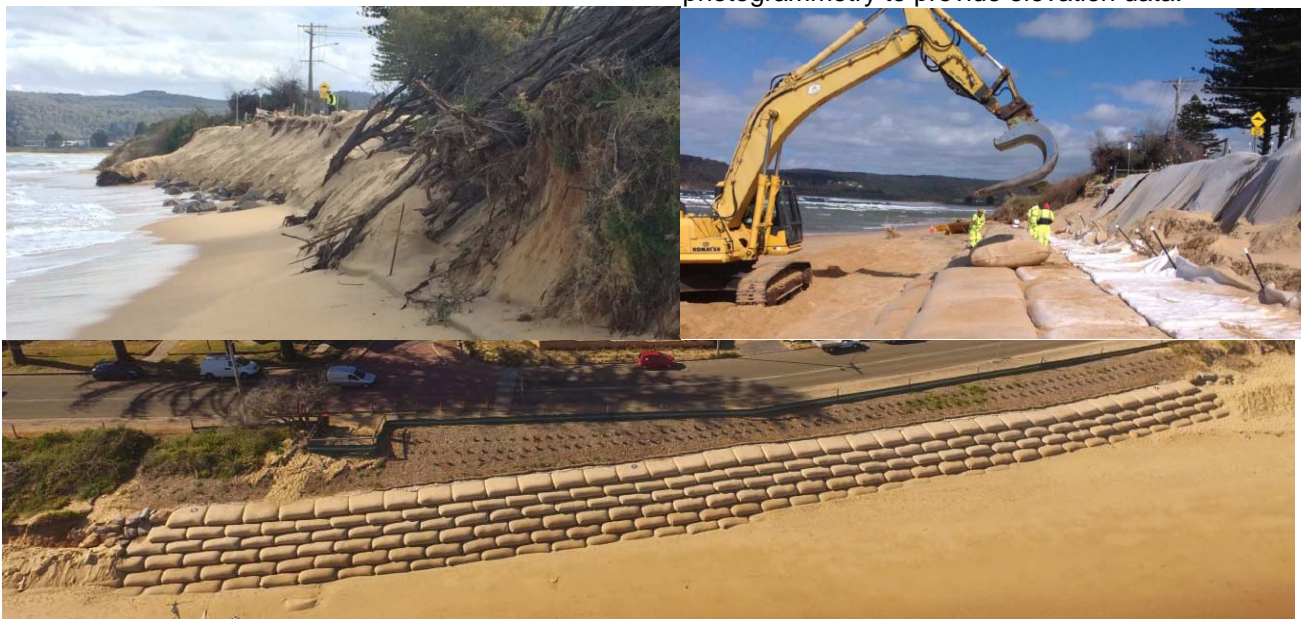
Figure 4 Construction of the GSC seawall. Clockwise from top left: the erosion scarp in August 2015; placement of 2.5 m<sup>3</sup> containers using modified rock grab; aerial view of completed GSC seawall after 3 months in operation.

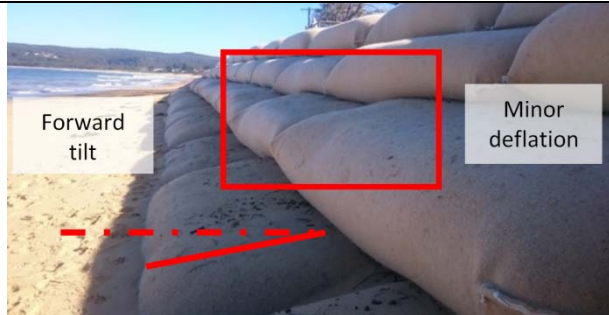
reductions in performance to parameters such as wave runup. These preliminary results suggest that GSC seawall crest levels should be designed with a sufficient factor of safety to account for settlement over the design life of the structure. Site investigations also identified that exposed courses of geocontainers have slightly deformed by “tilting forwards” (Figure 5). This is likely caused by the redistribution of sand within individual containers under wave action. Minor deflation and localised slumping of geocontainers has also been observed which is attributed to vandalism.

Figure 5: Evidence of minor deflation and “forward tilting” of geocontainers (photo taken 29<sup>th</sup> June 2016)

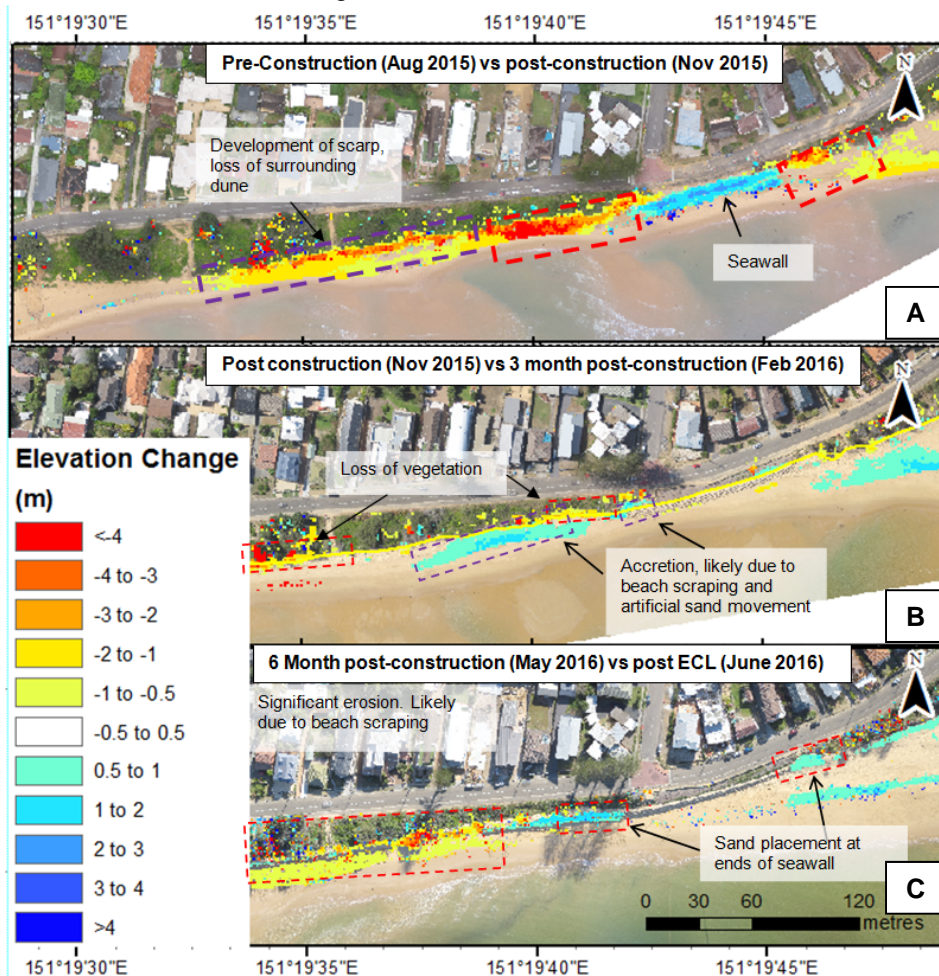
The erosion intensity maps and analysis of the vegetation line movement indicate that significant erosion occurred at Ettalong prior to and following the construction of the seawall with the dune face eroding/receding up to 13 m in three months (Figure 6 A). There was a prolonged period of larger than average waves (in excess of 2.5 m) originating from a SSE direction at the end of August 2015 which likely caused this erosion.

Figure 6: Erosion Intensity maps showing beach change between UAS surveys; pre-construction vs post-construction (top), post-construction vs 3 month post-construction (middle) and 6 month post-construction vs post ECL (bottom)

In the three months following the seawall construction (November 2015 to February 2016), erosion rates abated in the vicinity of the seawall (Figure 6 B). Sand accretion measured at the western end of the seawall during this period is attributed to beach scraping undertaken by Council. The minimal erosion in this period is likely due to the propensity for milder wave condition in NSW throughout summer months. While Ettalong is predominately exposed to waves from the SSE, the easterly waves produced by the June 2016 ECL storm event still caused moderate erosion at the site (Figure 6 C). In the 3 week period between the pre and post ECL storm survey, Council completed extensive beach scraping to mitigate the effects of the storm. Despite this, it is evident that the storm caused the vegetation line to recede by up to 7 m. During this period, Council also placed sand in the zones immediately west and east of the seawall to reduce the erosion effects caused by the structure, which is also visible in Figure 6 C. Analysis of the available storm demand and movement of the 1.5 m contour data also yield interesting observations. Figure 7 indicates that the beach located to the east of the structure towards Ettalong Point (Profile 5 and Profile 6) has been accreting and widening since

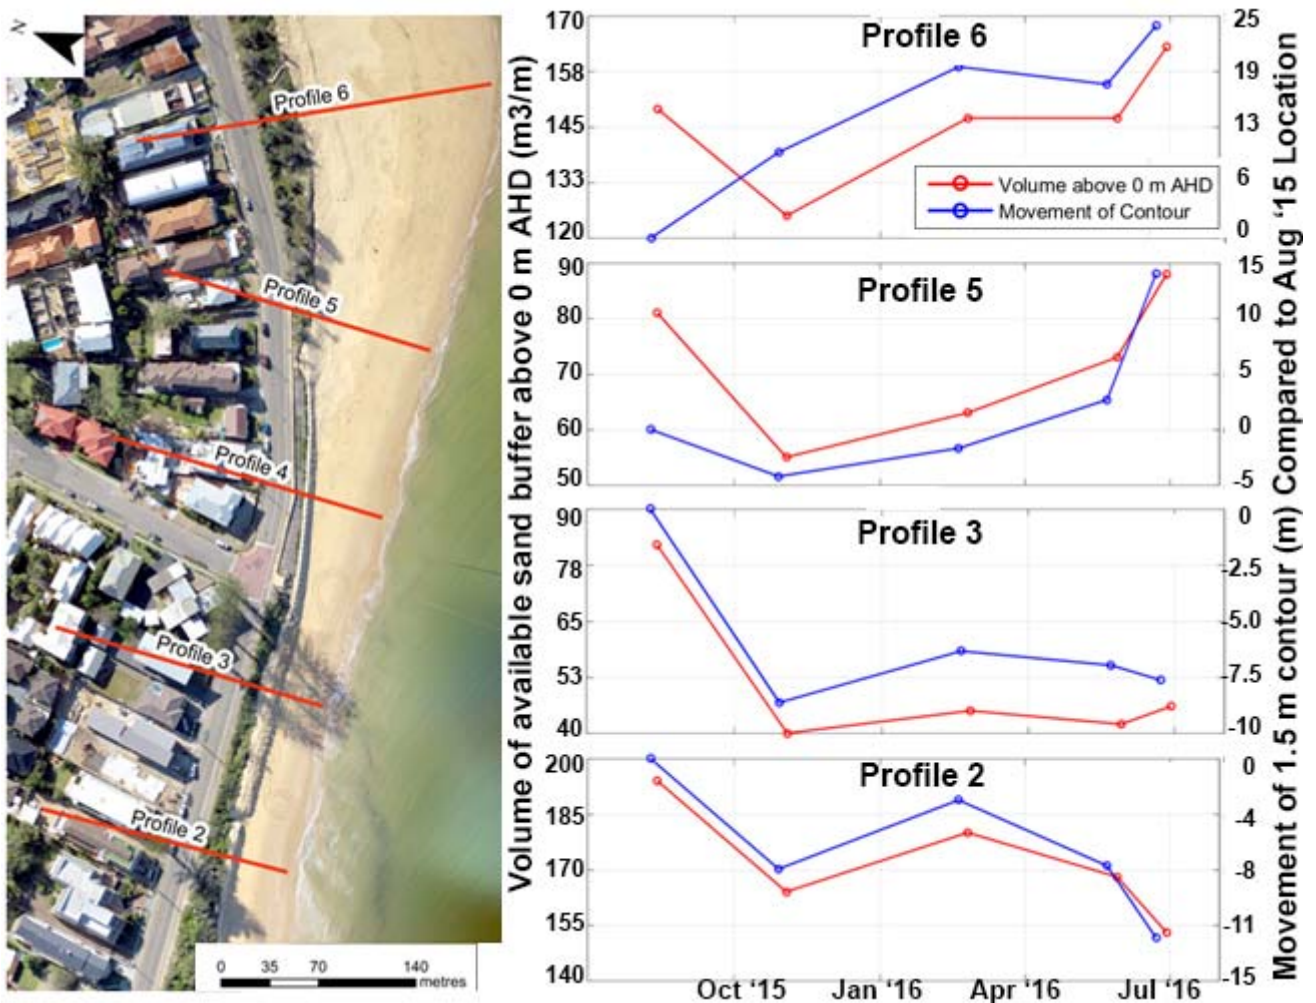
construction of the seawall. Approximately 1,500 m<sup>3</sup> of sand was harvested from this area to fill the geocontainers which is likely to be partially responsible for the observed volume loss between August and November 2015. Sand volumes at Profile 3 (immediately to the west of the seawall) have remained relatively stable since construction of the seawall which is likely attributed to Council's continued beach scraping efforts. Profile 2 located 75 m west of the seawall has generally eroded and narrowed throughout the survey period. Empirical relationships suggested by [14] indicate that Profile 2 is at the extreme western location where end effects from the seawall could impact upon sediment movement. Comparing the trends of recession and erosion for an additional profile located 150 m west of the seawall indicates a similar rate of recession and erosion. Based on this it is likely that the recession at Profile 2 is largely due to natural erosion and ongoing tendencies of the site, rather than directly caused by the seawall. Since the one year post construction survey in October 2016, sand has continued to accrete at the seawall such that five out of a total of eight courses of geocontainers have been buried.

Figure 7: Analysis of volume about 0 m AHD and movement of 1.5 m contour for profiles in proximity to GSC seawall

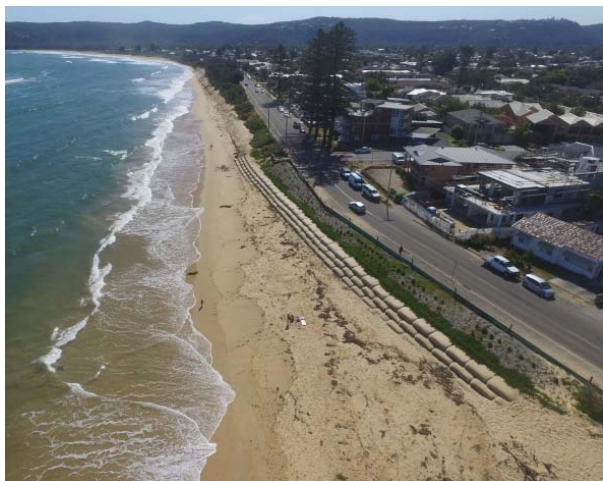
Figure 8: Photo of the CSG seawall looking west after one year in operation (Photo date:25/10/2016).
