Slope liquefaction failure of a rip-rap slope during springtime in a northern climate

Amaneh E. Kenarsari¹, Stanley J. Vitton²

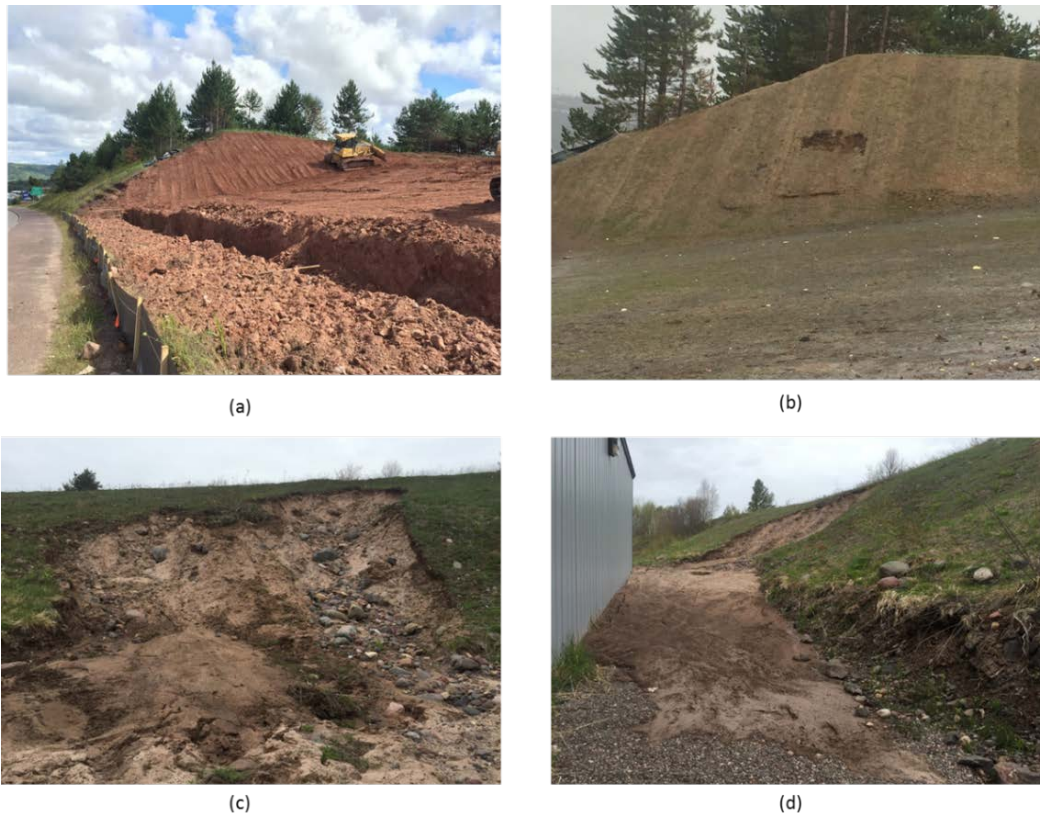
In northern Michigan it is common to have some limited landslides develop on newly constructed slopes the following spring due to a combination of freezing temperatures and high snowfall. Figure 2 illustrates two small-scale landslides near the site area that failed in the spring of 2016. The first slide (Figure 2 a and b) was constructed in the fall 2015 on a roughly 2:1 slope (27°) and sodded to prevent spring time erosion but had a small “pop out” the following spring. Figure 2 c and d, however, show a larger landslide on an established slope that was at least 30 years old that also occurred during the spring 2016.

One issue in the design of slopes in the site area is that the soils were deposited by glaciers. This can be seen in Figure 2 (c) and Figure 2 (d) showing a wide range of particle sizes including well-rounded cobbles and boulders. Overall, a large percent of the glacial soils tends to be coarse-grained with cobbles and boulders and a relatively high fine contents. Being geologically recent deposited soils, the sand and silt portions are relatively angular with corresponding high friction angles, although as seen in Figure 2c and 2d the cobbles and boulders are highly rounded due to glacial action.

Figure 2. Spring, 2016 small scale landslides in the Hancock-Houghton area: (a) slope constructed in fall 2015 and sodded, (b) spring 2016 small scale failure on slope; (c) small landslide on an established slope, (d) soil flowing behind a commercial building.

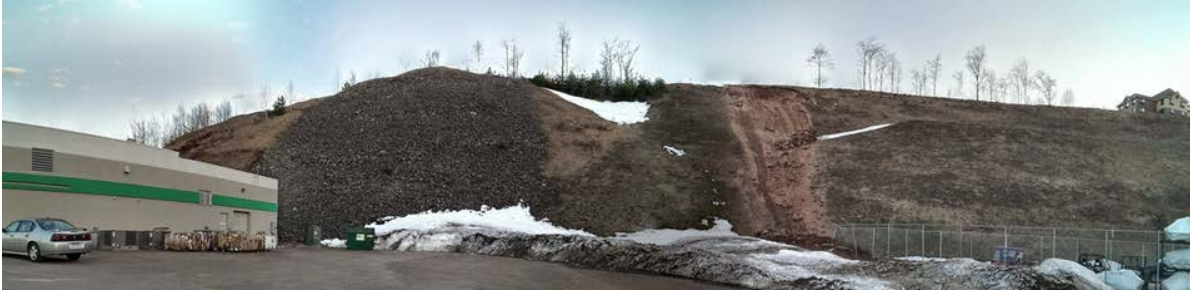
Figure 3 shows a commercial site where the slopes were excavated to an average slope of about 35° with some portions as steep as 40° . The slope remained stable for a number of years until fifteen years ago a portion of the slope failed. This failure was remediated with rip-rap and has remained stable since. A recent winter, however, with relatively high snowfall but with record low temperatures caused the slopes on each side of the remediated area to fail, while the rip-rapped section remained stable. These later failures have not been remediated but have

Figure 3: Commercial site with excavated slopes in the range of 30° to 40° that experienced three slope failures. The middle section of the slope, which failed first, was remediated with rock rip-rap, while the slope failures on either side have not been remediated

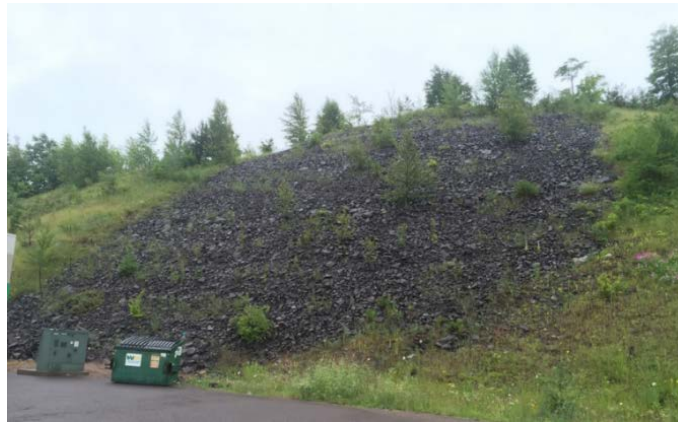
remained more or less stable. Figure 4 is a recent photograph of vegetation developing on the commercial site shown in Figure 3.

Figure 4. Recent photograph of the commercial site shown in Figure 2 with vegetation developing on the slope.

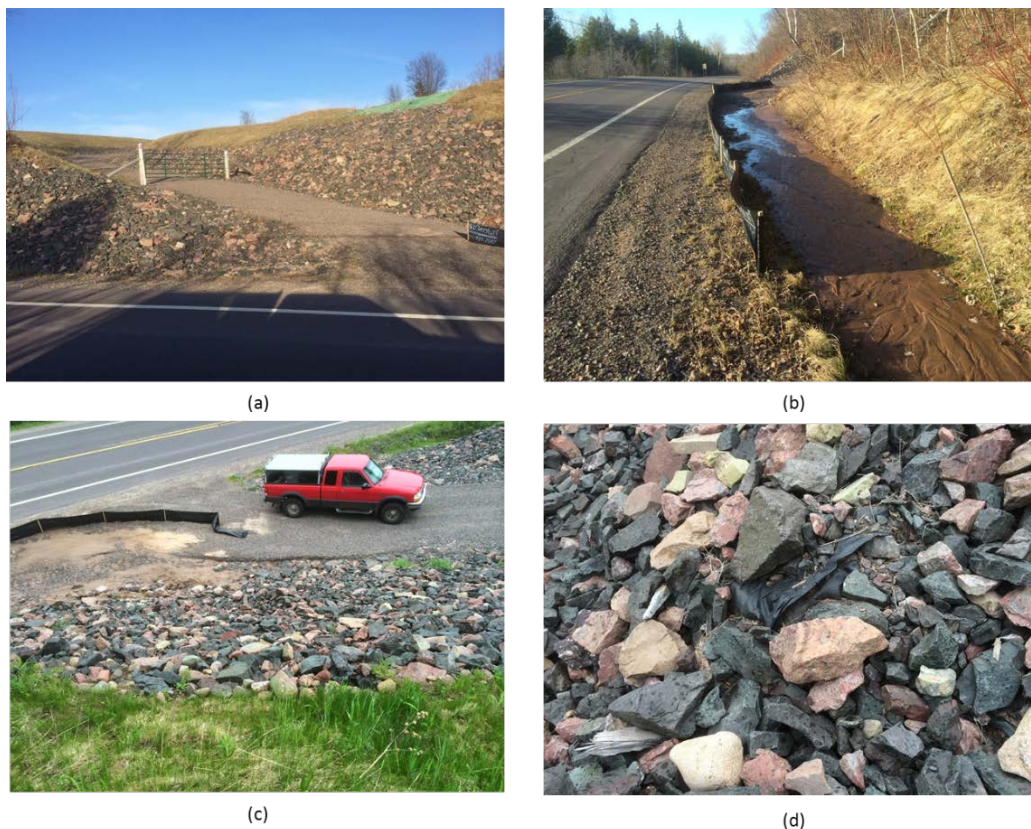
To gain access to Michigan State Route M-203 the road was constructed through a 30 ft (roughly 10 m) high glacial slope as shown in Figure 5 (a). The slopes were cut to a 2:1 angle (27°). Although a 2:1 slope is generally considered stable in the local area, a thin woven geotextile layer was placed on the slope and rip-rap placed on top of the geotextile in the summer of 2013 to protect the slope from erosion. In the spring 2014 the north facing slope failed causing a large amount of sand to flow out onto M-203 to a depth of 0.25 m, and forming a sinkhole behind the slope. The site was quickly repaired to allow traffic to use the highway. Unfortunately, no pictures were available to show this failure. Later that summer the slope was reconstructed with a new ditch, separation fabric (woven slit film geotextile similar to a silt fence material) and rip-rap. Figure 5(a) and (b) illustrates the road and slope after it was remediated in 2014. Figure 5(a) shows a green erosion control blanket where the sinkhole formed in back of the slope. In the spring of 2015 a much smaller failure occurred with sand and water again flowing out of the slope as seen in Figure 5(c). The site was cleaned up and minor modifications made to the slope. Figure 5(c) shows the site a few months after remediation with some water and sand still flowing out of the slope. Figure 5(d) shows the geotextile fabric placed below the rip-rap. Also, no soil blanket was placed over the geotextile fabric for cushioning the placement of the rip-rap, thus damage to the geotextile also occurred during placement of the rip-rap.

Figure 5. Road accessing M-203 with springtime failure: (a) road after the first failure and remediation, (b) silt fence containing additional sand and water still flowing from the slope, (c) 2014 second failure after remediation, (d) geotextile directly under the rip-rap on the slope.

be effective. Another issue was that no cushioning sand layer was used beneath the rip-rap (see Figure 5 d). A piece of exposed geotextile taken from the slope is shown in Figure 9 where a large hole formed due to the rip-rap being dropped onto the geotextile can be seen.

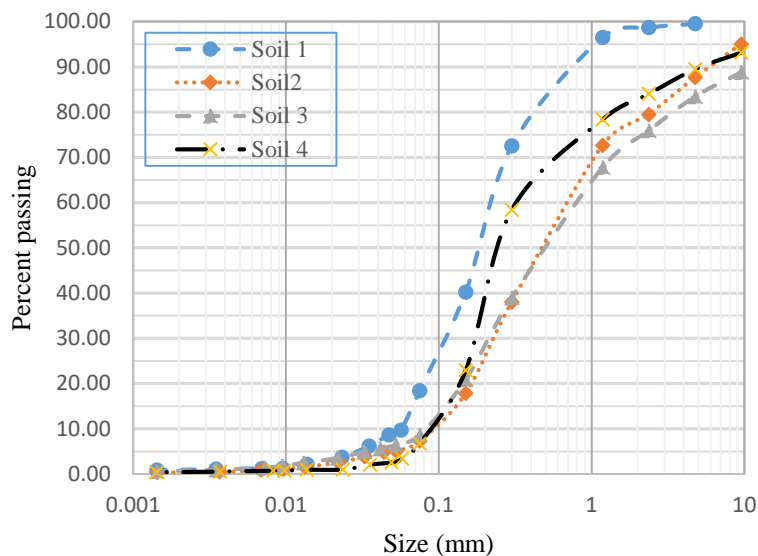
The slope soils consists primarily of stratified light brown sand and silt (glaciolacustrine), classified as a SM soil with fines averaging 8 to 15% [ASTM D1140-14(ASTM 2014)] with some limited gravel and cobbles. Figure 6 provides the mechanical grain size analysis on dry soils for three grab samples taken from the excavated soil (soil 2 to soil 4). Due to a larger amount of fines affixed to the larger size particles the fine content (>0.075 mm) shown in Figure 6 is lower than the washed fines analysis indicated above. The average coefficient of uniformity and coefficient of curvature is $C_u = 10$ and $C_c = 3.3$ for the four samples tested from the site based on the “dry sieve” analysis.

Figure 6. Grain size distribution of the soil samples

sections (wide range of particle sizes) in the lower section of their grading curves. As such, Figure 6 would suggest that the site soils have a high probability of being internally unstable.

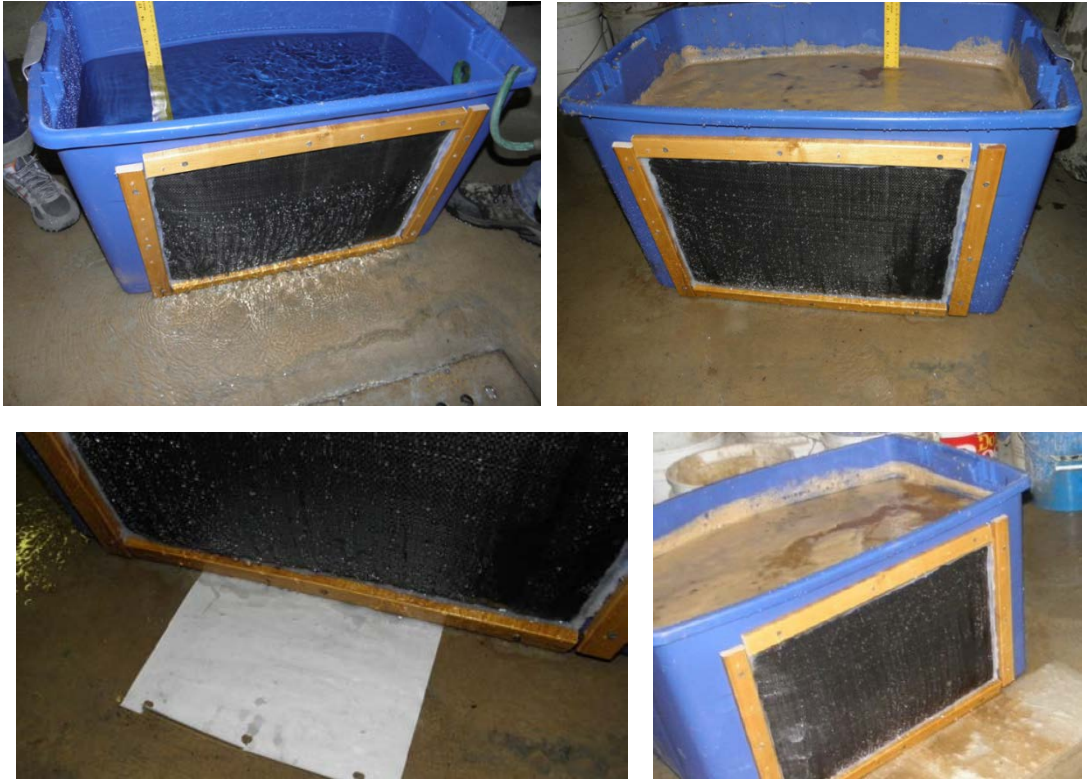
To assess the “filtration” capacity of geotextile used on the slope a simplified filtration and clogging test was conducted. The geotextile fabric used on the slope was a woven monofilament fabric commonly similar to fabrics used for silt fence control. To test the geotextile’s filtration and clogging capacity one side of a plastic container was cut out and the fabric placed and secured in the bucket as shown in Figure 7. The container was first filled with water to test the filtration capacity of the geotextile. After observing a relatively good water flow through the geotextile, five-gallon buckets were filled with soil and water creating sand/water slurry. The buckets were then filled with the sand/water slurry to a height above the fabric. Water, free of observable sediments, flowed from the fabric in a similar rate as with just water behind the fabric. During the test, water was added to the container to maintain a constant slurry height. The fabric functioned well, retaining the sand particles and allowing the water to pass and as shown in Figure 7. After completing the test, the buckets were emptied and the backside of the fabric washed with water. The test was then repeated filling the bucket with the sand/water slurry. On the second filling, however, the fabric failed to function properly not allowing water to filtrate through the fabric. The test was repeated a number of times without washing the fabric off and again with washing the fabric. In all cases, the fabric failed to function the second time the sand/water slurry was placed in the bucket. Inspecting the fabric, it was seen the much of the available openings were clogged with sediment, thus not allowing water to flow through the fabric.

Figure 7. Woven slit film geotextile simplified filtration test

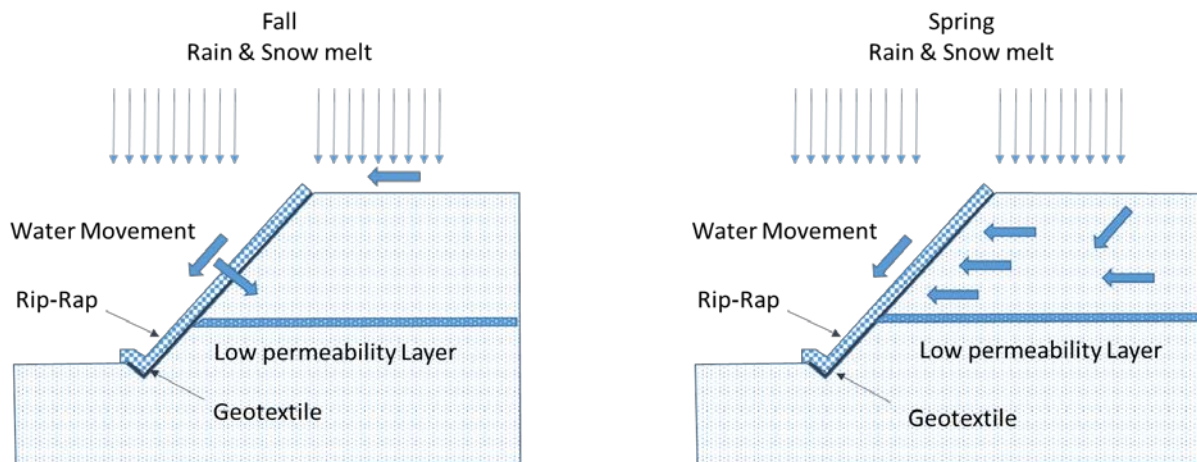
The slope was constructed in the summer. Since the groundwater table was below the slope, it did not contribute water flow into the slope. However, in the fall, rain and snowmelt would have flowed over and through the geotextile carrying some amount of sediment. This situation is shown in Figure 8. It is believed that at this point the geotextile developed some level of clogging but probably not sufficient to prevent water flow through the geotextile. In the spring, however, the snowmelt would have contributed significantly to groundwater flow.

Topographically, the slope was constructed at the base of a 100 m (300 ft) high hill and would have had significant groundwater moving through the soils. Seeps are common along this section of highway suggesting the presence of localized silt or clay layers in the soil. These layers in turn would pond the ground water causing the water to flow laterally towards the slope as illustrated in Figure 8. Further, the soils having the higher probability of being internally unstable, typical of glacial soils, would have caused particle migration into the geotextile, resulting in a more complete clogging of the geotextile. Once the geotextile was clogged pore water pressure developed causing the dramatic slope failure and soil liquefaction flow onto the state highway. If the geotextile had been designed for filtration it is likely that this slope would not have failed. Moreover, if the slope had simply been lined with the rip-rap, it is likely that water flow from the spring meltwater would have been able to exit the slope without building pore water pressure in the slope. In effect, it is believed that the geotextile, once clogged, acted as a barrier to the spring groundwater flow leading to the failure.

Figure 8 Schematic drawing of the slope's water movement in the fall and spring.

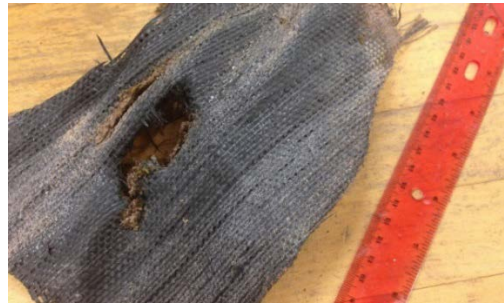
Figure 9. Large hole in the geotextile due to improper geotextile installation

This case study showed an inappropriate design and installation of a woven geotextile that caused slope failure. The geotextile was not designed for filtration and had been installed without proper bedding soils. Therefore, it was clogged and resulted in pore water pressures developing behind the slope. The pore water pressure in silty sand in slope causing soil liquefaction resulting in the flow of water unto a highway and a sinkhole developing on the backside of the slope.
