REPORT

Internal Task Force

No.: PRO-X15-0030
 Rev.: 01M
 Date: 2018-04-09
 Page: 1 of 25

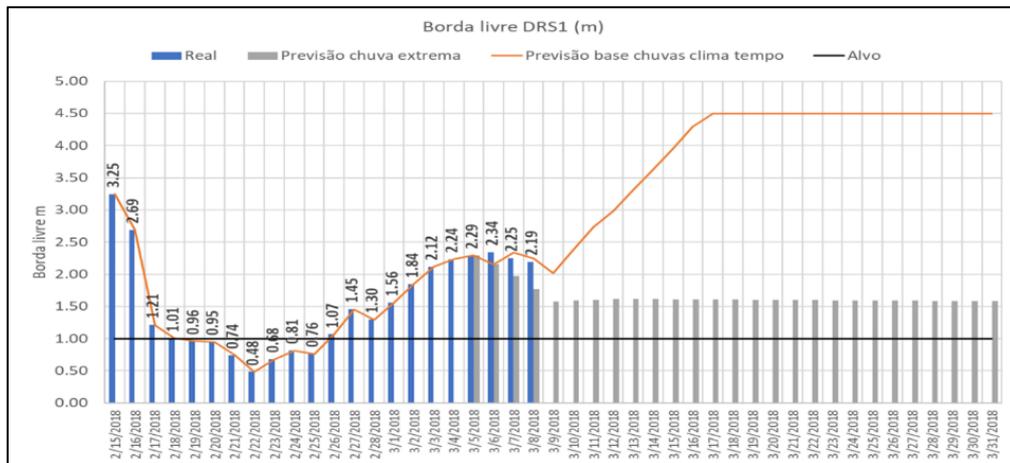
Around midnight (00:00) February 17th, the flows from BC1 and BC2 were stopped due to the reduced ETP capacity. The freeboard of DRS1 is shown in Figure 4.3: The variations in the freeboard (borda livre) in DRS1 as measured (taken from the Alunorte Plant Operations system - blue is actual, grey is forecast for extreme situation) Figure 4.3. The heavy rainfall the 16th and 17th reduced the freeboard level from 3.25 m on February 15th to 1.0 m on February 18th.

The freeboard level was below minimum requirement of 1 m from around February 18th to 26th.

Figure 4.3: The variations in the freeboard (borda livre) in DRS1 as measured (taken from the Alunorte Plant Operations system - blue is actual, grey is forecast for extreme situation)

February 22nd Operations started emergency works to place out sand bags and heighten levels around DRS1, to avoid overflow as a safety measure.

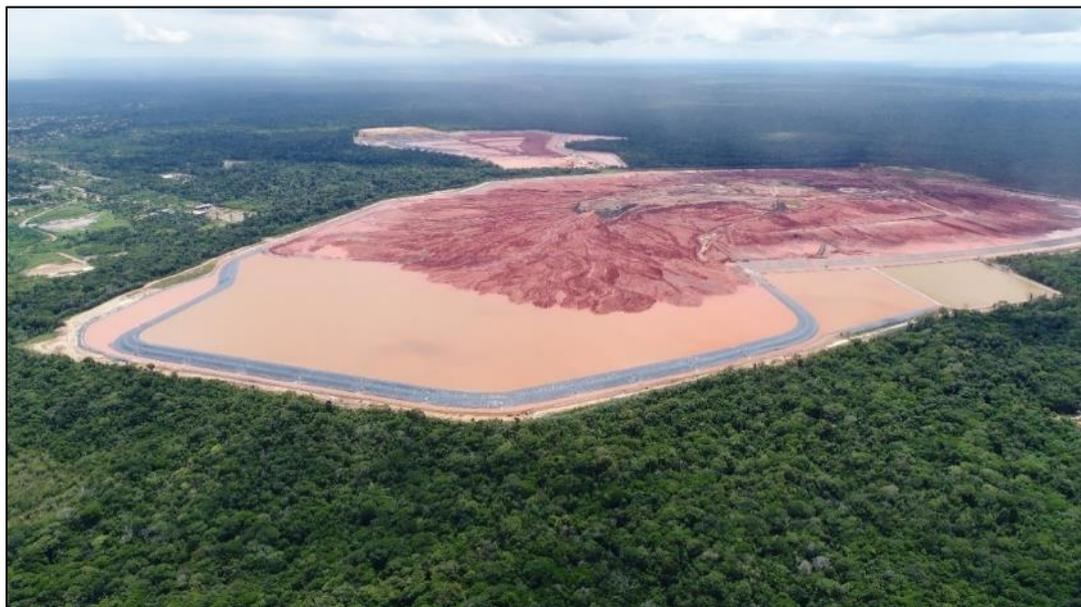
The Task Force has concluded that DRS1 did not overflow during the entire rainfall event. Site inspection along the full perimeter of DRS1 and inspection of drone photos and videos confirm this conclusion.

Figure 4.4 DRS1 Drone photo 24.02.2018 – DRS1 seen from north west.

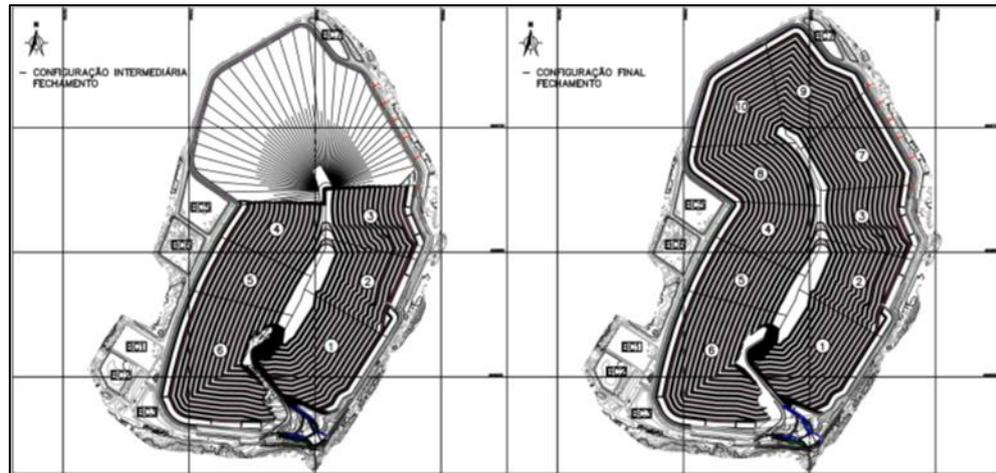
Figure 4.7 DRS1 closing

The closure scenario has investigated the safety of the anticipated slope angle of the residue deposit. It has been checked and confirmed that the minimum safety factor is between 1.6 (profile north) and 3.1 (profile south) at end of construction, compared to a minimum safety factor in Brazil of 1.5.

Progress closure project for DRS1.

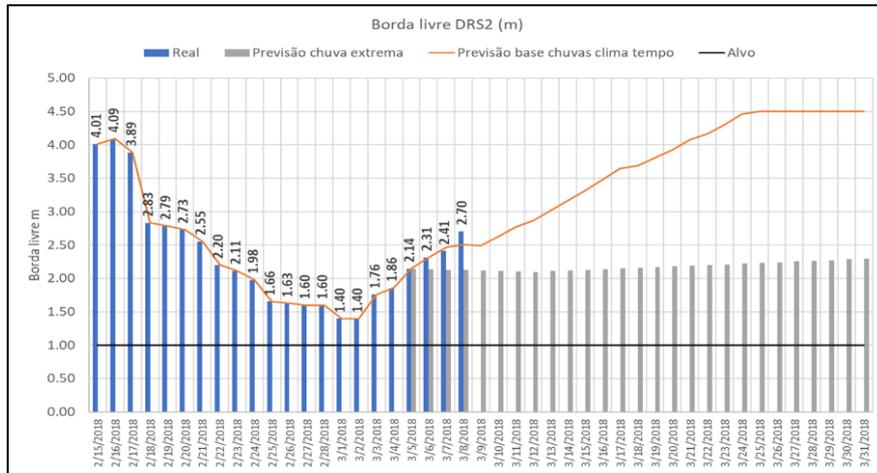
The Task Force has concluded that DRS2 did not overflow during the rainfall. Site inspection along the full perimeter of DRS2 and inspection of drone photos and videos made available show no signs of overflow. Figure 4.9 shows the free board curve for BC201 and 202 from the Operational system, shows that the free board is decreasing from 4.1 m February 16th to 1.4 m March 2nd due to the rainfall. During this period, no pumping out of the reservoir was performed, the water was kept in the reservoir to utilize BC-6 for DRS1 effluents. Pumping to BC-6 started March 3rd.

Figure 4.9: Free board of BC201 and 202 in DRS2 during the rainfall event; blue is actual, grey is forecast for extreme situation

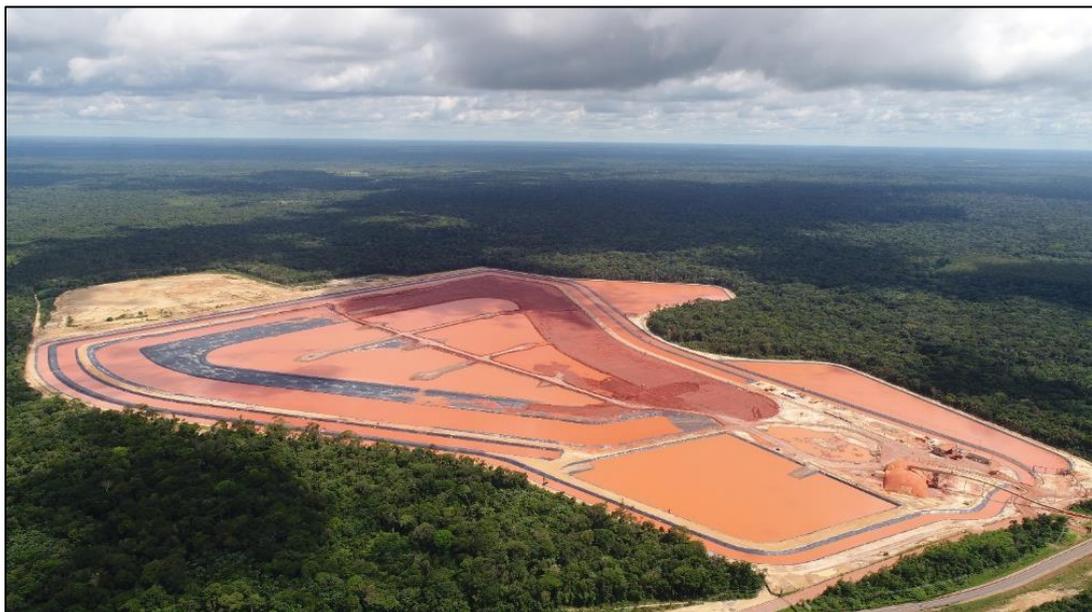
Figure 4.10: DRS2 drone photo March 2nd, 2018 –DRS2 when the free board was the lowest during the event.

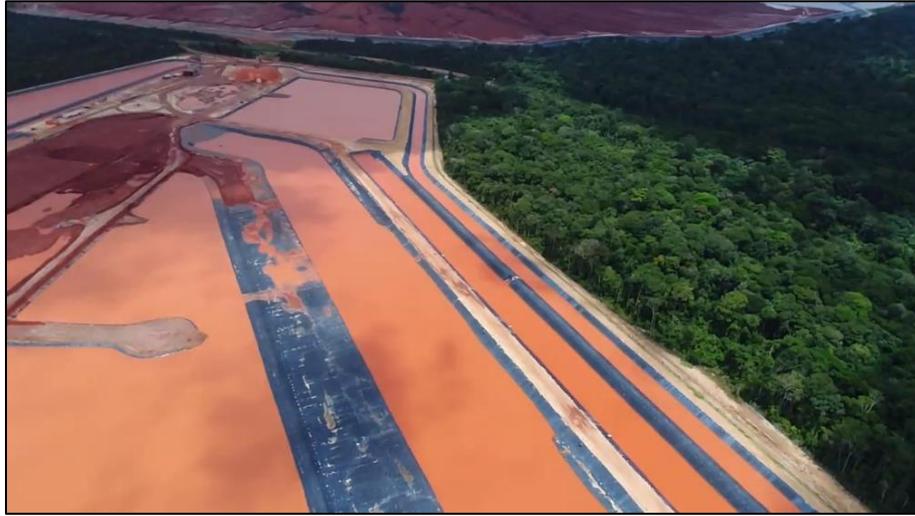
The picture below shows a flow through a dedicated low point from the waste reservoir according to design.

Figure 4.11: Section of DRS2 – Drone photo March 06th, 2018

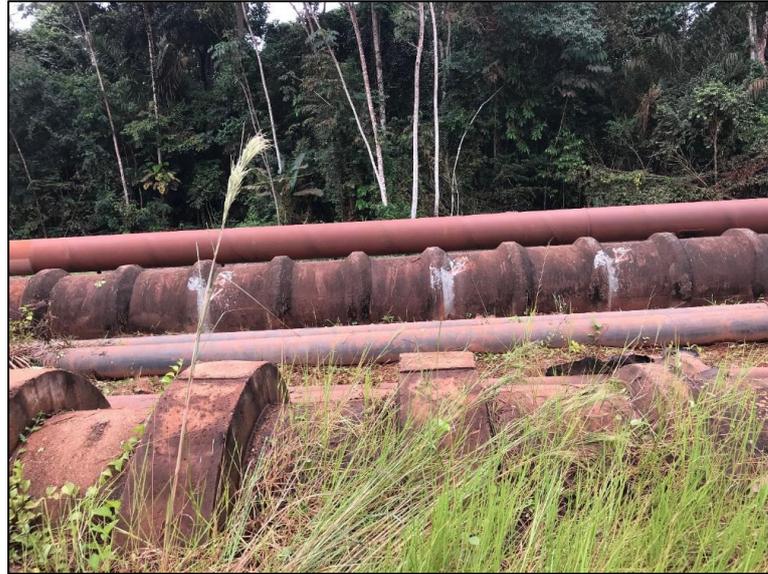
The pipes have been inspected for cracks on a regular basis and cracks are repaired as soon as they are discovered. All repairs are documented in reports.

Figure 4.15 Example of small repairs of concrete pipes

Install new transfer pipes and pumping facilities from the DRS1 to Effluent Treatment Plant. This has already been sanctioned by Alunorte as part of the Water Management Improvement Project.

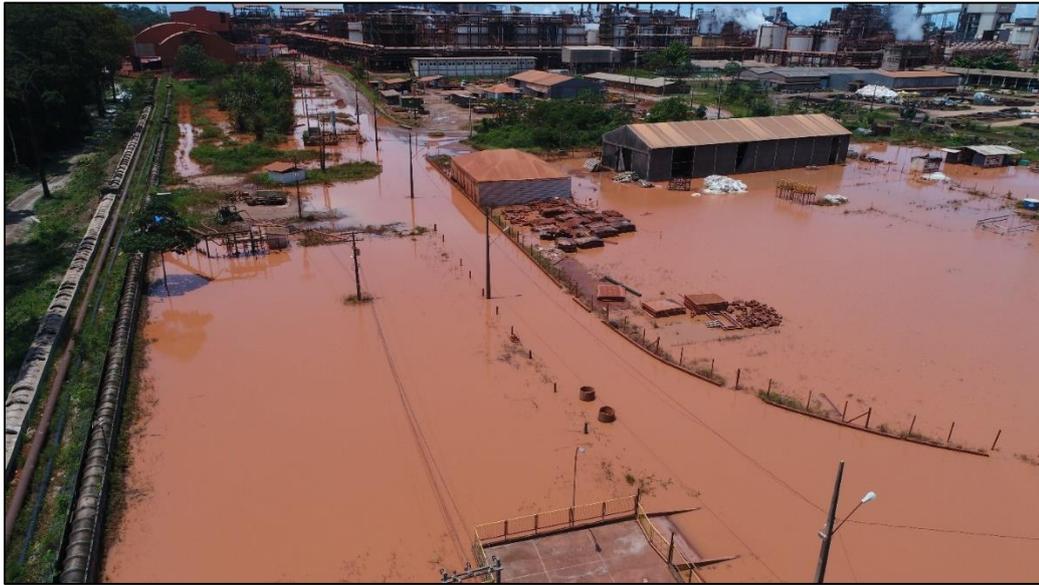
- 00:00, Area 45: The sump in area 45 went up to 100% in less than one hour, and the sump was flooded at around 01:00. The area remained flooded for six days. The Task Force has not found any signs of overflow to the outside.
- 06:20, Area 82A – Mixing box: Canal Velho was opened until 13 00.
- Time before 07:00 Area 82A: The plant effluent circuits coming to the mixing box showed low caustic concentrations.
- 07:00 (Approximately) Area 82: The collecting basins in the effluent treatment area were rising and reached a critical level of 98% (no freeboard)

Figure 4.20 Area 45 during the flooding

Build more holding basin capacity in the old lay down area (Area 45). This is already sanctioned by Alunorte. A new storm water system including holding pond capacity and sufficient pumping system will be constructed.
