CORROSION UNDER INSULATION IN OIL AND GAS PLANTS: CASE STUDIES IN A JAPANESE FIELD

T. Toyoda^{1,*}, K. Watanabe², Y. Kushima³, T. Sunaba¹

ABSTRACT

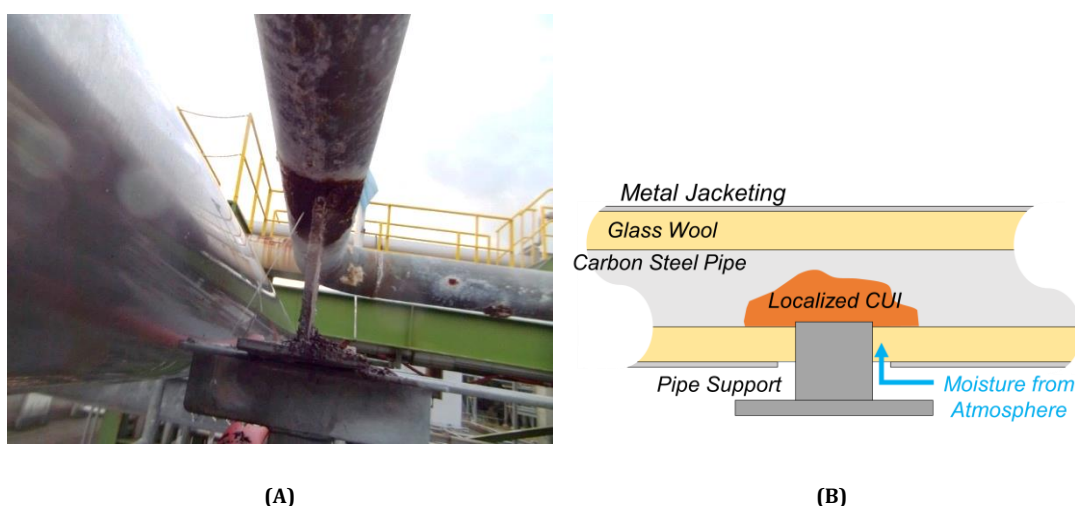
Figure 1 shows an example of CUI failure on a boiler feedwater line. The original thickness of the pipe was 5.5 mm, and after 11 years of usage, it developed leakage, indicating a corrosion rate of 0.50 mm/y. The operating temperature of the line was 105 °C, which falls within the temperature range of concern for high corrosion rates according to API RP583. What was notable about this pipe was the occurrence of localized CUI around the pipe support. It was hypothesized that moisture may have infiltrated the interior through gaps where the pipe support penetrated the metal jacket. Furthermore, moisture-absorbent glass wool insulation was commonly utilized, and external coatings designed explicitly for CUI prevention were not considered then. Due to numerous CUI cases, adopting water-repellent insulation materials and exploring external coatings gained momentum in our plant.

FIGURE 1: (A) SHOWS THE PHOTOGRAPH OF CUI AROUND A PIPE SUPPORT, (B) SHOWS THE SCHEMATIC DIAGRAM ILLUSTRATING CUI AROUND A PIPE SUPPORT

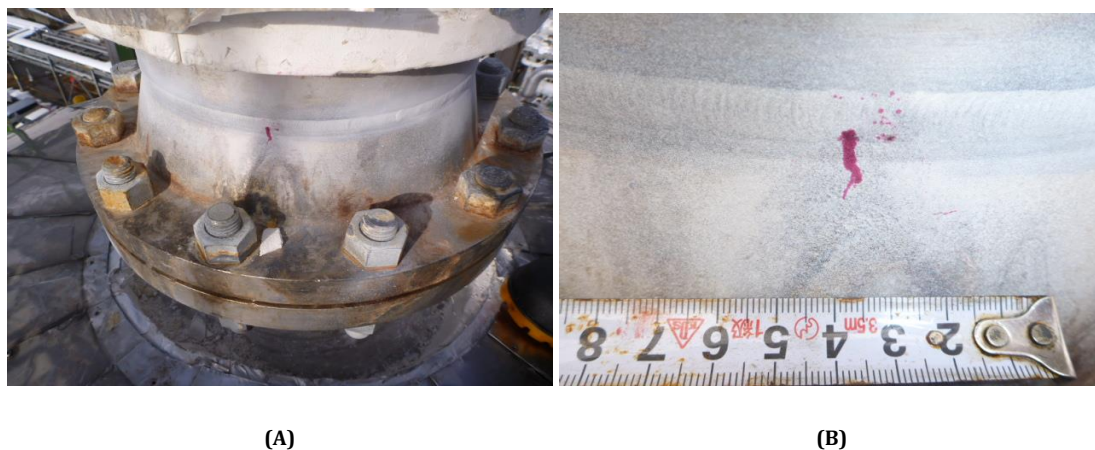
Figure 2 illustrates an example of CUI failure on an amine line. This pipe, made of type 304L, exhibited external stress corrosion cracking during an inspection after 20 years of use. The design temperature of this pipe was 130 °C, falling within the temperature range of concern for stress corrosion cracking according to API RP583. What was distinctive about this case was the cracks at the welds between the pipe and flanges and in their vicinity. It is hypothesized that the heat affected during pipe fabrication sensitized the material and introduced residual welding stresses, potentially promoting SCC. At that time, moisture-absorbent glass wool insulation was widely used, and external coatings specifically for CUI prevention were not considered. As a result of numerous similar cases, the use of water-repellent insulation materials and external coatings started to be actively explored, even for stainless steel equipment.

FIGURE 2: (A) SHOWS THE PHOTOGRAPH OF ECSCC AT TYPE 304L PIPE WELDS, (B) SHOWS ITS ENLARGEMENT

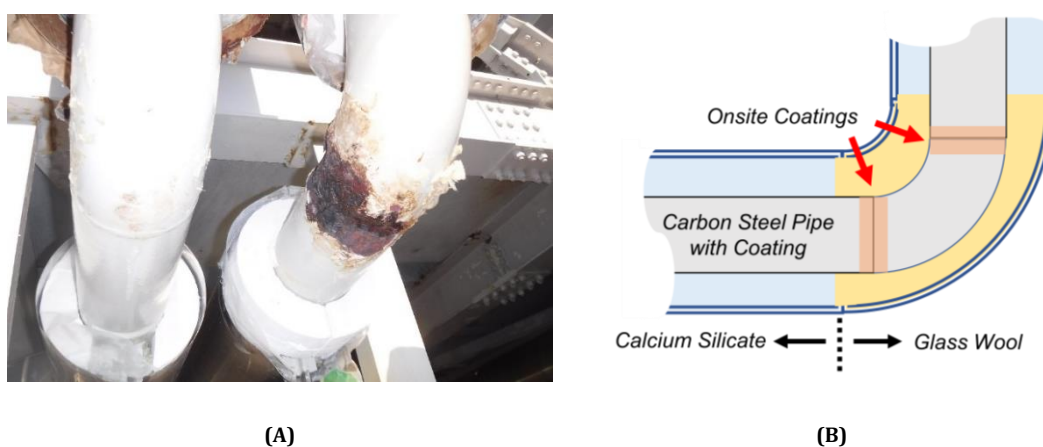
Figure 3 illustrates an example of CUI failure on a hot water line with an external coating. The original thickness of the pipe was 7.1 mm, and after 91 months of usage, it developed leakage, indicating a corrosion rate of 0.93 mm/year. The operating temperature of the line was 80 °C, which falls within the temperature range of concern for high corrosion rates according to API RP583. What was notable about this pipe was the occurrence of localized CUI around the area where the coating was damaged. This example demonstrates that CUI can occur even in piping where coatings have been applied.

FIGURE 3: (A) SHOWS THE PHOTOGRAPH OF CUI WITH COATING DAMAGE, (B) SHOWS THE SCHEMATIC DIAGRAM ILLUSTRATING CUI WITH COATING DAMAGE
