Preliminary Survey Report for Jagersfontein

Orthophotos, Topographic Surveys (DEM),
and Reconstructed Surfaces Produced
from Archive Satellite Imagery

First: January 20th, 2023

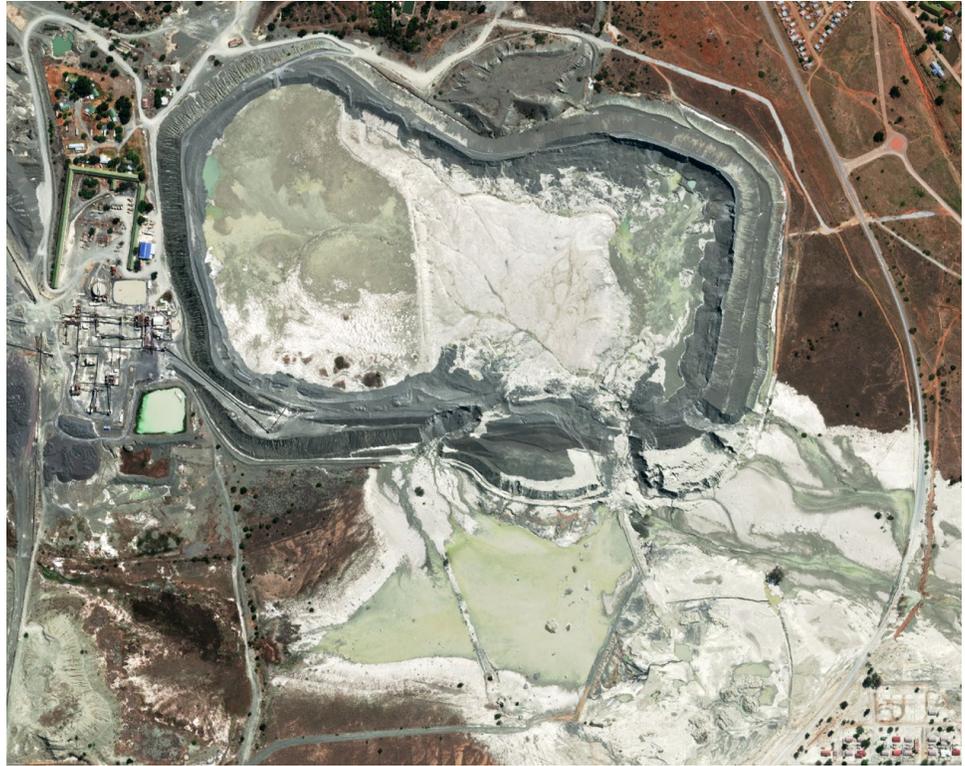
Figure 14: WV-2 satellite image for September 24th 2022

This orthophoto (Fig. 14) shows the Jagersfontein TSF in 2022, five days after the collapse.

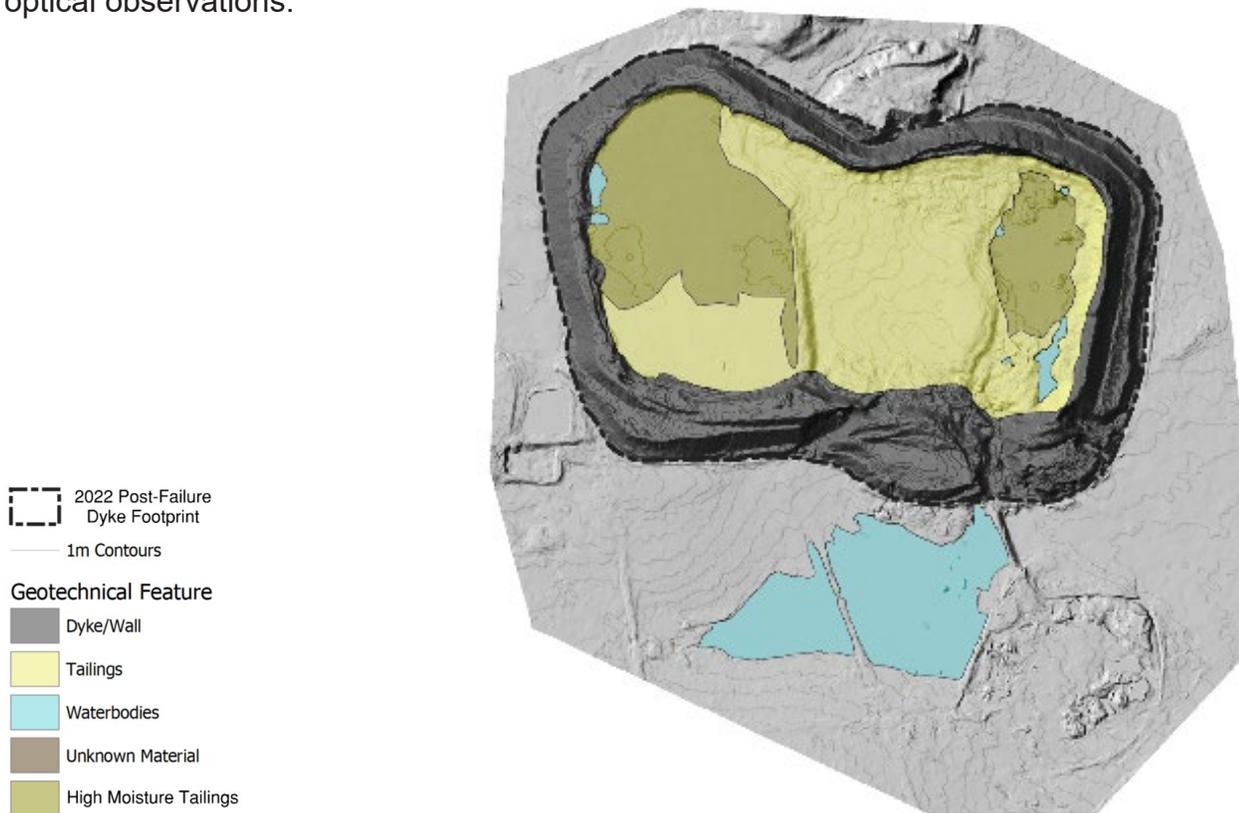
Figure 15: Component map for September 16th and September 24th

Shown below (Fig. 15) is a 3D topographic surface with segregated components with 1m contours and footprint of the 2022 TSF overlaid. Areas of high moisture tailings were determined using spectral analysis cross-referenced with optical observations.

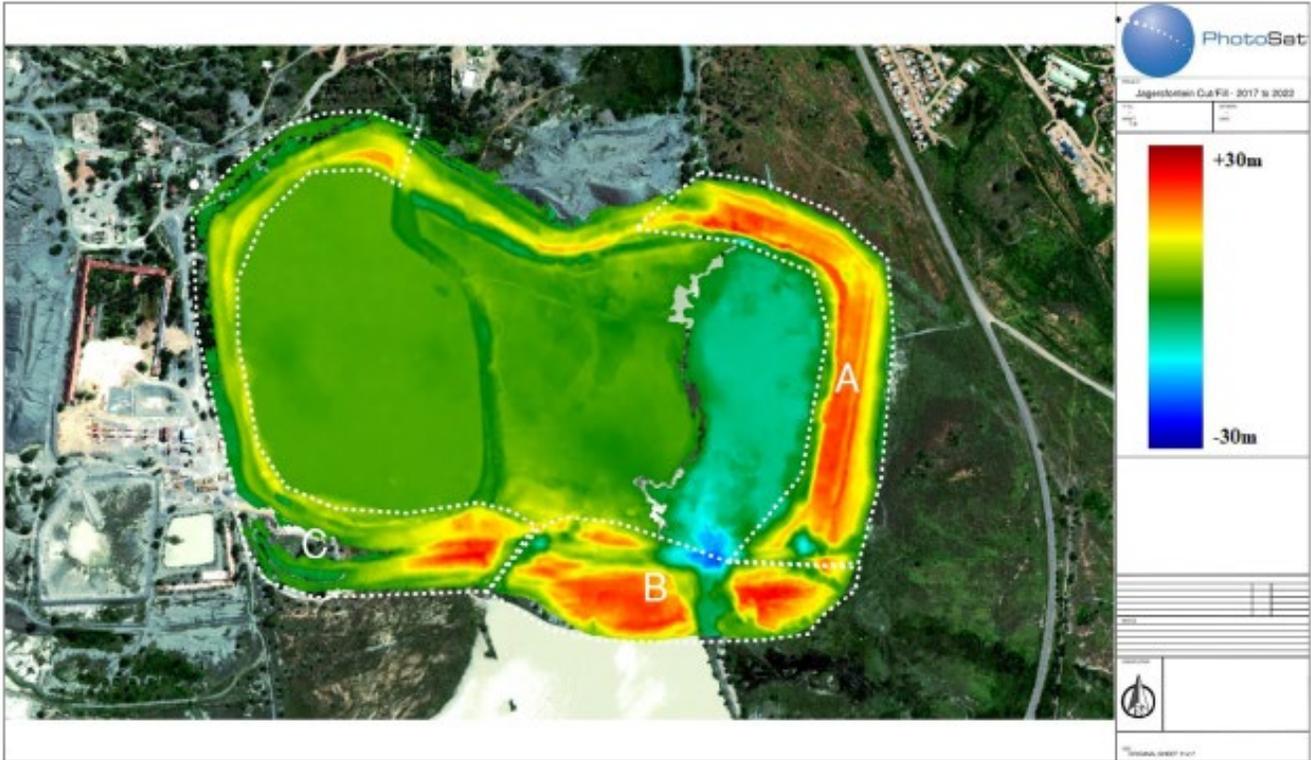
Figure 30: Cut and fill map from 2017 to 2022 post-failure surface

Zone	Area (sq.m)	Fill (cu. m)	Cut (cu.m)	Net (cu.m)
A	87,000	981,000	4,000	977,000
B	130,000	1,185,000	76,000	1,109,000
C	101,000	336,000	24,000	312,000
Total*	848,000	4,116,000	656,000	3,460,000

Table 4: Cut and fill volumes from 2017 to 2022 post-failure surface

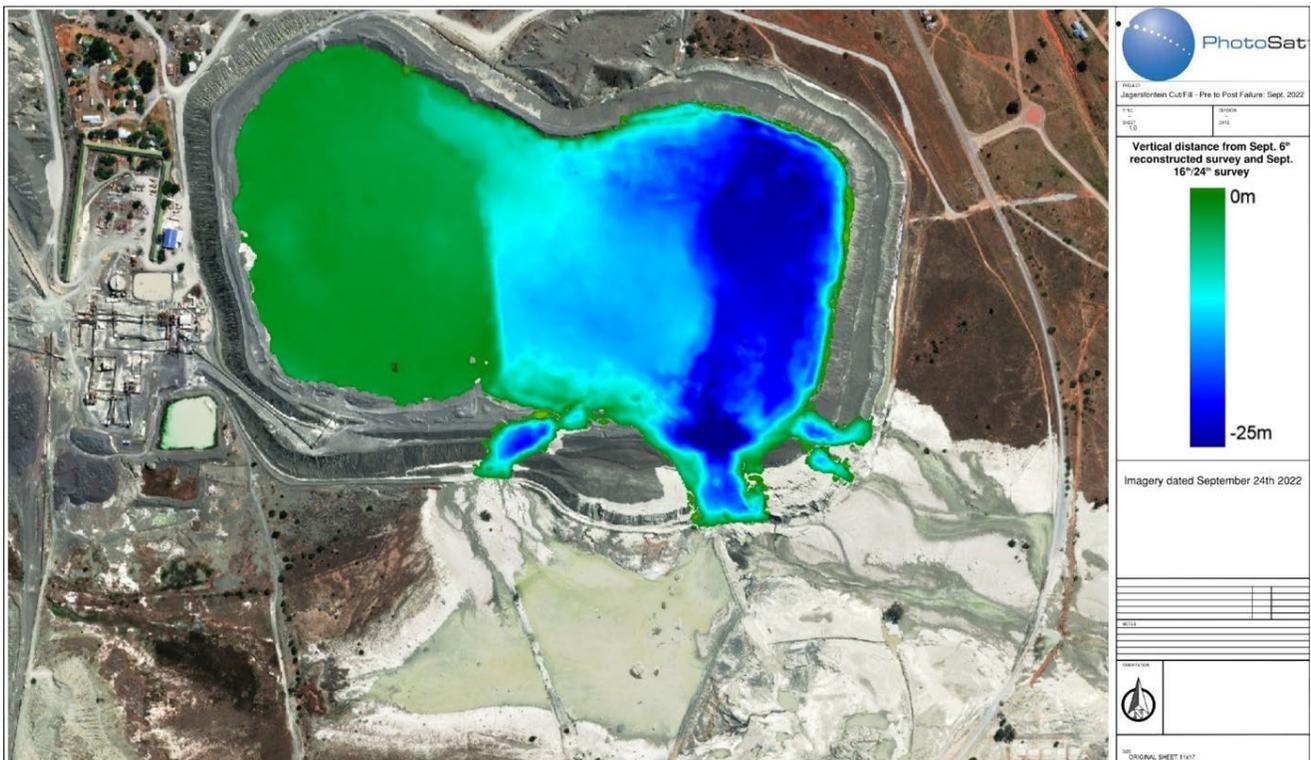
Figure 31: Cut and fill map from 2022 pre-failure to post-failure surface

Preliminary results show that approximately 5,040,000 cubic meters of material was released (page 23).

Zone	Area (sq.m)	Fill (cu. m)	Cut (cu.m)	Net (cu.m)
Embankment Structure	80,000	10,000	660,000	-650,000
Tailings	475,000	-	4,390,000	-4,390,000
TOTAL	555,000	10,000	5,050,000	-5,040,000

Table 5: Cut and fill volumes from 2022 pre-failure to post-failure surface

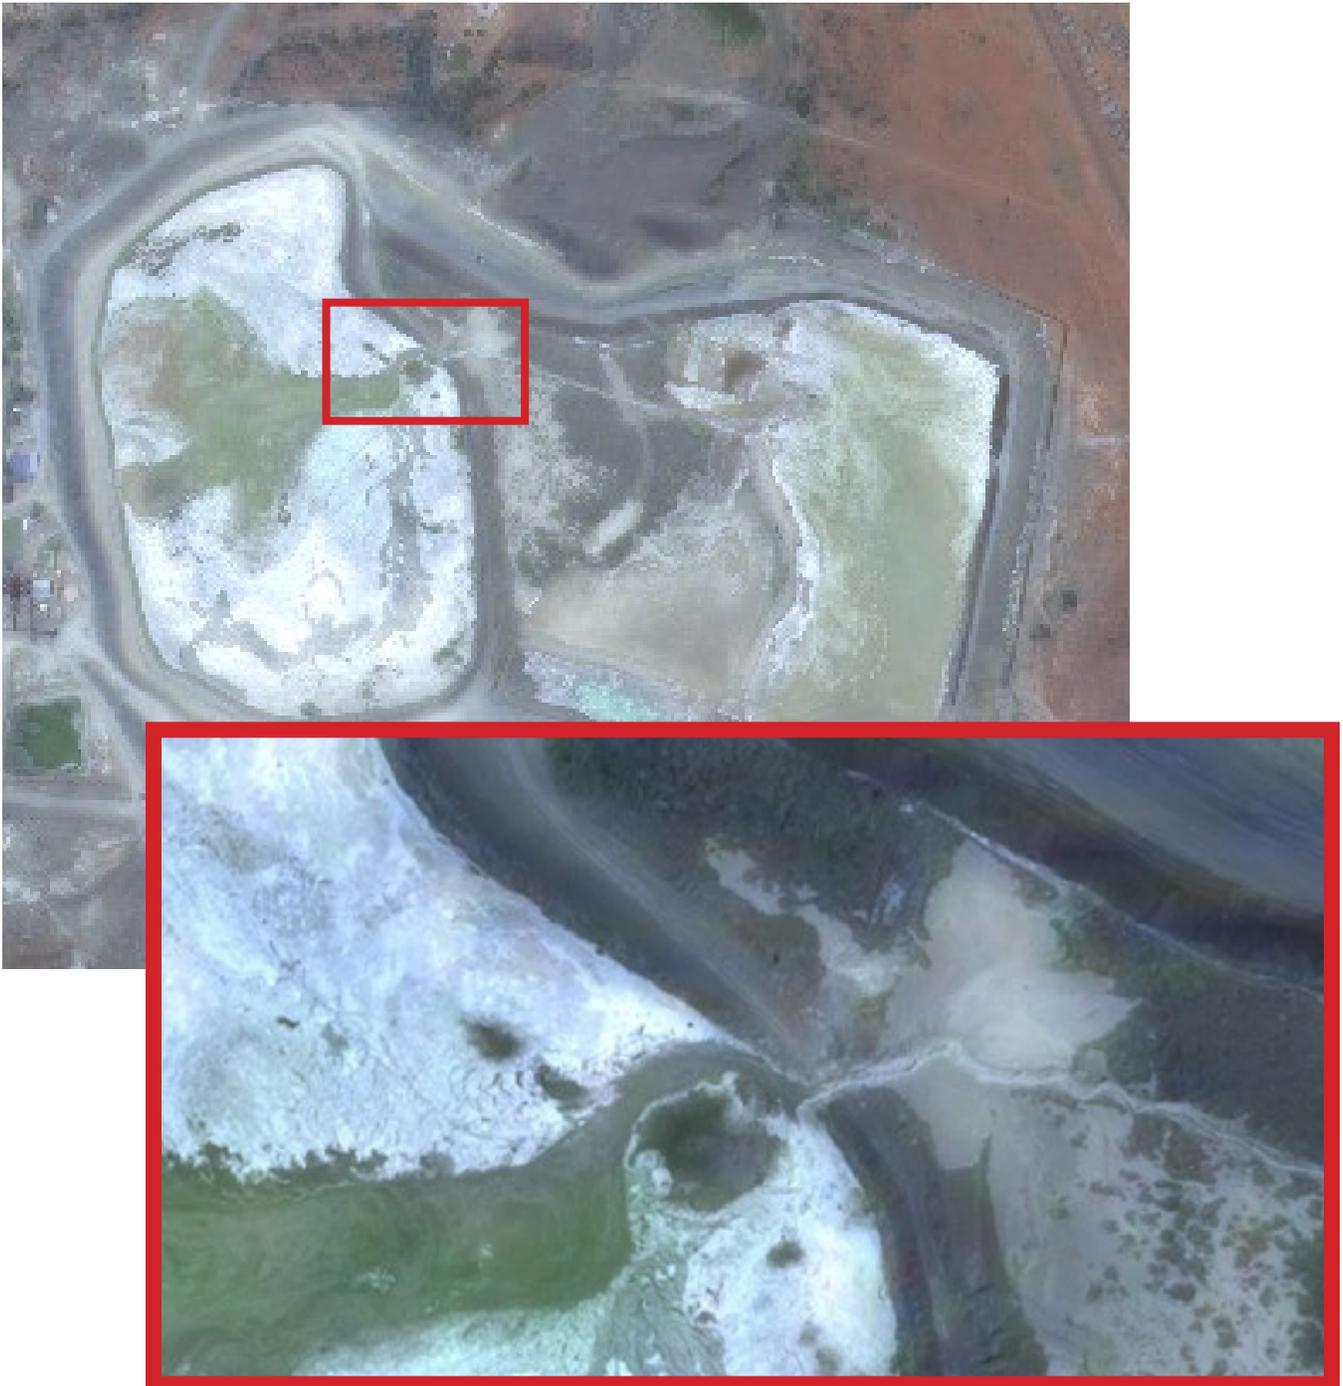
Figure 36: Spillway in dividing wall from October 19th 2017

There is a spillway visible in the dividing wall, shown below in Figure 36.
