Failure Analysis of Glass Fibre Reinforced Plastic Pipe Produced by Filament Winding Technique

Souvik Das · Gulshan Kumar · Ravikrishna Chatti · Soumendu Monia ·
Sunita Dey · Anup Kumar · Goutam Mukhopadhyay

Submitted: 3 September 2023 / in revised form: 20 October 2023 / Accepted: 29 October 2023
© ASM International 2023

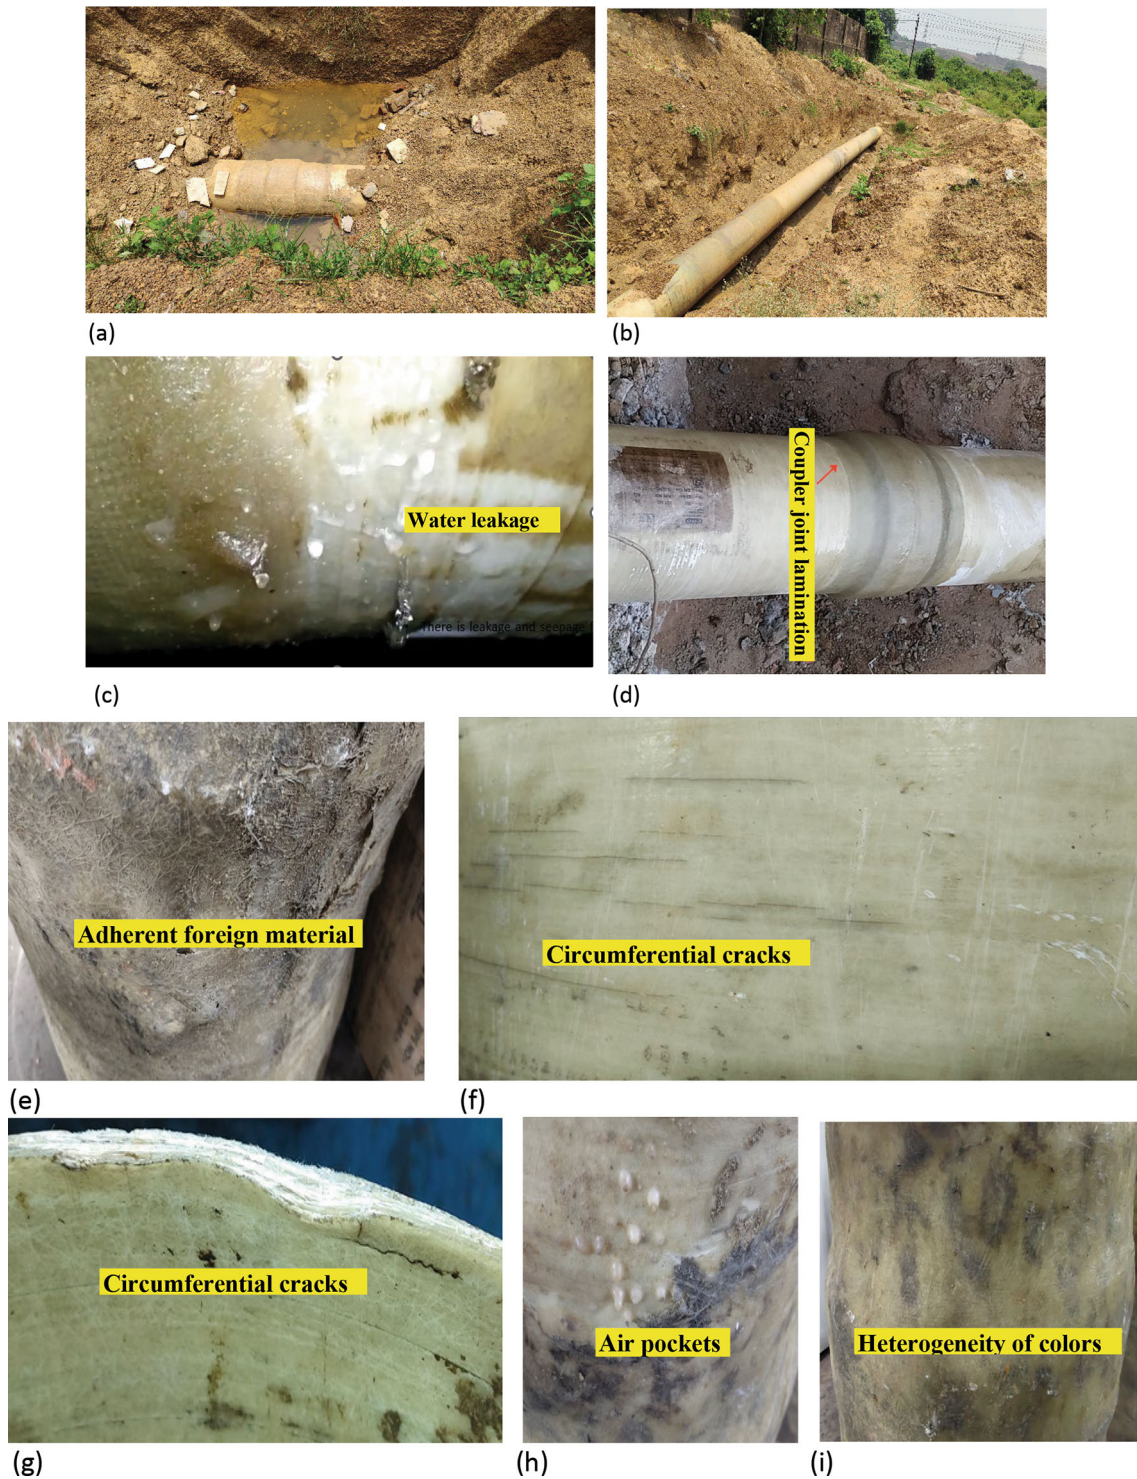
Fig. 2 (a, b) Site visit images at one of the locations (Graveyard) (c) Leakage through main pipe body (d) Coupler joint lamination where seepage was observed (e–i) Visual observations of unused pipe sample reveals abnormal features

Site visit was done in graveyard area where a 270-m length GFRP pipeline was laid (Fig. 2a and b). The then condition of site was not consistent to that of required for installation.

However, as per the construction team member present there, there was no maintenance of site for the previous few months. So, no conclusive remarks can be made about soil conditions. Hydrostatic test was carried out to find the internal soundness of the pipe before final laying. The test involves filling the vessel or pipe system with water, which stained to aid in visual leak detection, and pressurization of the vessel to the specified test pressure as per ASME B31 [9]. Pressure tightness was tested by shutting off the supply valve and observing whether there is a pressure loss. During laying of pipe of around 4500 m long leakage was observed during hydrostatic test. Hydrotest were carried out in all 9-10 locations, where pipeline was laid. At all locations, leakage along the joints was observed (Fig. 2c), lamination was done at all the joints where leakage was

observed (Fig. 2d). After providing lamination at joints, leakage was stopped however hydrotest failed as pressure droppage was observed due to seepage from the main pipe body and leakage could not be detected since most part of pipeline is underground and not visible, except joints.

Two sets of GRP pipe samples were collected from the manufacturer and construction site for characterization to find out the root cause of failure. The hydrotest failed pipe where leakage was found during testing was collected from the construction site. However, the leaked sample has a coupler joint within it and a thick layer of lamination was observed on it. Therefore, the location of leakage is not clear. Good pipe refers to the part of pipe which was passed though hydro test. Visual observations of leaked pipe sample reveal some abnormal features like reveals 2 abnormal features like delamination of layers, crack marks, circumferential cracks, and white spots (Fig. 2e, f, g, h, and i). Circumferential cracks are caused due to excess resin cured without glass fibre reinforcement, or resin cured at too high a temperature. Delamination of layers are caused due to too much sand being added during the

manufacturing process. In certain locations air pockets, adherent foreign materials, visible fibres, and heterogeneity of colours were also observed. Visual observations of good pipe sample don't reveal any such abnormal features.

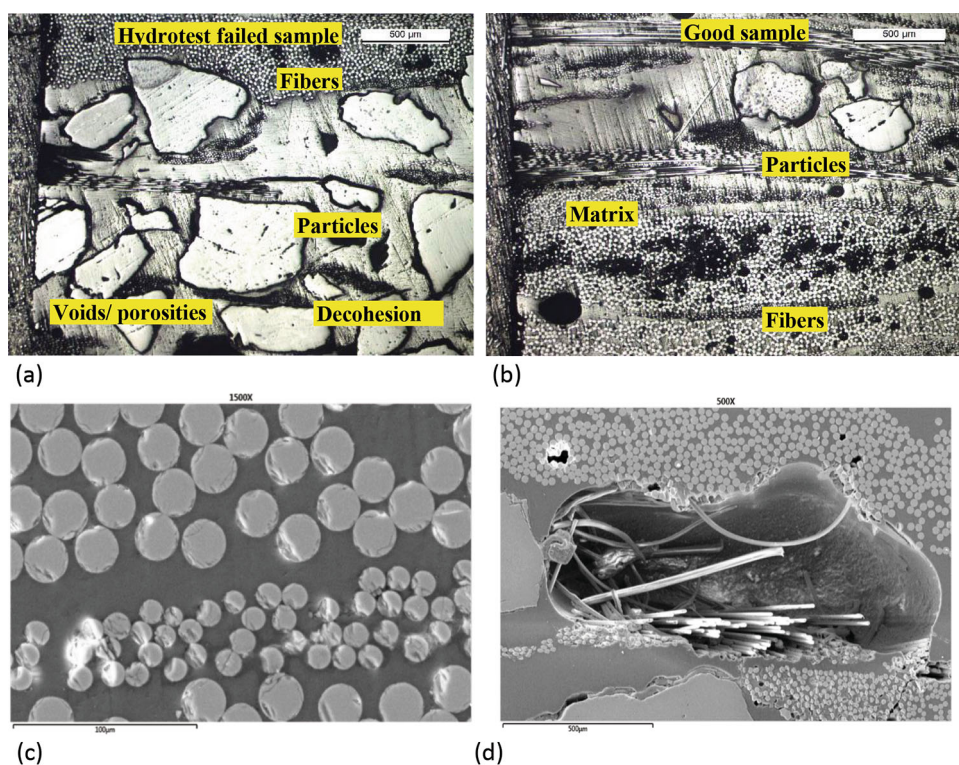
Fig. 3 (a) Microstructural examination of hydro failed pipe (b) Microstructural examination of good pipe (c) Non-uniform and varying size of fibres of hydro failed pipe (d) Large void with entangled fibres trapped inside hydro failed pipe

the fibres. In case of hydrotest failed samples, volume fraction of fibres was observed to be very less compared to resin matrix; distribution of fibres was observed to be non-uniform (Fig. 3a). Numerous voids or porosities were observed in the sample compared to those of good FRP Pipe sample. Plenty of particle like features were observed in the matrix. Decohesion or separation between the matrix and particles were distinctly observed (Fig. 3a and b).

Fibres were non-uniform and varying in size and large voids with entangled fibres inside observed for the hydrotest failed samples (Fig. 3c and d).

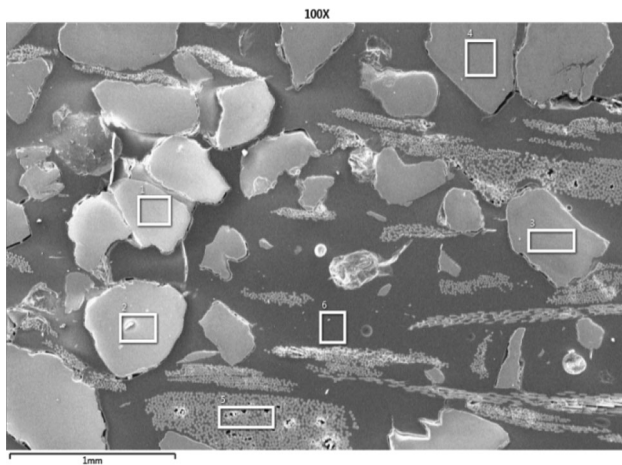
Fig. 4 EDX analysis of the hydrotest failed pipe sample

different phases present in the samples. The analyses were performed at 15 keV accelerating voltage and 510–8 A probe current. The GRP pipes were coated with gold using a vacuum coater. The gold contribution was manually subtracted from the final EDX data. EDX analysis of particles shows significant content of Si and O suggesting presence of sand (50–90%) as shown in Table 1.

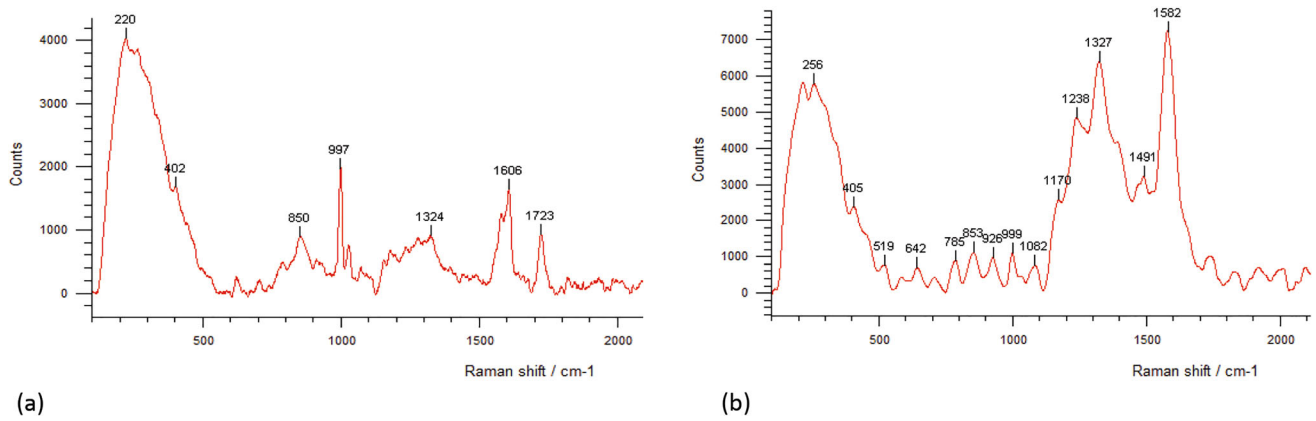
Fig. 5 Raman spectroscopy analysis (a) hydrotest failed pipe sample (b) good pipe sample

In case of hydro test failed pipe sample terephthalic acid (TPA) and isophthalic acid (IPA) peaks along with orthophthalic acid (OPA) peaks were observed which

indicates the resin material is not pure. Whereas in the good GRP pipe only, terephthalic acid (TPA) peaks were observed and the absence of isophthalic acid (IPA) and orthophthalic acid (OPA) peaks indicates high purity of resin sample in good GRP pipe [11, 12].

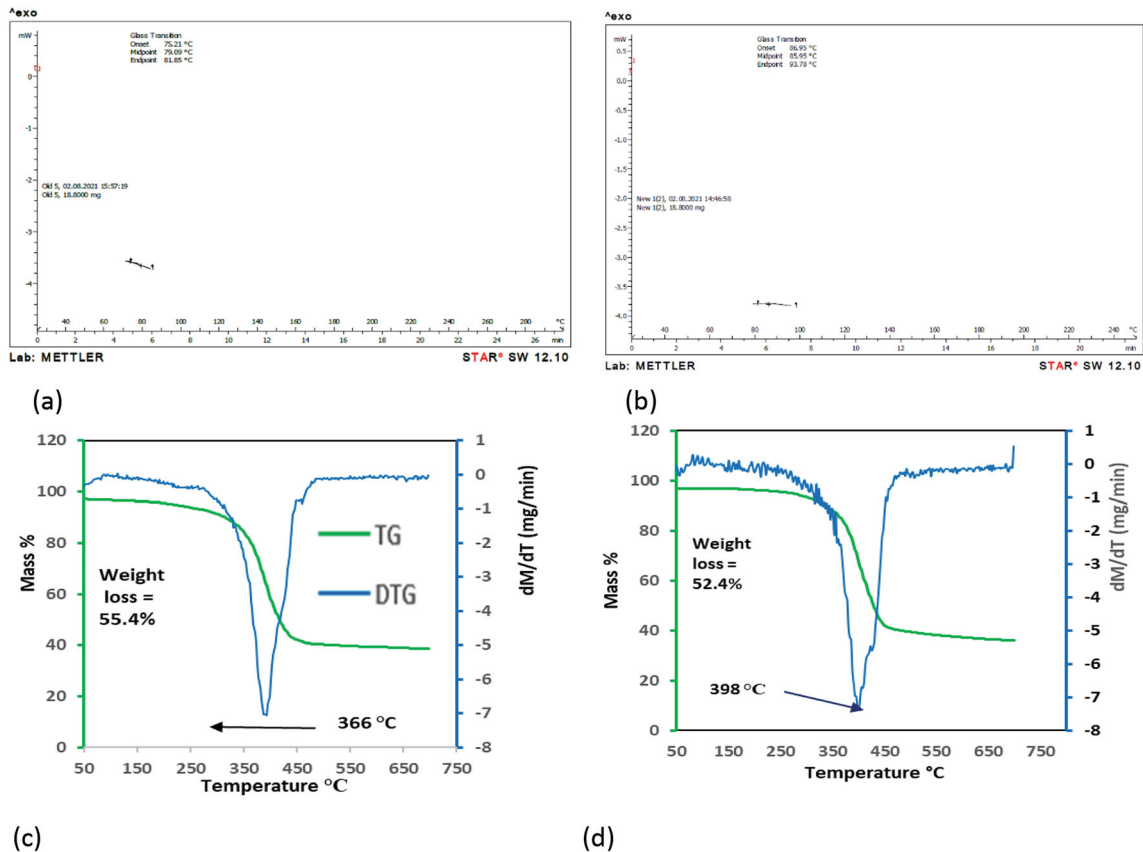
Fig. 6 TG and DTG analysis (a) hydrotest failed sample (b) good pipe sample

Thermogravimetric (*TG*) curve indicates weight loss as a function of temperature. Derivative thermogravimetric (DTG) curve Indicates rate of weight loss as a function of temperature. Highest weight loss (55.4 %) was observed for hydrotest failed pipe sample, whereas good pipe sample

(52.4%) showed incrementally lower values. The decomposition temperature of hydrotest failed pipe sample at 366 °C was lower than good pipe sample (393 °C). This indicates that hydrotest failed pipe is relatively less thermally stable (Fig. 6c and d). With the increase in temperature, the ring stiffness, bending strength and damage displacement of GFRP pipes will show a decreasing trend for the hydrotest failed pipe sample. Both temperature and continuous fibre content have essential effects on the damage mode [13, 14].

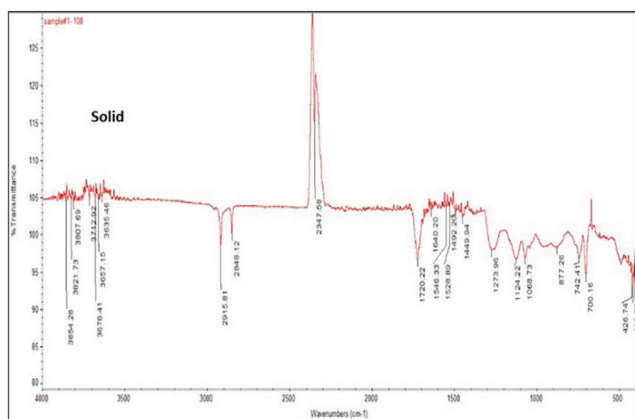
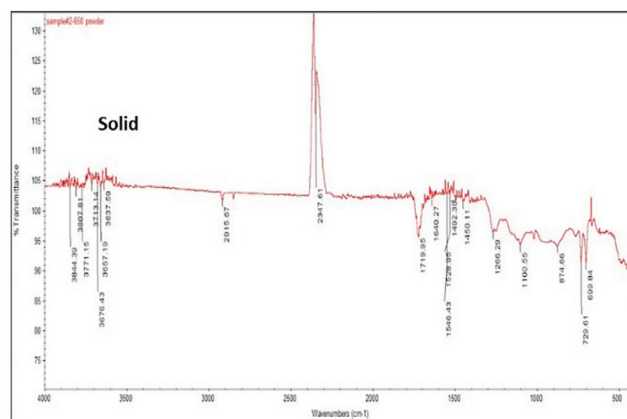
Fig. 7 Fourier transform infrared spectrophotometers (FTIR) analysis (a) hydrotest failed pipe sample (b) good pipe sample

The FTIR analysis was done using a Nicolet Magna 550 Fourier transform infrared spectroscopy (FTIR) analyzer with a resolution of 4 cm⁻¹ in the range of 400–4000 cm⁻¹ wave number. FTIR analysis shows that the intensity of FTIR peaks for leaked or used pipe was lower than that of new or unused pipe. Peak assignments for both the samples are presented in Fig. 7a and b, and Table 4. From these observations, it is seen that peak position 1643 cm⁻¹ is present in case of the leaked pipe sample which is a characteristic assignment for TPA [15]. Thus, the leaked pipe sample is not pure in form which can also be correlated to observations of Raman analysis and is prone to failure.
