The failure mechanism of field polyethylene gas pipeline with gas leakage at electrofusion joint

Purpose – A section of in-service PE gas pipeline in Guocun, Beijing, was found to appear gas leaking at the electrofusion (EF) joint. This study is dedicated to reveal the material cause of EF joint failure to help with a more accurate prediction of service life of PE gas pipe and further normalize the construction of PE gas pipeline.

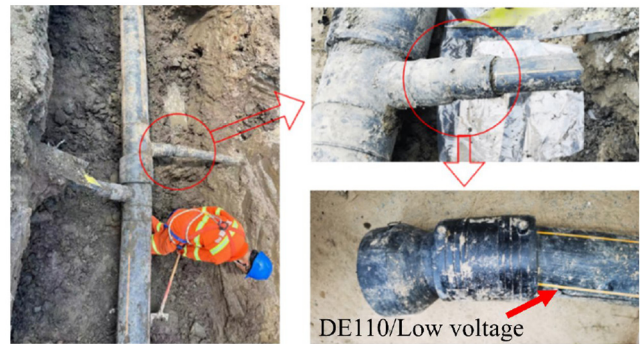
Figure 1 The emergency repair construction site and gas leakage location

In 2022, a gas leak incident transpired in Guocun Village, located within Yujiawu Township in Tongzhou District. The leak emerged at the EF joint after five years of service. The soil surrounding the leak site, at a depth of 0.8 m, was characterized as dry, coarse and sandy. The root cause of the gas leak was traced to the height discrepancy between the branch pipe and the main pipe, which induced excessive bending stress on the EF joint, ultimately leading to the exposure of the heating wire. Figure 1 depicts the emergency repair construction site and pinpoints the precise location of the leak. The compromised EF joint and the PE pipe (P1) were retrieved for subsequent laboratory analysis. It is worth noting that the pristine pipe (P2) shares the same material composition and manufacturing process as the pipe that was in service.

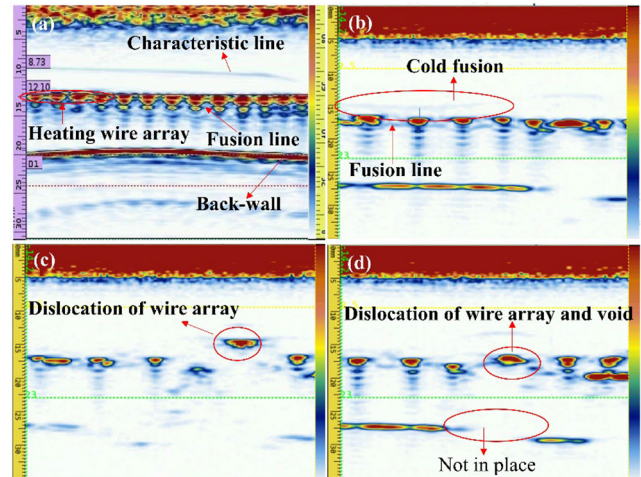
Figure 2 Phased array mapping, (a) normal EF joints; (b)–(c) failed EF joints

In Figure 2(a), a normal EF joint is characterized in well-organized resistance wires without any notable dislocations in the ultrasound image. The characteristic line above the heat wires is in right place. The inner wall of the EF fittings integrates seamlessly with the pipe material, and a fusion line is visible on the image. This fusion line is situated at a set distance

below the heat wire and runs parallel to the back-wall. Due to interference from the wire signal, fusion line can be seen as a connection line between different wire signals. Apart from the wire signal, there are no notable brightening, thickening or disappearance phenomena. The inner wall of the pipe displays a continuous and clear signal, and there are no other obvious signals in the welding area (Shin *et al.*, 2003).

In Figure 2(b), the distance between the characteristic line (the boundary between the molten and unmolten areas of the pipe or pipe fitting, marked by a red circle) and the wire is shorter than the standard, indicating a cold fusion in EF joint (Frederick *et al.*, 2010). According to DB 31/T1058-2017 standard, the cold fusion degree H is 48%. In Figure 2(c), the heating wire distribution appears uneven due to displacement during the welding process. Typically, over-welding is accompanied by such displacement defects in the heating wire. Figure 2(d) reveals a complete absence of signal at the echo of the pipe's inner wall. Concurrently, over-welding has led to displacement and hole defects in the upper heating wire. This incomplete socketing occurs when the pipe's insertion depth is insufficient to cover the heating wire, resulting in an over-welding phenomenon.

The ultrasound phased array technology effectively highlights various defects in the leaky EF joint. Under complex operational conditions, these defects can act as weak points, causing premature failure and significantly reducing the lifespan of PE pipelines.

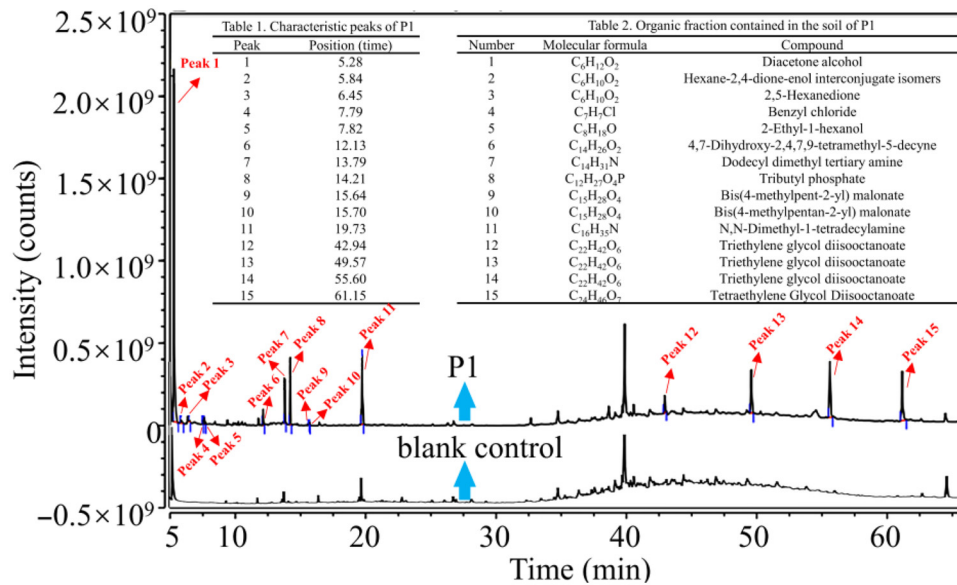
Figure 3 Results of physicochemical analysis of the soil in the service environment of P1

As depicted in Tables 1 and 2, Figure 3, the soil samples are abundantly enriched with surfactants, predominantly comprising polyesters, alcohols and amides. Notably, amide compounds exhibit distinct surface-active properties. The presence of these surfactants significantly diminishes the strength of secondary bonds between molecules. This weakening effect reduces the energy barrier for the sliding and disentangling of PE polymer chains, ultimately facilitating the formation of microcavities and stress concentration points. Consequently, the expansion energy required for microdefects to propagate decreases, leading to premature deterioration of the material's mechanical properties.

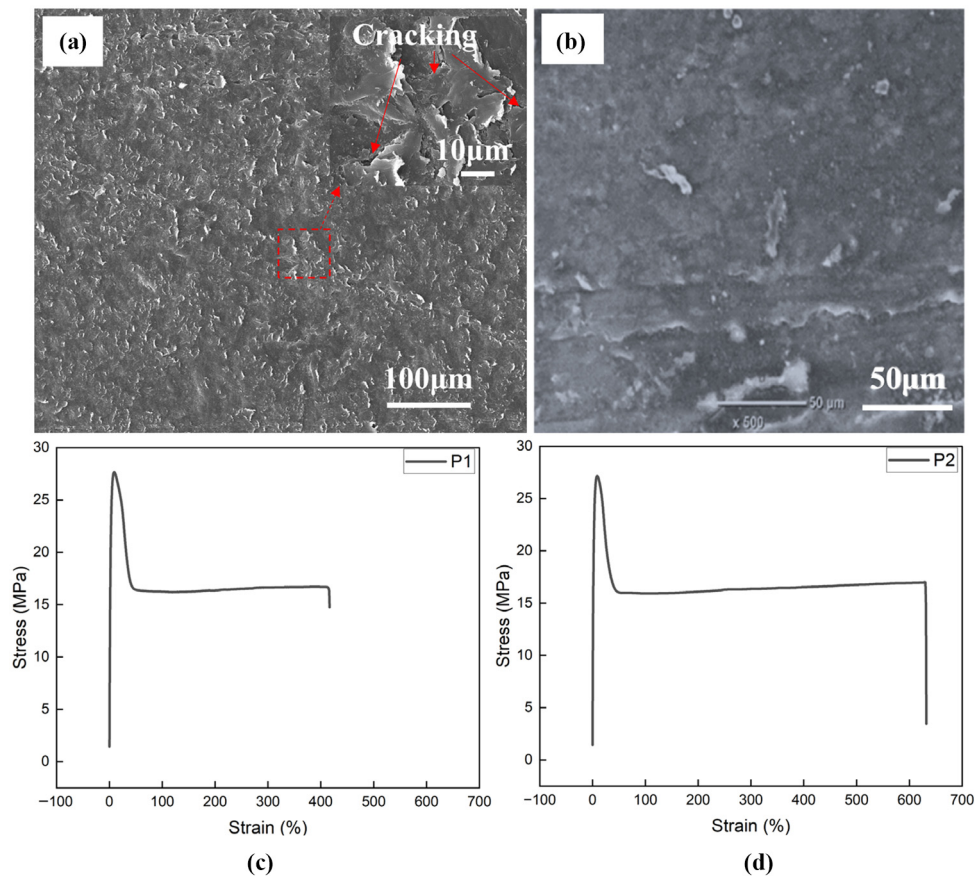
Figure 4 Microscopic morphology of the outer surface of (a) P1 and (b) P2, stress–strain curves of (c) P1 and (d) P2 pipe

Figure 4(a) and Figure 4(b) present the micrographs of the exterior surfaces of P1 and P2, respectively. As seen in Figure 4(a), the outer surface of P1 exhibits pronounced exfoliation, debris and microcracks. This exfoliation likely arises from the molecular chain scission resulting from the degradation of PE macromolecules during aging, as suggested by Larché et al. (2012). Furthermore, the presence of surfactants in the soil can decrease the energy barrier for the sliding and disentangling of PE polymer chains, contributing to the formation of microvoids. Under the combined effects of diminishing mechanical strength and anisotropic internal stresses within the sample, these microvoids tend to be the origin of microcracks (Rabello and White, 1997; Yang et al., 2008). When the mechanical

strength drops below the threshold required to contain internal stresses, minor cracks start to emerge. Conversely, Figure 4(b) reveals that the surface of P2 exhibits minimal defects, primarily consisting of minor scratches that are unavoidable during processing and transportation, maintaining an overall smooth and unblemished appearance.

been a well-established practice, with the corresponding framework continuously advancing (Guo, 1999; Li, 2012). Figure 4(c) and Figure 4(d) illustrate the stress–strain curves of P1 and P2 pipes, where P1 exhibits a tensile strength of 27.6 MPa and a yield strength of 16.5 MPa, while P2 demonstrates

slightly lower values of 27.2 MPa and 16.0 MPa. The differences in these parameters are minimal. According to the specifications outlined in GB 15558.1-2015, it is evident that both P1 (with a break elongation of 413%) and P2 (with a break elongation of 626%) meet the criterion of $\geq 350\%$. The

substantial difference in break elongation could potentially be attributed to the premature aging and brittleness of PE pipeline materials in their operational soil environment.

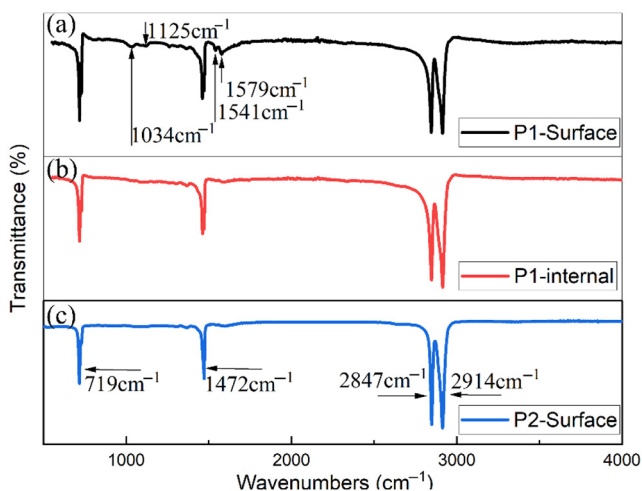
Figure 5 FTIR spectrogram

The FTIR results are depicted in Figure 5, highlighting characteristic peaks that are indicative of PE structure. Specifically, the peaks at 719 cm^{-1} , $1,472\text{ cm}^{-1}$ and $2,914\text{ cm}^{-1}$ correspond to the bending vibration of -C-H , the deformation bending of -CH_2 , and the stretching vibration of -CH , respectively (Zha et al., 2023; Chen et al., 2019). These peaks are features of PE. Moreover, the peaks at 719 cm^{-1} and $1,472\text{ cm}^{-1}$ are attributed to the crystalline phase of PE, and the prominent increase in intensity at 719 cm^{-1} signifies an enhancement in crystallinity, as evident in Figure 5(a).

Notably, on the outer surface of P1 in Figure 5(a), novel peaks emerge at $1,034\text{ cm}^{-1}$, $1,125\text{ cm}^{-1}$, $1,579\text{ cm}^{-1}$ and $1,541\text{ cm}^{-1}$. These changes are likely associated with chain scission and crosslinking reactions on the P1 surface. Short chains may participate in crosslinking reactions or bond with oxygen radicals to form ether groups (-C-O-C , within the range of $1,000\text{ cm}^{-1}$ to $1,200\text{ cm}^{-1}$) (Hu et al., 2018; Colom et al., 2003) and carbonyl groups (C=O , within the range of $1,540\text{ cm}^{-1}$ to $1,600\text{ cm}^{-1}$). Furthermore, surfactants present in the soil environment, such as ketones, carboxylic acids, peroxides and esters, can adhere to the pipe surface, resulting in additional peak formation and accelerating the aging process of PE pipe materials. It is crucial to note that these substances have not yet penetrated the interior of P1 [(as seen in Figure 5(b)); thus, its FTIR spectrum remains similar to P2 [depicted in Figure 5(c)]. As aging progresses, the degree of chain breakage and degradation in PE pipes gradually increases, potentially leading to a decrease in thermal stability.

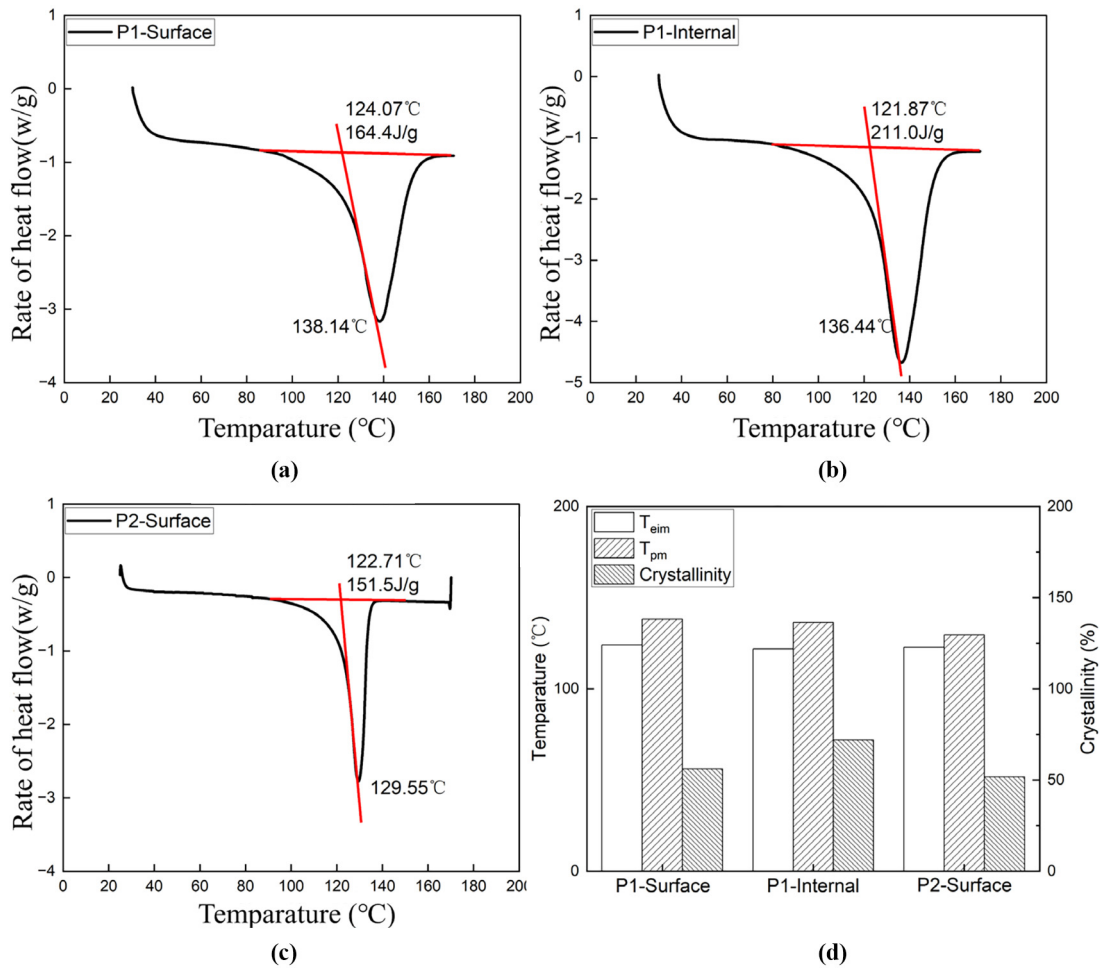
Figure 6 (a), (b), (c) DSC results of P1-Surface, P1-Internal and P2-Surface, (d) Transition temperature and crystallinity of service pipe

Crystallinity refers to the proportion of crystalline area in a polymer, which reflects the regularity of the internal structure of the material. High crystallinity indicates great impact strength but poor ductility. The DSC curves of P1 and P2 are shown in Figure 6(a)–Figure 6(c).

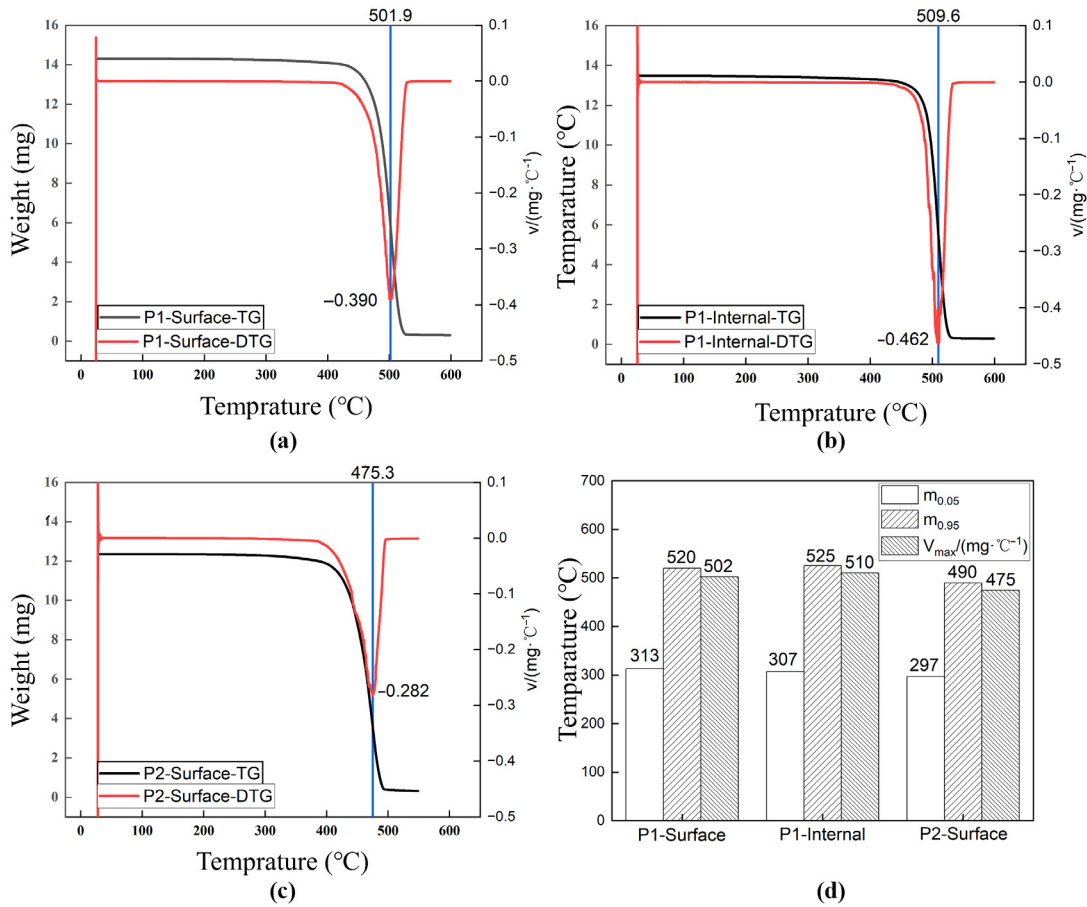
Figure 7 TG curves of (a), (b) P1 and (c) P2, (d) transition temperature and crystallinity of service pipe

The thermal decomposition behavior of PE pipes is shown in Figure 7(a)–Figure 7(c). As the thermal decomposition temperature increases, the weight of PE pipes decreases continuously. The thermal decomposition behavior of PE pipes at different locations varies. P1 and P2 have the maximal rate of thermal degradation between 400 and 500°C . And, the final mass loss of P1 and P2 reaches more than 97%. It can be seen that all TG plots are similar to each other and have only one platform, indicating that the thermal degradation of buried PE gas pipes during service is a one-step process (Huo et al., 2013; Xu et al., 2010), which is related to random chain scission and free radical formation.

thermal decomposition temperature of P1 increases with the extension of aging time, indicating that aging has an impact on the maximum thermal decomposition temperature of PE. This may be related to the increase of crystallinity of P1, which leads to more regular segments of PE polymer and increases the energy required for material decomposition. In addition, fewer amorphous segments that are easier melting decomposition cause further increases of the decomposition temperature.

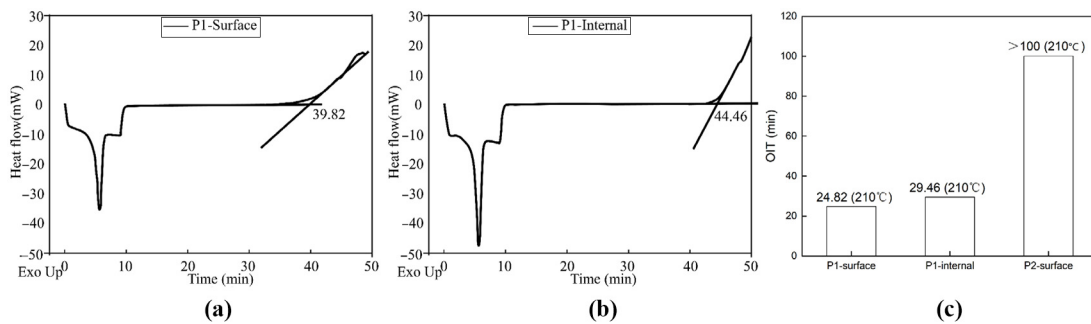
Figure 8 (a, b) OIT test of P1-Surface and P1-Internal, respectively, (c) OIT results

Figure 8(c) shows that the OIT of P1 was significantly higher than that of P2 (100 min, much larger than 24.82 min). The outer surface groups of PE pipe were stimulated by the surfactants and oxidized rapidly, generating a large number of free radicals, which weakened the antioxidant capacity and thermo-oxidative stability of PE pipe. At the same time, oxygen penetrates into the interior of the pipe through surface defects and consumes a large amount of antioxidants. Pipe degradation becomes dominant (Miao *et al.*, 2017). Thus, the antioxidant properties of both the interior and outer surface of the pipe deteriorate.
