Feedback from the bituminous geomembrane (BGM) implemented 20 years ago at the Galaube dam

ABSTRACT: The Galaube dam is a 40 m high French rockfill dam commissioned in 2001. The upstream facing is ensured by a 4.6 mm thick bituminous geomembrane (BGM) directly laid on a cold mix layer and an impregnated layer gavel.

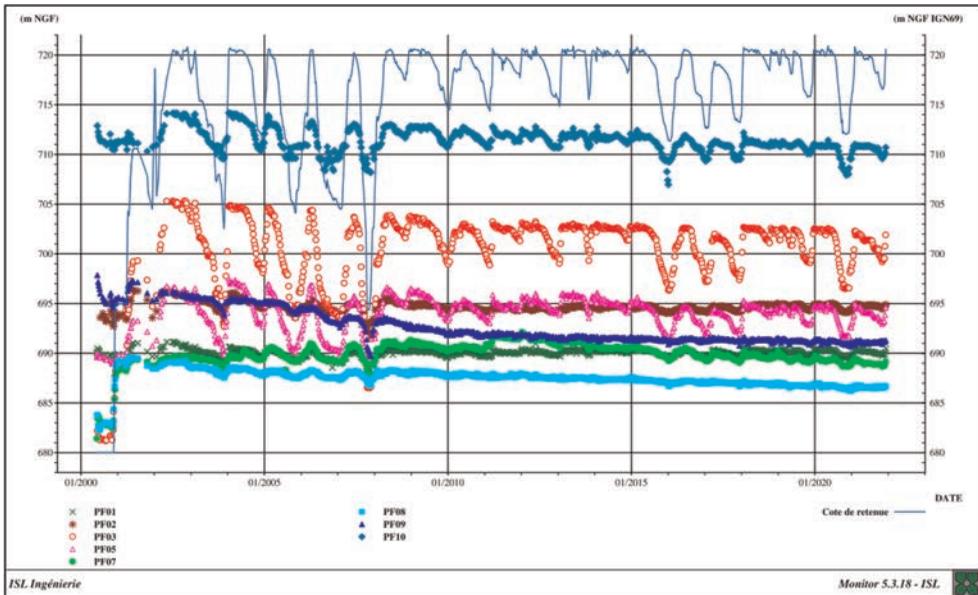
Figure 3. Time evolution of the piezometric levels in the foundation, downstream of the plinth.

The piezometry at the downstream foot of the plinth (Figures 3 and 6) appears to be well draw down with a low (less than 30%) to very low (less than 10%) dependence on the reservoir level. Only PF03 piezometer shows particularly sensitive to the level of the reservoir

and reacts by faithfully reproducing the reservoir curve. This singular behavior, detected immediately after the first filling, is not reproduced by its neighbors (PF07 and PF08). As PF03 is drilled in a zone where the rock is of good quality and low permeability, it is likely that PF03 measures a singularity of piezometry, for example by capturing a fine fissure, where pressures can become high due to the low permeability of the medium. Watertightness of the geomembrane is therefore not in question.

Overall, the analysis of piezometric levels downstream of the plinth over the period 2001–2021, shows that they are constantly decreasing since impoundment, on average by about -10 cm/year. It is most certainly a consequence of the progressive sealing of the upstream foot of the dam in connection with the progressive silting of the reservoir.

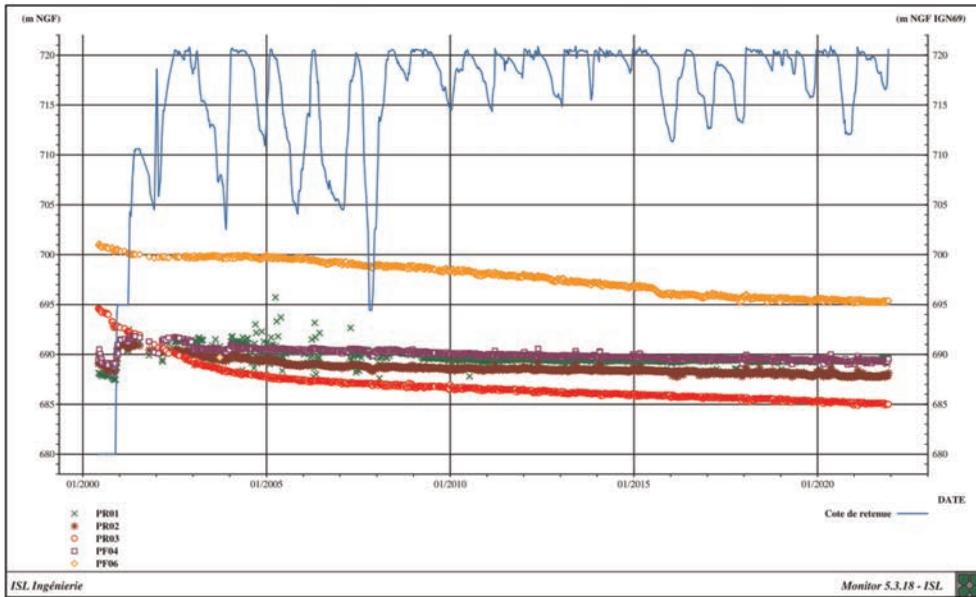
Figure 4. Time evolution of the piezometric levels at the interface of the dam body and the foundation.

In the axis of the dam (Figure 4), PF06 and PR03 were apparently above the piezometric level at the first filling but they have shown a continuous decrease since then confirming the very good behaviour of the upstream facing. The piezometry at the bottom of the valley (Figure 4, PR01, PR02, PF04), is quite homogeneous under 690 m NGF, which corresponds to the foundation level of the dam in this area. The rockfill, which is very draining, does not allow piezometry to develop.

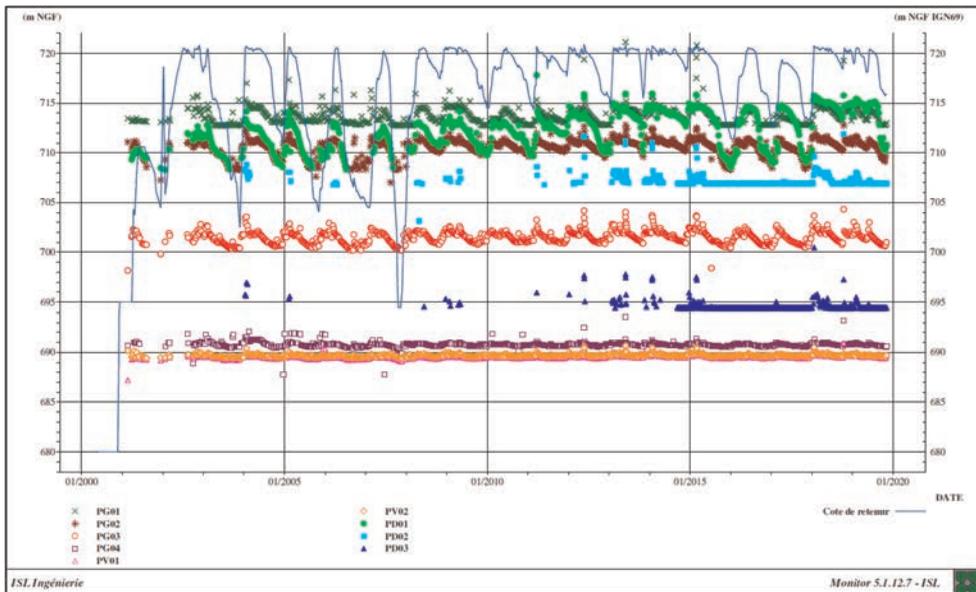
Figure 5. Time evolution of piezometric levels downstream of the dam and on the riverbank.

Regarding the piezometry downstream of the dam (Figure 5), only the piezometers at the top of the bank (PD01, PG01 and PG02) reacted to first filling and show now a strong dependence on the reservoir level. These piezometers are the closest to the reservoir and they are located in an area (the upper bank) where the foundation is permeable (upper left bank made up of deeply altered granite, and upper right bank where there is an interface between the granite foundation of the dam and the shale that overhangs it). All these piezometers are traditionally influenced by weather conditions, especially the heaviest rainfall events which lead to reversible peaks.

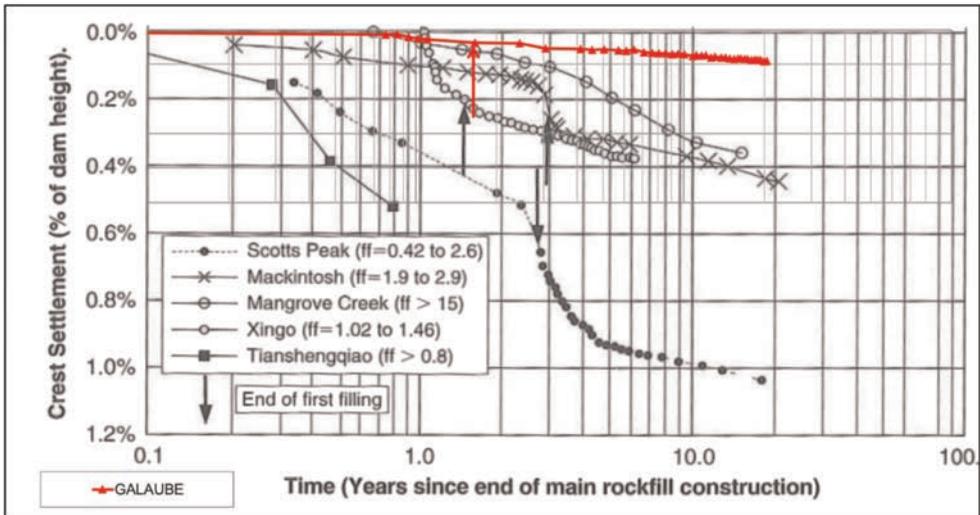
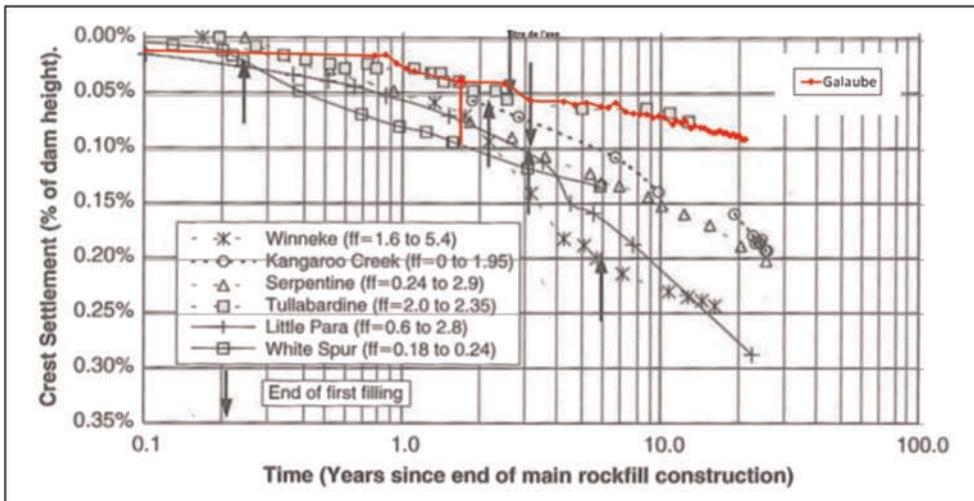
- The proven behavior of the structure: it has settled very few in practice (cumulative settlement less than 4 cm at the crest, i.e. less than 0.1% of the total height of the dam) and less than most upstream facing rockfill structures of the same type (see comparison in the graphs on Figure 7 and Figure 8 with 11 well compacted dams, i.e. with materials of medium to high quality $20 < RC < 70$ MPa) ;
- The precautions taken during the construction phase to compact the rockfill, in particular: a maximum layer thickness of 80 cm, a minimum of 8 passes (one way) of a heavy smooth

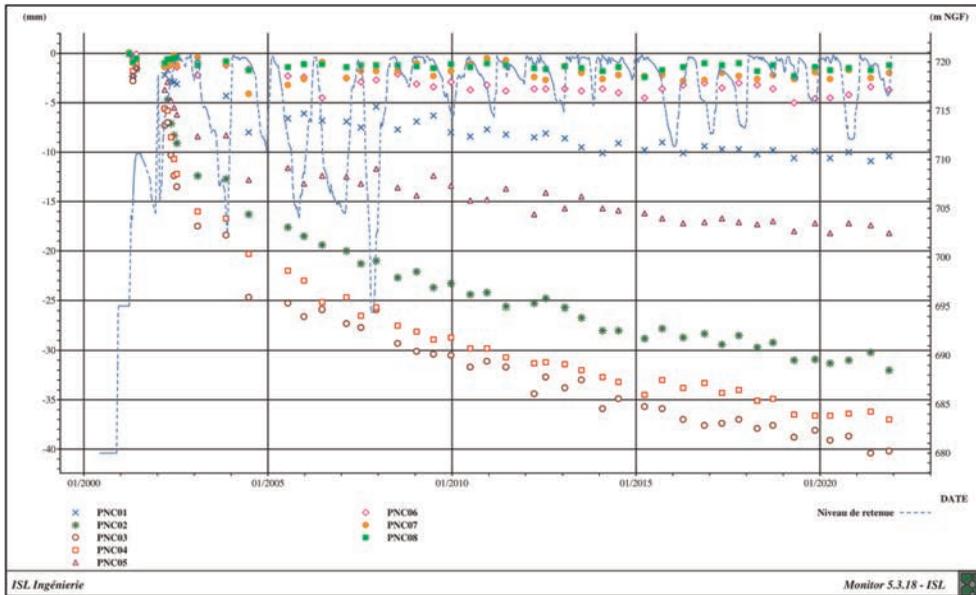
Figure 9. Time evolution of crest elevation measurements.

It should be noted that a slight elevation of the dam crest was recorded (of the order of 1 to 2 mm and visible on all the height benchmarks on the crest of the dam), during the emptying (cf. Figure 9). This is a mechanical consequence of the decrease in hydrostatic

pressures of the reservoir on the upstream face of the structure (decompression of the rockfill).

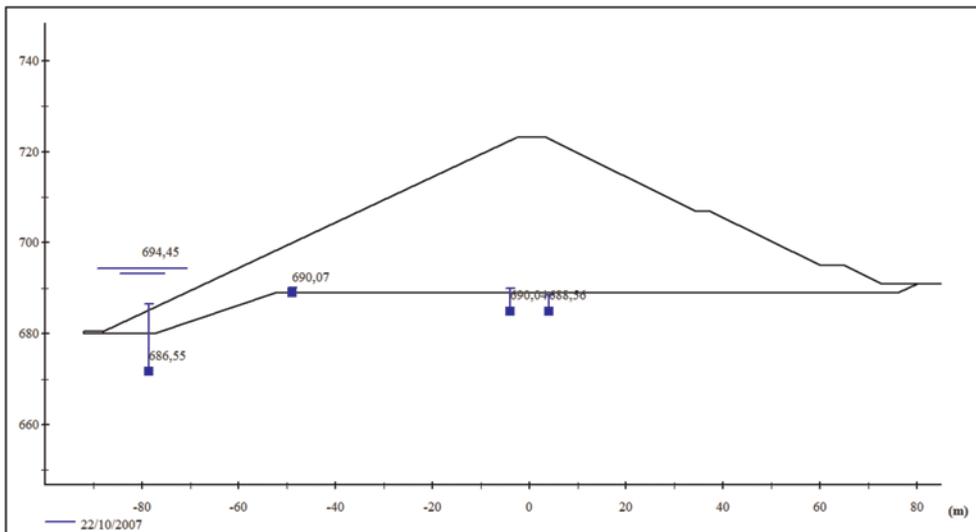
Figure 10. Maximum piezometry downstream of the plinth at the time of the 2007 reservoir emptying.

It was also checked that the under-pressure behind the facing remained below the hydrostatic pressure exerted by the reservoir on the facing, which did not create a risk of lifting the geomembrane or the concrete protection slabs (cf. Figure 10).
