# **SUBACUATIC REPAIRS OF A HDPE LINER SYSTEM BY USING AN ASPHALTIC BASE GEOSYNTHETIC MATERIAL AT “EL VALLE –BOINAS” MINE, ASTURIAS, SPAIN**

Authors: Castro Tejerina S.; Sánchez Arrótegui K.; Lázaro J.  
Position & company: Project Manager; Project Engineer; Area Responsible  
Golder Associates Global Ibérica S.L.U & Axter S.A.  
E-mail: SCTejerina@golder.com; KSanchez@golder.com;  
jlazaro@axter.es

## **Abstract**

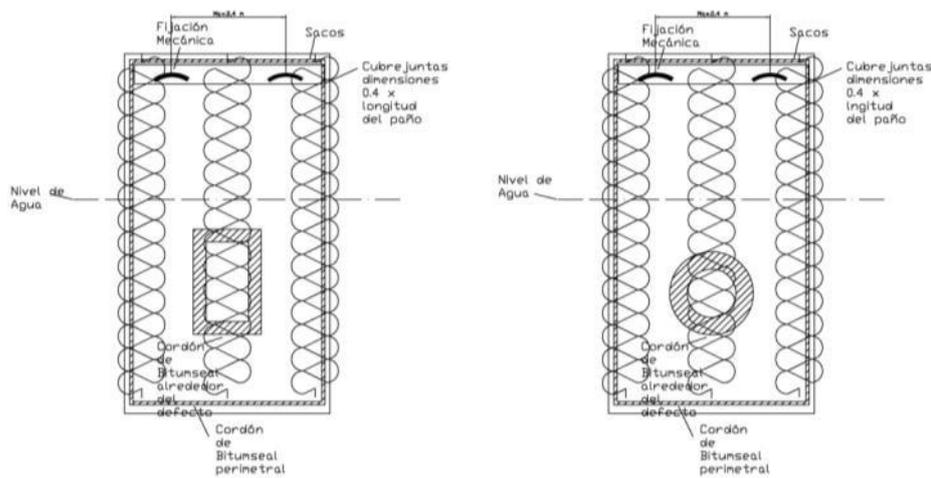
Figura 1: Material piece configuration

- 6) Material preparation: Once the defect is located, the measurement will be transfer to the piece of material already cut.
- 7) Surrounding the defect will place a thick and abundant cord of adhesive, attending to site engineer criteria to ensure the maximum seal of the defect (see figure 1 and 2).

- 8) On the perimeter of the piece and up to the water level will be place a finer cord which purpose is to avoid possible undesired movements of the piece (see figure 1 and 2).

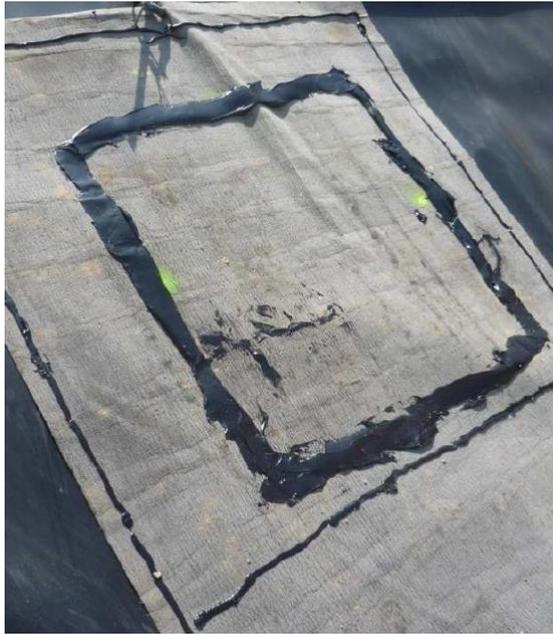
*Figura2: Geosynthetic cloth ready to be place*

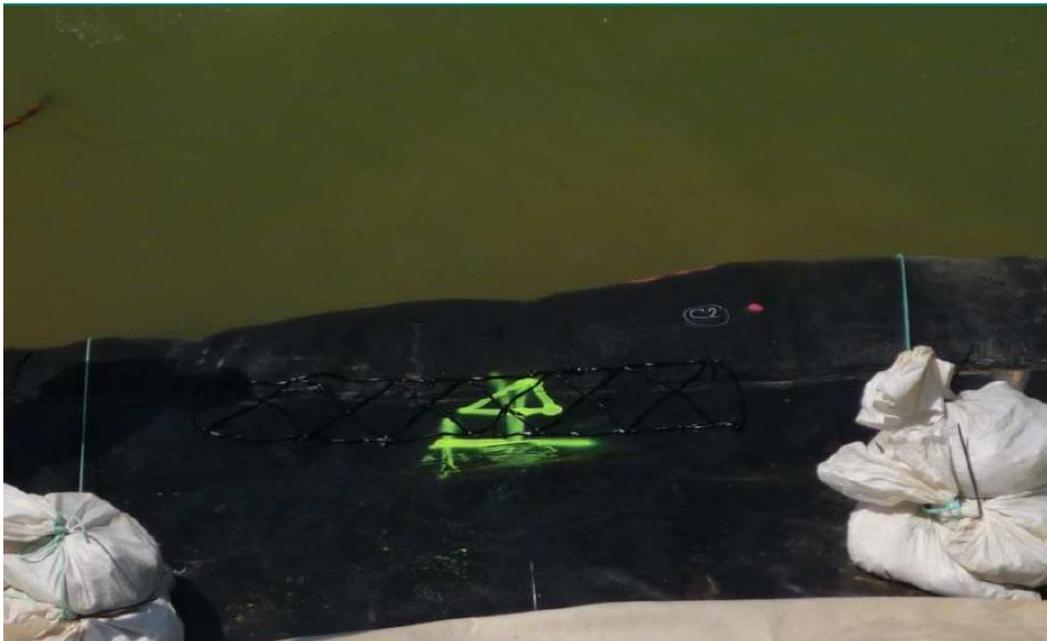
*Figura3: Axis of the defect marked on the Berm*

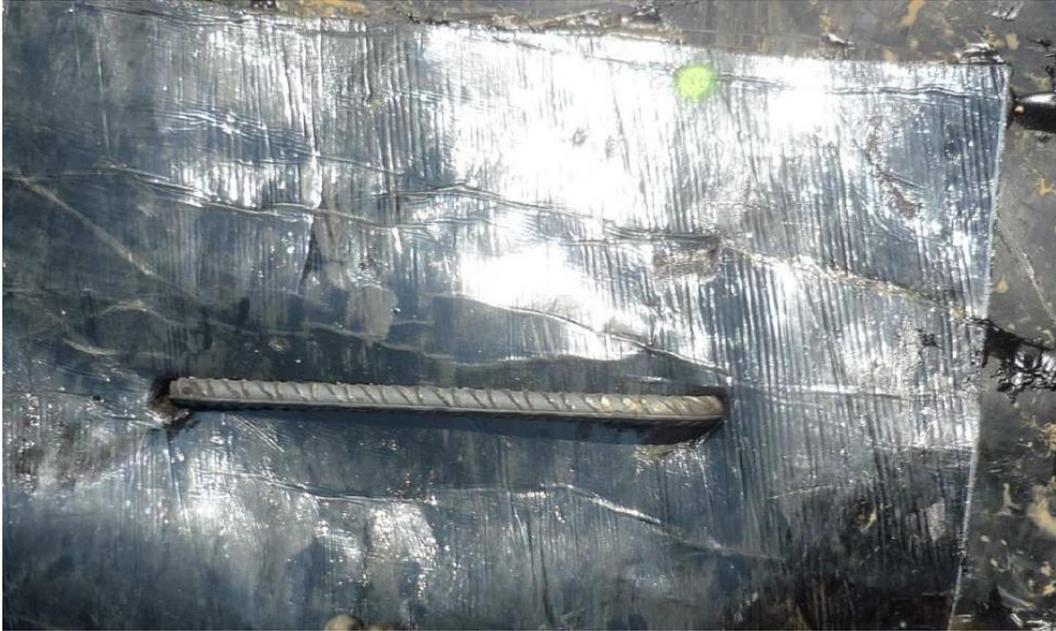
*Figura4: Mechanical fixation of the geosynthetic colth*

- 14) The mechanical fixes will be seal by welding a piece of geosynthetic material on top of the thread bar, by using this will be ensure that no infiltration will pass through this point. The dimension of the fixes and the sandbags lines can be modify according with the dimension of the piece and are left to the site engineer criteria.

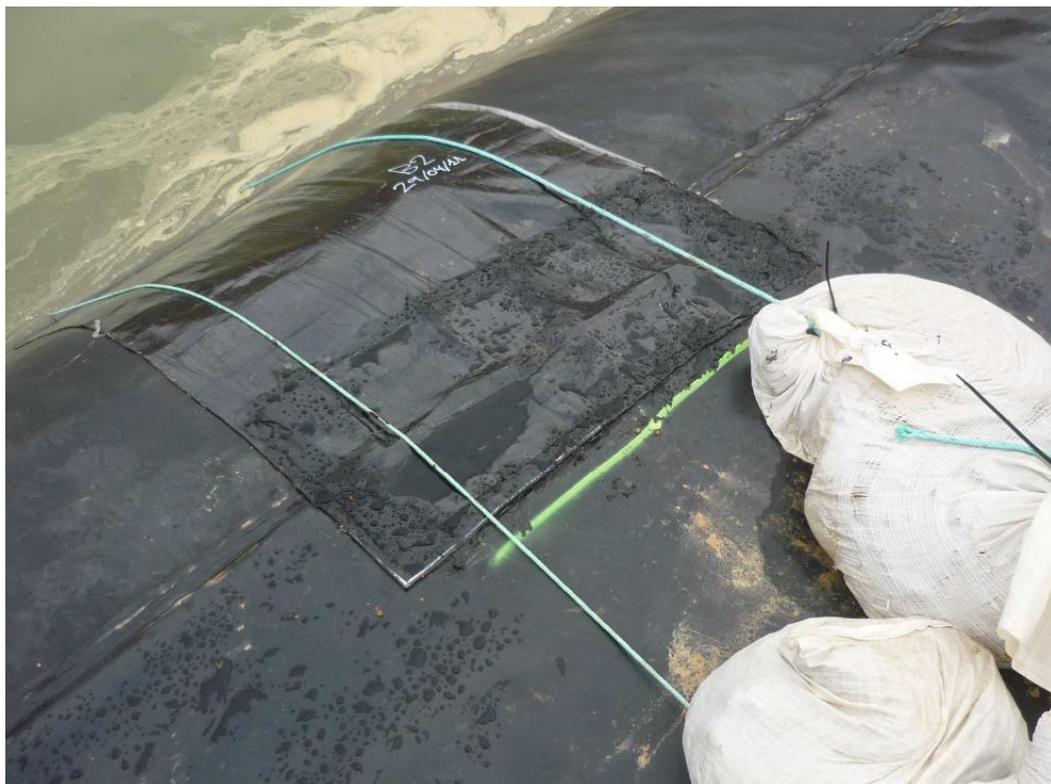
*Figura5: Final result of a repaired defect*
