Natural aging mechanism of buried polyethylene pipelines during long-term service

Ying-Chun Chen ^a, Yan-Feng Li ^a, Yan Xi ^{a,*}, Qiang Li ^b, Qi Lu ^a, Jie Yang ^a^a Beijing University of Technology, Beijing, 100124, China^b Xinjiang Inspection Institute of Special Equipment, Urumqi, 830011, China

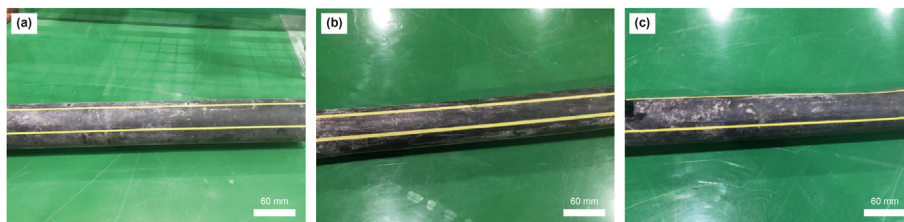
Fig. 1. Photos of buried pipelines in service; (a) 9 years in service, (b) 13 years in service, and (c) 18 years in service.

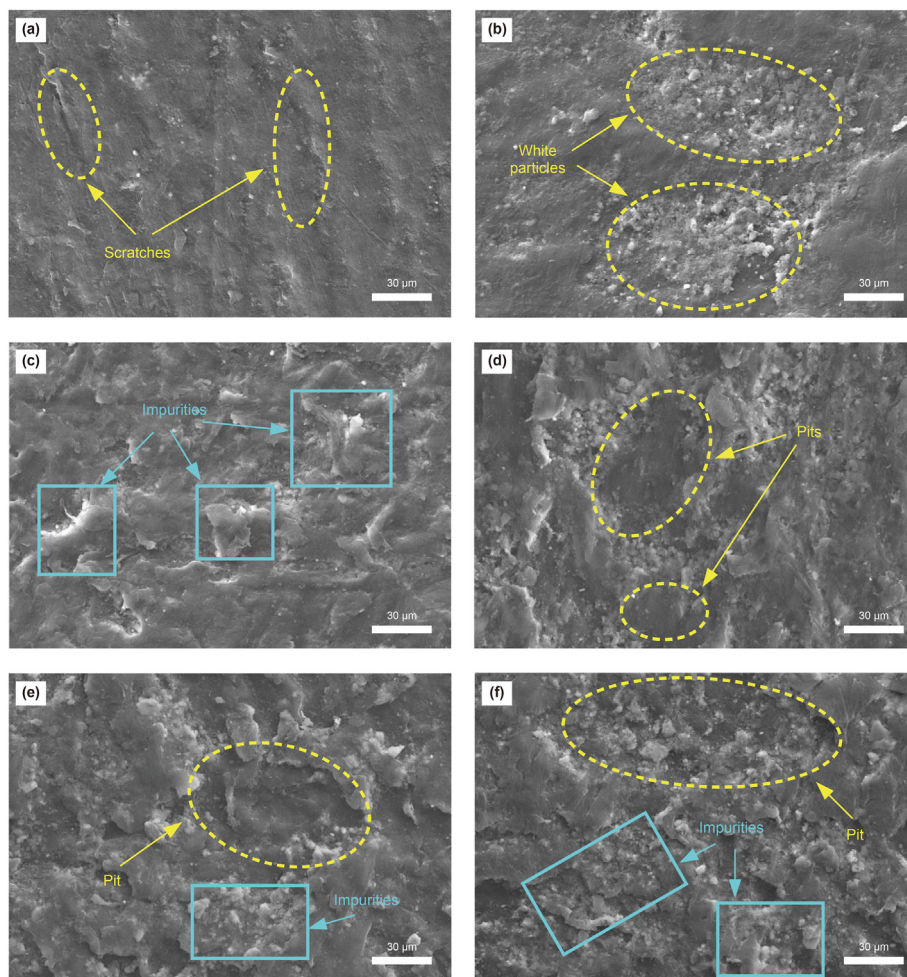
Fig. 12 shows the outer surface microstructure of polyethylene pipelines with different service times.

As shown in Fig. 12 (a), due to processing and other factors, the outer surface of the new pipeline contains some scratches. Furthermore, there is no obvious aging on the surface. In Fig. 12 (b), a large number of white particles appeared on the outer surface of the pipeline after 9 years in service, indicating that the outer surface of the pipeline began to age, and the surface degraded to produce debris. When aging begins, the molecular chain breaks and introduces carbonyl-dominated defective substances.

It also proves the aging process and mechanism of the pipeline: With the increase in service time, the antioxidants in the pipe are gradually consumed, and the matrix begins to age. Water and oxygen in the soil environment lead to an oxidation reaction on the outer surface of the pipe. Macromolecular chains and short branched chains are broken to varying degrees. On the microstructure, white particles and impurities appear on the surface of the pipeline. As aging intensifies, they peel off and form pits. The longer the service time is, the more and deeper the pits are.

Fig. 12. The outer surface morphology of polyethylene pipelines with different service times: (a) New pipeline, (b) 9 years, (c) 11 years, (d) 13 years, (e) 16 years, and (f) 18 years.

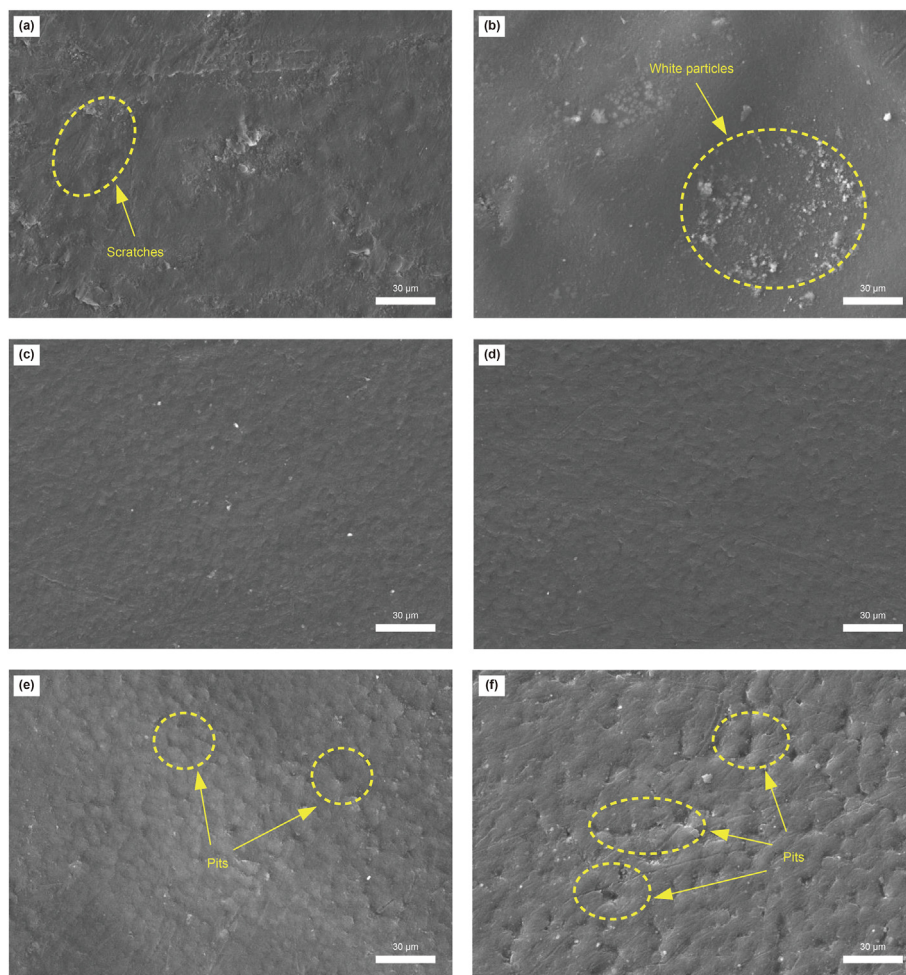
Fig. 13 shows the inner surface microstructure of polyethylene pipelines with different service times. After 9 years in service (Fig. 13 (b)), white particles appeared on the inner surface. After 11 and 13 years in service (Fig. 13 (c) and (d)), there were many small pits and lines on the surface. However, compared with the new pipeline (Fig. 13 (a)), their inner surfaces are smoother without obvious scratches. When the service time reached 13 and 16 years

(Fig. 13 (e) and (f)), the depth of the pits on the inner surface deepened, and the range enlarged. The overall roughness of the inner surfaces increased, especially the pipeline in service for 16 years, whose pits connected and formed fine cracks.

Comparing Figs. 12 and 13, there is no obvious difference between the microstructure of the outer and inner surfaces of the new pipeline. However, the microstructure gradually varies with the service time when the pipeline is in service. Many irregular defects appear on the outer surface, and the aging degree is severe. In contrast, the inner surface is slightly aged, and only shallow pits are produced. It shows that the aging rate greatly relates to the exposed

In addition, the inner surface of the pipeline in Fig. 13 gradually exhibits roughness, flatness, and potholes with the service time. The formation was explained by the aging mechanism in Fig. 19 (c). As shown in Fig. 13 (a), scratches formed on the inner surface due to processing factors. The rough particles of the matrix increased the drag force on the inner surface during natural gas flows. Under the long-term circulation of natural gas inside the pipeline, the fluid polished the inner surface of the pipeline. Therefore, in Fig. 13 (b–d), the inner surface was gradually flattened. After 16 and 18 years in service, antioxidant consumption and internal surface aging products increased gradually. Under the long-term flow of gas pipeline transportation, loose aging products are removed.

Fig. 13. The inner surface microstructure of polyethylene pipelines with different service times: (a) New pipeline, (b) 9 years, (c) 11 years, (d) 13 years, (e) 16 years, and (f) 18 years.

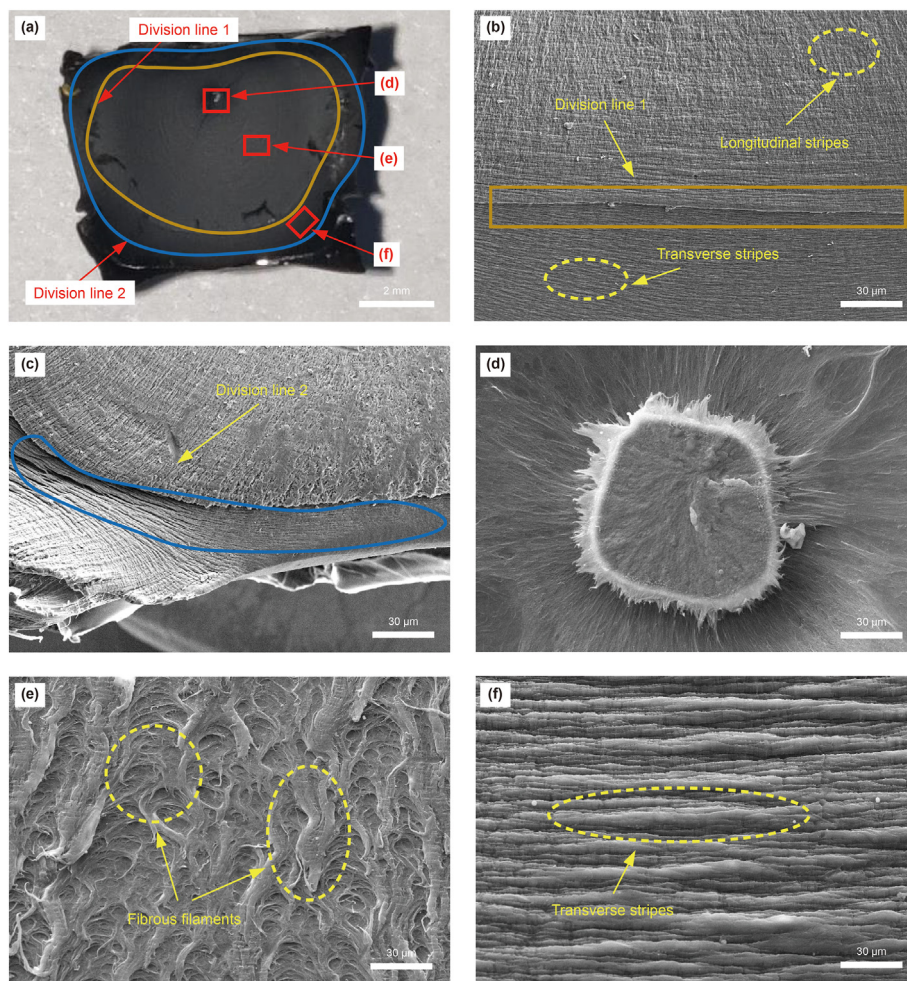
Fig. 15 shows the microstructure of the tensile fracture surface that was in service for 9 years. As shown in Fig. 15 (a), the yellow and blue lines represent division lines 1 and 2, respectively. The surface morphology of the fracture can be divided into three areas according to the division line: The main collapse area is inside division line 1. The buffer area is between division lines 1 and 2. The first fracture area is outside division line 2.

Fig. 15 (b) and (c) show the microstructure near division lines 1 and 2, respectively. According to Fig. 15 (b), the texture of the main collapse area (inside division line 1) is longitudinal stripes. The texture of the buffer area is a transverse stripe. Close to division line 1, the texture of the main collapse area gradually becomes a transverse stripe. Compared with it, the cracks near division line 2 and the first fracture area are deeper in Fig. 15 (c).

In addition, the microstructure of three typical regions in Fig. 15 (a) are identified as follows: the central hole of the fracture surface is shown in Fig. 15 (d), and the side wall of the main collapse area is shown in Fig. 15 (e), and the buffer area is shown in Fig. 15 (f). It is seen in Fig. 15 (e) and (f) that the fiber texture of the side wall of the main collapse area and the buffer area are significantly different. The section of the main collapse area shows fiber pullout, and the adhesion between the fiber and the surface matrix is less. Since the medium-density polyethylene is mainly in C=C configuration and has good ductility, it produces obvious filaments during elongation.

Fig. 15. Fracture surface of the tensile sample with 9 years' service; (a) Fracture surface image, (b) microstructure near division line 1, (c) microstructure near division line 2, (d) central hole, (e) main collapse area, and (f) buffer area.

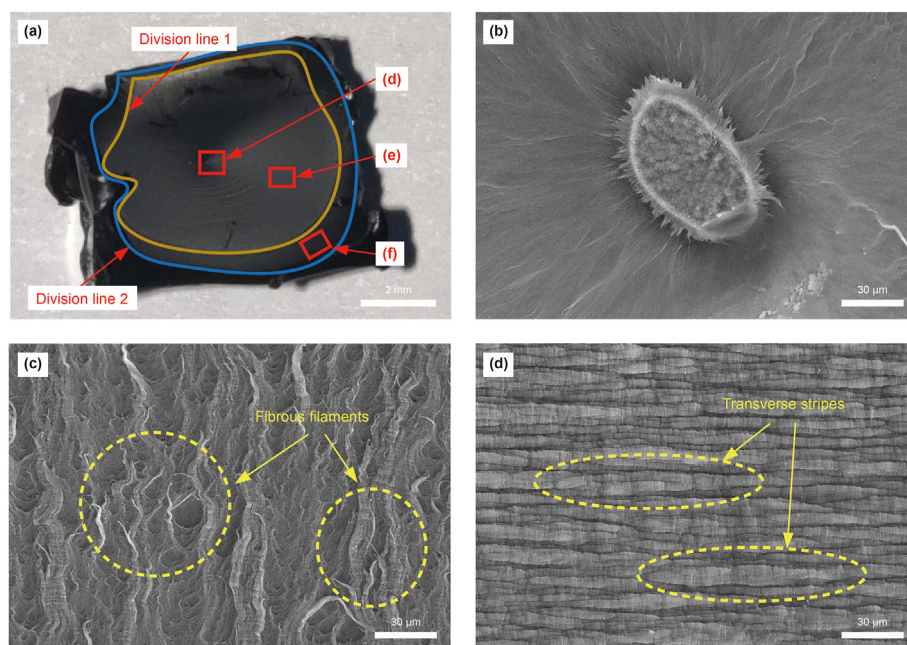
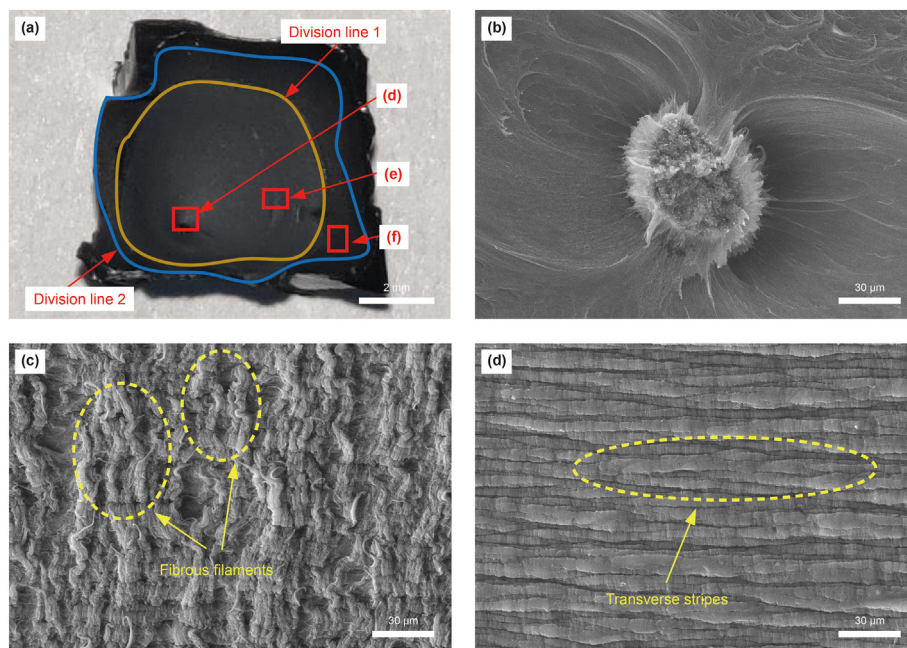
Figs. 16 and 17 show the microstructure of the tensile fracture surfaces with 13 and 18 years in service, respectively. Comparing Figs. 15–17, it can be seen that there is no significant difference in the surface morphology of the central holes (Figs. 15 (d), Fig. 16 (b), Fig. 17 (b)) and the first fracture area (Figs. 15 (f), Fig. 16 (d), Fig. 17 (d)). However, through the surface morphology of the buffer area (Figs. 15(e) and Fig. 16 (c), Fig. 17 (c)), it is seen that with the increase in service time, the pullout of the fiber from the matrix gradually weakens, and the fiber filament is shorter. It indicates that with the increase in service time, the aging of the pipeline becomes severe, the C=C bond breaks, and the material ductility is weakened.

Fig. 16. Fracture surface of the tensile sample with 13 years' service; (a) Fracture surface image, (b) central hole, (c) main collapse area, and (d) buffer area.

Fig. 17. Fracture surface of the tensile sample with 18 years' service; (a) Fracture surface image, (b) central hole, (c) main collapse area, and (d) buffer area.
