In the Wake of the Mount Polley Mine Tailings Breach

Tailings Dam Design, Innovation, and Practice Changes

By Harvey N. McLeod, P.Eng., P.Geo.

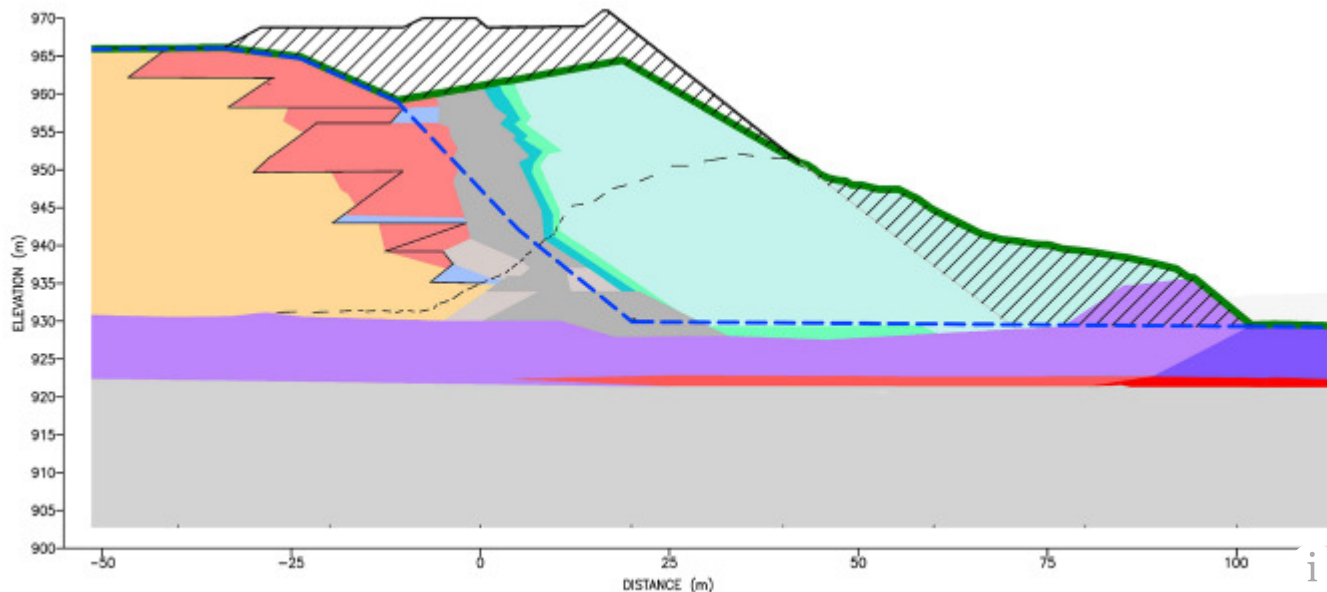
The Mt. Polley dam failed because of an unidentified glacial clay layer that caused the dam to "slump" (i.e., the dam crest dropped approximately 3-5 m as depicted in Figure 1). This slumping allowed the impounded water to flow over the crest of the dam, initially very slowly. However, within approximately ½ hours, the flow rate continued to increase and eventually led to catastrophic release of water and tailings.

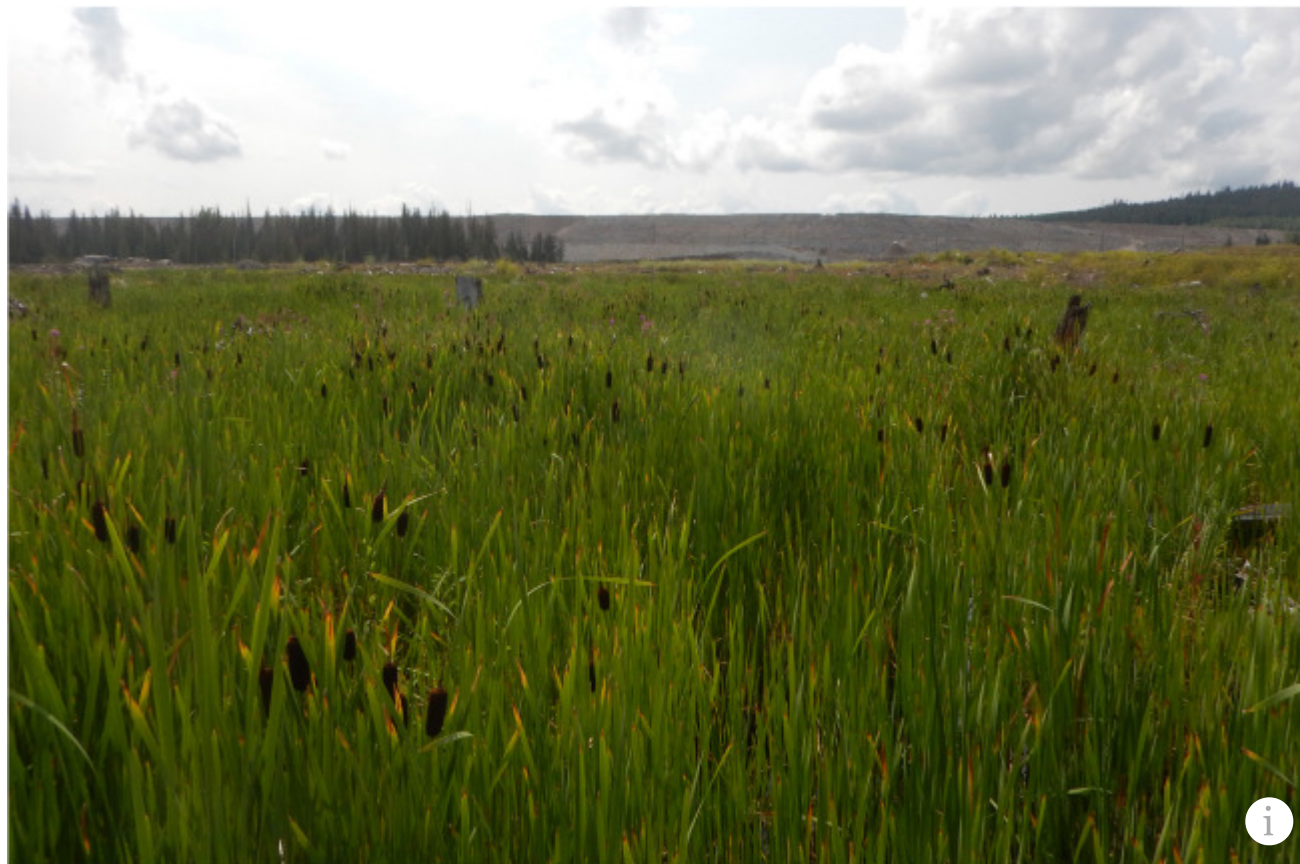
Fortunately, no one died, and the tailings and impounded water that were released were not particularly toxic. Environmental effects were primarily limited to physical impacts to Hazeltine Creek and Polley Lake, and loss of low-quality aquatic habitat in Hazeltine Creek. A large portion of the released tailings was deposited 15 km downstream of the dam in Quesnel Lake, the deepest freshwater lake in Canada. Since the failure, progress has been made on rehabilitating the impacted areas: more than 500,000 native trees and shrubs were planted, 3+ km of new trout-spawning and rearing habitat were created, and Hazeltine Creek was reconstructed to control erosion of the residual tailings with channel bank re-sloping and placement of erosion-control materials. Monitoring of the water quality in Quesnel Lake indicates that the deposited tailings are physically and chemically stable and are not releasing metals

into the lake. Overall, the terrestrial and aquatic ecosystems are showing positive signs of recovery as shown in Figure 2.

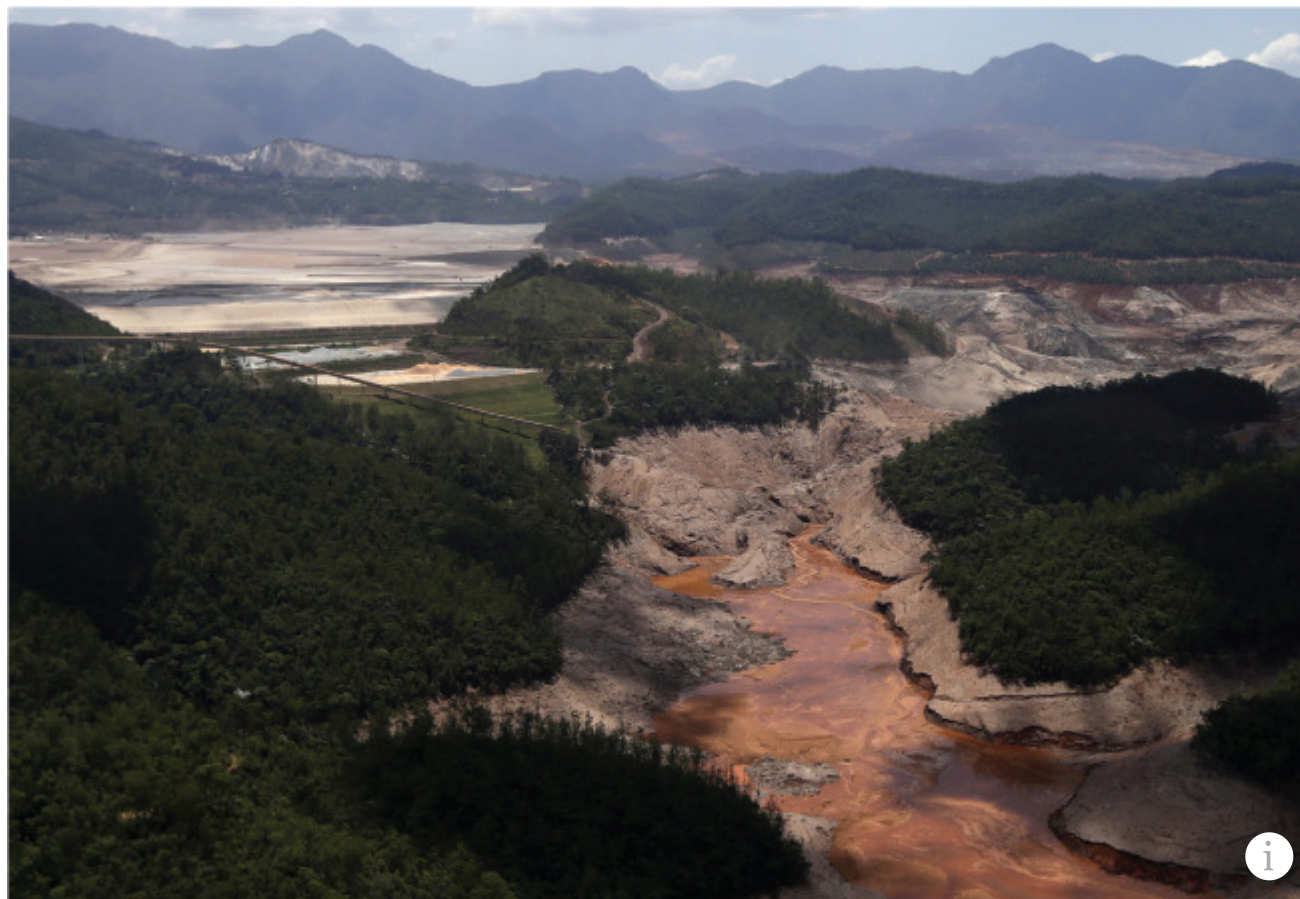
Since the Mount Polley failure, there have been two tragic, catastrophic failures of tailings dams in Brazil: Samarco's Fundão in 2015 (Figure 3), and Brumadinho in 2019 (Figure 4). Both dams were constructed by applying variations of

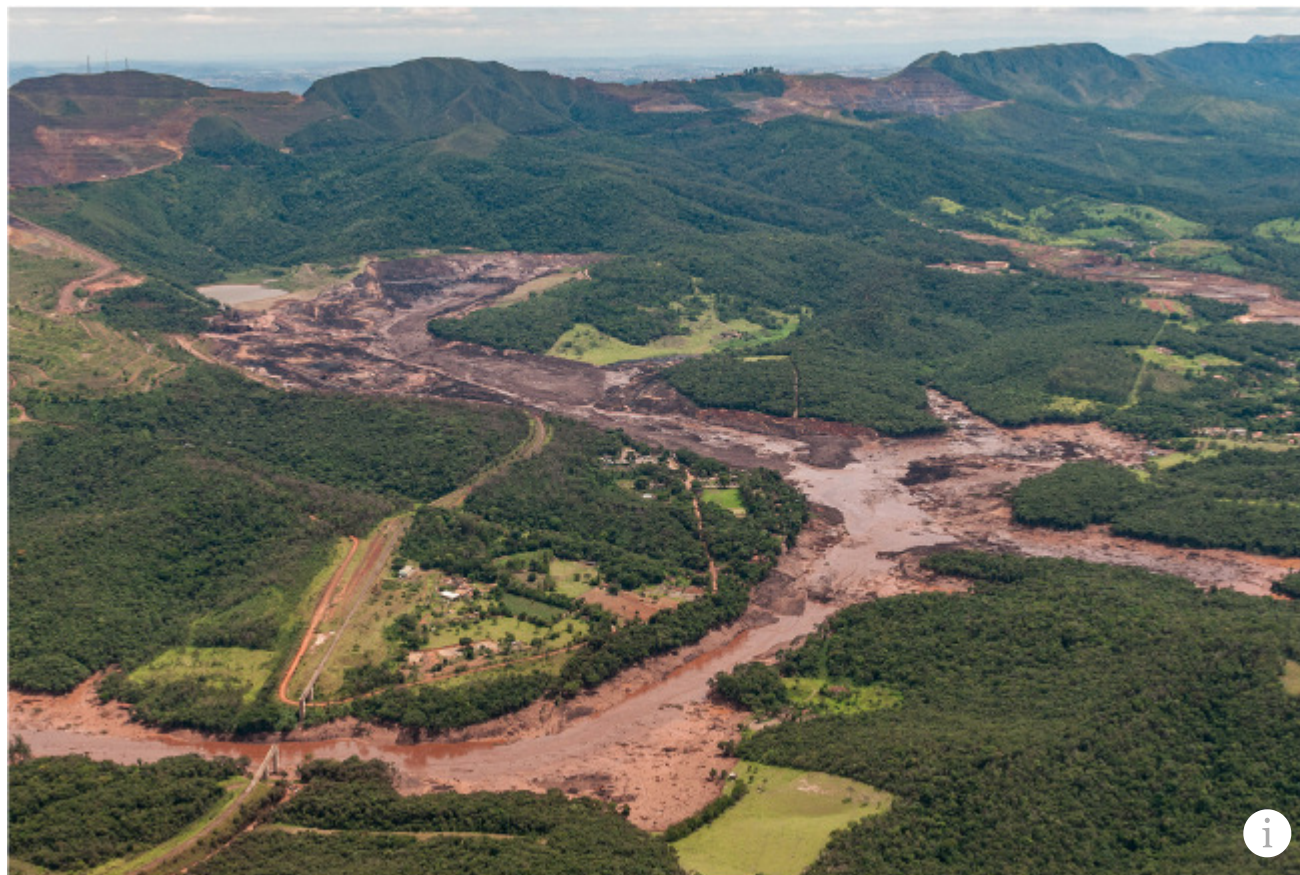
The most recent Brumadinho failure in Brazil (Figure 4) precipitated the initiation of a Global Tailings Review (GTR), which aims to develop a global standard for tailings dams. The GTR is supported by the International ICMM, the United Nations Environment Program (UNEP), and the Principles of Responsible Investment (PRI), the members of which, including the Church of England and the Swedish Pension Funds, have over 10 trillion U.S. dollars invested in the mining industry. The standard is in the consultation phase, which has included public presentations and industry meetings in numerous countries and an online, Internet-based forum for gathering and collating comments on the standard.

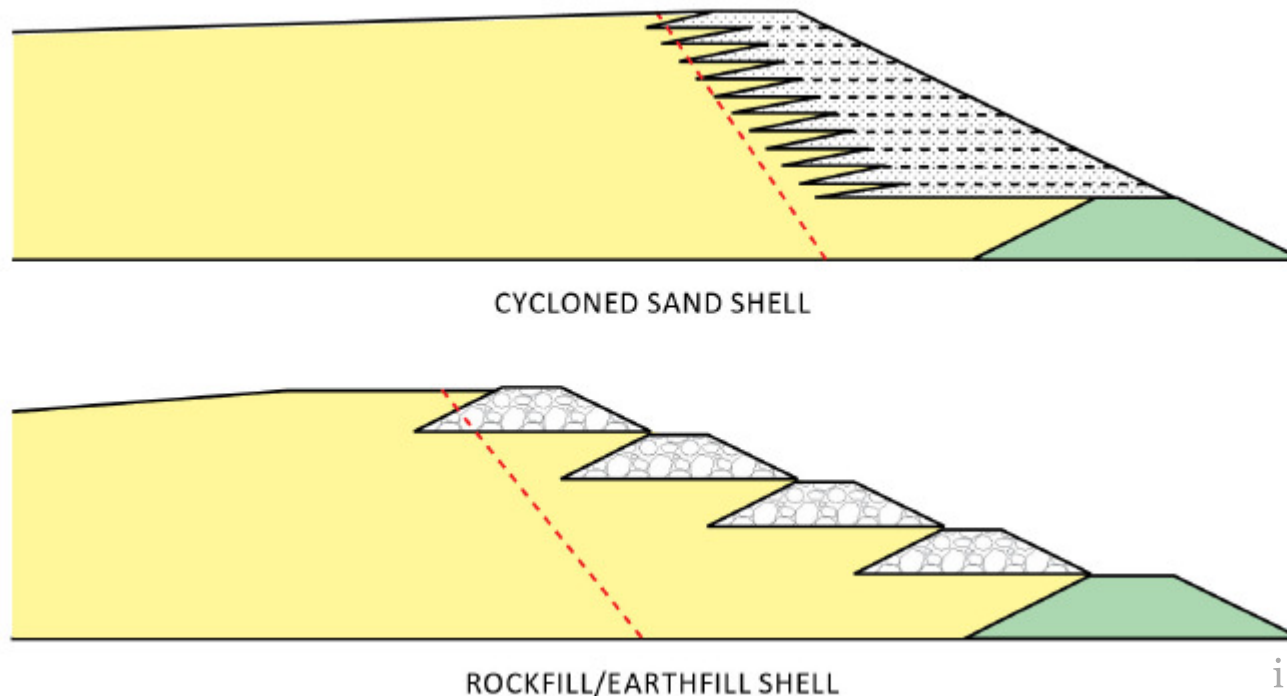
the upstream construction method, depicted in Figure 5. Trapezoidal embankments are constructed on top, toe to crest of each other, as the tailings are deposited, and the crest migrates further upstream. This method of construction relies on the strength of uncompacted tailings for support because the dam is constructed ovetop previously deposited tailings.
