Failure Analysis on Premature Fracture of Polyethylene Pipe for Floor Heating System

Abstract Polyethylene (PE) pipes are widely used in floor heating system due to their corrosion resistance, low cost and other advantages. This paper investigated the premature fracture of PE pipe for floor heating system in a residential building in the northern part of China for only serving less than 3 years, while the design service life was 50 years. In order to ascertain the root causes of this failure, a series of macro- and micro-scope characterization methods were conducted. The comprehensive analysis results showed that failure mechanism of the failed pipe was slow crack cracking with defects. Low molecular weight and substandard molecular weight distribution are the root causes of that premature fracture. Excessive bending, fibrous inclusions and shrinkage holes in the matrix are also important causes of the failure. Subsequently, the influence of polymer molecular weight on the mechanical properties of materials and the micro-configuration response of polymer pipes under tensile stress was analyzed in depth. It is theoretically demonstrated that polymer microstructures such as molecula

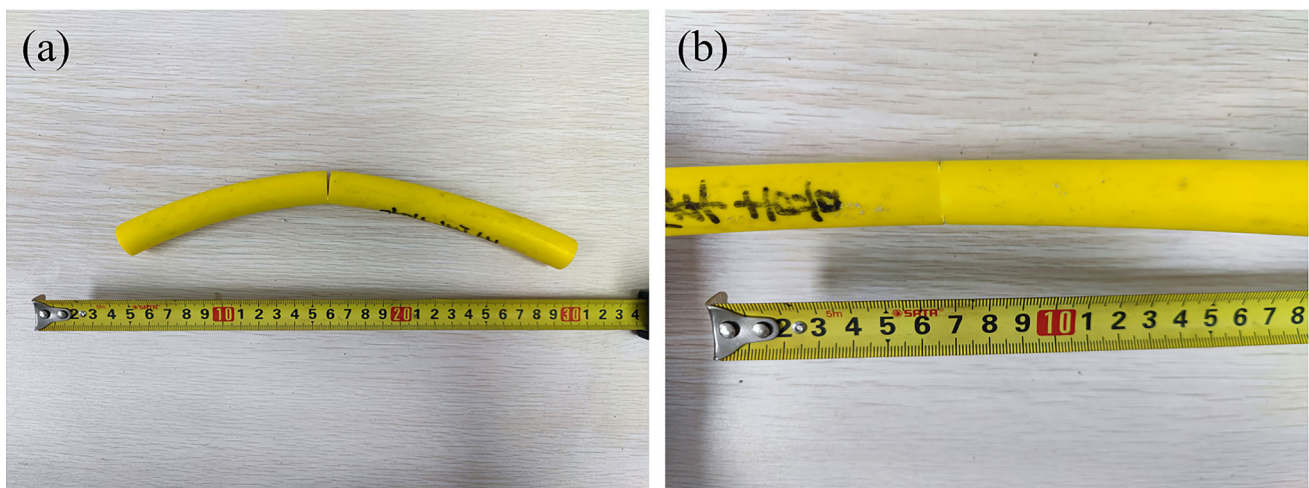
The appearance of the failed heating pipe is displayed in Fig. 3, whose design sizes were $\varphi 20.0 \text{ mm} \times 2.0 \text{ mm}$. The inner and outer surfaces of the pipes away from the fracture were smooth, flat and clean, free from dents, bubbles, obvious scratches and other surface defects that affect performance, and there were no visible impurities. Table 1 shows the test results of the pipe wall thickness. Obviously, the wall thickness of more than half of the detection sites is thinner than the allowable range [21].

The failed pipe (Fig. 3a) exhibits certain degree of curvature, which is consistent with the structure of the coil, but the changing of the fracture section sizes, indicating that excessively bent has occurred. The cross section of the pipe was approximately transformed from a perfect circle to an ellipse-like shape with a long axis of 20.4 mm and a short axis of 19.3 mm. There is a clear crease on the opposite side of the fracture as shown in Fig. 3b; it can be speculated that the fracture at this position experienced rapid instability during the fracture process.

Fig. 3 (a) Side, and (b) opposite side of fracture appearance of failed pipe

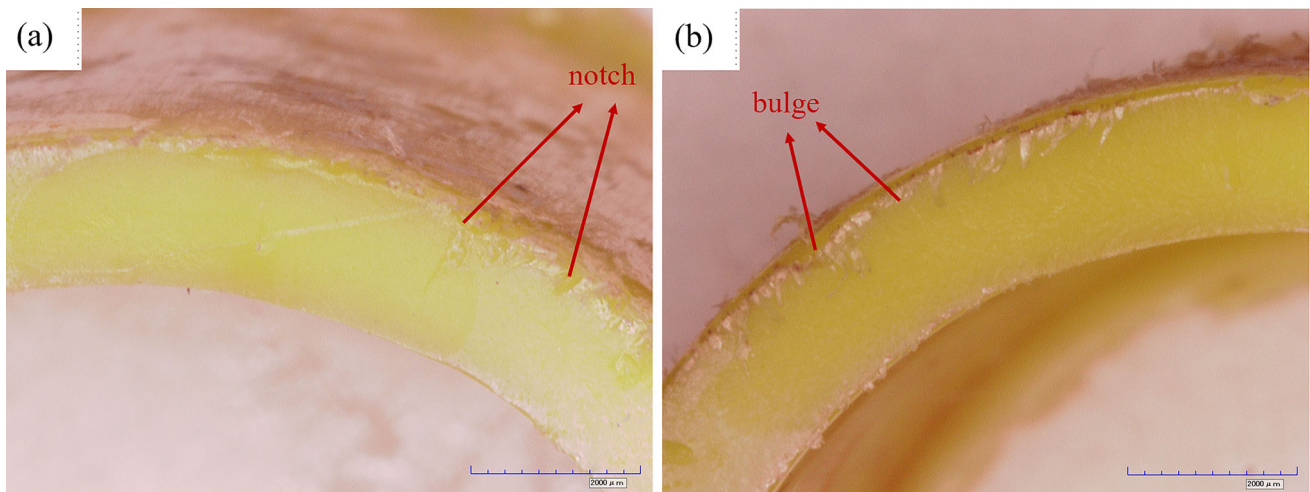
Cutting the failed PE pipe along the fracture section, the visual inspection of the fracture section was conducted by three-dimensional stereoscopic microscope. From Fig. 4a, it can be seen that there is a long stripe, which originating from the outer wall and finally ending at the inner wall, on one side of the fracture section, which side was named as I side. Strangely, there is no corresponding stripe being found on the opposite side of the fracture section as shown in Fig. 4b, and which side was named as II side.

Fig. 4 Visual appearance of the fracture section under 3-dimensional stereoscopic microscope of (a) I side, and (b) II side

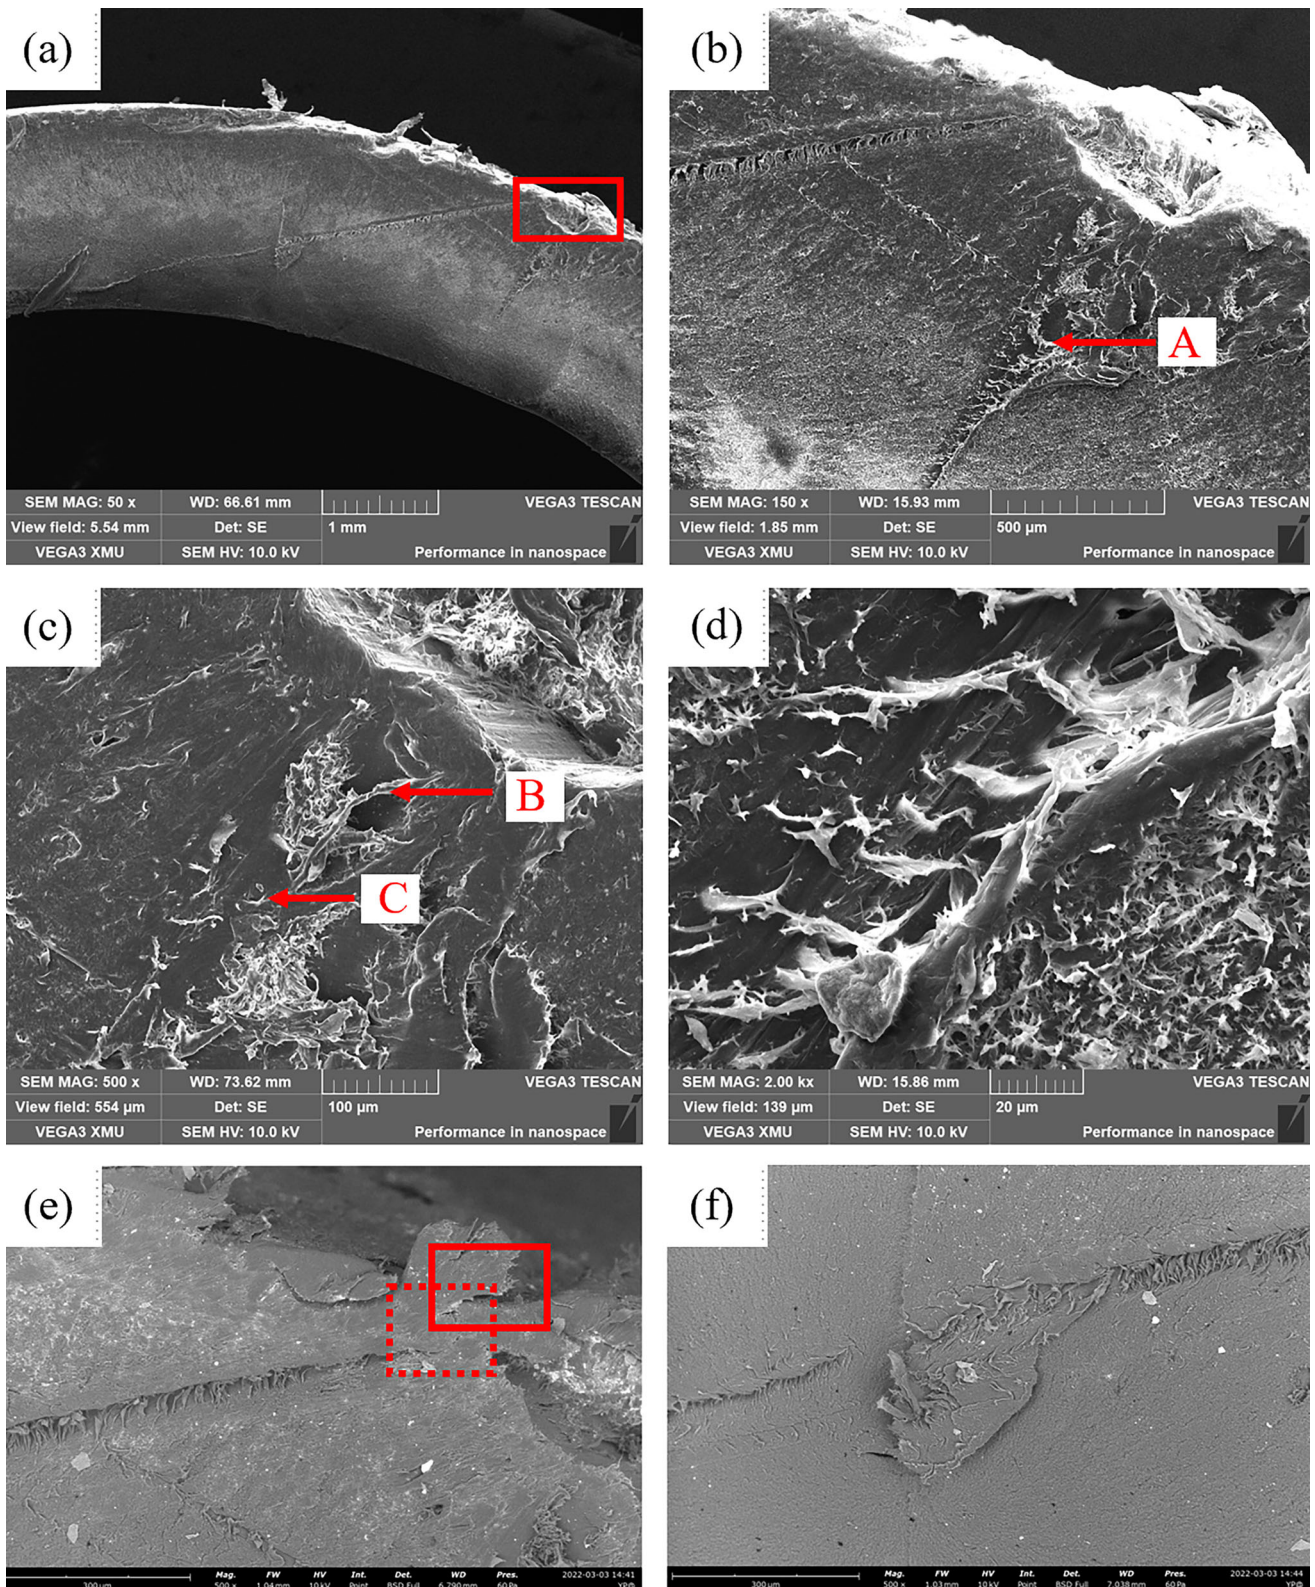
the outer wall of the failed pipe has a certain degree of defects. There is a notch as shown as shown in Fig. 5a on the outer wall of the pipe, and two stripes extend from this notch to the inner wall. The long stripe leads to the inner wall with a 30° angle, which is consistent with that shown in Fig. 4a, and the short stripe leads vertically to the inner wall and interrupted in the middle, which is not so clear as former under the three-dimensional stereoscopic microscope. Magnifying the notch (Fig. 5b and c), it can be observed that the short stripe is virtually composed of a series of inclusions. These inclusions are essentially fibrous tissues. Some holes of various sizes below the fibrous tissue indicate that the inclusions are not well combined with the polymer matrix, and delamination should occur during the fracture process. Once external stress is applied, those regions would become the source of stress concentration. In addition, many fine particles are also irregularly distributed on the matrix.

In order to determine the chemical compositions of the inclusions and the fine particles, EDS was performed in the location A, B and C, and the results are shown in Table 2. The chemical compositions of the fibrous tissues and fine particles are basically same, while the proportion of each element is quite different. Location A and B which represents the fibrous inclusions was detected with larger content of carbon, while location C which represents the fine particles was detected with larger content of nitrogen and oxygen. Whether in shape or in chemical compositions, fibrous inclusions and fine particles are two different types of inclusions with different causes, although they are both organic components.

Figure 5d shows the dimple morphology around the cut-off region of the short stripe, which is the typical morphology of ductile fracture. On the contrary, the dissociated morphology could be observed on the outer wall part. That

is, the fracture section close to the outer wall shows dissociated morphology, while that close to the inner wall shows dimple morphology.

Different with the short stripe which is composed of fibrous inclusions, the long stripe is actual a craze morphology. As the range bounded by the red dashed box shown in Fig. 5e, there is a series of intermittent small pits with a size of several microns as the bridging region that induces crazing. The arrangement of these intermittent small pits indicates the path through which the presence of outer wall defects leads to the formation of crazing during fracture process. Meanwhile, there is a bulge with a size of about 100–150 μm in the middle of the crazing in Fig. 5f, which is a delamination morphology.

Fig. 5 Microscopic morphologies of I side of the failed pipe fracture section. (a) overall appearance (b) appearance of crack initiation source (c) fibrous aggregates and small-sized particles on the fracture surface (d) morphology of the short stripe in the cut-off region (e)

craze propagation path from the crack initiation source and (f) bulge in the middle part of the long stripe

As shown in Fig. 5b, the outer and inner fracture sections show the morphologies of brittle fracture and ductile fracture, respectively. Obviously, according to the above analysis, the tensile stress strength of the two is different. Since the failed pipe was excessively bent at the fracture, and the pipe wall on the fracture side was subjected to tensile stress. It can be further deduced that, in the early stage of fracture, the outer wall part suffered the action of small tensile stress in a relatively long time and occurred brittle fracture, and in the second half of the fracture process, the tensile stress on the fracture increases and ductile fracture would occur in a short period of time. The question is why the tensile stress on the inside and outside of the pipe wall is different.

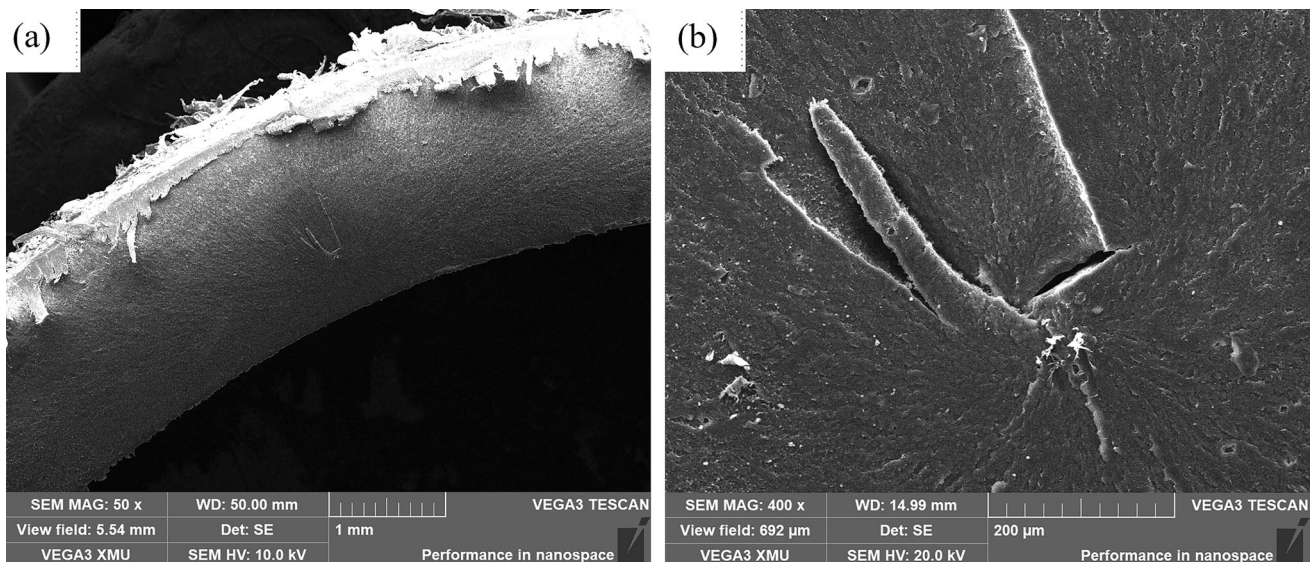
Figure 6 shows the microscopic morphologies of the II side fracture section. In Fig. 6a, several bulges can be observed on the outer wall of the fracture section, which just consistent with the notch at the corresponding location on I side. However, neither the long stripe nor the short stripe could be observed on the II side. As discussed above, the short stripe is virtually composed of a series of fibrous inclusions, and the failure to find a corresponding arrangement of inclusions on the II side indicates that the pipe might crack precisely along the interface of the inclusions and the matrix. The weak bonding force between the inclusions and the matrix leads to poor compatibility between the two.

In addition, there are several stripes developing in the circumferential and radial directions in the middle part of the II side fracture section. Some of these stripes are stripe-shaped holes with different depths, which are framed by red solid lines in Fig. 6b, and the substrates on both sides of these stripes are not completely on the same level. Although irregular-shaped inclusions can be observed on the fracture surface around the stripes, there are no obvious

large-sized inclusions inside these strip-shaped cracks (Fig. 6c). Meanwhile, these inclusions are small in size and far away from each other (several times larger than their own scale); it is difficult to believe that the existence of these inclusions caused the generation of strip-shaped holes. According to relevant literature reports, due to the high shrinkage rate (0.02–0.05) of polyethylene, it is easy to introduce internal shrinkage holes during the molding process. Therefore, the appearance of these striped holes is most likely caused by shrinkage cavities during the molding process of polyethylene pipes.

Fig. 6 Microscopic morphologies of II side of the failed pipe fracture section (a) overall appearance of the source of cracking, (b) crack concentration zone, and (c) Irregular inclusions near the crack concentration zone

In Fig. 6, shrinkage cavities can be observed inside the failed pipe. In the injection molding process, shrinkage cavity is a very common problem, mainly due to the following reasons: Firstly, if the design of the main runner, runner and gate of the mold is unreasonable, there will be shrinkage cavities caused by the injection pressure not fully acting on the molten material in the mold cavity [36]. Secondly, due to the poor thermal conductivity of

- The material of the floor heating pipe must ensure that it has sufficient molecular weight and meets bimodal molecular weight distribution required for polyethylene of temperature resistance.
- During installation and using, make sure that the pipe is not bent beyond the design allowable range.
- In the production of floor heating pipes, the use of recycled materials should be avoided, especially those whose molecular weight is not up to the standard and containing fibrous inclusions.
- During the molding process, appropriate molds and processing techniques should be selected to avoid leaving shrinkage cavity in the final product. For example, strengthen the injection pressure, keep the wall thickness of pipe fittings uniform and so on.

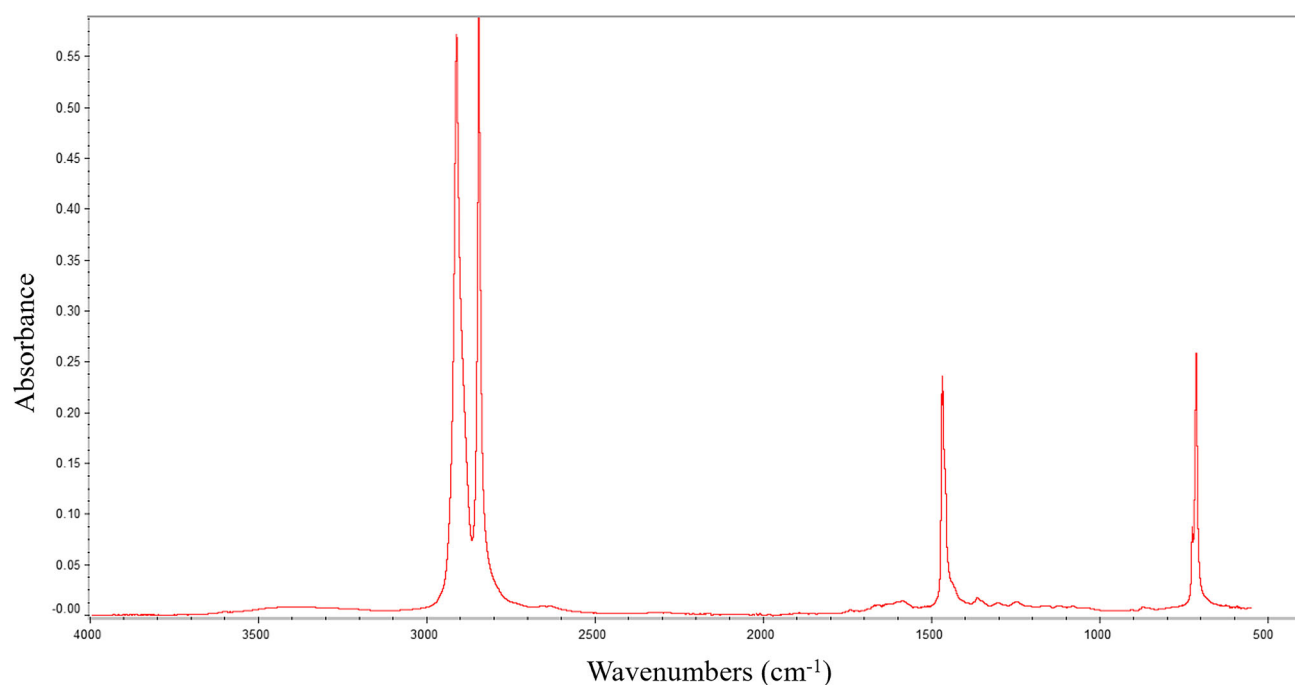
FTIR was conducted the chemical structural of the failed PE pipe for floor heating system. Figure 7 shows the FTIR spectra, which proved the material of the failed pipe is polyethylene. The main peaks present at 2912 cm⁻¹ and 2849 cm⁻¹, which are, respectively, attributed to the CH₂ antisymmetric stretching vibration and CH₂ symmetric stretching vibration. CH₂ scissor vibration peak appears at 1472 cm⁻¹. The peak observed at 729 cm⁻¹ and 717 cm⁻¹ indicates the presence of the in-plane rocking vibration of CH₂, while the peak present at 729 cm⁻¹ indicates the degree of the failed pipe’s crystallinity is relatively weak.

Fig. 7 FTIR spectra of the failed pipe

There is a series of weak CH_2 out-of-plane rocking vibration peaks between $1340\text{--}1150\text{ cm}^{-1}$, which also indicates that the polymer pipeline is not completely crystallized, and the CH_2 groups are disordered and not completely arranged in a zigzag pattern [22]. Since in the FTIR results, we almost did not observe the existence of miscellaneous peaks, it can be seen that the purity of polyethylene in the failed pipe is very high.

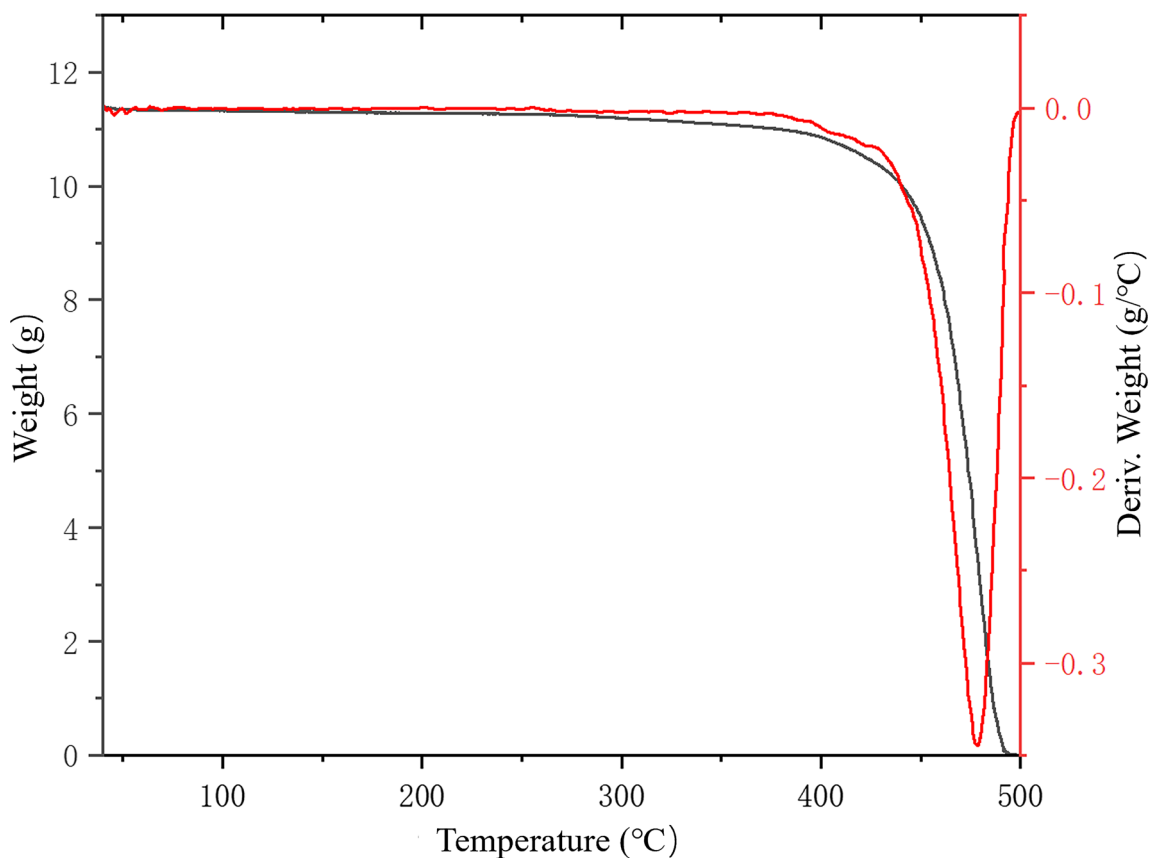
The failed pipe is analyzed by TGA. The temperature is specified from $40\text{ }^\circ\text{C}$ to $500\text{ }^\circ\text{C}$ under nitrogen environment, and the heating rate is $2\text{ }^\circ\text{C}/\text{min}$. As shown in Fig. 8, the initial decomposition temperature is about $200\text{ }^\circ\text{C}$ and completely decomposed at $500\text{ }^\circ\text{C}$. When heated to $400\text{ }^\circ\text{C}$, the sample entered the accelerated decomposition stage and the temperature of the largest decomposition rate is about $480\text{ }^\circ\text{C}$. The result that there is nothing remaining after heating decomposition indicating that almost all the components of the failed pipeline are organic compounds, especially polyethylene, and almost no inorganic additives such as carbon black or carbides are contained.

Fig. 8 The TGA analysis of the failed pipe

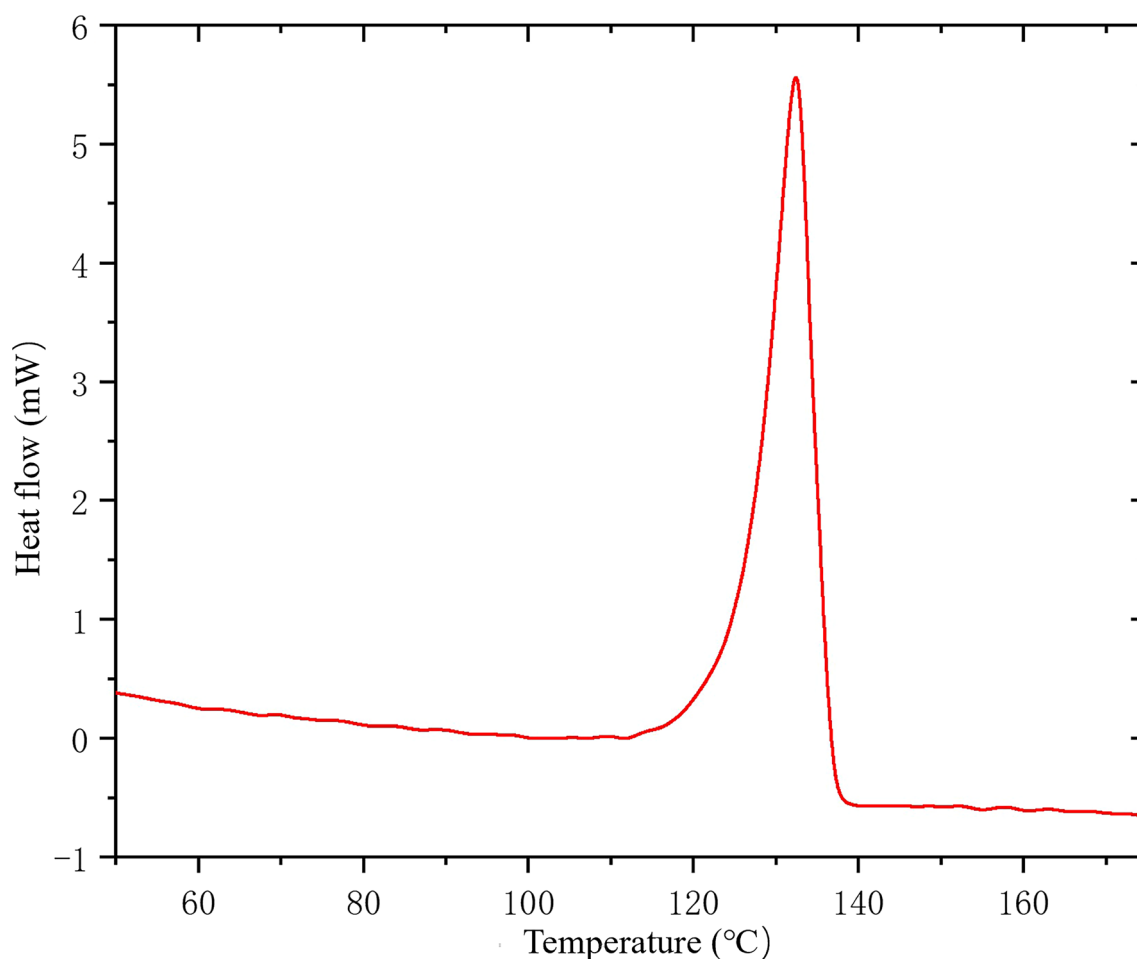
temperature to $175\text{ }^\circ\text{C}$ with heating rate $2\text{ }^\circ\text{C}/\text{min}$. As shown in Fig. 9, the melting peak temperature of the failed pipe is $133\text{ }^\circ\text{C}$ and the heat flow at which temperature is about 6 mW . The mass crystallinity of the failed pipe could be obtained by the following equation:

where Δh is the enthalpy of the fusion of the failed pipe and Δh^0 is the enthalpy of fusion of polyethylene with 100% crystallinity (293 J/g) [12]. Integrating the endothermic peak area shown in Fig. 9, the enthalpy of the fusion of the failed pipe can be obtained as 155 J/g . Correspondingly, the mass crystallinity of the failed pipe is 52.9% .

Fig. 9 The DSC analysis of the failed pipe

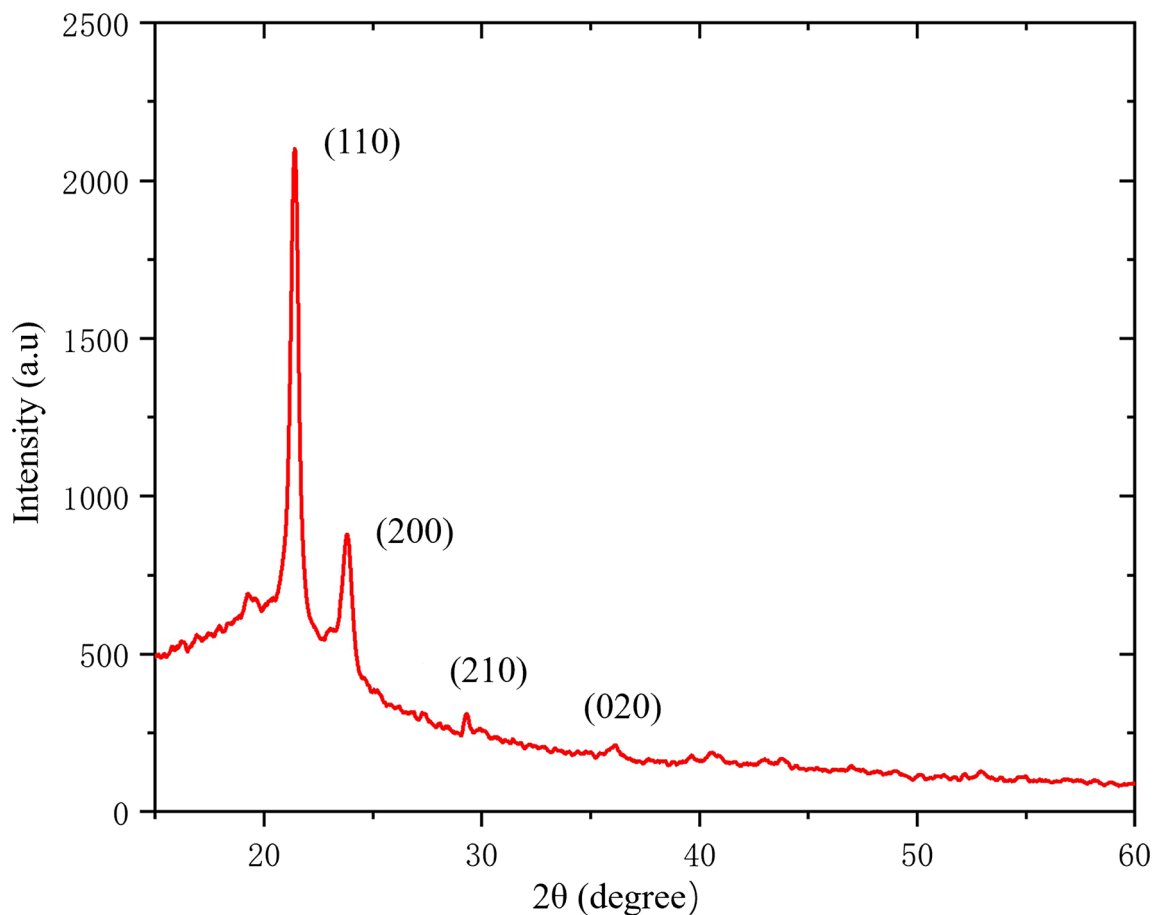
Figure 10 shows the X-ray diffraction spectra of the failed pipe. Data was collected by detector system with a continuous scanning mode over a scattering angle (2θ) range from 10° to 80° , and copper was used as anode target material. When the value of 2θ angle equal to 21.45° and 23.84° , two main characteristic peaks appear on the XRD spectra, corresponding to the two crystal planes (110) and (200). Substituting the area of the crystalline peak and the amorphous peak into the following formulas, the crystallinity of the failed pipe can be calculated [23]:

At last, the crystallinity of the failed pipe calculated by the XRD method is 53.9%.

Fig. 10 XRD spectra of the failed pipe

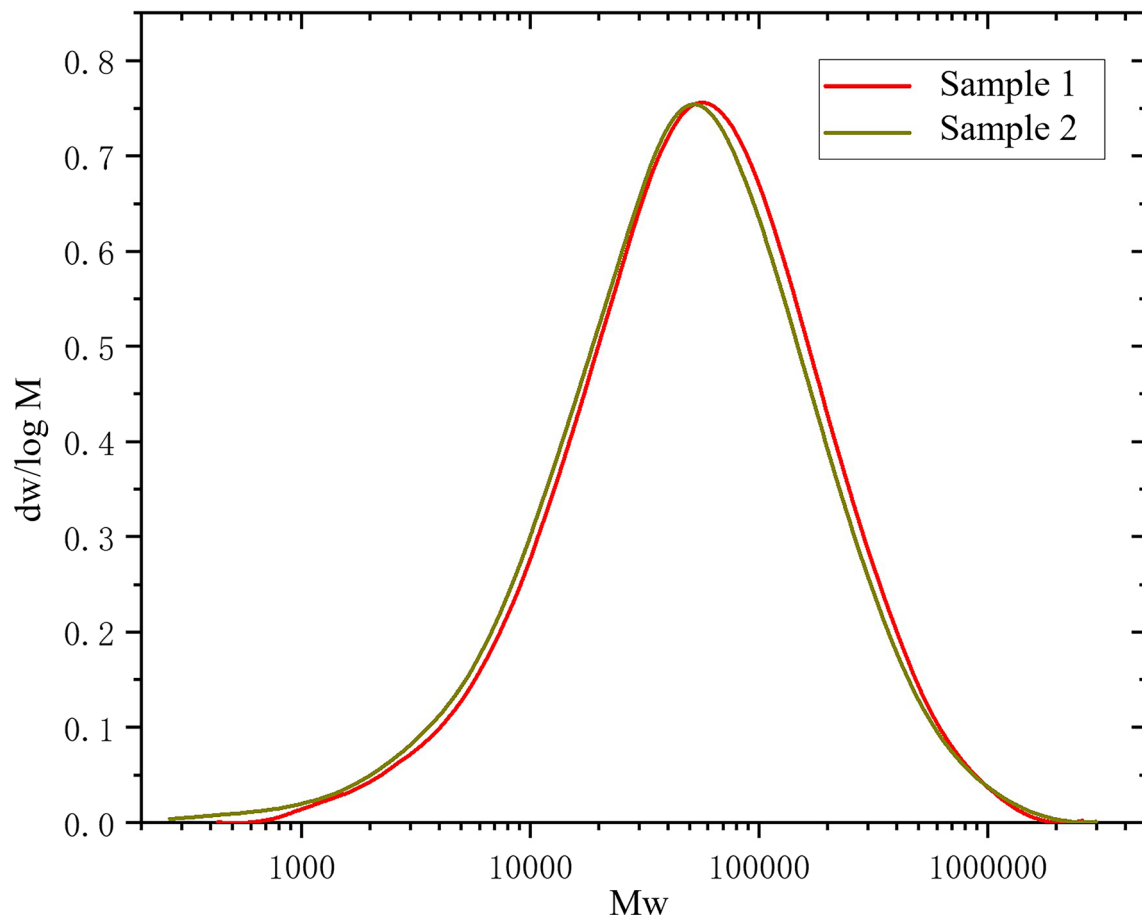
GPC analysis was conducted to obtain the molecular weight distribution of the failed pipe. The mobile phase used in the test was heated trichlorobenzene (160°C), and the solution concentration was 0.10 mg/ml with injection volume 100.0 μl . Figure 11 shows the weight average molecular weight distribution and Table 5 shows the value of number average molecular weight, weight average molecular weight and polydispersity coefficient. Obviously, its unimodal molecular weight distribution was inconsistent with the PE-RT requirements for bimodal molecular weight distribution [25]. Besides, its relatively low molecular weight made it prone to molecular chain movement resulting in poor mechanical properties.

According to the results of FTIR, TGA and DSC, the material of the failed pipe for floor heating system is indeed polyethylene. However, the results of GPC show that this material does not meet the bimodal molecular weight distribution requirements of floor heating pipes at all. Based on the micromorphology analysis and mechanical properties analysis, the failure mechanism of the failed pipe should be slow crack cracking with defects.

Fig. 11 GPC analysis of the failed pipe
