Satellite Imagery Reveals Tiltex Barrier Failure at Drainage Control Mining Project for Newmont Mines

17th July 2024

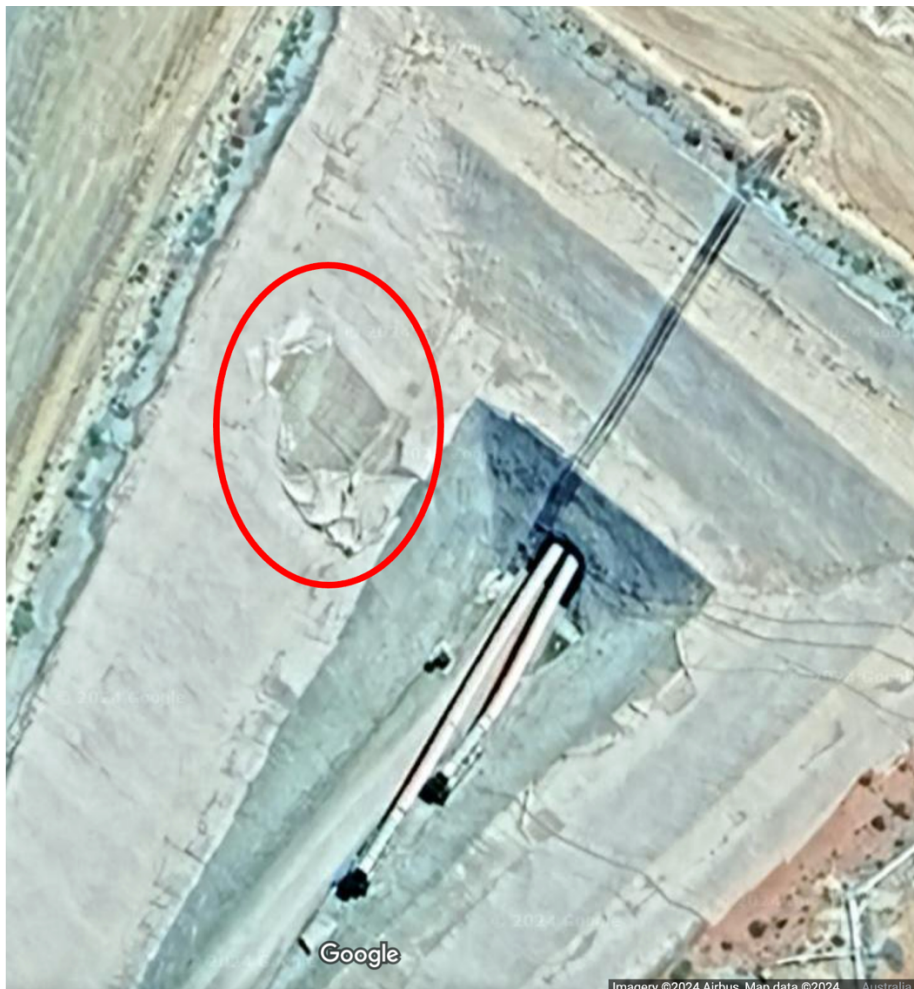
Figure 1. Shows the Tiltex surface barrier failure (in red) on the slope of the portal of the Havieron gold-copper mine in WA. [Google Maps link [here](#)]

The liner, specifically identified as the Tiltex 10B Basalt fibre enhanced Anti Cracking GCCM, was installed to prevent erosion and stabilize the box cut benched batter sidings leading to the underground access tunnel. However, recent satellite images indicate failure and collapse.

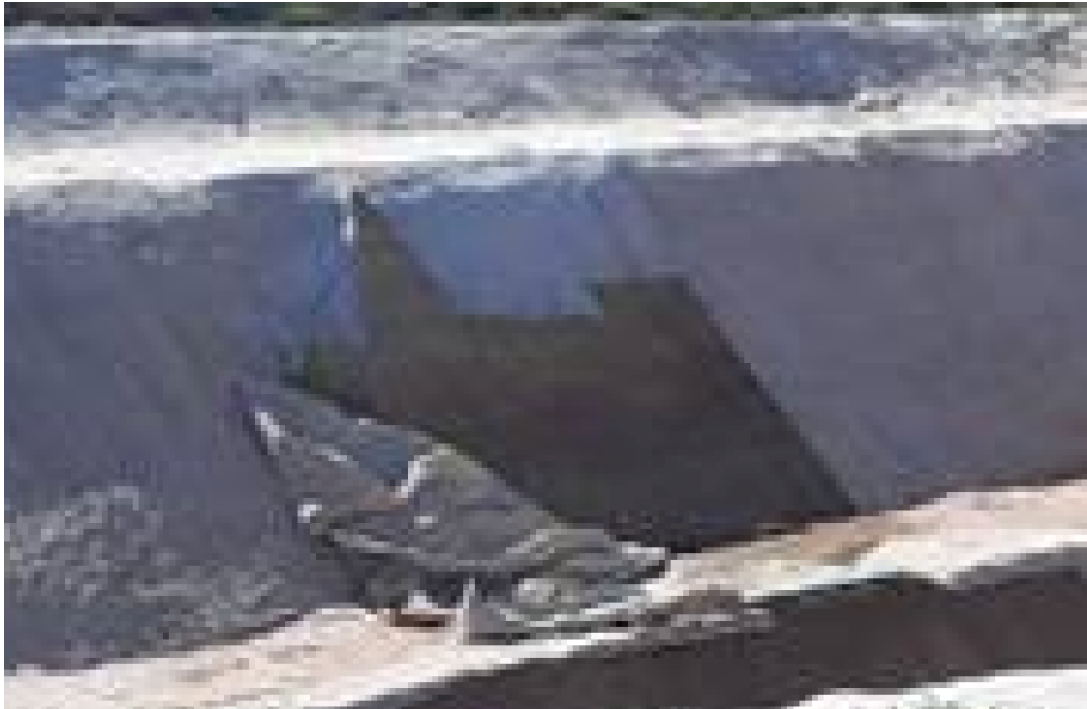
The photograph below which is a highly magnified image of the failure zone with digital enhancement shows the crumpled barrier piled on the bench.

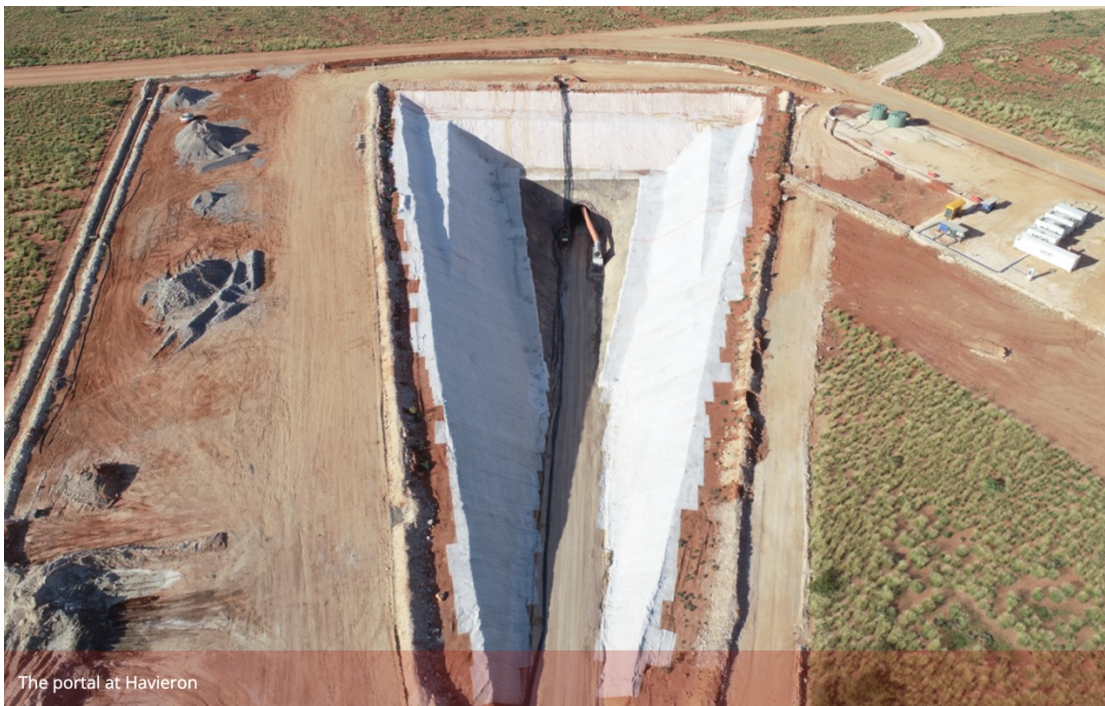
The photograph below taken around the time of installation of the liner shows no issues with the liner. (Source Tiltex Australia Press Release June 2024
