# **EXCELPLAS AND RED EARTH ENGINEERING**

## **TECHNICAL NOTE**

### **Title: Stress Cracking Failure of HDPE Geomembranes Installed on Slopes without Compensation Slack and Without Adequate Geotextile Cushioning**

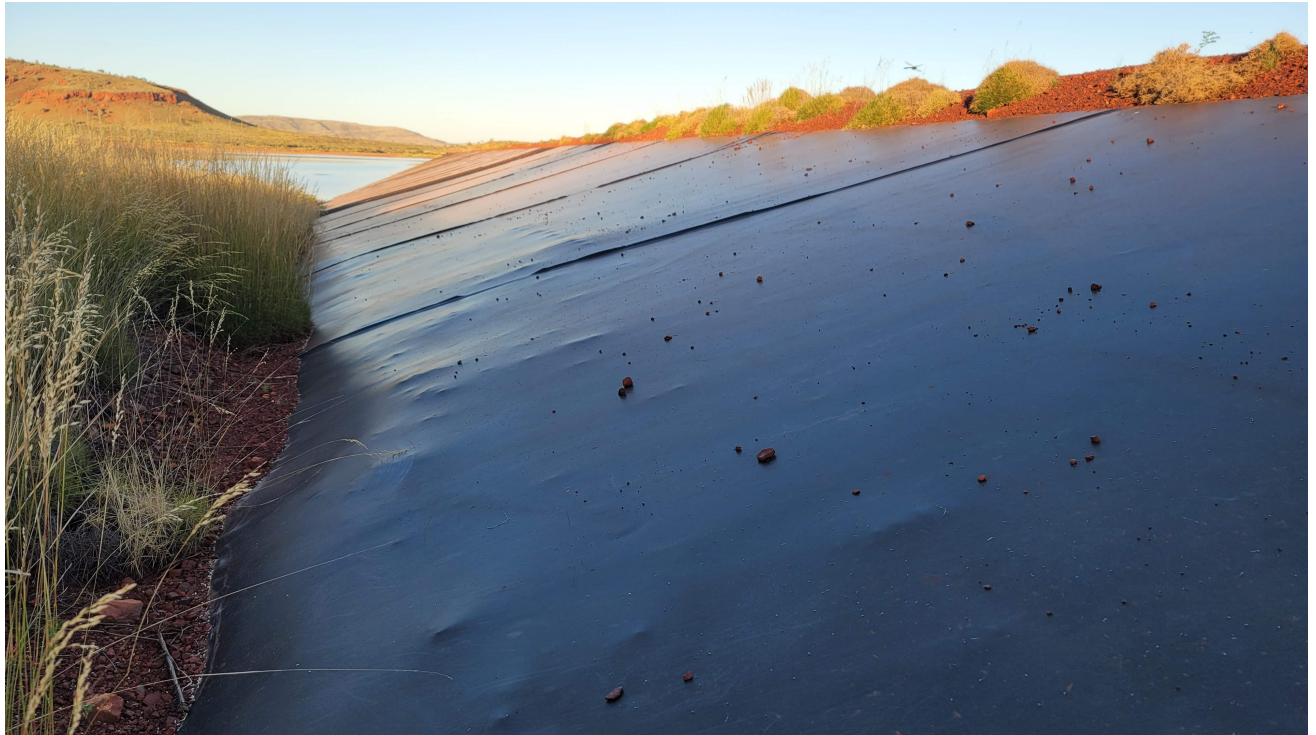
**Introduction:** High-density polyethylene (HDPE) geomembranes are used to prevent fluid migration in a variety of applications, including landfills, mining, and wastewater treatment. However, the installation of HDPE geomembranes on slopes without compensation slack can lead to excessive strains, which can cause stress cracking (see Photo 1 below).

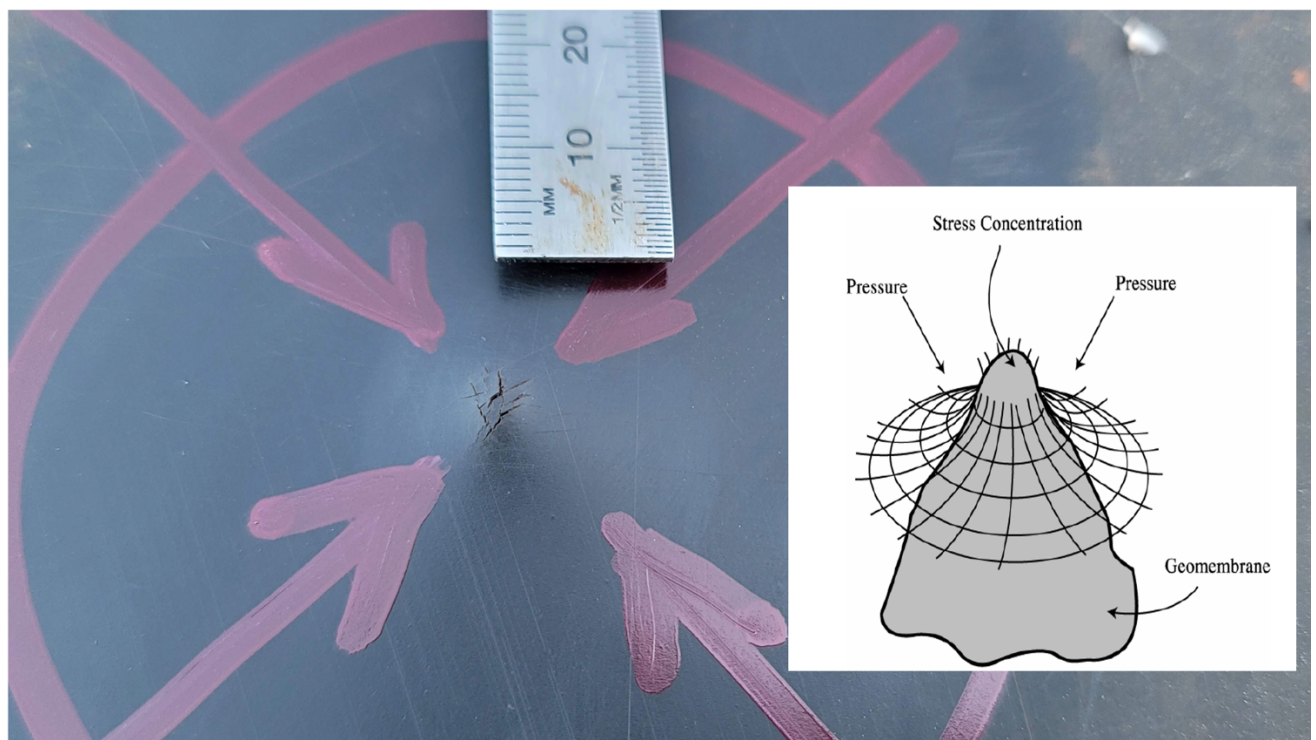
The situation is exacerbated by the presence of underlying rocks and aggregate, which can exert point loads on the geomembrane and promote stress cracking. The puncturing stresses imposed by angular rocks and aggregate on the geomembrane are significant in the field situation. The concern, particularly with HDPE, is not whether the geomembrane is punctured but rather whether it is stressed sufficiently to induce stress cracking in the longer term (see Photo 2).

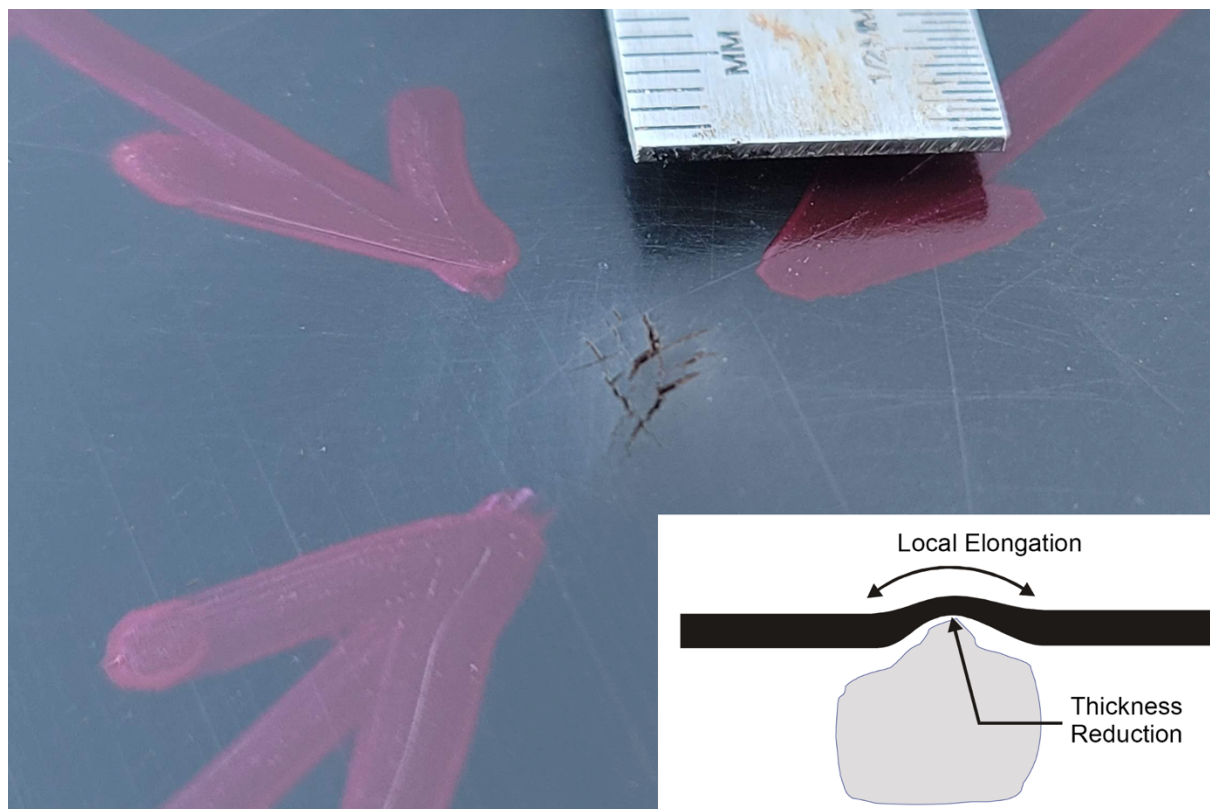
**Stress Cracking:** Stress cracking is a well-defined “sharp” cracking with a brittle failure mode characterized by no or nearly no elongation. Stress cracking in polyethylene is caused by sustained tensile stresses lower than the tensile yield stress of HDPE. The failures are manifested as localized stress concentrations where point loads from oversized aggregates are creating excessive surface strains that induce and promote the development of stress cracking. The concern is not whether the geomembrane is punctured, but rather whether it is stressed sufficiently to induce stress cracking in the longer term. Damage can be done to the geomembrane during installation that does not become a leak until much later.
