# **Understanding the Failure Modes of Multilayer Composite PE Pipes**

# **By PPN Editor**

## 24 June 2024

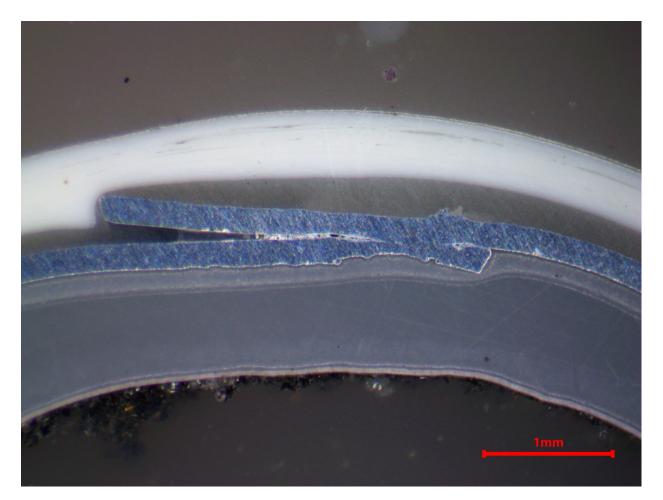
- 1. Weld Quality: The quality of welds between the aluminium layers can vary, impacting the structural integrity of the pipe. Poor weld geometry or defects in the bonding process can lead to localized stress concentrations, potentially resulting in premature failures under pressure.

The photograph below shows a poorly forming overlap weld in the aluminium layer of a MLCP pipe that has led to bursting failures.

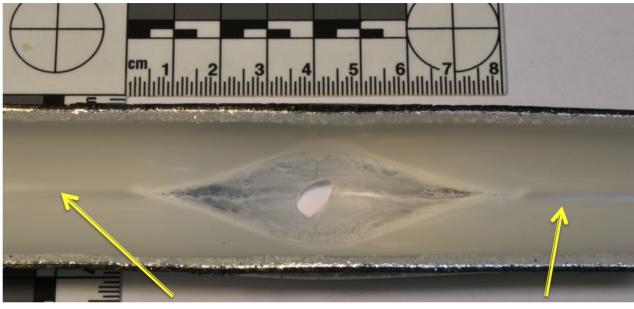
Weld line

The photograph below shows the bursting failure of the MLCP pipe with the defective weld line which has acted as a stress concentration.

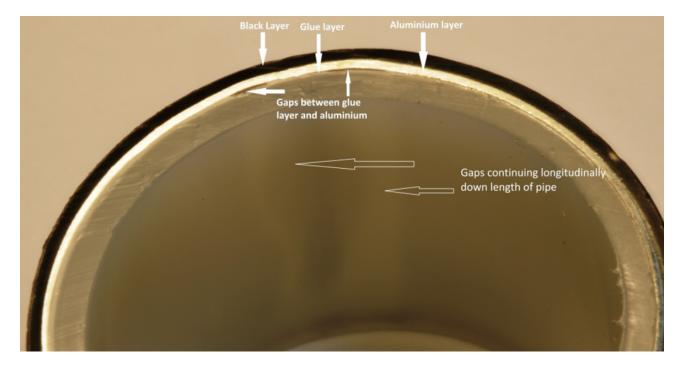
- 2. **Delamination and Corrosion**: Delamination between the aluminium and polyethylene layers can occur, especially in regions where the bonding adhesive may not form a uniform seal. This can create spaces where moisture ingress promotes corrosion of the aluminium, leading to structural weakening and pipe failure over time.

The photograph below shows zones of delamination in a defective MLCP pipe.

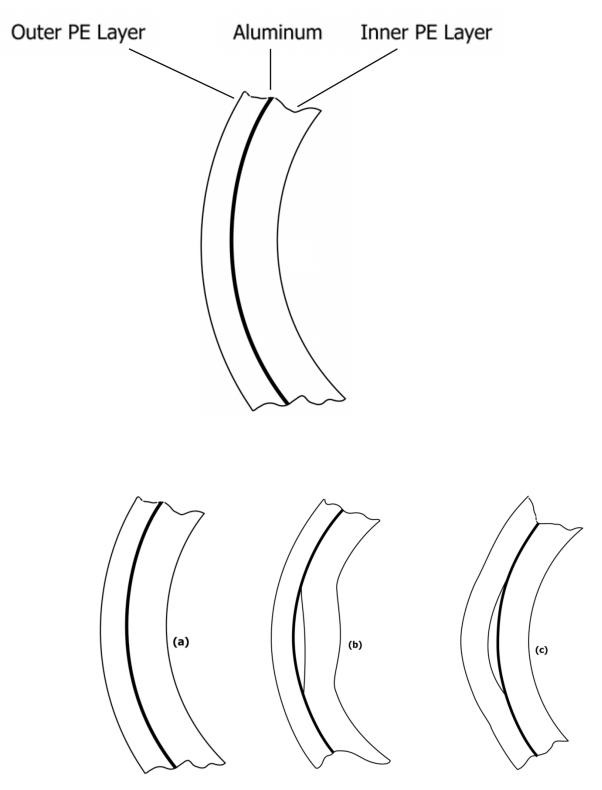
ASTM F1281 – 17 Standard Specification for Crosslinked Polyethylene/Aluminium/Crosslinked Polyethylene (PEX-AL-PEX) Pressure Pipe warns of the delamination risks of MLCP pipes and provides the schematics below.

NOTE 1-(a) Good pipe showing no delamination, (b) Delamination between the inner layer and the aluminum, and (c) Delamination between the outer layer and the aluminum.

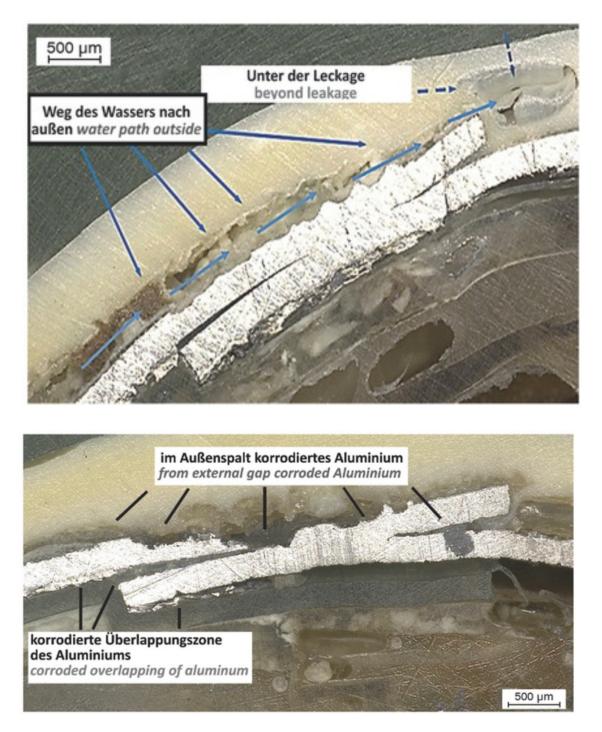
The photographs below from Pajonk (2023) show the problems of corrosion of the aluminium layer due to water penetration through areas that have gaps in the glue and poorly formed welded in the aluminium layer.

At the aluminium interface, the glue failed and the PE liner detached from the aluminium barrier; thus, a gap was formed which was filled by water, by water compounds, as well as by aluminium and silicon salts. In this region corrosion caused voluminously aluminium salts; the outer PE-jacket bulged and fractured longitudinally forming a notch.
