Geotextiles and Geomembranes

Investigations of geomembrane integrity within a 25-year old landfill capping

Investigations have been undertaken at a 16 ha landfill capping to assess performance of the geomembrane component some 20–25 years after installation. The site has been the subject of quite extensive monitoring together with hydrological and other studies. Although environmental monitoring has shown no major concerns, there have been discrepancies in calculated water balance, leading to the recent investigations reported here. The capping, which is an interim solution, comprises about 1 m of cover soils over 0.375 mm LDPE geomembrane and surrounded by a perimeter drain. A robust final capping system will be constructed at a later date. Various remedial works were undertaken between 2010 and 2014 at the cap perimeter drains, also at a series of gas vent/probe holes through the geomembrane, to address the discrepancies in water balance, and the opportunity was taken to investigate the condition of the geomembrane which revealed a series of unanticipated gaps in the geomembrane. These investigations were subsequently extended over the whole cap to characterise the nature and e

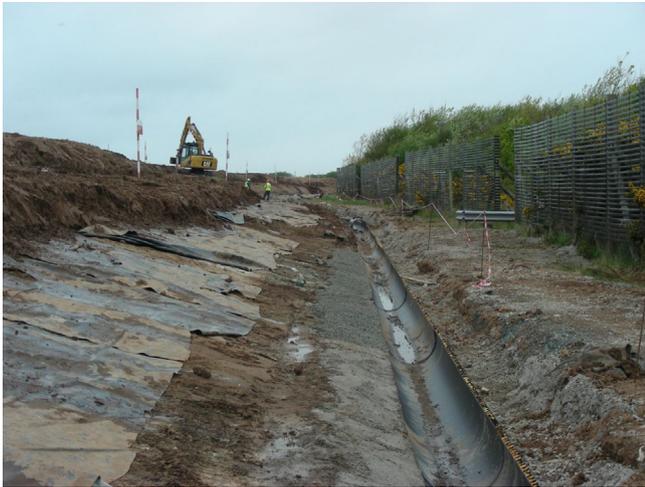
During these remedial works the opportunity was taken to inspect the areas of the interim trench cap adjacent to the perimeter drains, exposed during the works. Fuller details are given below. In brief, the areas of the interim cap exposed were found to be in quite good condition considering the length of time for which

it has been in place. The number of defects was moderate, consistent with a thin geomembrane without particular protection measures. Some more significant defects (tears) encountered were almost certainly the result of activity to expose the liner. The other main defects were a variable number of small holes, some of which may have been caused by exposing the liner, but most of which probably date back to construction. There was no particular evidence of deterioration with time.

Fig. 2. Image during 2010 remedial works to perimeter drain. Original 0.375 mm LDPE geomembrane upslope of the drain exposed for examination.

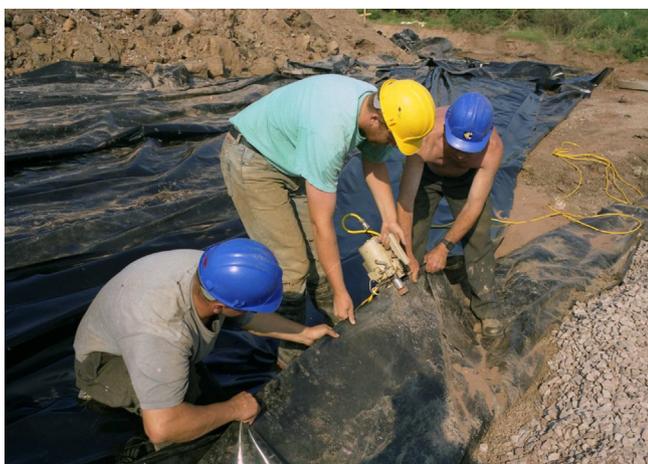
Fig. 3. Contemporaneous image of original work of fusion welding of the cap geomembrane to the perimeter drain liner. Of note: single track welding machine being used; also behind the welding team the geomembrane shortly after its installation is in a significantly wrinkled/folded condition.

It was found that weld strengths were poorer and weaker than the parent geomembrane material, whereas the opposite is typically the case with modern seaming. This is thought to relate to the welding methods then used, rather than showing degradation. The adjacent fill materials were generally soft and without hard or sharp objects which might cause damage. However, the most defects were found in a few areas of comparatively hard, abrasive underlying materials (gravels). Protector geotextile was not used, as would be required by modern design procedures, although protector geotextile was used in the reinstatement works (Fig. 6).

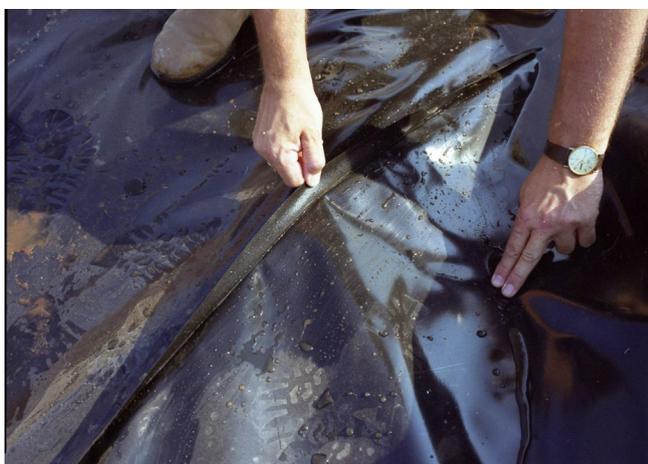
Fig. 4. Contemporaneous image/close up of single track weld.

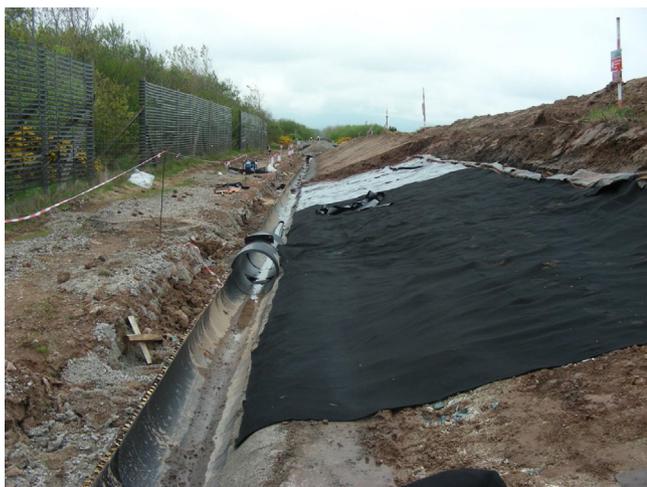
Fig. 6. Geomembrane reinstatement works including use of geotextile protector following 2010 installation of replacement perimeter drain.

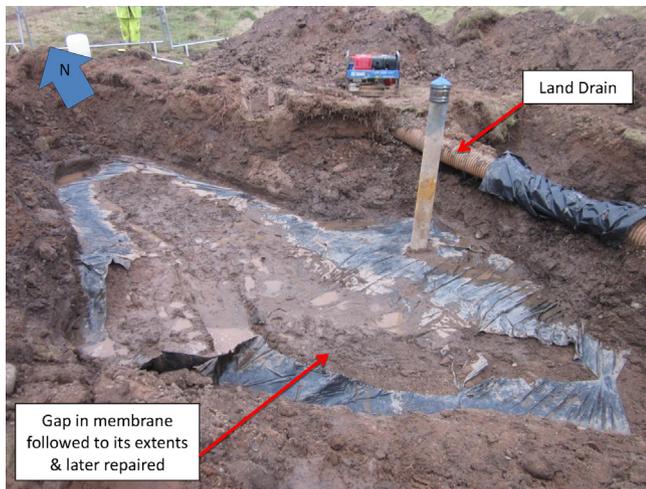
More significant damage to the geomembrane was found at 12 locations. Of these, eight were considered to be minor damage and were either covered by the boot skirt or a small patch was installed. The damage at the remaining four locations was more significant and in two cases extended beyond the initial excavation. All were rectified. Four GV locations showed nearby damage to seams, all of which were remediated locally. – refer to Fig. 8 for damage at GV 4.13. The discovery of this damage led to further investigation works to establish the extent and representativeness of data obtained up to that stage, and these investigations are discussed below. Six locations had significant depressions local to the probe-geomembrane interface, in the order of 50–100 mm maximum depth, generally less. They were all remediated by being infilled with bentonite powder before backfilling.

Fig. 8. Damage to liner near gas Vent GV 4.13 – 2013 investigations. Note the observed damage here is not at a seam.

A 'boot' repair was used to provide a seal between the geomembrane and the gas vent pipe. The boot comprised a polyethylene 250 mm diameter pipe with a skirt of 1 mm thick low density polyethylene (LDPE). All 96 probes were investigated and at 86 of these over T1–6 were found to be as per available information; these were without seals to the geomembrane and all were remediated with boots. All these showed some damage/lack of seals. The other 10 probe locations, all in T7 were found to have been originally fitted with boots (not previously known or expected) and already satisfactory.

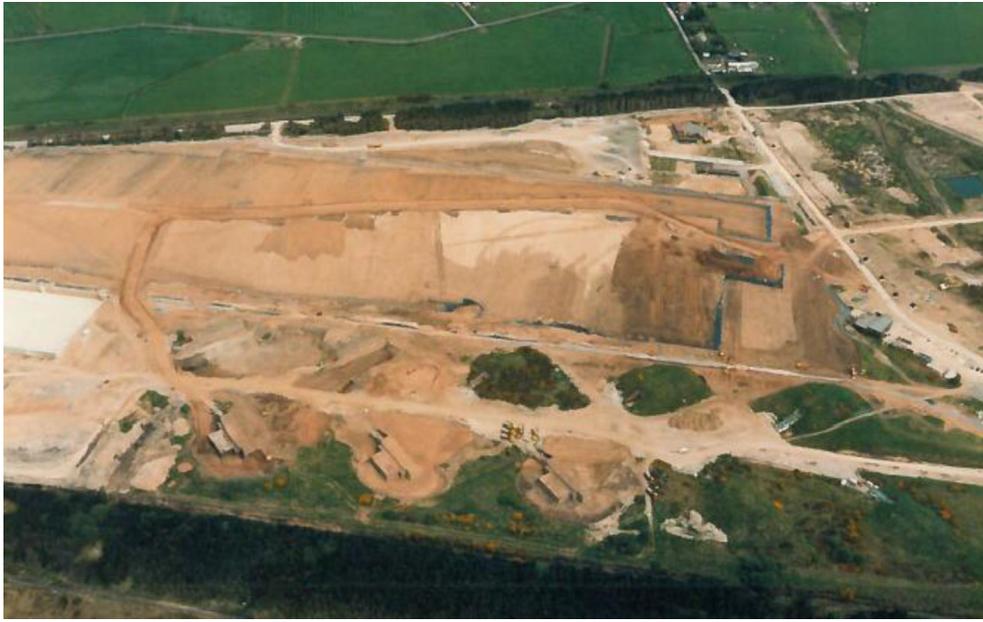
Fig. 9. Aerial image circa 1989–90: apparent downslope cap soil placement consistent with construction haul road position along crest spine of cap.

in the cover soils during construction, although there was no remaining evidence of soil movements at the ground surface. It is noted that slope inclinations are very modest. It is considered most likely that failures within the geomembrane such as tears and perforations were induced during the construction phase, due to plant movements and practical difficulties such as working with excessively wet soils (discussed below in Section 3.1). These gaps and wrinkles therefore are thought likely to have been present from that period and it is thought most likely that these occurred soon after placement of the initial layers of cover soils over the geomembrane, while plant was emplacing subsequent cover materials.

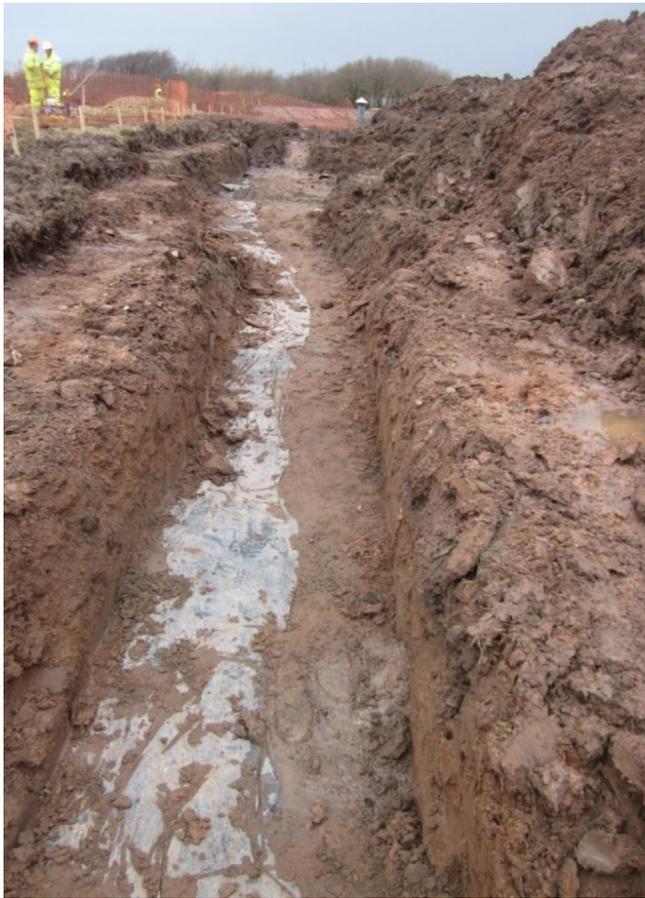
Ultimately three phases of additional investigations were implemented, with the areal extents of investigations increasing each time until the full extent of the trench cap had been investigated to some degree (Fig. 7). It was initially thought that the main damage might be in a limited area around the southern crest and associated with a construction haul road (Fig. 9). As the investigations proceeded it became clear that this was not the case. Strip trenches of about 1 m width were located throughout the cap area, essentially random, but extended to follow seams, particularly where gaps were found (Fig. 10).

Fig. 10. Strip trench showing split near membrane seam – 2013 investigations.

About 7% by length of the investigation trenches (over T1–6, but not T7) show linear gaps, up to 2.5 m wide and 40 m length found (maximums recorded or followed to their limits). The gaps are immediately adjacent to seams, with tears in the geomembrane rather than the seam itself. They appear consistent with downslope panels having been dragged away from the upslope panels by unsatisfactory construction plant operations (these panels are oriented transverse to the slope, rather than downslope, which is better practice).

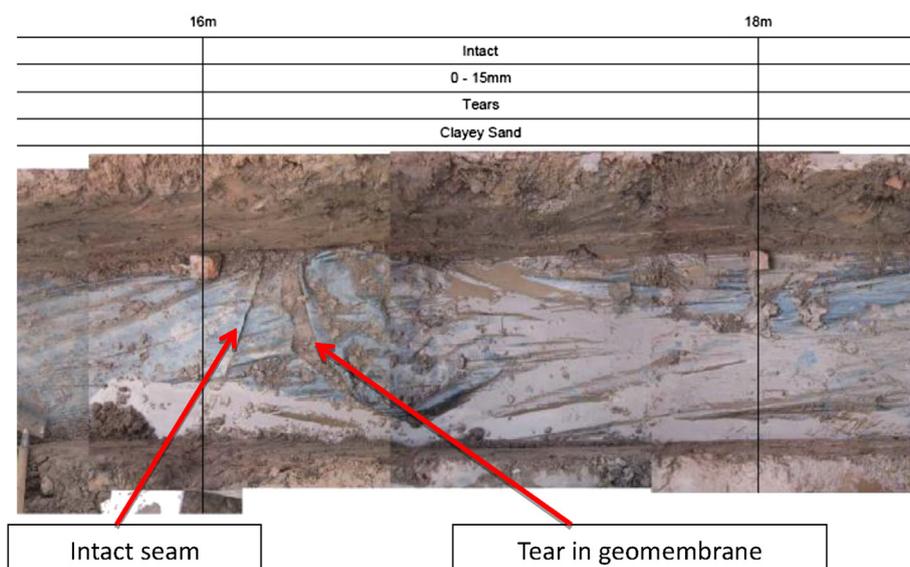
In all 23 strip trenches were excavated, of total length 1942 m, i.e. approximately 1.2% of the cap geomembrane and adjacent soils was viewed. Significant previously unknown damage was found, notably major gaps between geomembrane panels at seam locations, up to 2.5 m wide over T1–6. Approximately 7% by length was missing. T7 had missing geomembrane at four locations and the T7 subgrade was observed to be affected by numerous hummocks, discussed below. Limited other damage/defects to the geomembrane was found (approximately 3% by length), apparently almost entirely at or adjacent to seams – see Fig. 11 for an example of a tear in the geomembrane near an intact seam at ST 4B.

Fig. 11. Strip trench ST 4B showing tear to geomembrane near an intact seam – 2013 investigations.

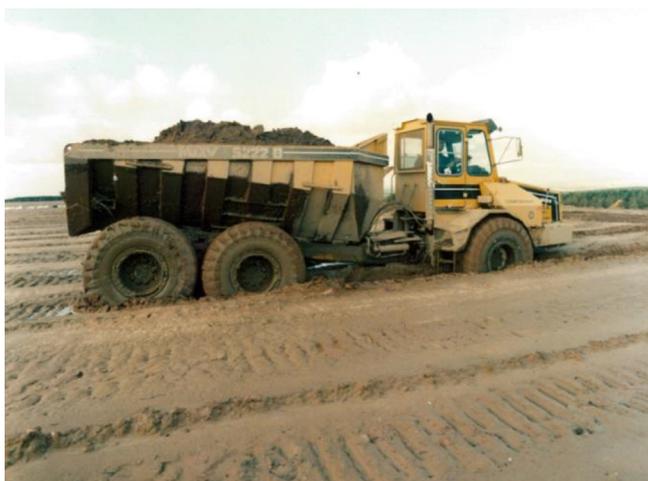
The most probable cause is considered to be damage during original placement of the cover soils, associated with locally poor soils, wet weather and/or poor construction practice. Of note:-

- Construction photographs clearly show soft ground and plant bogged (Fig. 12), which might be expected to lead to damage in the geomembrane and/or subgrade, consistent with that recently found.
- From review of aerial photographs from around 1989 (Fig. 9) it appears that T1-6 cover soils were generally placed working downslope (not recommended practice; Qian et al., 2001),
- Layer thicknesses and suitability of the fill materials are not known. Problems would arise if too wet (typically >3% wet of optimum, but no earthworks specification are known here).
- Contemporaneous records report the earthworks being problematic over winter and much of the fill reportedly 'unsuitable for earthworks' (apparently just too wet). There is no indication, however, that the integrity of the cap was compromised by the materials used.

Fig. 12. Contemporaneous image of original cap construction in soft, wet ground conditions showing dump truck bogged to its axles prior to geomembrane placement, indicative of the challenging site and climatic setting.
