International Journal of Applied Earth Observations and Geoinformation

New insights into the 2020 Sardoba dam failure in Uzbekistan from Earth observation

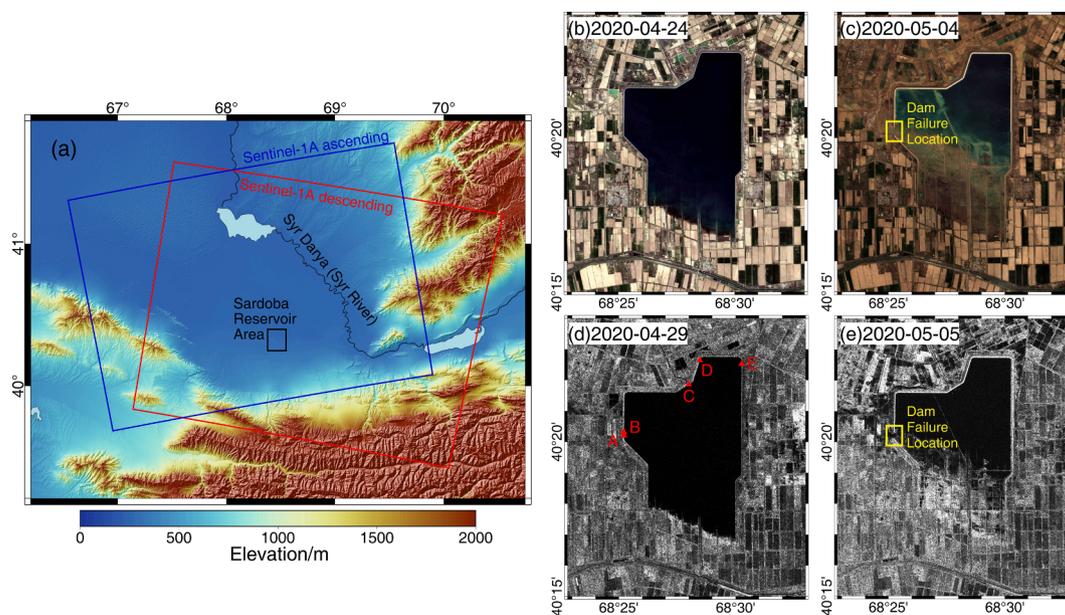
Fig. 1. Overall study area. (a) Location of the Sardoba Reservoir with topography as the background map, and the coverage of Sentinel-1 data used. (b) and (c) are optical remote sensing images from Sentinel-2 satellite (natural colour band combination of red B4, green B3, and blue B2) acquired before (on 2020-04-24) and after (on 2020-05-04) the dam failure, respectively. (d) and (e) are SAR intensity maps from Sentinel-1 acquired on 2020-04-29 and 2020-05-05, respectively. The rectangles in (c) and (e) indicate the location of the failure section on the dam.

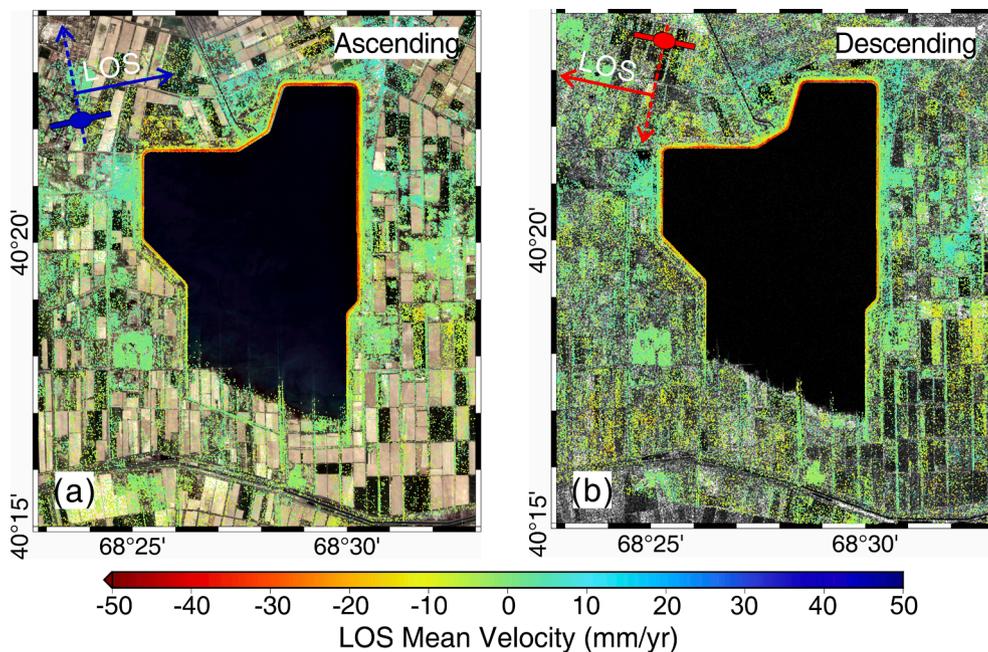
Due to the different imaging geometries, the displacements observed from the ascending and descending satellite tracks present different patterns. For example, the east side of the embankment dam shows obvious deformation in the ascending track (Fig. 7a), while being relatively stable in the descending map (Fig. 7b). This is because, besides settlement, the dam is also experiencing horizontal displacement. The loads acting on the Sardoba Reservoir dam includes self-weight, water level oscillation and seepage pressure, etc. Deformation is the response to the acting loads and is mostly due to the materials adjusting to stress distribution.

Fig. 7. LOS displacement rate observed by the ascending and descending geometries. A negative value means motion away from the satellite.

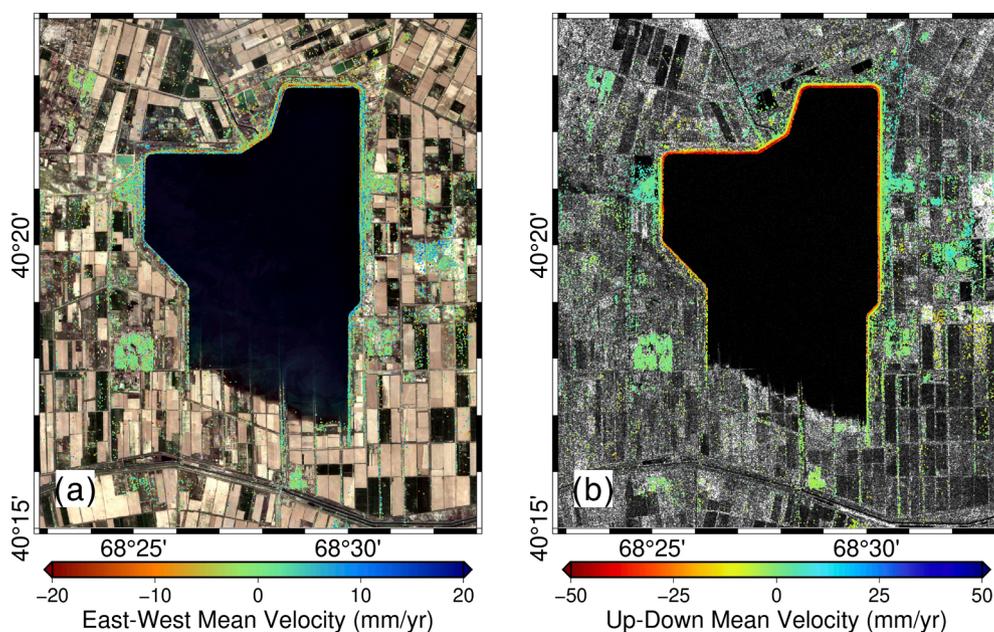
The spatial deformation patterns of the Sardoba Reservoir dam show that the northern part (including the north bank and the northern region on the east and west banks) settles faster than the southern part. The largest subsidence is observed on the north bank, with a maximum rate of over 50 mm/yr. Smallest settlements are found on the southern part of the east bank, whose displacement rate is less than 10 mm/yr. The spatial difference in settlements of the two regions may be attributed to two factors: (i) higher dam height of the northern dam part than the southern as the ground elevation in the area gradually decreases from south to north; and (ii) deeper reservoir water in the north, which causes

Fig. 9. (a) The mean horizontal East-West displacement velocity map, with the positive values implying eastward motion. (b) The mean vertical Up-Down displacement velocity map, with the negative values indicating settlement.

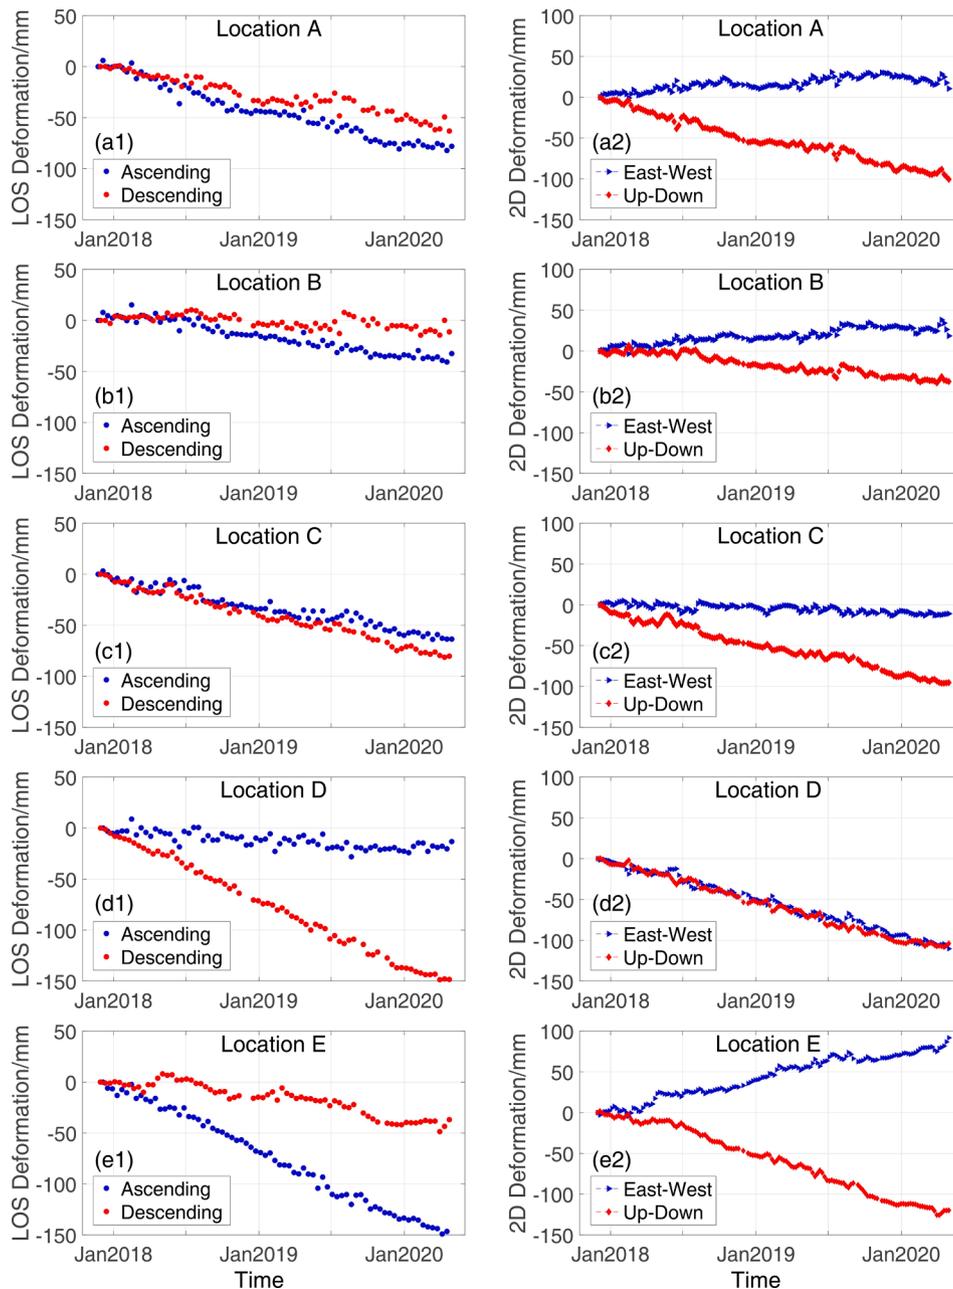
Site A is located within the dam failure section, and B is on the embankment to the north of the break. The deformation time series (Fig. 10a1 and 10a2 vs Fig. 10b1 and 10b2) exhibit similar characteristics but of different magnitudes. Both sites experienced eastward horizontal motions and the cumulative settlements at sites A and B

reached ~100 mm and ~40 mm, respectively. The differential settlement in this area is the physical cause of the dam failure on 1st May, which will be further discussed in Section 5.1.2.

Site C is close to the outlet works of the Sardoba Reservoir. Since the conduits of the outlet works are constructed through the embankment, differential deformations may occur at the joint. Relative movements could cause flow surface irregularities, giving rise to an erosion failure of the appurtenant structure. Therefore, deformation observations at this location play a primary role in ensuring the safety of the outlet structure. The horizontal displacement at site C is fluctuating slightly, and the net horizontal deformation is minimal, being less than 10 mm throughout the monitoring period (Fig. 10c2). Results indicate that the vertical motion dominates the dam crest area near the outlet works. The cumulative subsidence at site C reached more than 90 mm, equivalent to a settling rate of ~40 mm/yr.

Fig. 10. Deformation time series and 2D (E-W horizontal and vertical) decompositions for selected sites A - E, whose locations are marked in Fig. 1d. The first column (a1 - e1) shows the ascending and descending LOS displacements; the second column (a2 - e2) presents the horizontal (E-W) and vertical displacements.

For site D, the magnitude of the cumulative deformation observed from the ascending path is relatively small, whereas that is large from the descending geometry. The situation for site E is the opposite (large for the ascending but small for the descending path). The opposite horizontal motion directions at these two sites (shown in Fig. 10d2 and 10e2) are responsible for the difference. From the 2D results, we can see the cumulative settlements of both locations exceed 100 mm. Site D moved ~100 mm to the west, while E experienced a motion of more than 90 mm to the east.

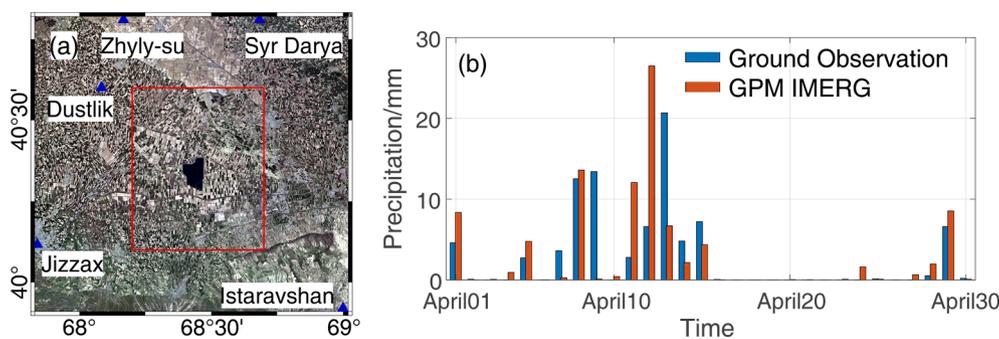
However, we accessed five ground observations in the vicinity of the Sardoba Reservoir, as well as the Integrated Multi-satellite Retrievals for Global Precipitation Measurement (IMERG) data, and found that there is no heavy rain within the region in the past month. The precipitation for April 2020 is shown in Fig. 11. The five weather stations, with the World Meteorological Organization identifier 38581, 38583, 38584, 38579 and 38713, are at distances of approximate 44 km, 56 km, 59 km, 58 km and 63 km from the Sardoba Reservoir (data provided by the website “Reliable Prognosis”, https://rp5.ru/Weather_in_the_world). We used 1 Day IMERG Late Run precipitation accumulations (Huffman et al., 2020) of ~ 10 km spatial resolution and calculated a 50×50 km² average. Both ground and satellite datasets show no significant rainfall (daily precipitation > 10 mm) in the two weeks before the dam breach. Even throughout April, there were no extreme storms or intense rainfall in the region.

Fig. 11. Precipitation in April 2020 for the Sardoba Reservoir region. (a) The blue triangles are locations of nearby ground meteorological observations, and the red rectangle indicates the area for the Global Precipitation Measurement products. (b) The daily precipitation from ground observations (average of five stations) and the satellite products (average of the region).

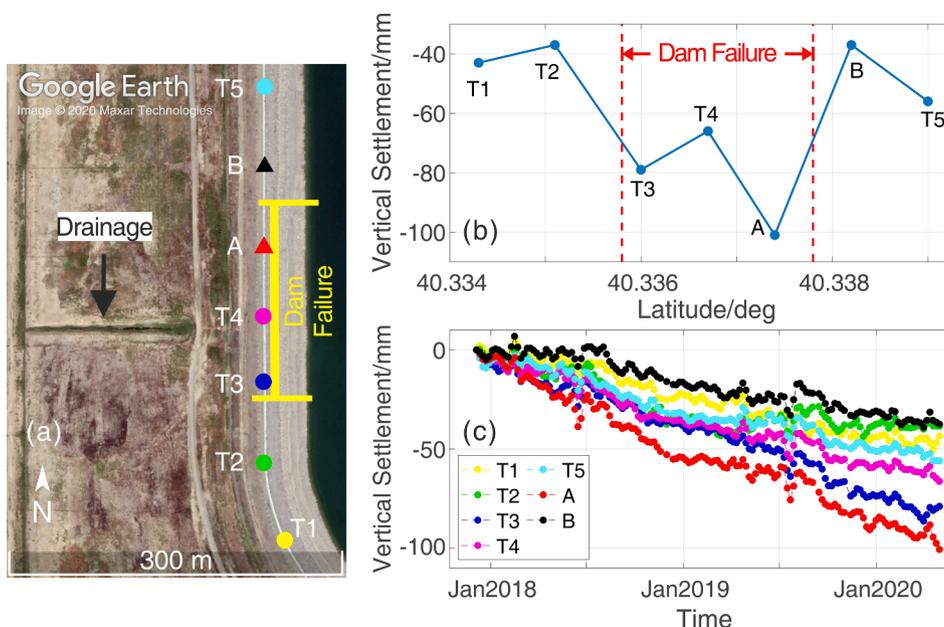
In Figs. 9b, 10a and 10b, we note that the section of embankment dam near the breach location experienced differential settlements before the failure event. A close-up of the dam break section on the satellite image is shown in Fig. 12a, with seven measurement points marked. These selected measurement points derived from SBAS InSAR are all located on the crest of the embankment dam, with distances between adjacent positions less than 100 m. Fig. 12b represents the vertical settlement profile along the dam, where T3, T4 and A are within the dam failure section and T1, T2, B and T5 are not. The vertical deformation of the dam failure section before the burst is more significant than that of the non-failure section. On average, the dam break section (T3, T4 and A) settled by ~ 40 mm more than the non-failure section (T1, T2, B and T5) during the monitoring period. The maximum settlement occurred near location A and reached 100 mm from December 2017 to April 2020. The subsidence difference between A and B, with a distance of ~ 90 m, exceeded 60 mm, which approximates 0.2% of the dam height. From the Google Earth™ historical images, the dam breach section was put into use from the end of 2015. Upon reasonable speculation, the actual uneven settlement between 2015 and 2020 could reach twice the observed value from 2017 to 2020. Although the deformation pattern of the embankment is on a case-by-case basis, experience has shown that

zones with differential settlement greater than 0.5% of the dam height are most likely to suffer cracking and hydraulic fracture (Fell et al., 2015). It is wise to consider the differential settlement as an unusual deformation pattern and take proper interventions.

Fig. 12. The differential settlements near the Sardoba dam break section. (a) A closer look of the dam break section at satellite images from Google Earth™. T1 ~ T5, A and B show the locations of measurement points from SBAS InSAR. (b) Displacement profile along the embankment dam. (c) InSAR-derived settlement time series for locations T1 ~ T5, A and B.

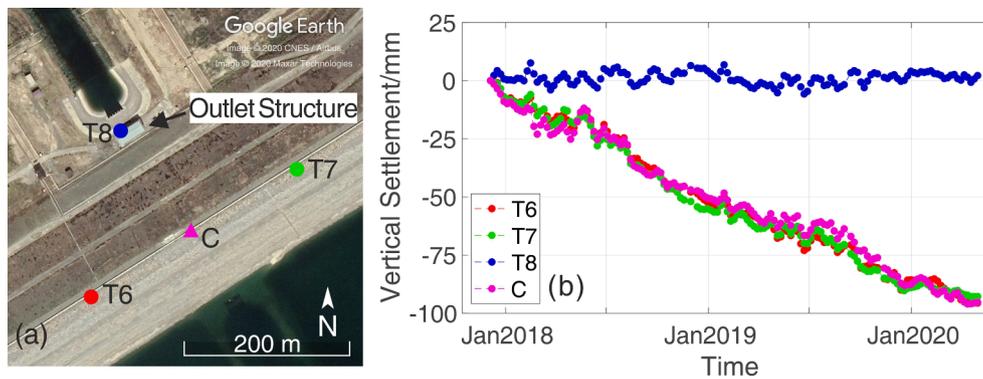
The reservoir outlet works are vital appurtenant structures, which need attention during deformation monitoring. In Fig. 13a, T6 and T7 are located on the dam crest, and T8 is on the roof of the outlet gatehouse. The outlet structure (gatehouse) remains stable, and the cumulative net settlement is almost zero. The dam section near the outlet works has settled by ~100 mm in more than two years, and the time-series deformation demonstrates that the area was experiencing the primary consolidation settlement. Compared to the deformation process near the failure section shown in Fig. 12, we can see the noticeable difference: the cumulative settlement, as well as the deforming rate, are highly consistent at the monitoring points (T6, T7 and C). No differential settlement occurs on the embankment near the outlet works of the Sardoba Reservoir.

Fig. 13. An example of the settlement monitoring result by InSAR. (a) A closer look of the Sardoba Reservoir outlet works at satellite images from Google Earth™. T6 ~ T8 and C show the locations of measurement points from InSAR. (b) Monitoring results (vertical deformation time series) from December 2017 to April 2020 derived from InSAR measurements.
