Feedback from the bituminous geomembrane (BGM) implemented 20 years ago at the Galaube dam

N. Pepin & L. Deroo

ISL Ingénierie, France

ABSTRACT: The Galaube dam is a 40 m high French rockfill dam commissioned in 2001. The upstream facing is ensured by a 4.6 mm thick bituminous geomembrane (BGM) directly laid on a cold mix layer and an impregnated layer gavel.

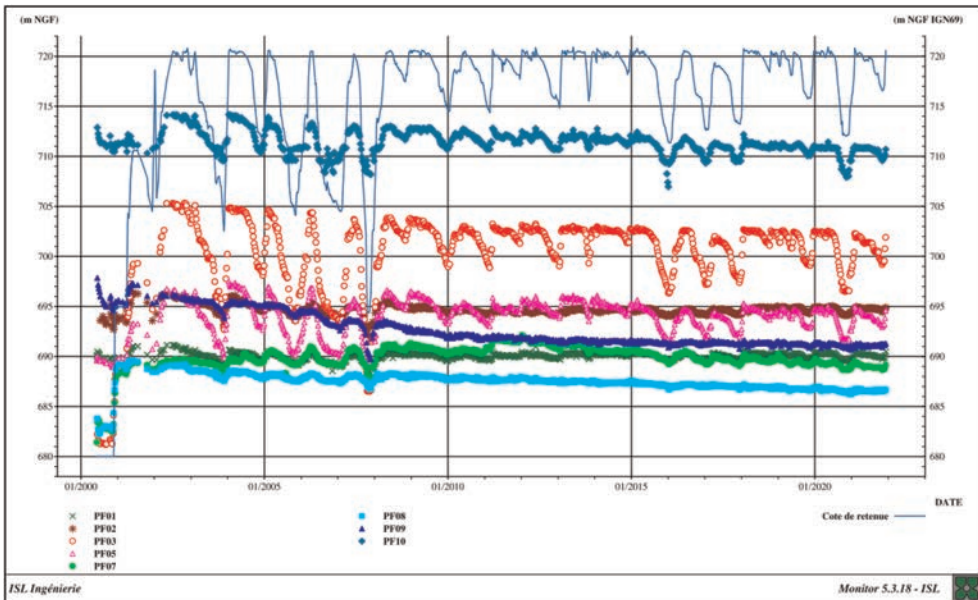
Figure 3. Time evolution of the piezometric levels in the foundation, downstream of the plinth.

The piezometry at the downstream foot of the plinth (Figures 3 and 6) appears to be well draw down with a low (less than 30%) to very low (less than 10%) dependence on the reservoir level. Only PF03 piezometer shows particularly sensitive to the level of the reservoir

and reacts by faithfully reproducing the reservoir curve. This singular behavior, detected immediately after the first filling, is not reproduced by its neighbors (PF07 and PF08). As PF03 is drilled in a zone where the rock is of good quality and low permeability, it is likely that PF03 measures a singularity of piezometry, for example by capturing a fine fissure, where pressures can become high due to the low permeability of the medium. Watertightness of the geomembrane is therefore not in question.

Overall, the analysis of piezometric levels downstream of the plinth over the period 2001–2021, shows that they are constantly decreasing since impoundment, on average by about -10 cm/year. It is most certainly a consequence of the progressive sealing of the upstream foot of the dam in connection with the progressive silting of the reservoir.

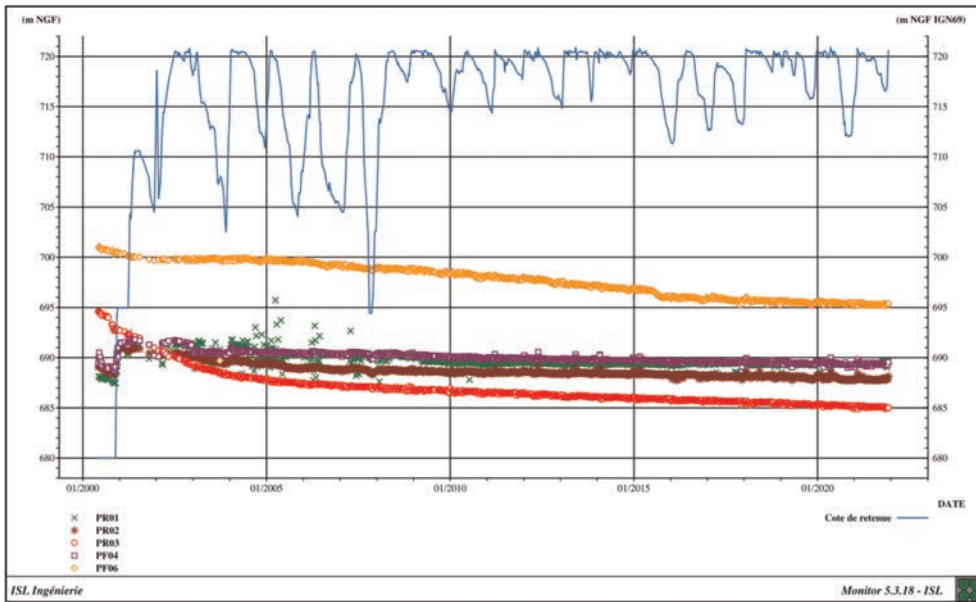
Figure 4. Time evolution of the piezometric levels at the interface of the dam body and the foundation.

In the axis of the dam (Figure 4), PF06 and PR03 were apparently above the piezometric level at the first filling but they have shown a continuous decrease since then confirming the very good behaviour of the upstream facing. The piezometry at the bottom of the valley (Figure 4, PR01, PR02, PF04), is quite homogeneous under 690 m NGF, which corresponds to the foundation level of the dam in this area. The rockfill, which is very draining, does not allow piezometry to develop.

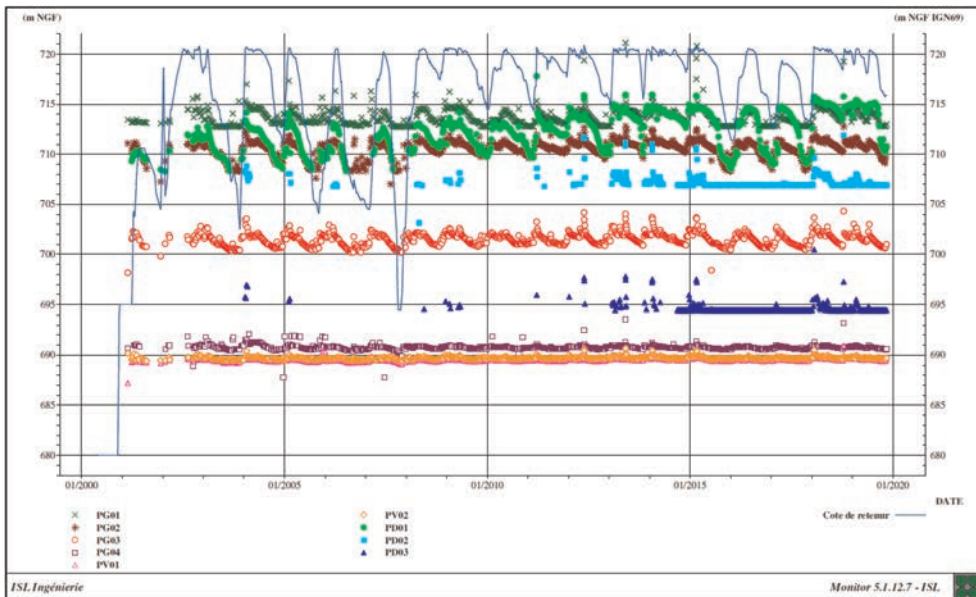
Figure 5. Time evolution of piezometric levels downstream of the dam and on the riverbank.

Regarding the piezometry downstream of the dam (Figure 5), only the piezometers at the top of the bank (PD01, PG01 and PG02) reacted to first filling and show now a strong dependence on the reservoir level. These piezometers are the closest to the reservoir and they are located in an area (the upper bank) where the foundation is permeable (upper left bank made up of deeply altered granite, and upper right bank where there is an interface between the granite foundation of the dam and the shale that overhangs it). All these piezometers are traditionally influenced by weather conditions, especially the heaviest rainfall events which lead to reversible peaks.

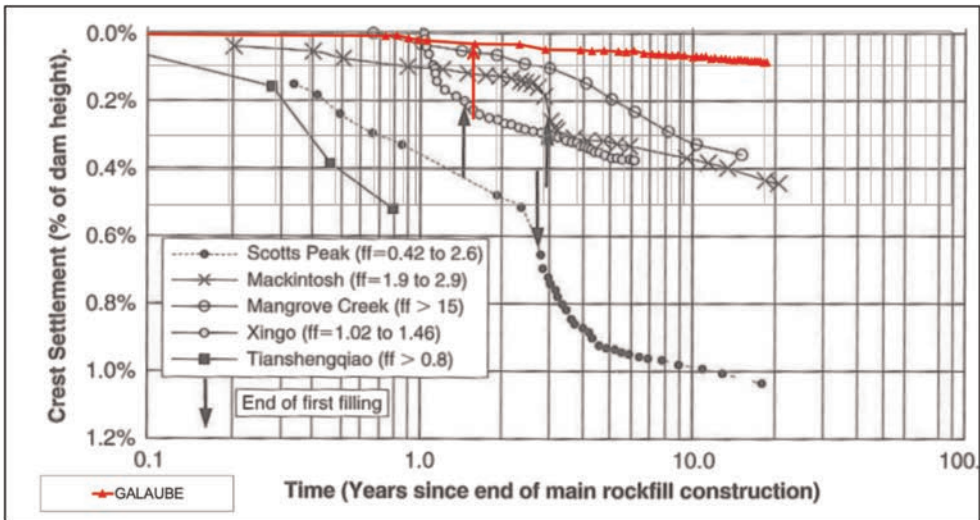
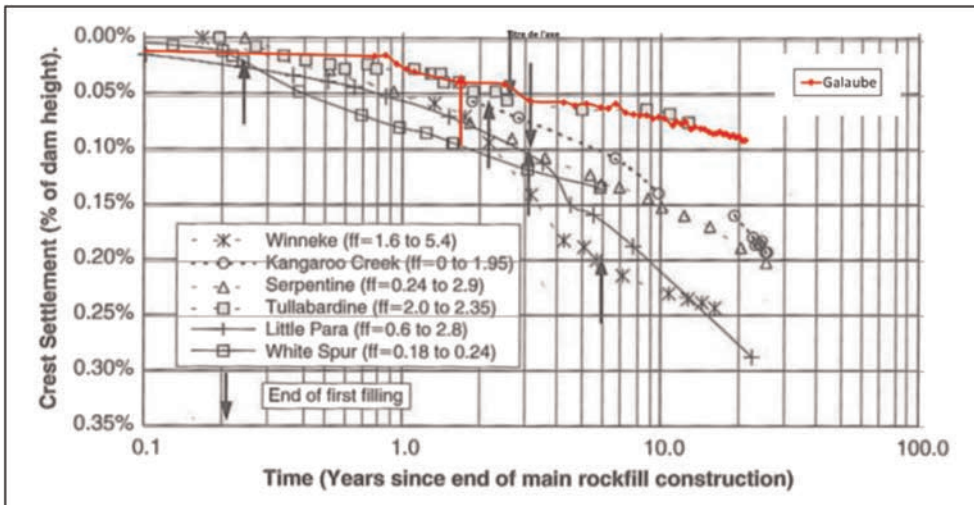
- The proven behavior of the structure: it has settled very few in practice (cumulative settlement less than 4 cm at the crest, i.e. less than 0.1% of the total height of the dam) and less than most upstream facing rockfill structures of the same type (see comparison in the graphs on Figure 7 and Figure 8 with 11 well compacted dams, i.e. with materials of medium to high quality $20 < RC < 70$ MPa) ;
- The precautions taken during the construction phase to compact the rockfill, in particular: a maximum layer thickness of 80 cm, a minimum of 8 passes (one way) of a heavy smooth

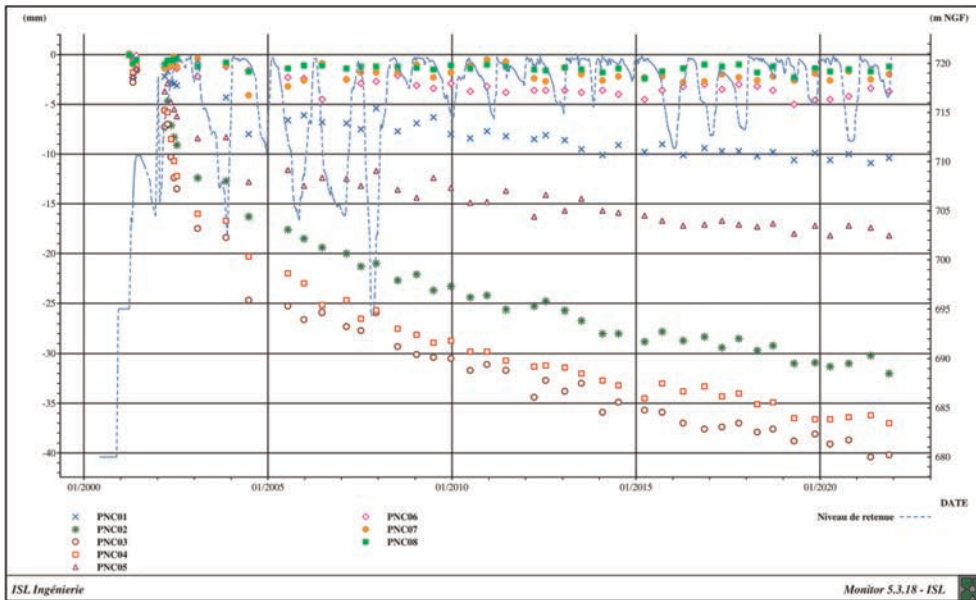
Figure 9. Time evolution of crest elevation measurements.

It should be noted that a slight elevation of the dam crest was recorded (of the order of 1 to 2 mm and visible on all the height benchmarks on the crest of the dam), during the emptying (cf. Figure 9). This is a mechanical consequence of the decrease in hydrostatic

pressures of the reservoir on the upstream face of the structure (decompression of the rockfill).

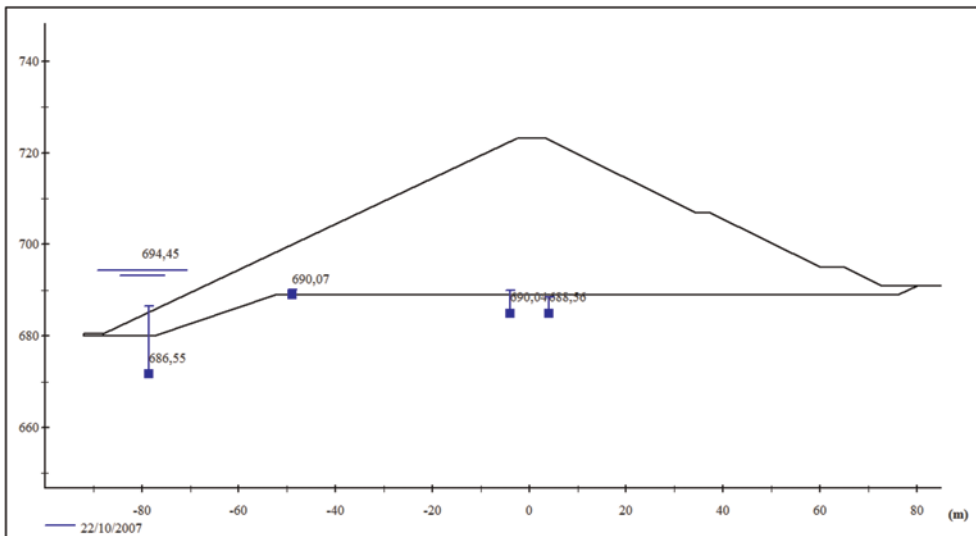
Figure 10. Maximum piezometry downstream of the plinth at the time of the 2007 reservoir emptying.

It was also checked that the under-pressure behind the facing remained below the hydrostatic pressure exerted by the reservoir on the facing, which did not create a risk of lifting the geomembrane or the concrete protection slabs (cf. Figure 10).
