Lessons Learned from the Two Major Tailings Dam Accidents in Brazil

Keywords Brumadinho accident · Mariana accident · Static liquefaction · Dam management

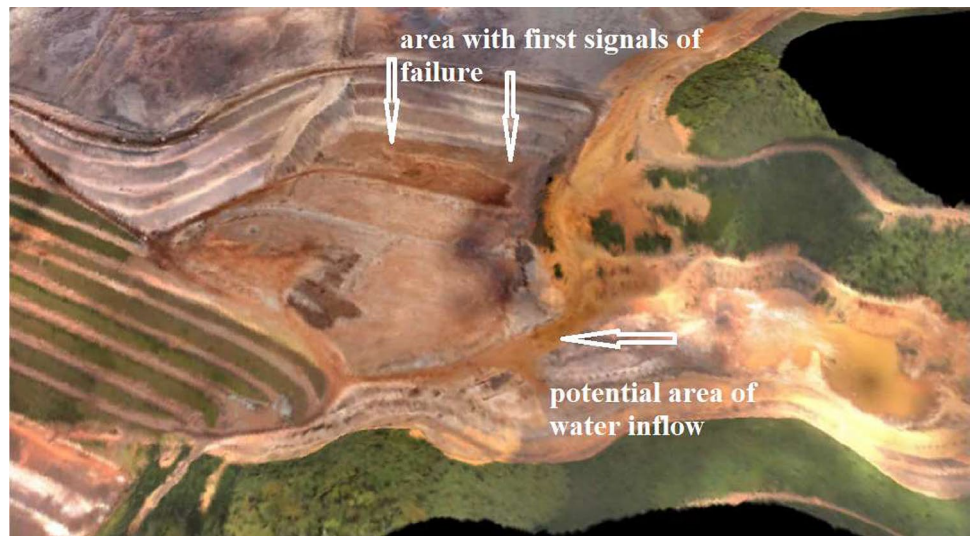
Fig. 1 Change in design of the Fundão Dam with retreat of the left dam shoulder. The new dyke was raised in saturated tailings (modified from Morgenstern et al. 2016)

- (vii) *Bad management practices*: these included deviations from the original dam designs, which produced a setback that pushed the upper portion of the slope over weaker fine tailings; other changes that led to the deposition of fine tailings in places where there should only have been coarser tailings; as the dams were raised, the drains were not properly connected, creating drainage problems; several incidents during the life of the dams that were not properly addressed that increased saturation of the tailings; and many times, the water was close to the dam crest, resulting in weak tailings close to the crest and interbedded layers of fine and coarse tailings within the dam;

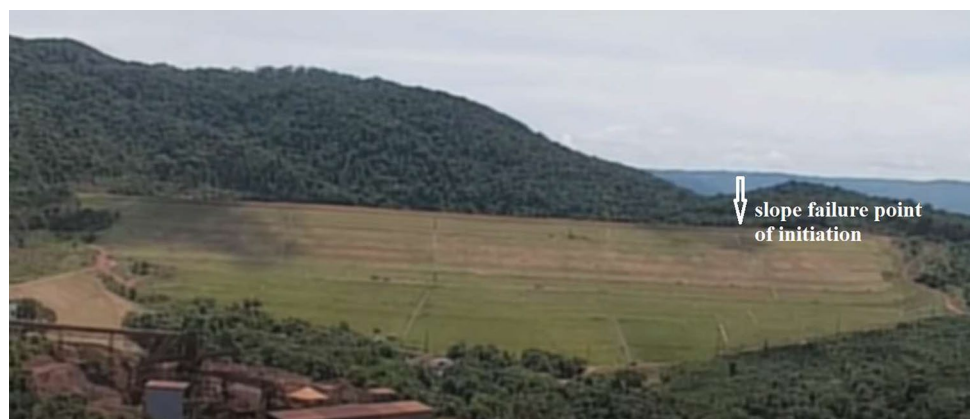
concluded that the main cause was again static liquefaction of materials within the dam. They observed that unexpected cementation of the tailings grains made the tailings brittle. This feature, not seen in other iron ore tailings dams, meant that the inclinometers and motion survey markers did not indicate significant movements before the failure. The tailings in the dam showed a sudden and significant loss of strength, and rapidly became a heavy liquid that flowed downstream at high speed. Less than five minutes was enough to liberate more than 9.7 million m³ of materials. Approximately 75% of the tailings flowed out of the dam. Figures 2, 3, and 4 shows the failure starting at the top of the dam and moving to its toe. The presence of a video camera in front of the dam allows good analysis of the failure process.

Fig. 2 Feijão Dam I initiation point of slope failure captured by video camera in front of the dam (modified from public images first shown on TV by Globo)

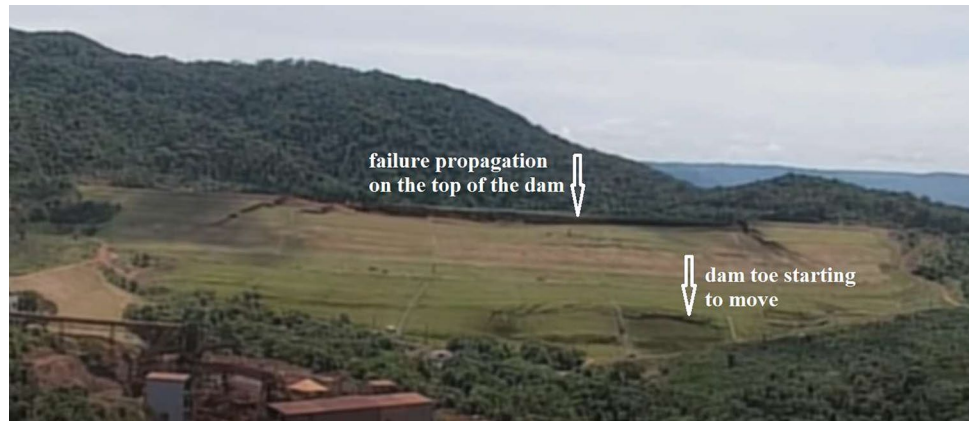
Fig. 3 Toe movement and propagation of the failure at the Feijão Dam I (modified from public images first shown on TV by Globo)

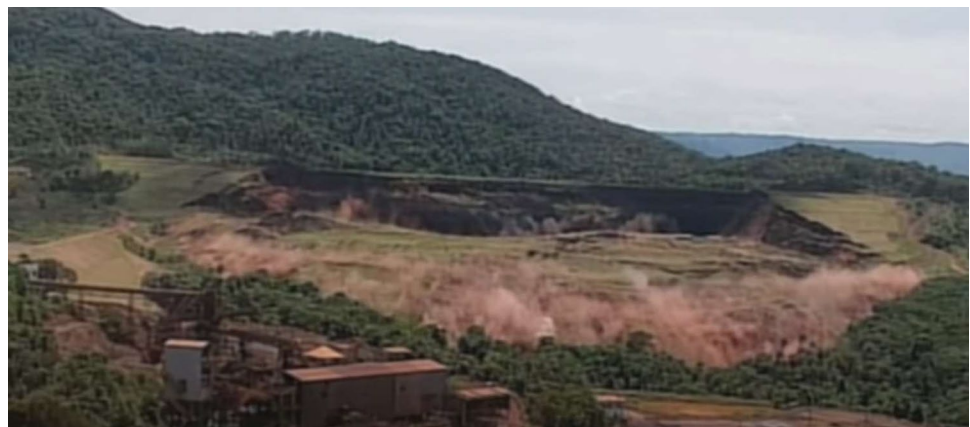
Fig. 4 After a few seconds, the failure propagated throughout the Feijão Dam I (modified from public images first shown on TV by Globo)
