ANALYSIS OF MAIN CAUSES OF STRUCTURAL FAILURES IN IMPERMEABLE GEOMEMBRANE LINERS OF HYDRAULIC STRUCTURES

S. V. Solsky¹ and S. A. Bykovskaya²

Translated from *Gidrotekhnicheskoe Stroitel'stvo*, No. 2, February 2021, pp. 33 – 40. DOI: 10.34831/EP.2021.50.18.003

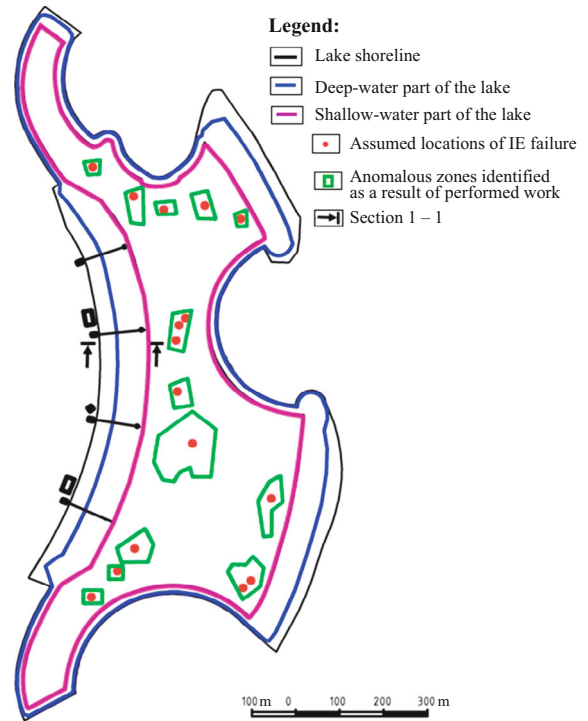
Fig. 4. Schematic of the artificial lake drawn up on the basis of the performed work: locations of section, junction, and failures in the IE.

Upon completing construction and filling the artificial lake in 2013, an off-design lowering of the water level was observed to occur as a result of leakage through the impermeable barrier. In order to determine the causes of the leaks, identify the areas exhibiting increased seepage, and develop recommendations on eliminating seepage in the reservoir, specialists from the Department of Foundations, Earth, and Underground Structures at the B. E. Vedenev All-Russia Research Institute of Hydraulic Engineering conducted comprehensive studies including an analysis of design and execution documentation, field engineering inspection via destructive and nondestructive methods, verification calculations, and the development of measures to restore the surface integrity of the IE. A visual and instrument-aided structural inspection (including via indicator dye and geoelectrical methods) of the bed and flanks of the artificial lake revealed local failures (Fig. 4) in the impermeable barrier scattered across the site area. The analysis suggested that the leakage

areas, confined to breaches in geomembrane liners, accounted for about 30% of the total lake area.

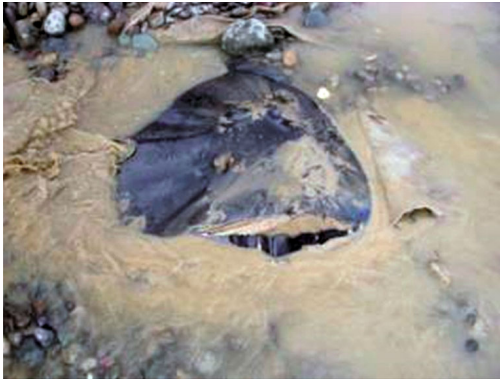
Rupture of the geomembrane along the edges of a boulder embedded in the barrier base

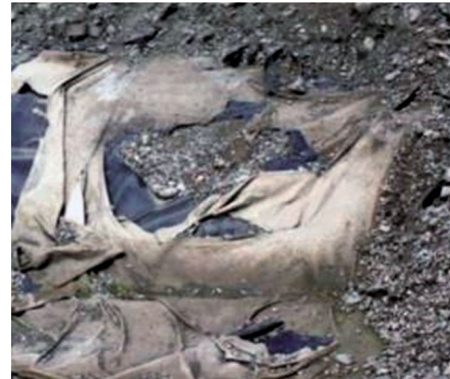
Damage to the geomembrane liner due to its placement on inadequately prepared subgrade

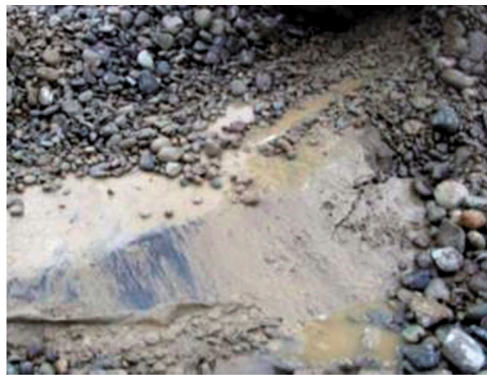
Rupture of the geomembrane along the edges of a sinkhole formed in the sandy-loam bedding at the geomembrane base

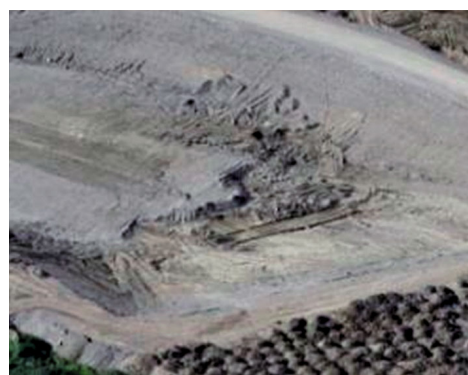
Violation of the subgrade surface by machinery during construction

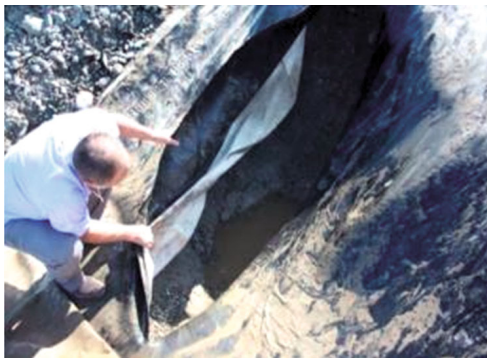
Rupture of the geomembrane on the slope in the area of a pit/track due to poor subgrade preparation

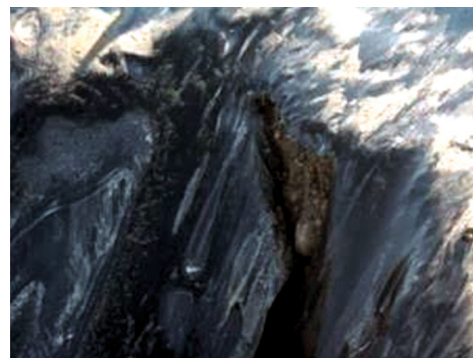
Further expansion of geomembrane rupture in the transverse direction

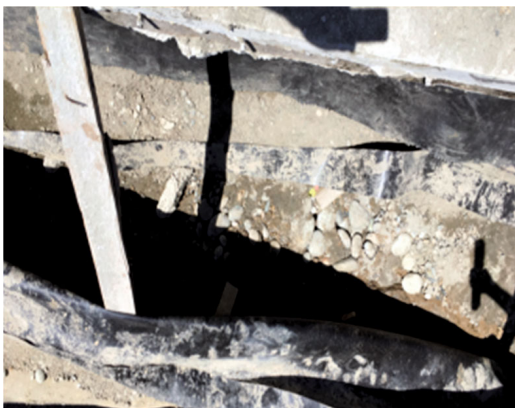
Washed-out cobbles under the breached geomembrane seam

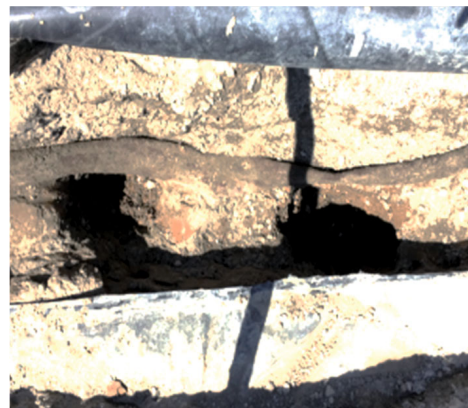
Sinkholes formed in loam
