Integrity of Polyethylene Butt Fusion Joints

Suleyman Deveci, Nisha Antony, Sulistiyanto Nugroho, Birkan Eryigit

Borouge Pte. Ltd.

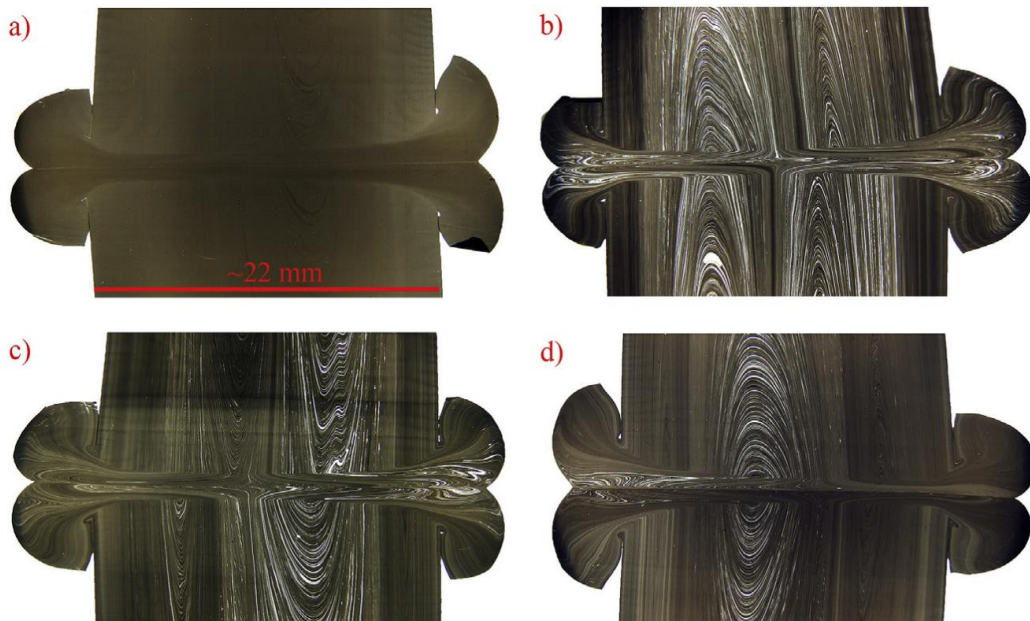
Figure 1 shows the effect of butt-fusion welding on CB distribution in the in-flow (extrusion) direction. The CB distribution in the weld zone is seen to be strongly dependent on the CB distribution or amount of windows present in the parent pipes. A clear interface cannot be differentiated in the weld zone for Sample 1, indicating homogeneity of material from both pipes, resulting in a continuous weld morphology. On the other hand, for Samples 2, 3, and 4, a drastic change in morphology is seen at the weld zone, wherein the windows are seen to be flattened out in a region of about 1 mm thickness. As a result, the alignment of the flow-fronts changes by 90°, and an interface region with smears perpendicular to that in the pipe can be seen.

Figure 1 Microscopy images of 15 μm sections (in-flow direction) taken from the weld zone: (a) Sample, (b) Sample 2, (c) Sample 3 and (d) Sample 4.

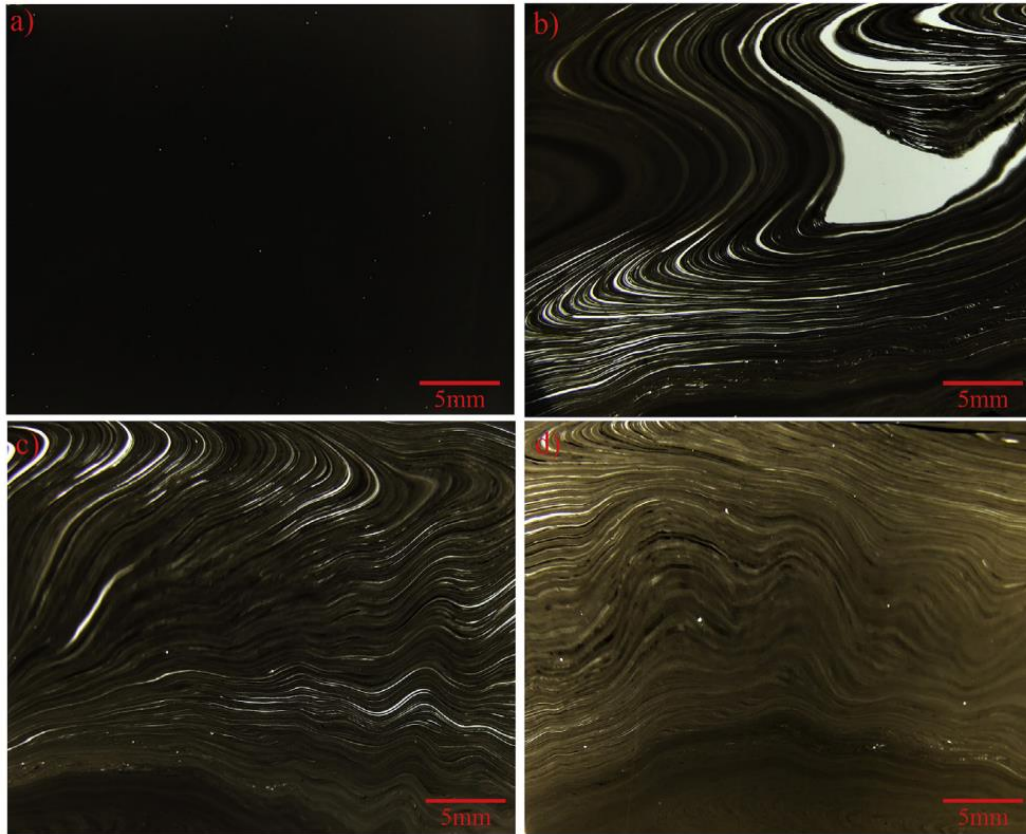
Figure 2 shows the effect of butt-fusion welding on CB distribution in the cross-flow direction from 15 μm -thick sections at the weld interphase. It was found that there was a significant difference in the homogeneity of the CB distribution for these samples between the in-flow and cross-flow directions. As expected, the white area fraction at the weld zone of Sample 1 was similar to that obtained for the pipe (close to 0%), for both the in-flow and cross-flow directions, given in Table 2. For Sample 2, although the white area fraction at the pipe and weld zone were similar in the in-flow direction, a significant difference was observed between the in-flow and cross-flow directions. This is attributed to flattening of windows at the weld interphase during welding. The difference in white area fraction of Sample 3 in the in-flow and cross-flow directions was not significant, but the windows appeared to be more blurred at the interphase, indicating a certain level of shear mixing perpendicular to the pipe axis during welding. This phenomenon became clearer for Sample 4, where the distinct borders between the windows and matrix become more interfused and co-continuous. The width of the most prominent window increased dramatically for Sample 2, whereas that of Samples 3 and 4 remained the same as their respective parent pipe samples.

Figure 2 Microscopy images of 15 μm sections (cross-flow direction) taken from the weld zone: (a) Sample 1, (b) Sample 2, (c) Sample 3 and (d) Sample 4.

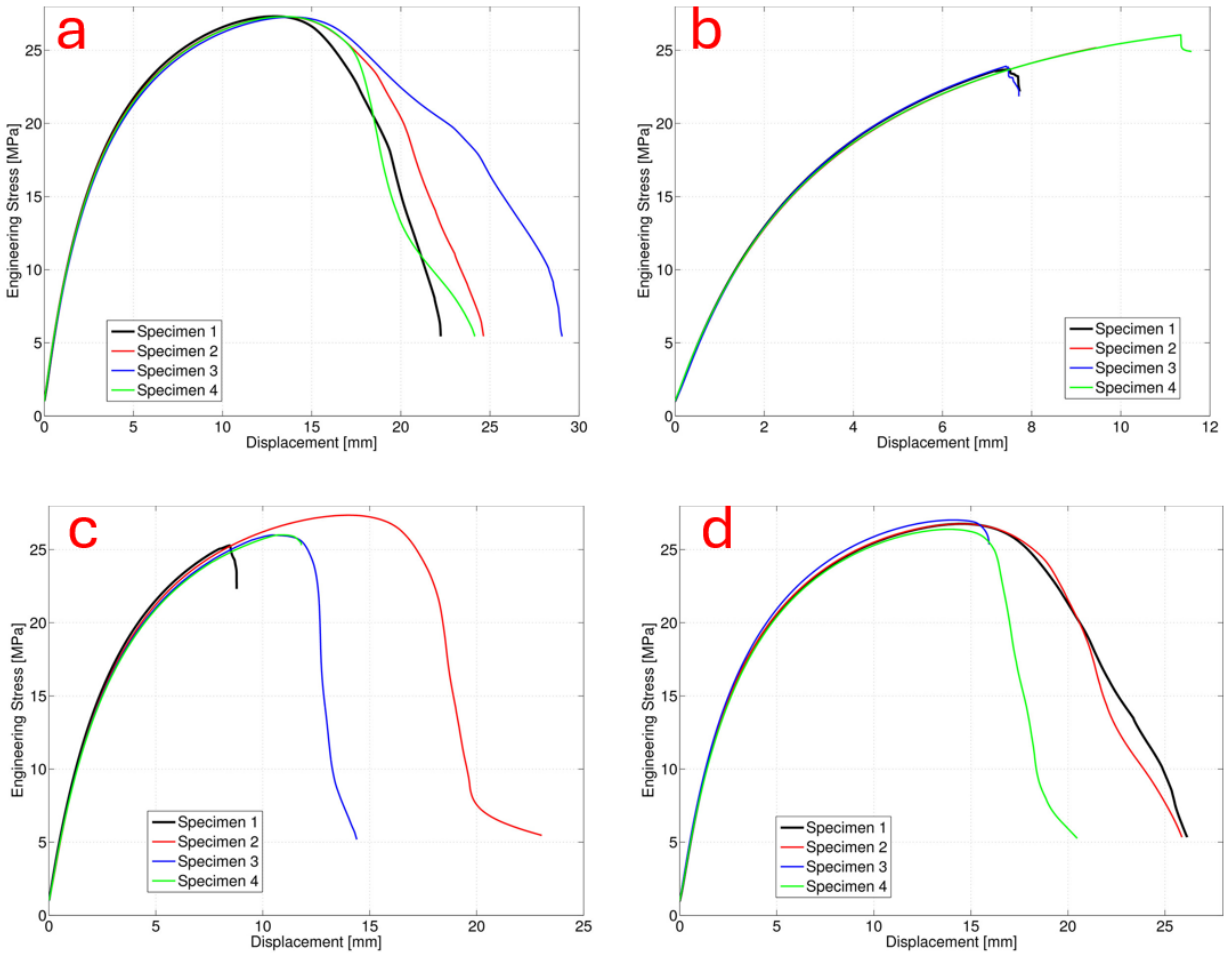
The tensile test results of waisted specimens from welded pipe samples are summarized in Table 3. Figure 3 shows tensile curves of each specimen for each sample. All specimens of Sample 1 showed ductile failure (Figure 4a) away from the fusion interphase after reaching a maximum at the yield point, following the typical stress–strain curve of butt-fusion joint tensile specimens. In contrast, all specimens of Sample 2 showed brittle-like failure (Figure 4b) at the fusion interphase before yielding. Two out of four specimens from Sample 3 (Figure 4c) and one out of four specimens from Sample 4 (Figure 4d) also showed brittle failure at the fusion interphase. Accordingly, the average energy required to break the specimens was found to be significantly different for the tested samples.

Figure 3 Engineering stress–displacement curves of welded pipe specimens elongated to fracture at a test speed of 5 mm/min, Sample 1 (a), Sample 2 (b), Sample 3 (c), Sample 4 (d)

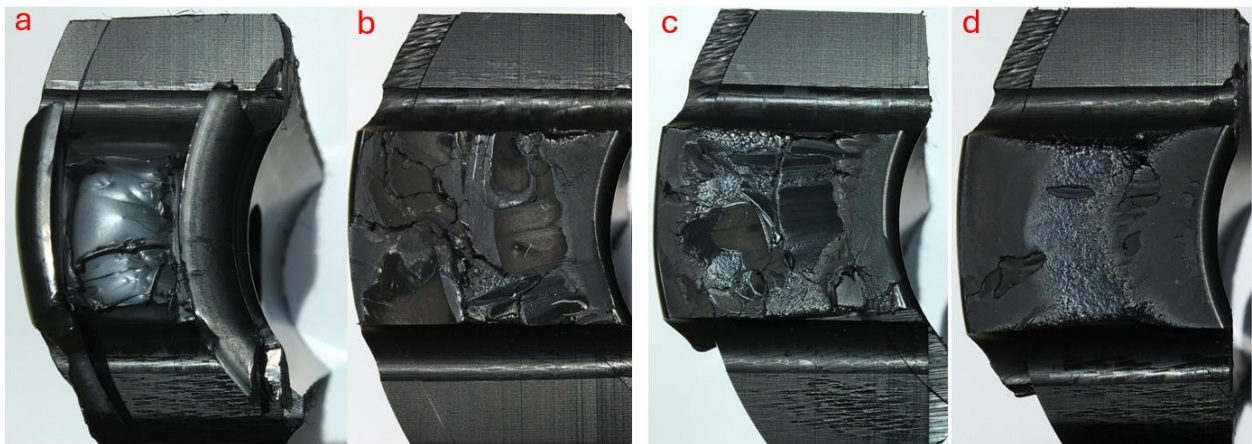
Figure 4 Tensile fracture surfaces of butt fusion welds after tests; (a) Sample 1, (b) Sample 2, (c) Sample 3, (d) Sample 4

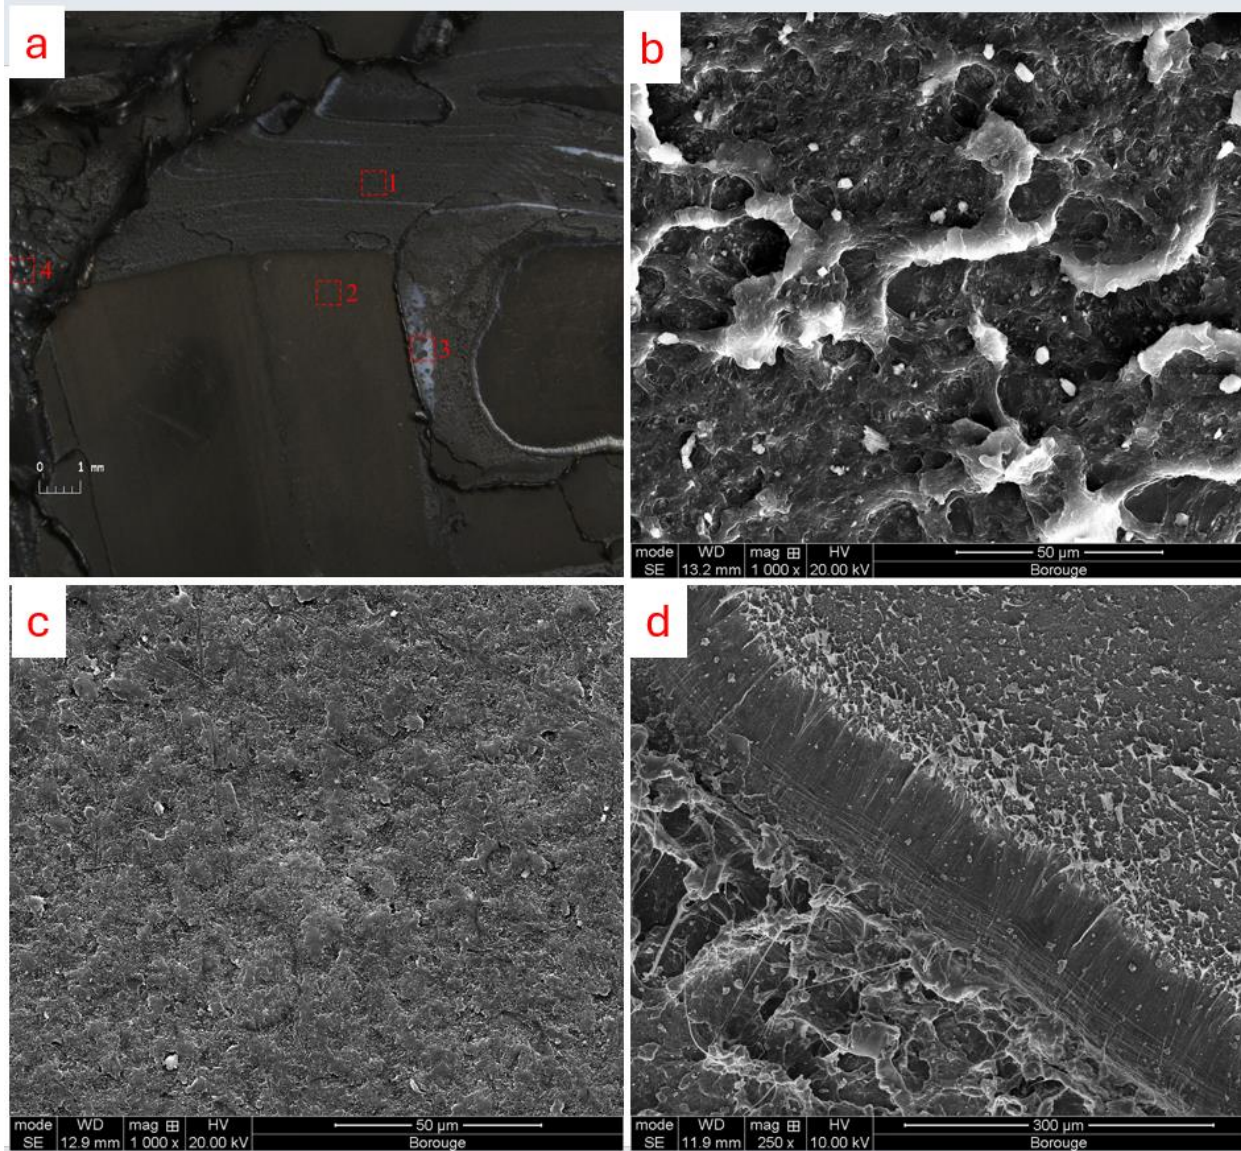
Fracture surface of one of the specimens of Sample 2 with high windows is given in Figure 5a. Widely varying fracture morphologies can be readily seen on the fracture surface, which occurred exactly at the butt-fusion interphase. The presence of a large number of windows is clear, and the bigger windows are observable to the unaided eye. While ductile deformation crazes are not seen in the region marked with 1 in Figure 5a at SEM images (Figure 5b), fibrillation of the material (corresponding to characteristic brittle failure in slow crack growth conditions) is not seen either, as the fracture was rapid and at a strain range below the yield point. To a small extent, flake-like rough pull-outs are observed. SEM analysis of region 2 (Figure 5c), does not evidence any appreciable deformation, yielding, or failure propagation in these regions. This is comparable to catastrophic bulk failure in the brittle mode, which is seen where fine dust or contamination are introduced into the butt-fusion weld, or improper welding conditions, such as lower temperature or shorter times, were used. Unlike the flat-rough regions, no flake-like pull-outs were observed, which means that the crack velocity was higher than in the flat-rough zones. It was also demonstrated by slow crack growth studies that that crack speed increases at windows [8]. A lower magnification SEM image of a region containing a window (marked 3 in Figure 5a), a neighbouring black region, and the interface between the two regions is given in Figure 5d to show the transition of morphology between the two regions. Crazing can be observed at the interface here. In some other regions of the sample, delamination of the windows was seen at these interfaces.

Figure 5 (a) Low magnification microscopy image of fracture surface of butt fused Sample 2 given in Figure 4b, (b) SEM images from region 1 in Fig. 5(a); (c) region 2 in Fig. 5(a); (e) lower magnification of region 3 in Fig. 5(a) showing interface near a window.

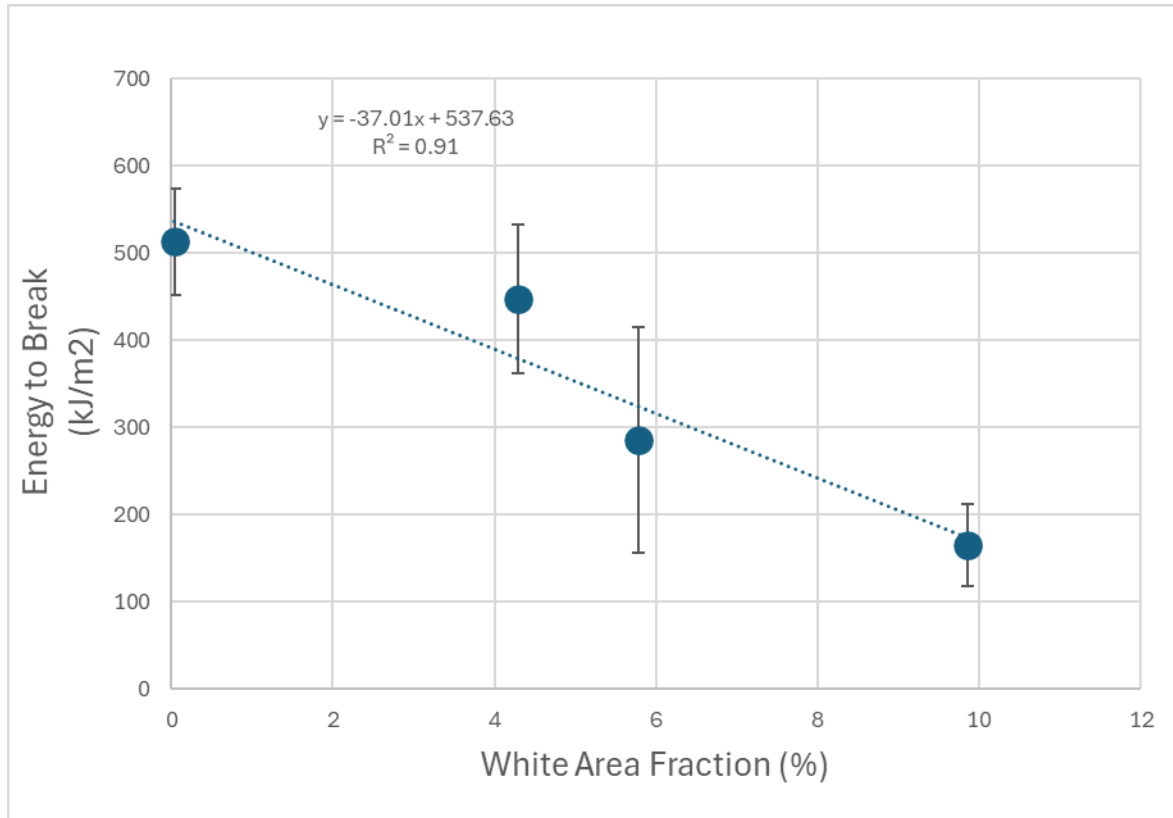
It appears that distribution of CB on extruded pipes measured as white area fraction (WAF) has a significant influence on weld integrity measured as energy required to break per weld test cross-section area (kJ/m^2). This is demonstrated in Figure 6 below. Sample 1, which has no windows shows around 515 kJ/m^2 energy to break value with a standard deviation 60 kJ/m^2 . Considering the measured standard deviation, one may claim that energy to break value above 455 kJ/m^2 is acceptable for ductile failures, which means maximum WAF of 2.2 %. Confirming previous works [9, 10]. For safety critical applications such as nuclear power plants etc., where thicker pipes are used, the effect of “windows defects” is expected to be more significant. Therefore, a lower level of WAF, that is less than 1% when measured on 15-micron slices, is suggested by the authors. Furthermore, pipes with windows that has less than Grade A1, A2 or A3 appearance rating according to ISO 18553 has a potential to get worse at the weld interphase by smearing and shearing effect of the welding process and negatively affect the weld integrity.

Figure 6 Energy to break value of tensile testing of welded samples as a function of white area fraction
