One Leak Every 25.65 m² - The Critical Importance of Electrical Leak Detection on Flat Roofs

by Oliver Hinca, COO, ELIS Detect Division, ELIS Technologies

Jan 15, 2025

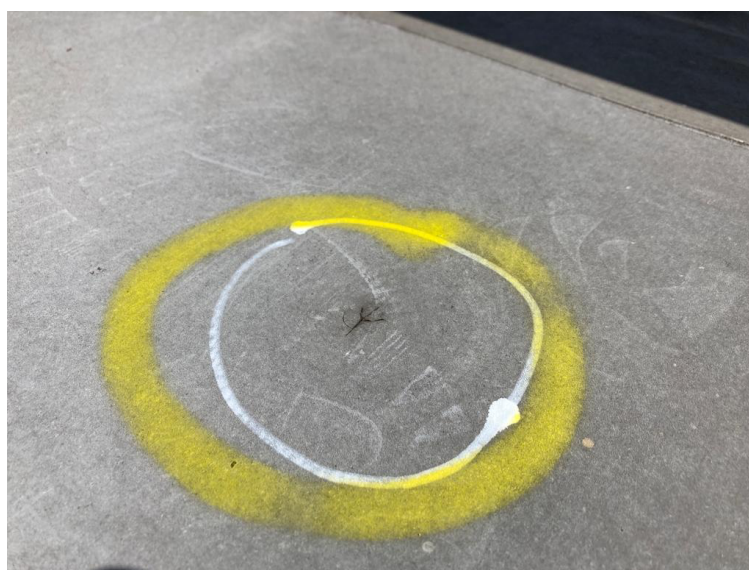
PVC liner mechanical damage – likely caused by a subcontractor or liner installer

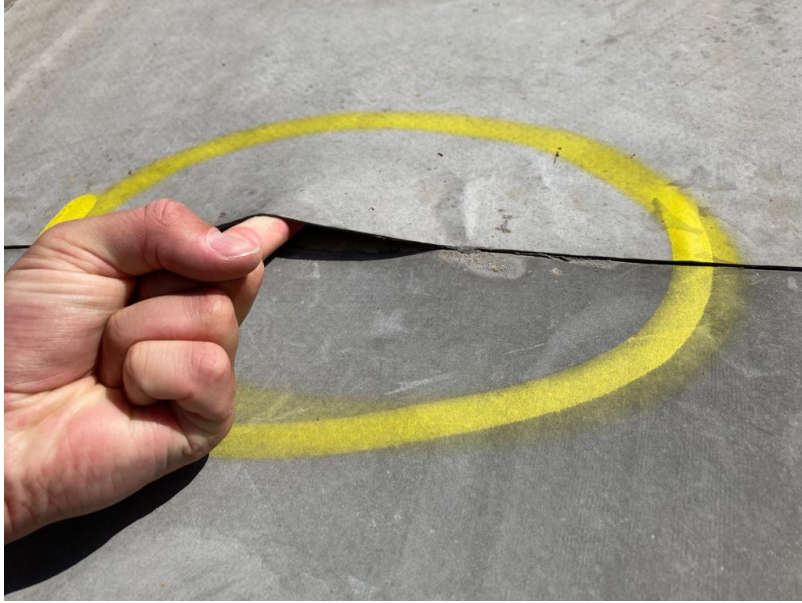
PVC liner - poor welding

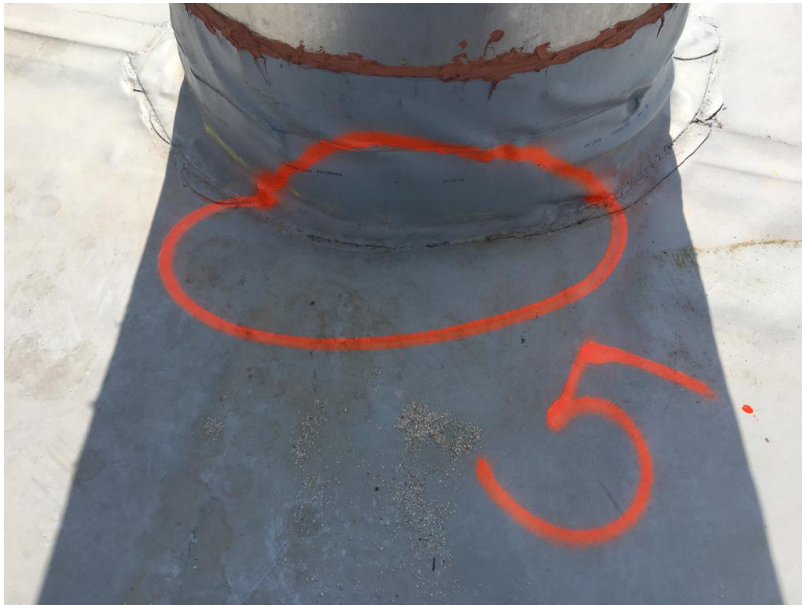
PVC liner - poor welding

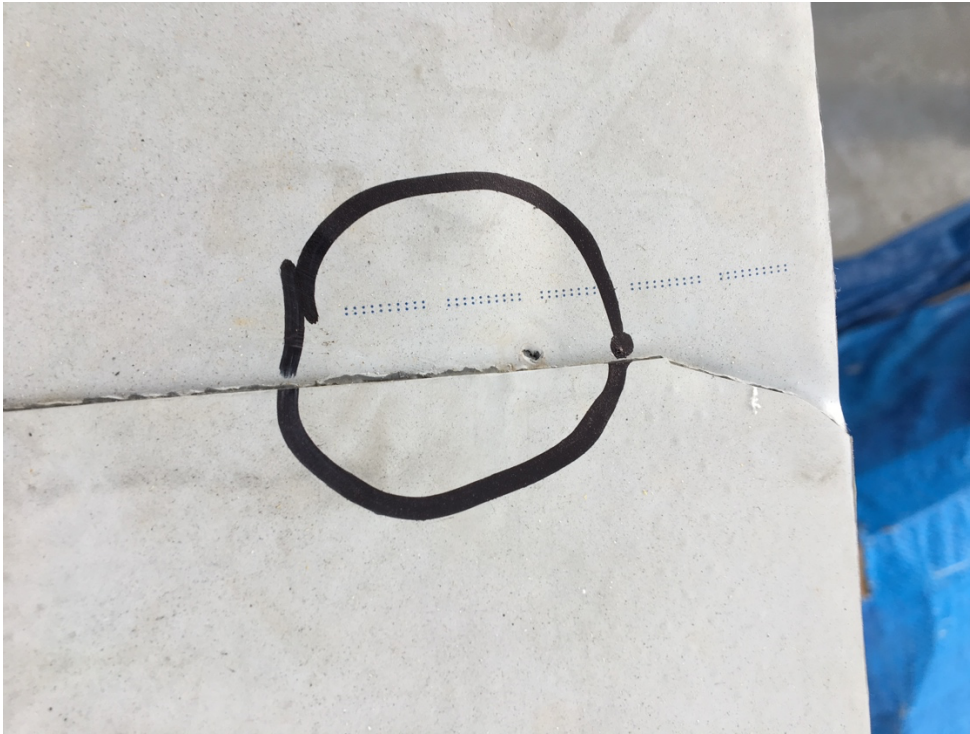
TPO liner - poor welding/stress fracture

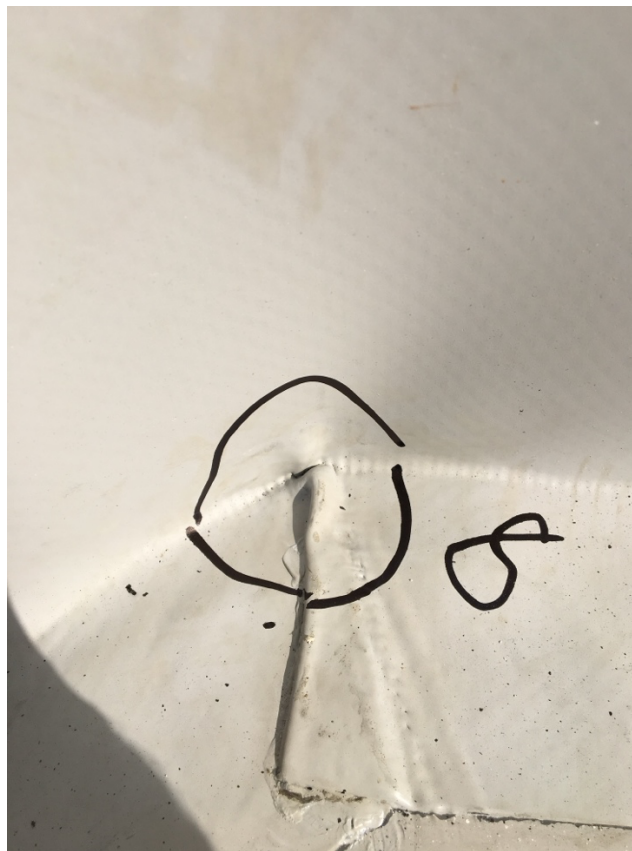
TPO liner - poor welding/stress fracture

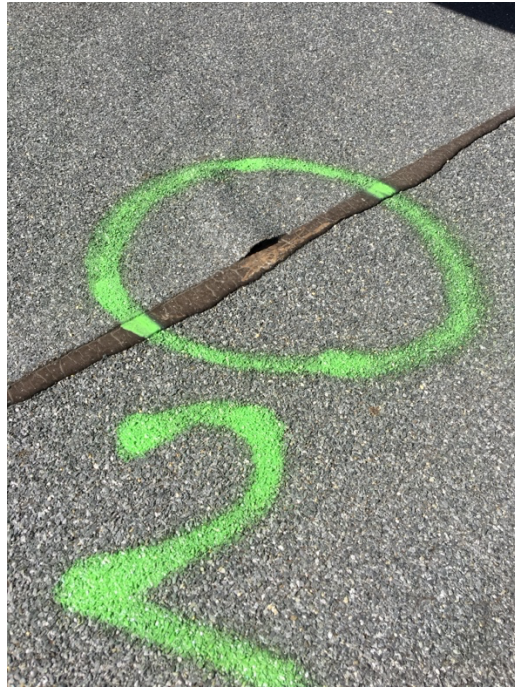
Bitumen liner - poor installation/stress fracture

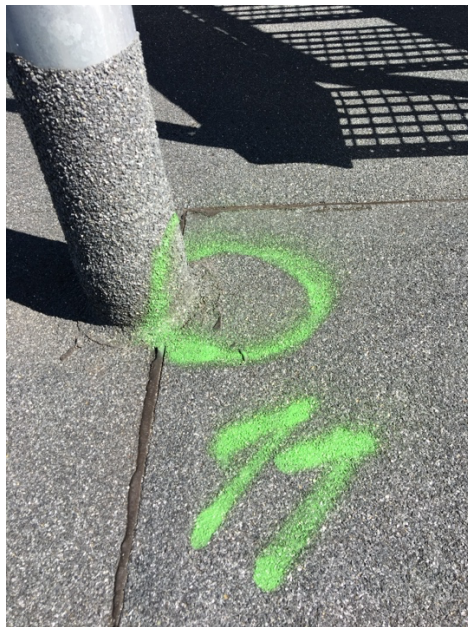
Bitumen liner - poor installation/stress fracture

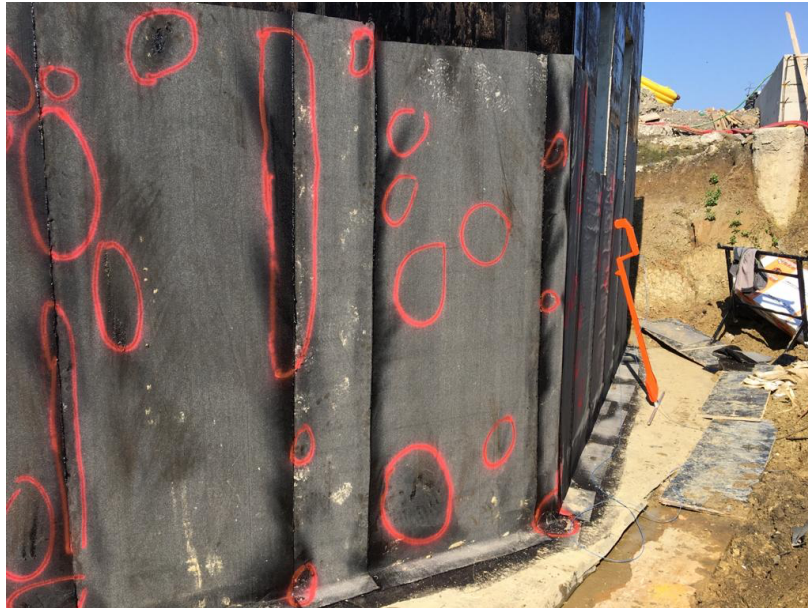
Bitumen liner - poor installation/low quality material
