PEX Pipe Failure Analysis by Fractography

Source: Jeffrey Jansen

29 August 2024

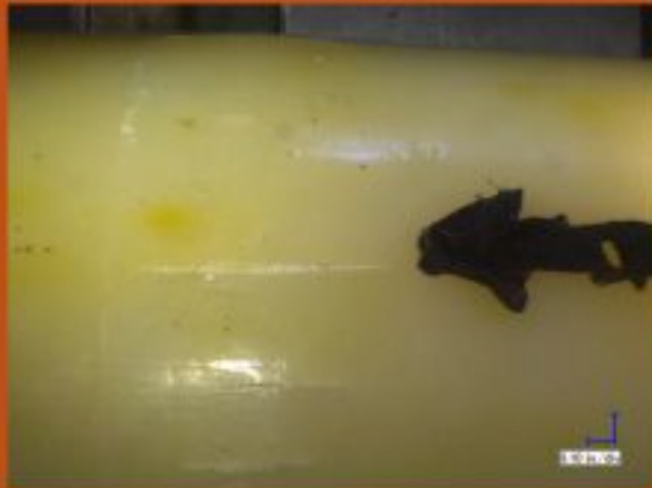
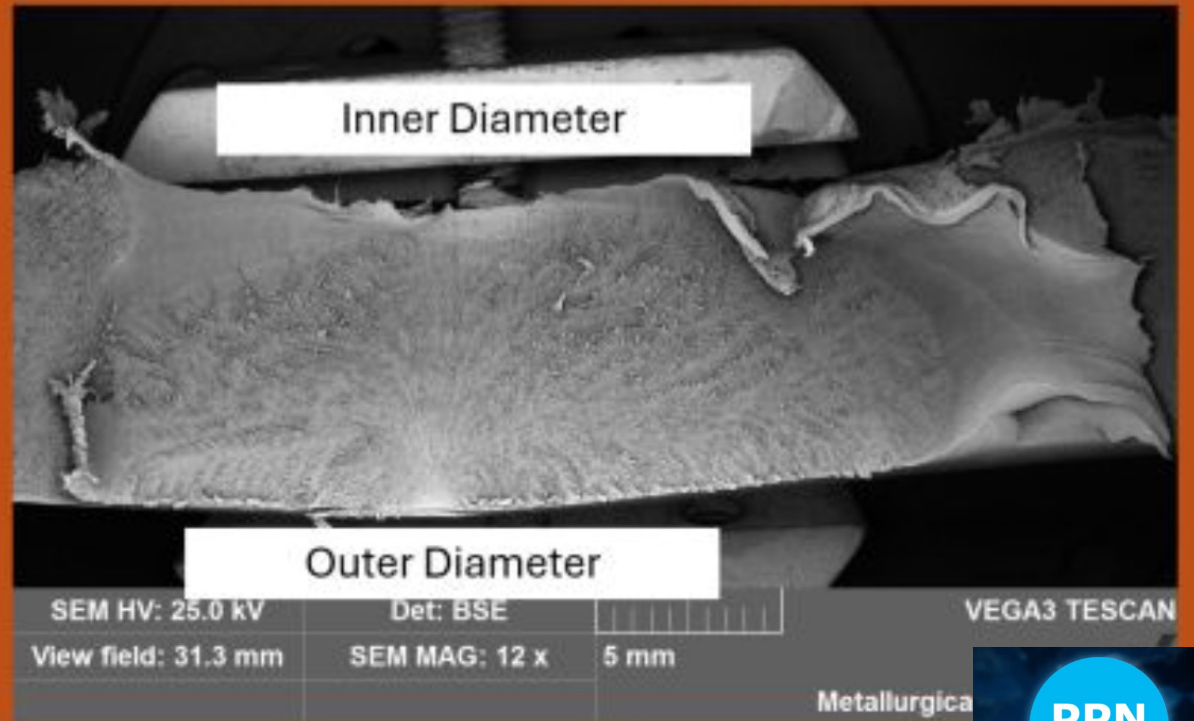
Fractography of PEX Pipe

As is often the case in failure investigations, the fractographic examination provided key information to distinguish the mechanism of the failure, essentially how the pipe failed. In this instance, the initial visual examination identified the presence of a longitudinal crack on the outer diameter surface of the pipe. The longitudinal nature of the cracking was indicative of failure associated with internal forces. Internal stress, such as pressurization, typically produces a longitudinal crack as a result of the hoop stress present in a cylindrical component, such as the pipe.

The microscopic examination of the crack exterior showed evidence of stress whitening indicative of macro ductility. Further evidence of ductility was evident once the crack was completed in the laboratory. Continued microscopic examination revealed evidence indicating some stretching and deformation. This indicated stresses that exceeded the yield point of the material over some period of time.

The fracture surface was further inspected using scanning electron microscopy (SEM) to allow examination at high magnification with relatively great depth of field. The SEM examination revealed fracture surface features indicating that the cracking initiated along the outer diameter edge of the pipe wall and progressed principally radially through the wall. Multiple individual sites of crack initiation were present.

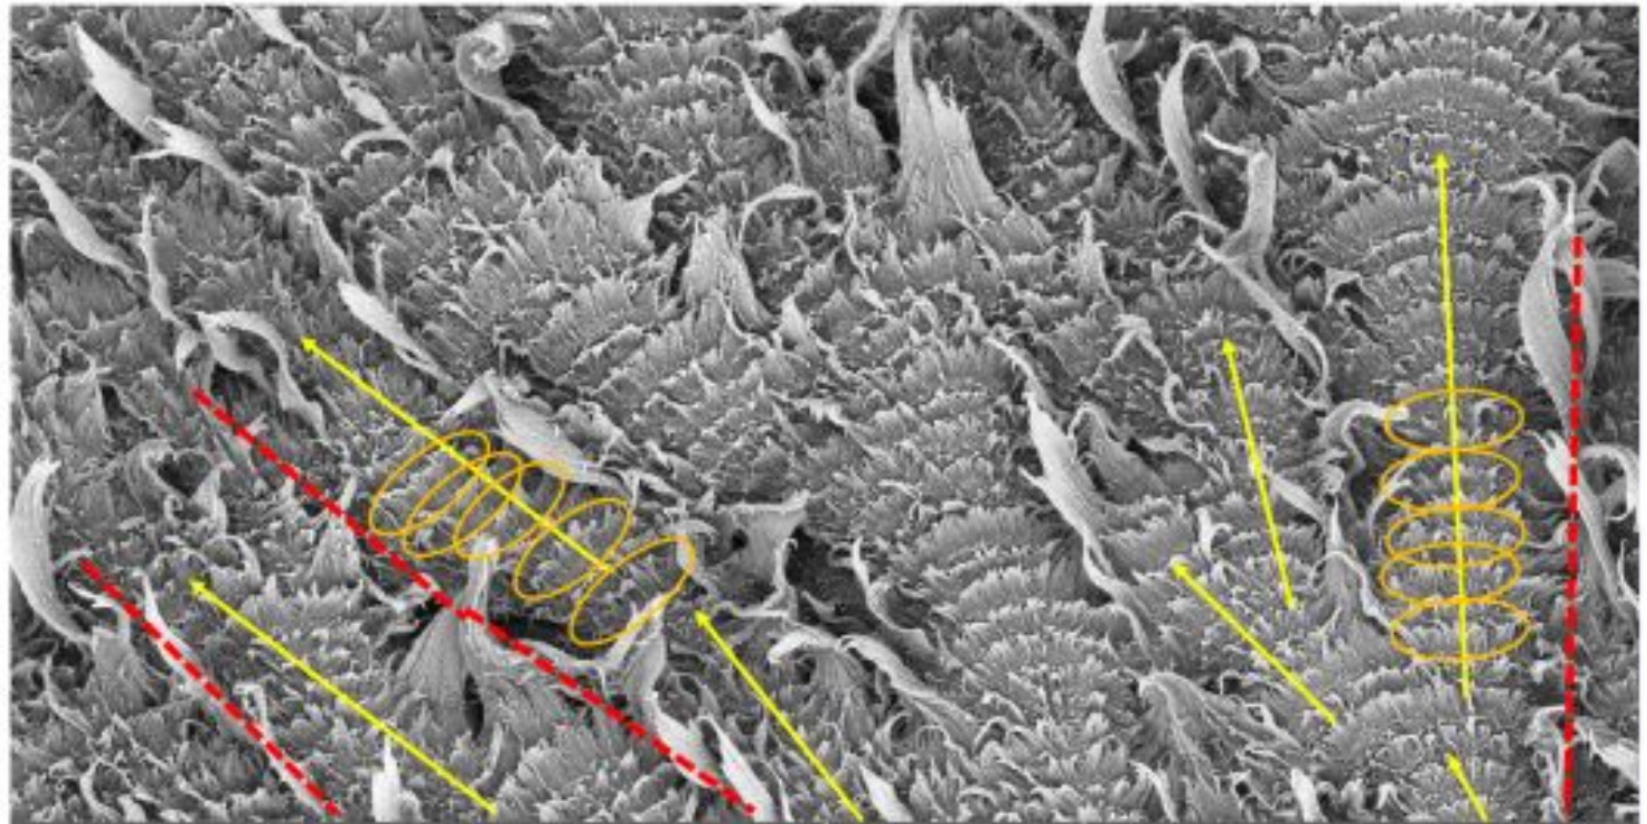
The outstanding feature on the fracture surface was the presence of striations extending out from the origin locations associated with alternating cycles of cracking and arrest. The number of striations and their relative spacing were consistent with low cycle fatigue. This, coupled with the substantial stretching within these striations, indicated that the pipe had been exposed to relatively high cyclic stresses. Fatigue failures often initiate at multiple distinct sites, which propagate and coalesce into a unified crack front. Linear features representing these crack unions were evident on the fracture surface. In metallurgical failures, these are often called ratchet marks.

Crack propagation

Crack unions

Fatigue striations

In summary, the fractographic examination indicated that the pipe had been exposed to cyclic internal stress while in service, which resulted in the initiation of multiple individual cracks. The cracks subsequently propagated and coalesced to form a crack that extended through the complete pipe wall, resulting in rupture. The observed macro ductility together with the significant micro ductility of the fatigue striations indicated that the magnitude of the internal stresses was relatively high.
