MSE Wall Failures Lessons Learned

Jim Collin, Ph.D., P.E., D.GE., F. ASCE The Collin Group, Ltd. jim@thecollingroup.com

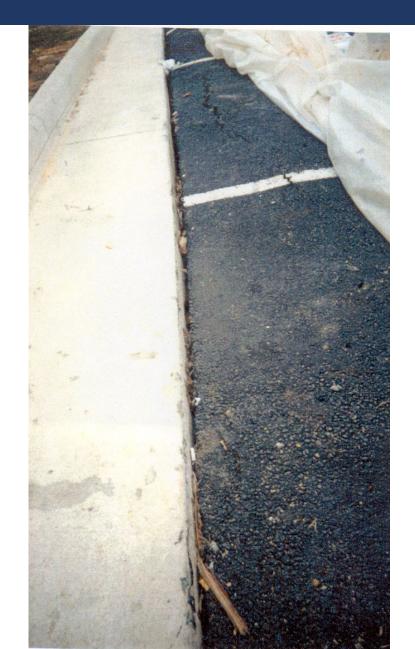
FGI Signs of Distress

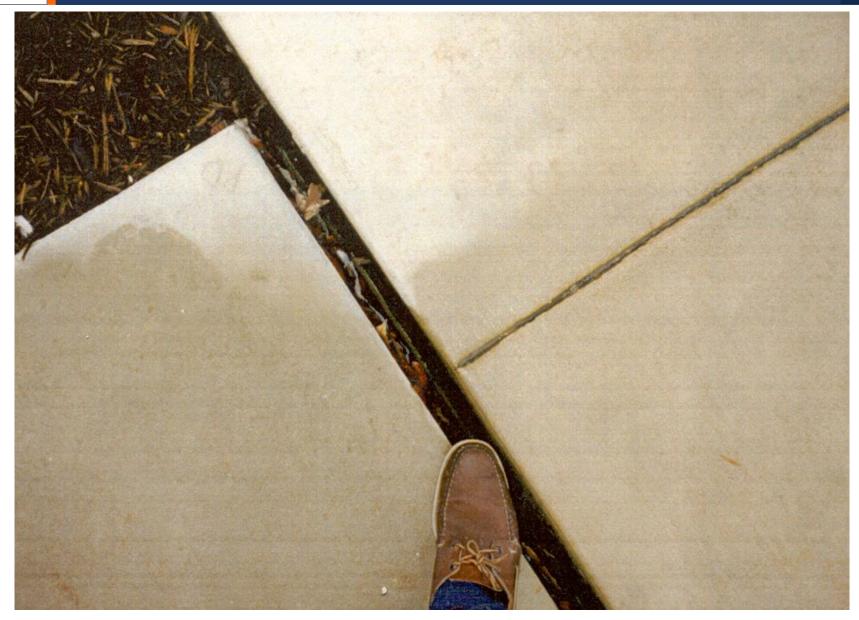
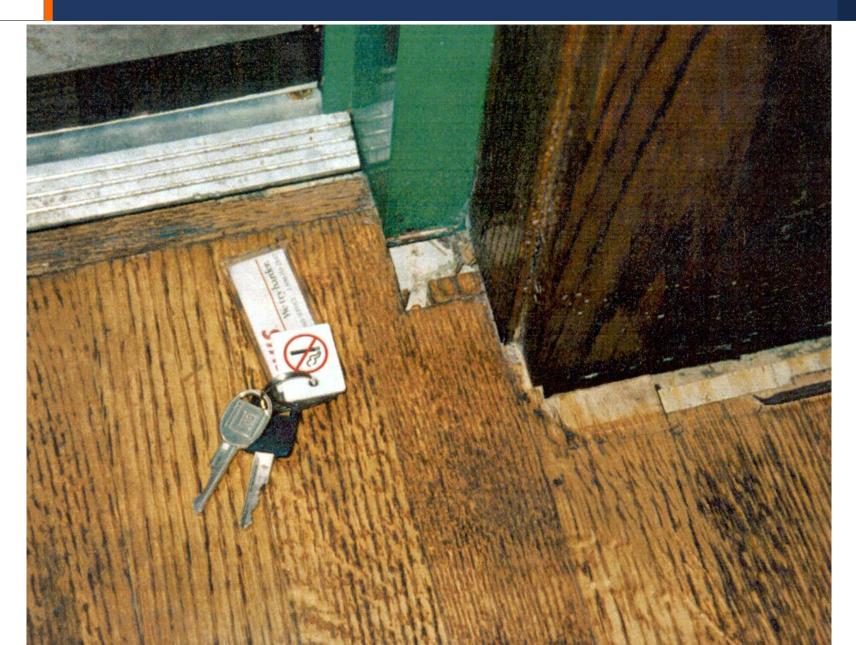
Signs of Distress

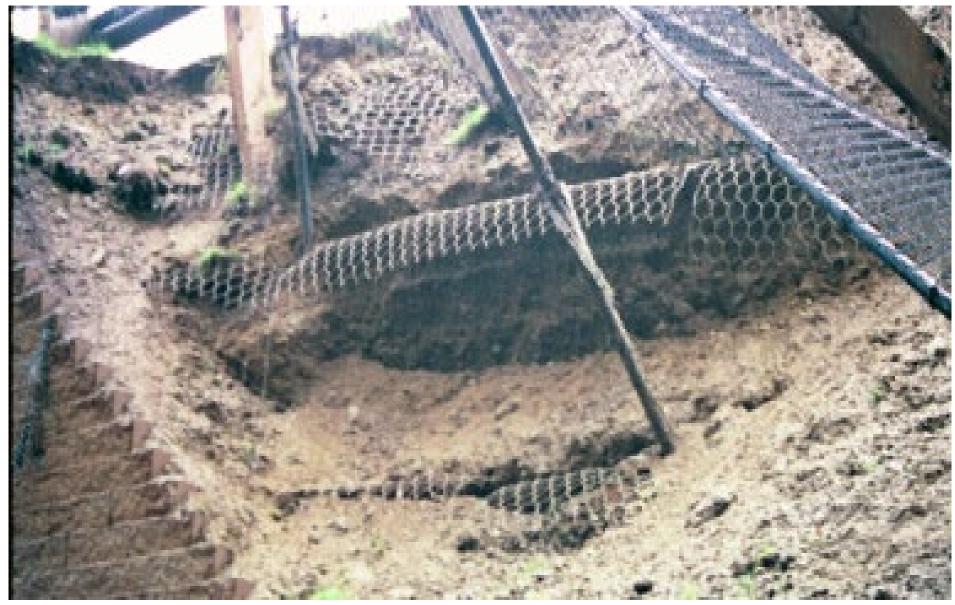
First Failure May 1999

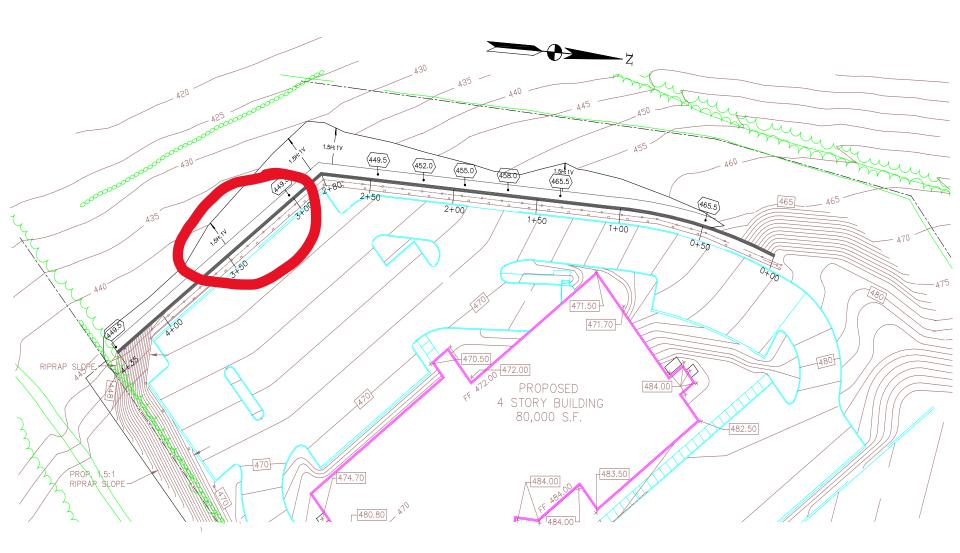
FGI Location of the failure

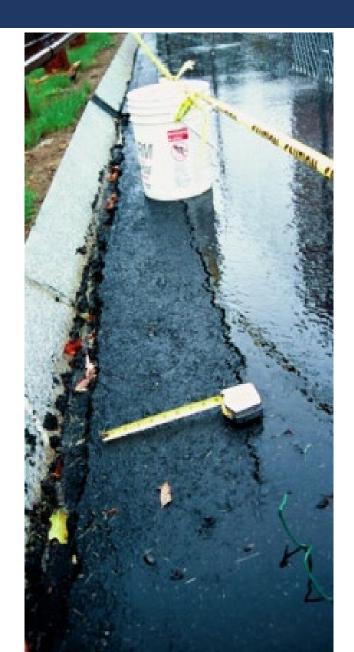
FGI Observed Distress of Curb and Gutter

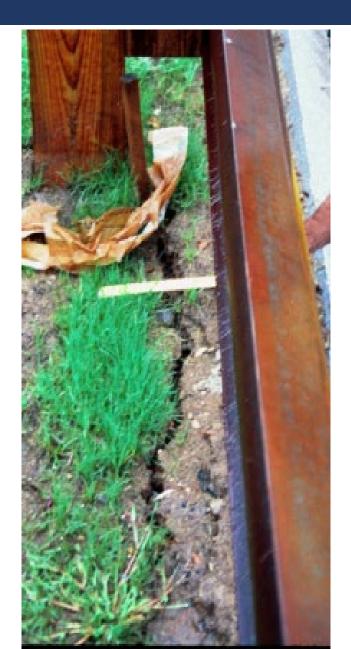
Observed Distress of Curb and Gutter

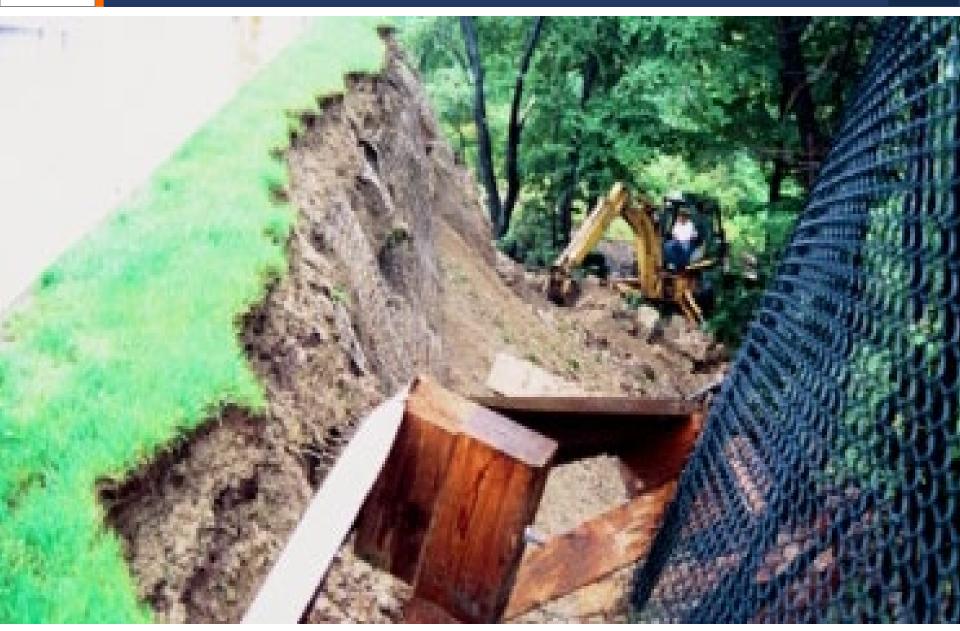
FGI Second Failure

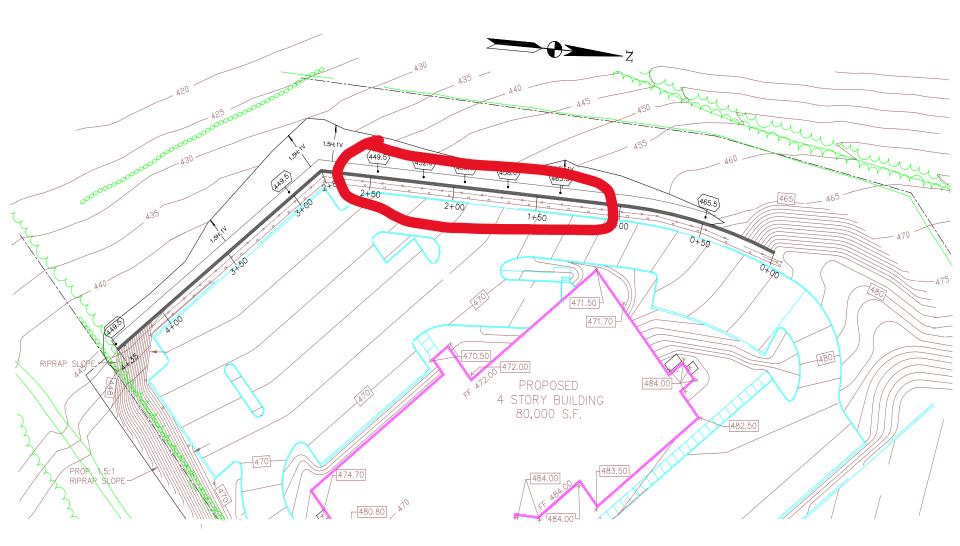
FGI Location of Second Failure

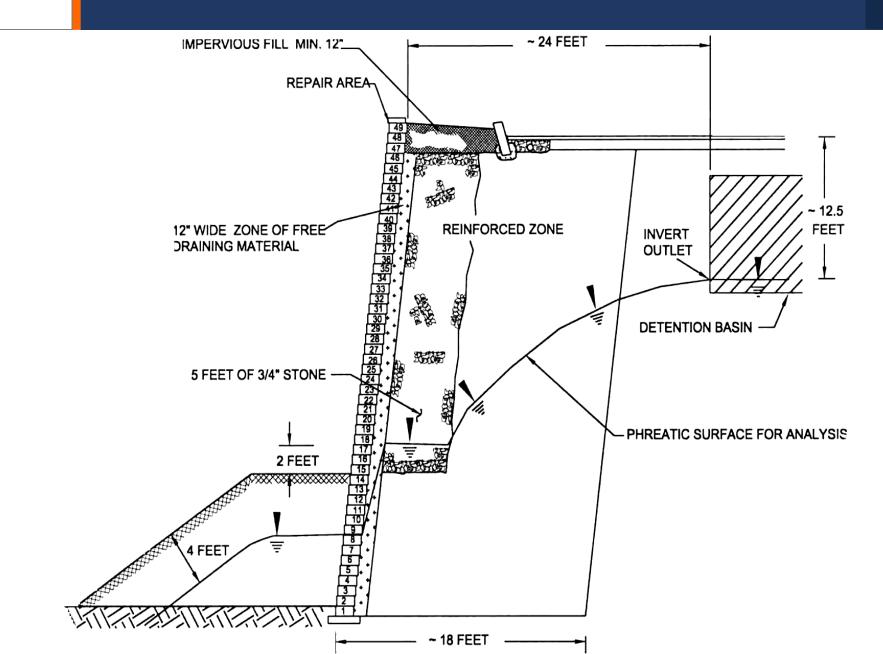
- Did not consider connections
- Used proprietary software for one SRW system and substituted another system with different connection properties
- Did not consider hydrostatic effects on stability

FGI Hydrostatic Pressure

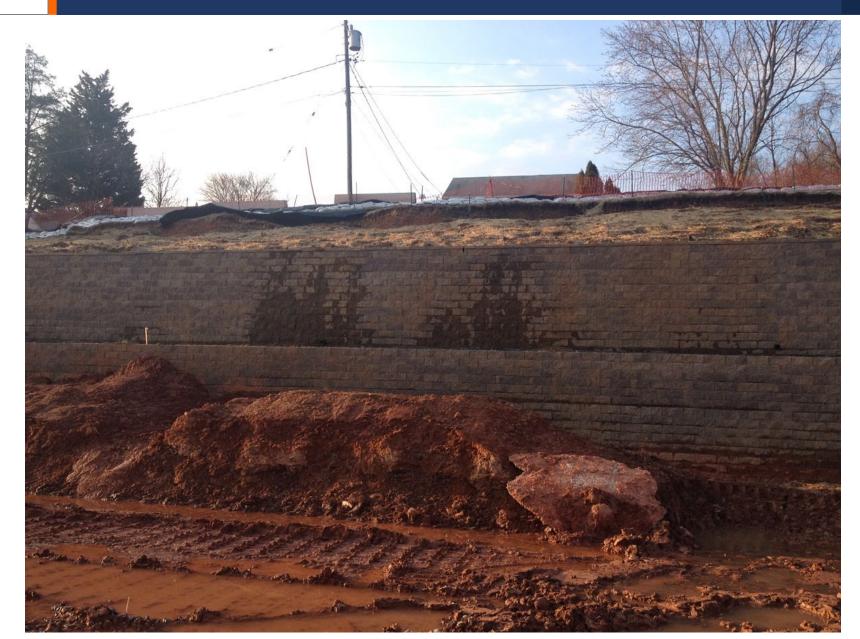
FGI First Failure of Wall

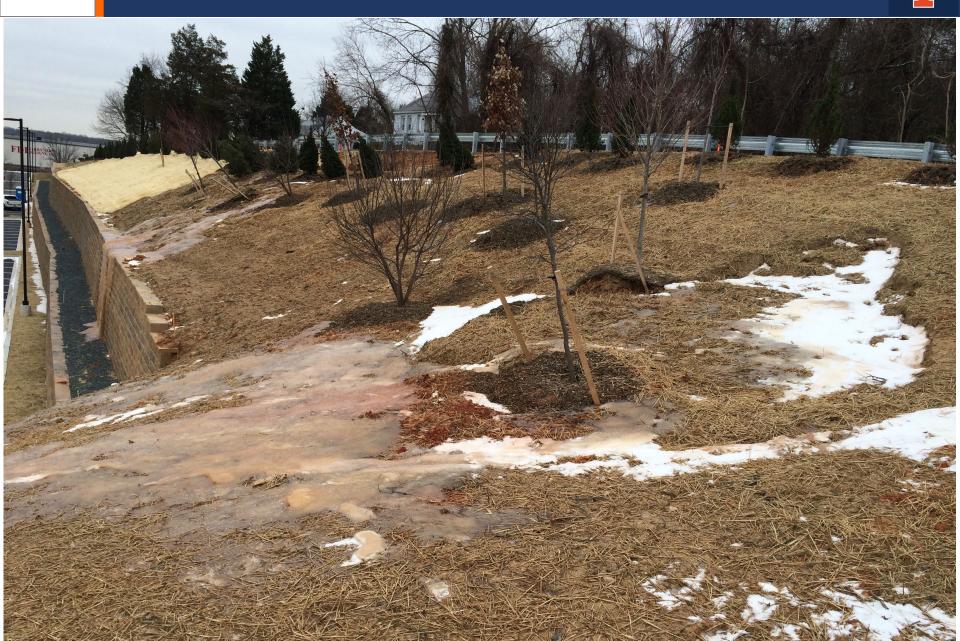
FGI Distress after rebuild

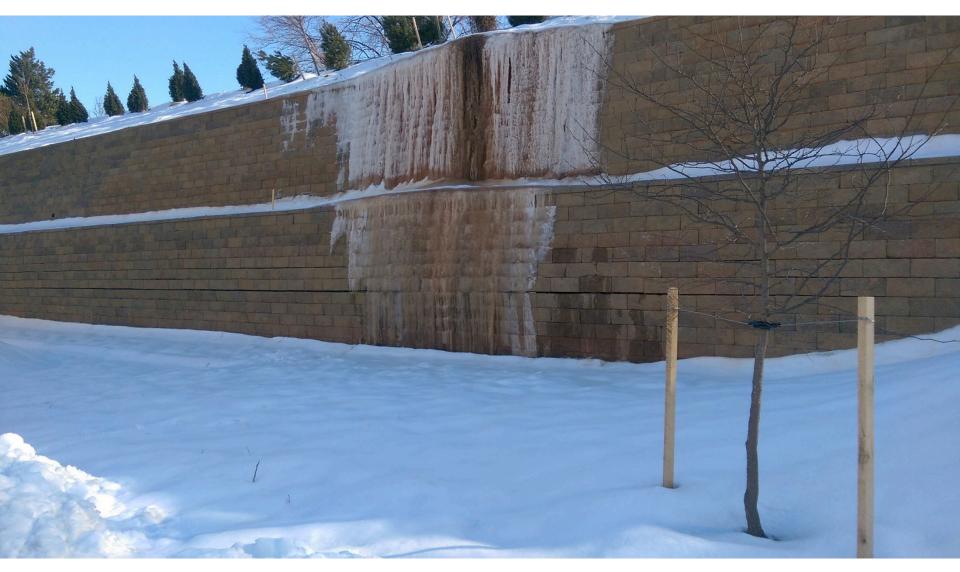
FGI Distress after rebuild

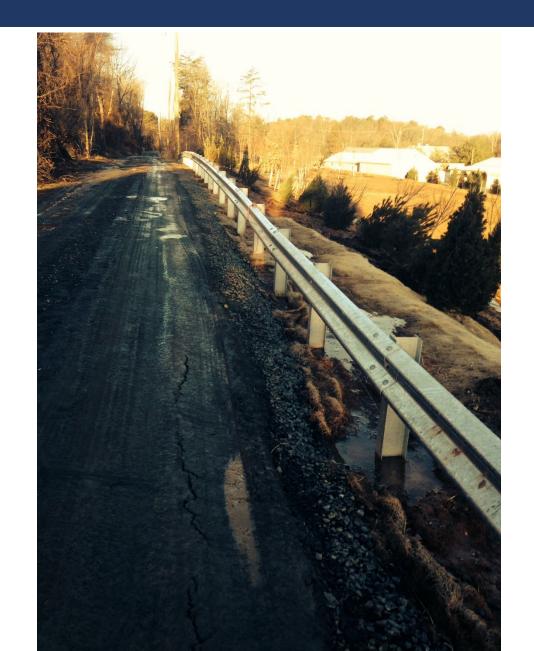
FGI Distress after rebuild

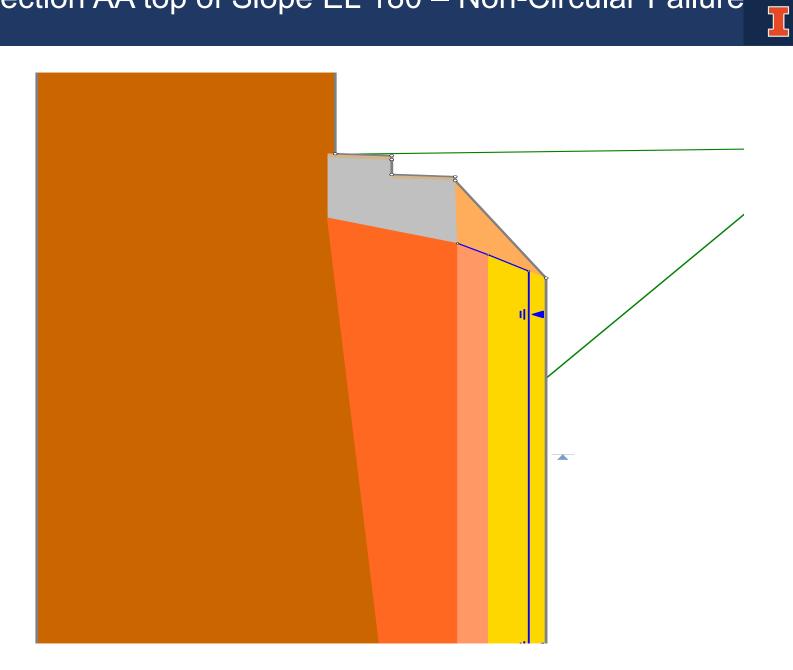
CL directly below wall normal load 50 kPA use $\varphi = 28^{\circ}$
