**Journal of Failure Analysis and
Prevention**

J Fail. Anal. and Preven.
DOI 10.1007/s11668-020-00997-5

Premature Failure of CPVC Drainpipes

Abstract Water leaks were noticed from a chlorinated polyvinyl chloride (CPVC) drainpipe system used in a cafeteria only 3 months after the commissioning of the building. The drainpipe was used to recover food waste using various systems installed directly in the kitchen. The leak was caused by the presence of numerous cracks in some of the elbows from the drainpipe system. Scanning electron microscopy showed the presence of mud cracking, which is generally associated with environmental stress cracking. Chemical analyses revealed the presence of incompatible products with the CPVC, coming from the chemical transformations in the composting process and from excess cement used to assemble the various sections of the drainpipe system.

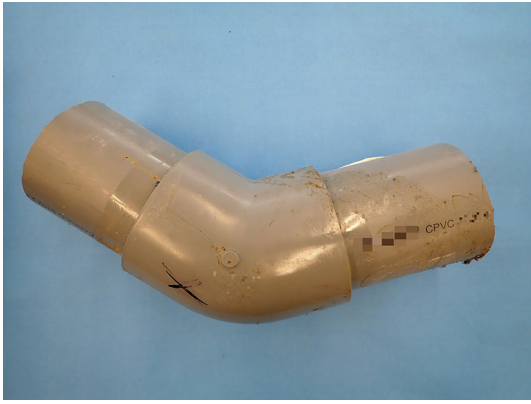
Figure 1 shows one pipe-and-elbow assembly as received. The elbow exhibited three cracks on the outer surface. They were on average of 10 cm long and mostly parallel to each other. On the inner surface of the assembly, traces of

Fig. 1 Two pipes inserted into a 45° elbow. The pipes were cut during sampling. The elbow exhibited three longitudinal cracks

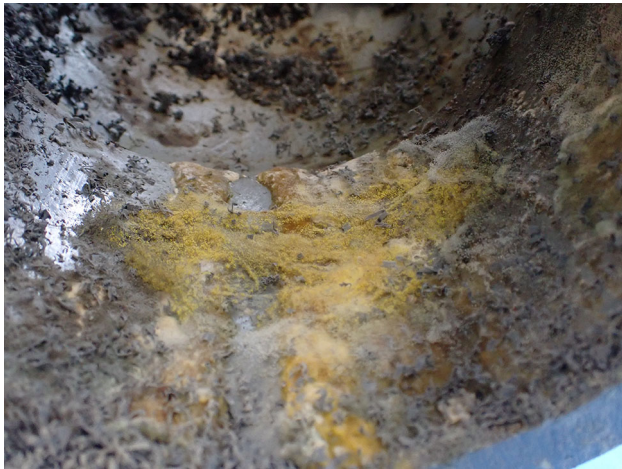
Fig. 2 Mold formation on the inner surface of the pipe-and-elbow assembly

mold were apparent (Fig. 2). Upon the cleaning of the part, we could observe that the cracks were propagating on both sides on the elbow. They seemed to initiate from the cement weld between the pipe and elbow, on the inner surface of the assembly (Fig. 3). Examination at higher magnification revealed microcracks on the fracture. On the internal surface of the elbow, mud cracking was apparent (Fig. 4).

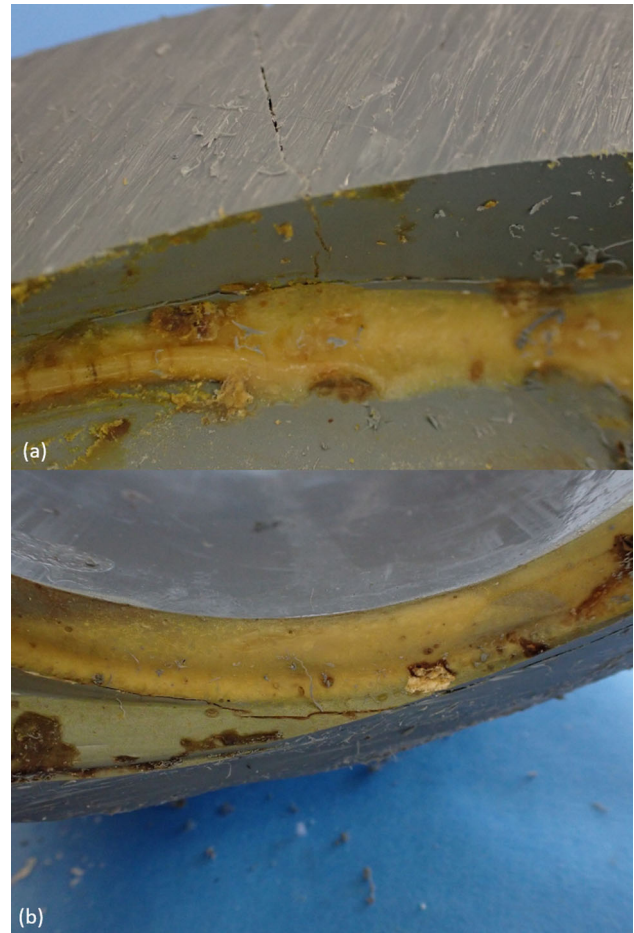
Fig. 3 Inner surface of the assembly showing crack visible on (a) both sides of the elbow and along the cement weld and (b) the internal side of the assembly along the cement weld

The failure under study only occurred in the elbows. Indeed, the submitted elbows were found cracked at the interface between the pipe and the elbow, at the location of

the cement weld. This is an area of mechanical stress concentration, which is, moreover, covered in cement residue. In addition, according to the installation layout, it was also an area facilitating the accumulation of food residues (Fig. 9). The accumulation of food residues will increase the duration and the frequency of exposure to incompatible products which will affect the resistance of CPVC.

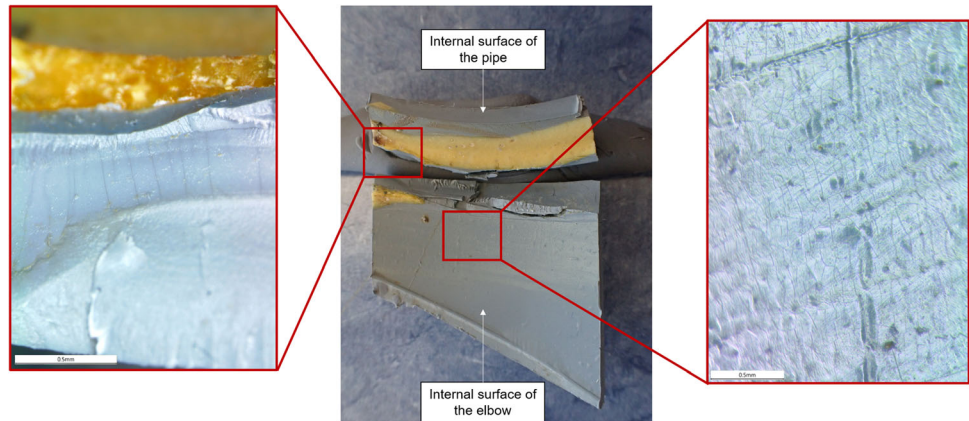
Fig. 4 Crack opened with close-up view of microcracks originating from the internal surface (left-side picture) and craze formation (right-side picture)

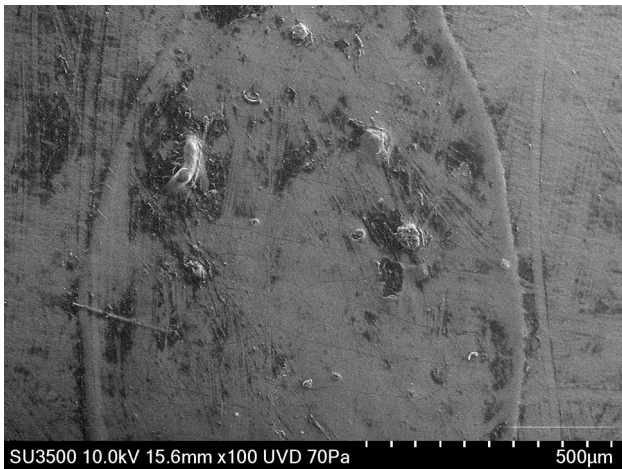
Figure 5 shows a SEM image of the inner surface of the elbow. On this surface, evidence of mud cracking was apparently close to the fracture. Mud cracking is a visual clue of multiple fracture initiations with an easy diffusion

path, in closely spaced locations. This is a phenomenon, in plastics, generally associated with environmental stress cracking (ESC), a typical failure mode in plastics [2].

Fig. 5 SEM image of the internal surface of the pipe showing mud cracking

Mud cracking, which is typically found in ESC, was visible close to the area covered by cement residue, inside the elbows. Mud cracking, also known as crazing, is identifiable by its visual aspect composed of a network of fine cracks on the surface of a material. Crack formation due to ESC is often preceded by craze formation [8]. Crazes are expanded regions held together by highly drawn fibrils which bridge these microcracks [9]. Crazes form and grow within the chemically affected zone. Eventually, the crazes rupture to form a crack [3]. Cement itself is an ESC agent for CPVC. When too much cement is applied, it can run down the inside of the pipes. While trapped inside the pipes, the solvent contained in the cement cannot evaporate and will attack the CPVC.

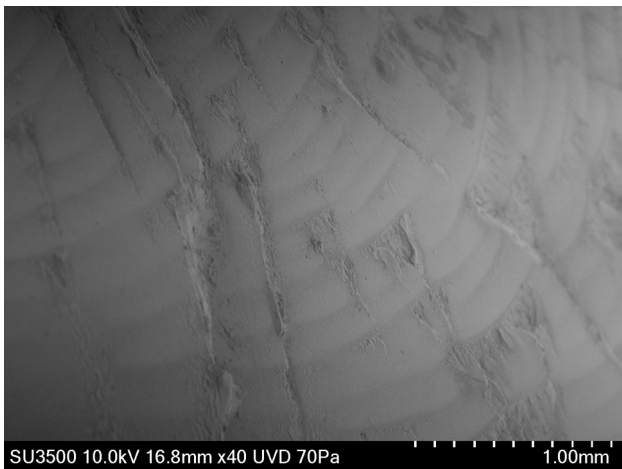
Figure 6 shows evidence of a progressive brittle fracture. This type of failure is characteristic of high localized stress. The ESC agent reduces the level of stress required to initiate the failure by a mechanism of localized plasticization, through stress enhanced fluid absorption, causing a slow-crack-growth mechanism [3].

Fig. 6 SEM image of the fracture surface showing a progressive brittle fracture

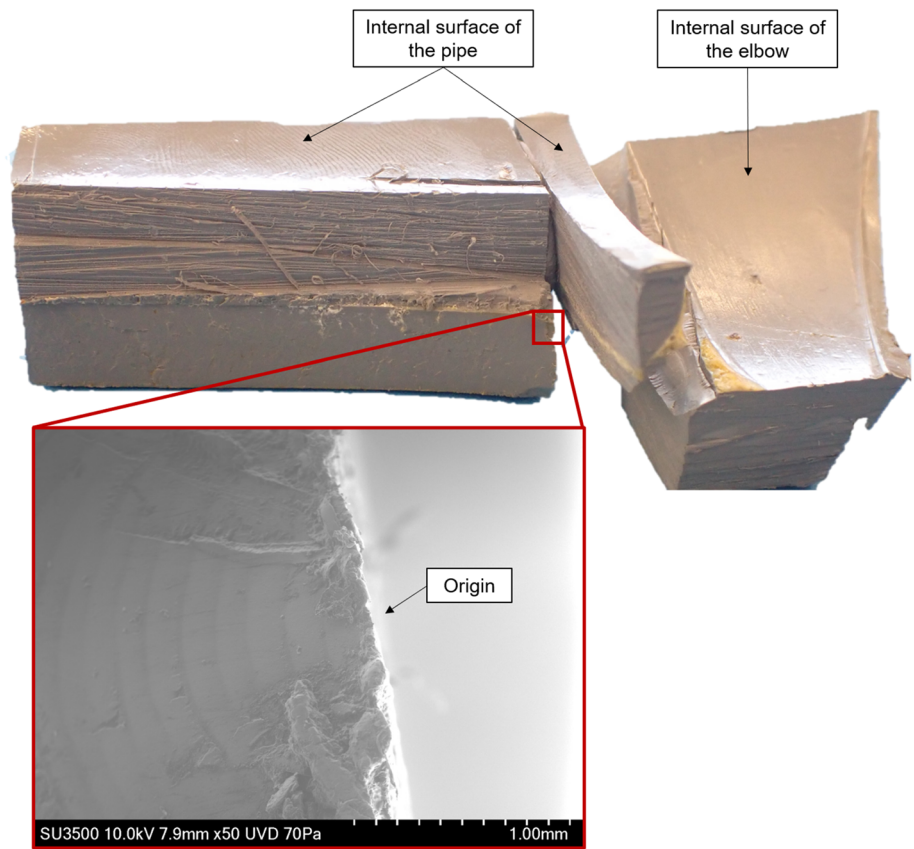
Figure 7 shows the origin of the crack. Our observations indicate that the crack originated from the inner face of the elbow and propagated toward the outer face (Fig. 7). The origin is in a location of high localized stress and in direct contact with the ESC agent.

Fig. 7 Crack origin at the junction between the cement weld and the internal surface of the elbow

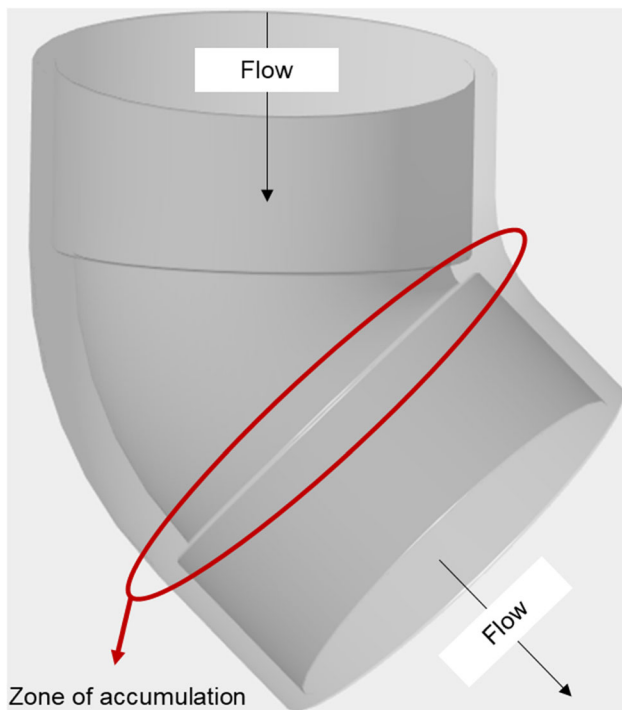
Fig. 9 Diagram representing accumulation zones in an elbow fitting in the assembly
