RTD LABORATORY REPORT

Project Information (Siplast job file)

Project Name:	Casper Alcova Irrigation District
Project Location:	Casper, WY
Construction Date:	Completed January 1991
Area of Membrane Installation:	Approximately 2,000,000 square feet

Type:		
Irrigation Canal

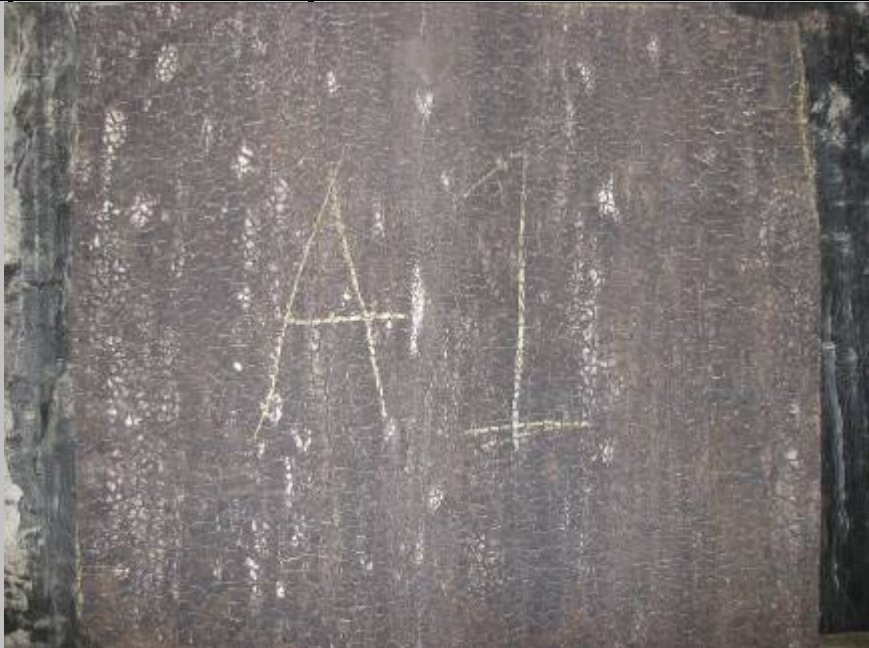
Sample Description: Sample Size and Surface Appearance		
Sample #A1	Size: 590 in ² (4.1 ft ²)	Comments: Cracking was observed on the surface of the Teranap.

1. Samples A1 and A2 were taken from the upper wall of the irrigation canal where the membrane was directly exposed to UV light and the elements. These samples exhibited alligating on the surface. Microscope imagery indicated that the depth of the crazed SBS bitumen waterproofing did not penetrate to level of the reinforcement within the cross-section of the Teranap.

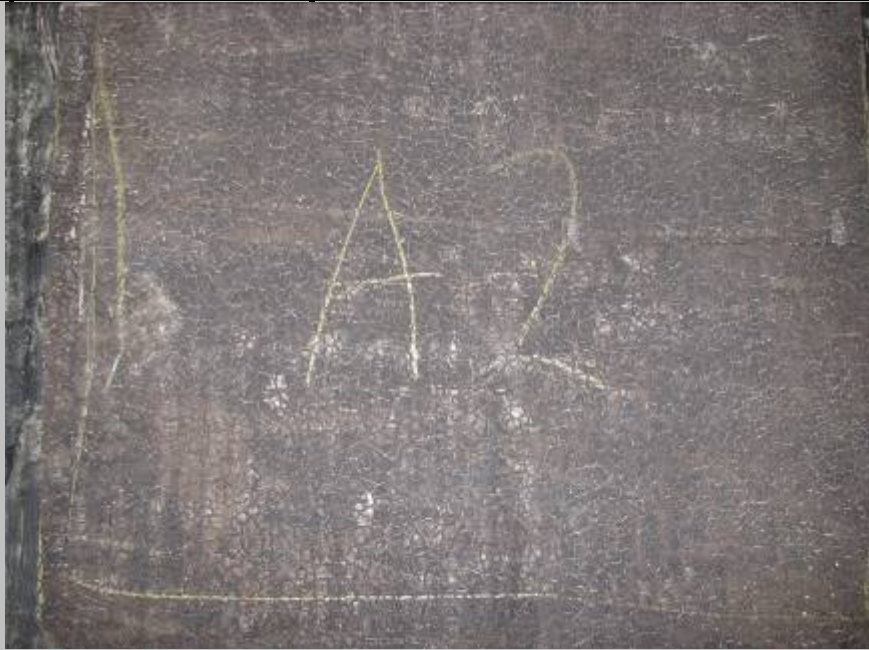
Sample #A2

Comments: Craziing was observed on the surface of the Teranap.

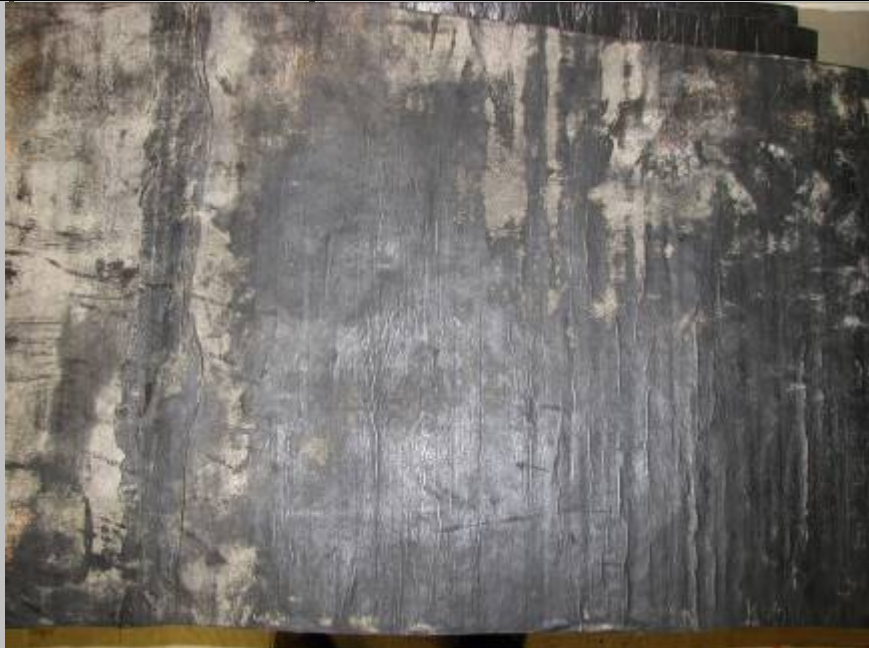
Sample #B1

Comments: No obvious signs of product or application issues were visible on the surface of the sample.

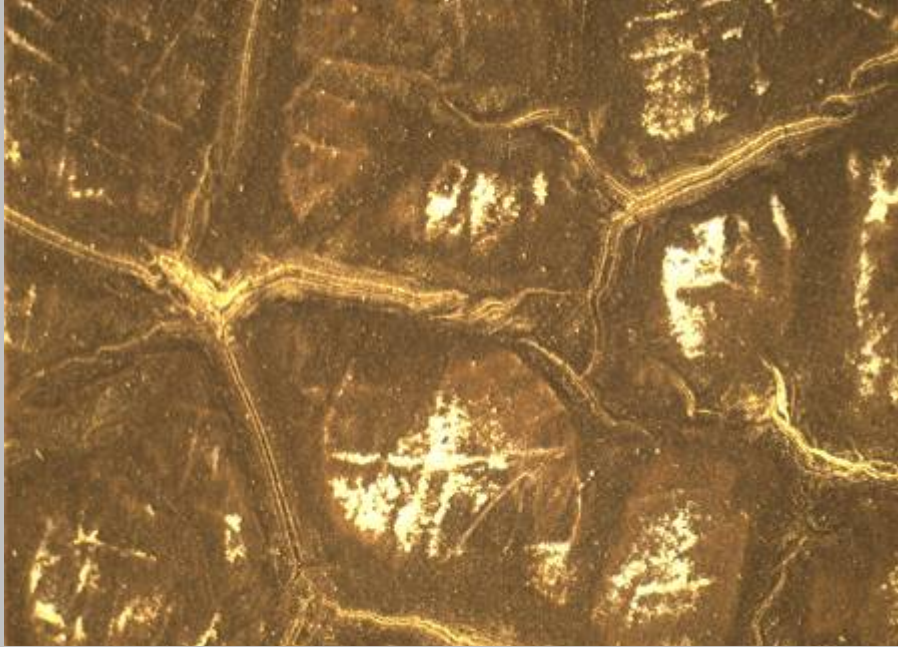
Sample #A1

The microscope image indicates alligating in the surface of the Teranap.

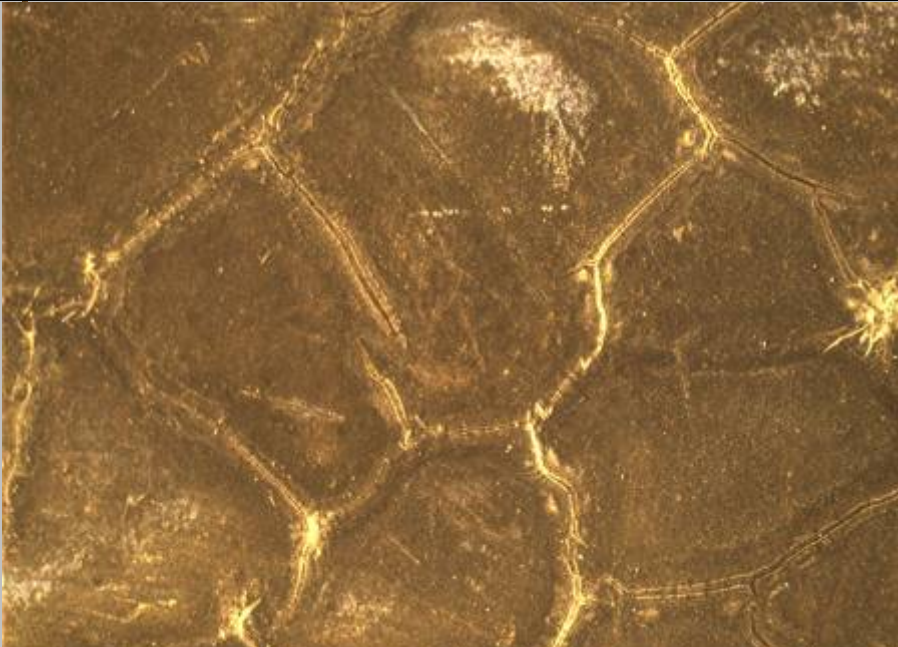
Sample #A2

The microscope image indicates alligating in the surface of the Teranap.

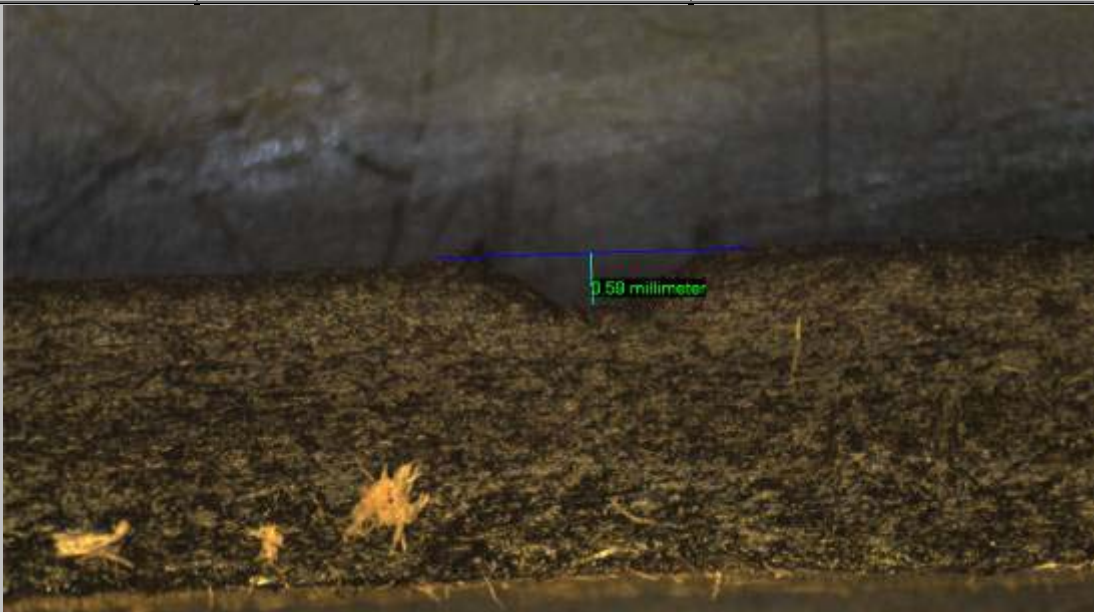
Sample #A1

Average Channel Depth
23 mils (0.58 mm)

Reinforcement Depth
40 mils (1.02 mm)

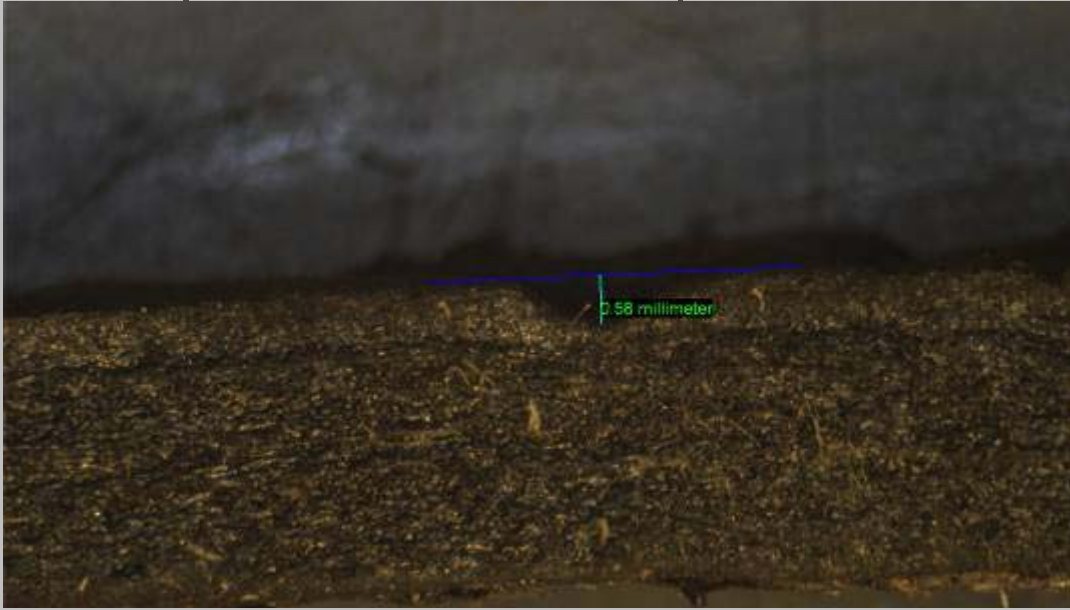
Sample #A2	Average Channel Depth 21 mils (0.54 mm)	Reinforcement Depth 28 mils (0.70 mm)
-------------------	---	---

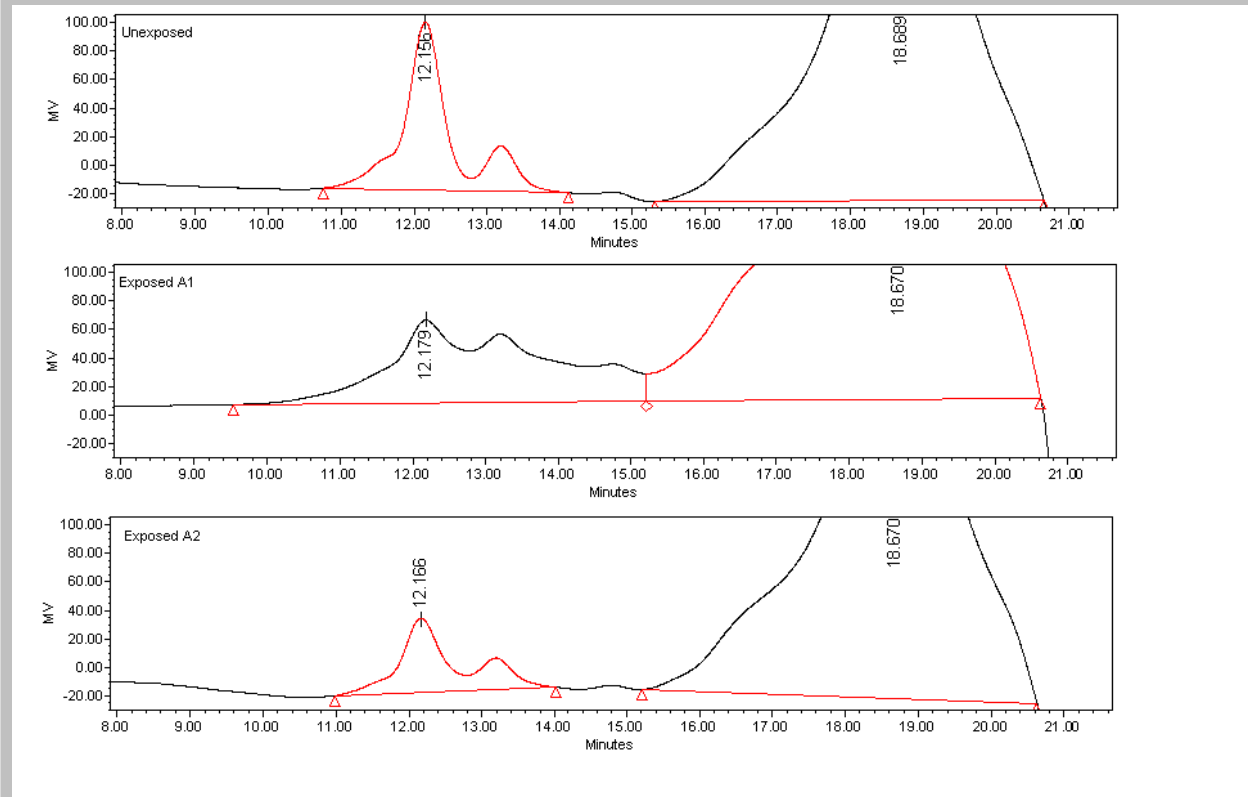
Comments: The image compares the GPC curves for the individual samples. Based on the results there appears to be some polymer degradation in the exposed samples.

5. GPC (gel permeation chromatography) analysis was performed on the SBS bitumen, and the exposed samples experienced a higher rate of polymer degradation than B1, however active (intact) SBS polymer remained in both A1 and A2.

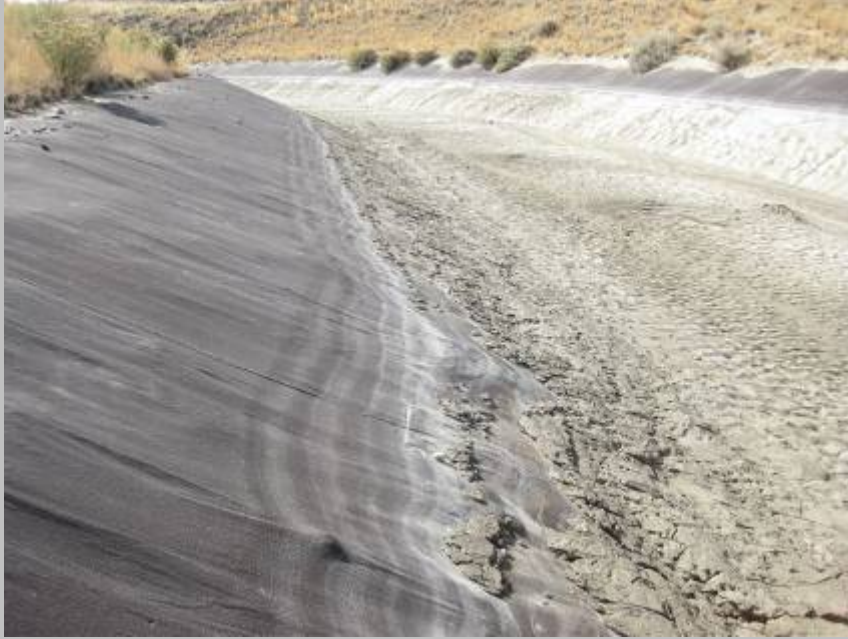
Comments: The image depicts the general condition of the irrigation canal. Note the exposed Teranap on the walls of the canal; this is the general area where Samples A1 and A2 were taken.

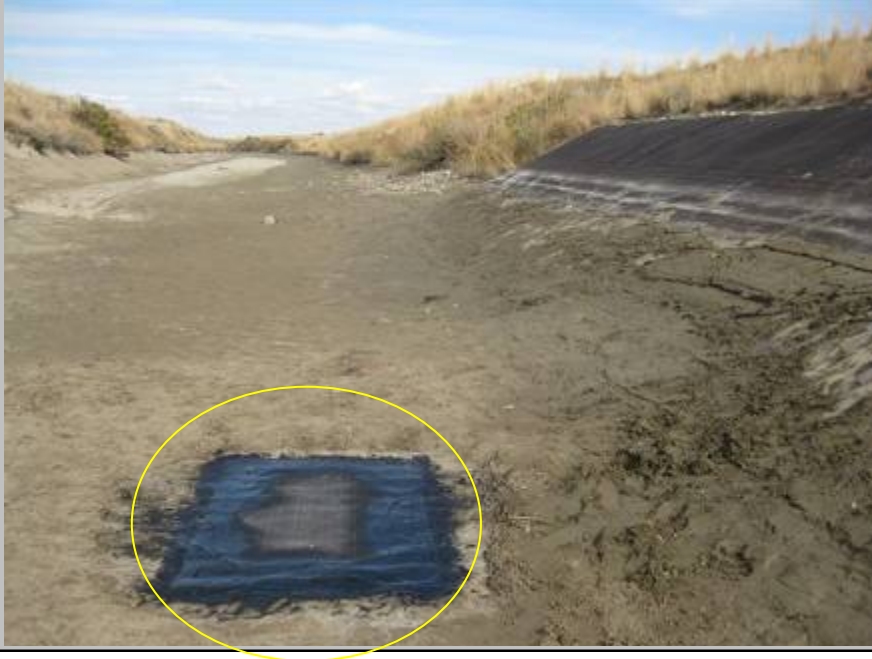
Comments: The image indicates where Sample B1 was extracted.
