In-pipe Ultrasonic Inspections of Mud and Tailing Lines: how to manage difficult to remove Scaling, provide quality and accurate Defect Assessments of steel and HDPE

A. O'NEILL¹; H. QUAKKELSTEIJN² > ¹RIO TINTO YARWUN REFINERY; ²INTERO INTEGRITY SERVICES AUSTRALIA

RTY has been working since 2019 to introduce Intero's Pipeline Surveyor as inspection technology for difficult-to-inspect mud, slurry, and caustic pipelines. In 2021 an inspection was carried out on an 8kms steel mud line of DN750.

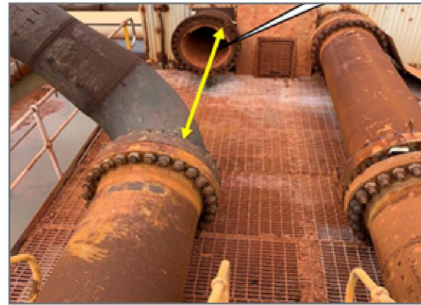
The mudlines are open ended during normal operations. A challenge was the receiving area which has very limited space, hence a tailored receiver was built for the job with sufficient capacity to release scaling.

Figure 3: Tight receiver location

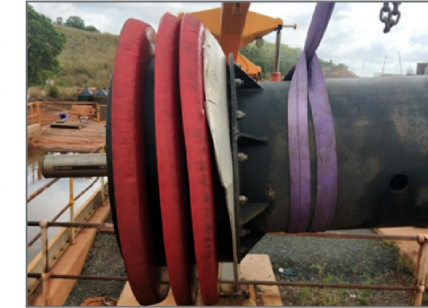
The bidi run had two unexpected results. First one was that the receiver was seriously challenged to deal with a huge amount of scaling the bidi had removed and secondly because the bidi gauging plate was damaged beyond what would have been acceptable. The other challenge was that it was very difficult to control the speed of the tool.

The damage of the bidi was deemed to be a result of hitting an air pocket while navigating a section of back-to-back bends leading to an underground section. Consequently, based on the first run parameters it was decided to perform a second bidi run, with the aim to simulate the optimum for the ILI run. The results of the second bidi were within the set conditions with no damage to the gauge plate. With some minor changes at the launching, it was also possible to control the inspection speed. Finally, the amount of scaling was much less this second run.

Figure 6: Damaged gauging plate

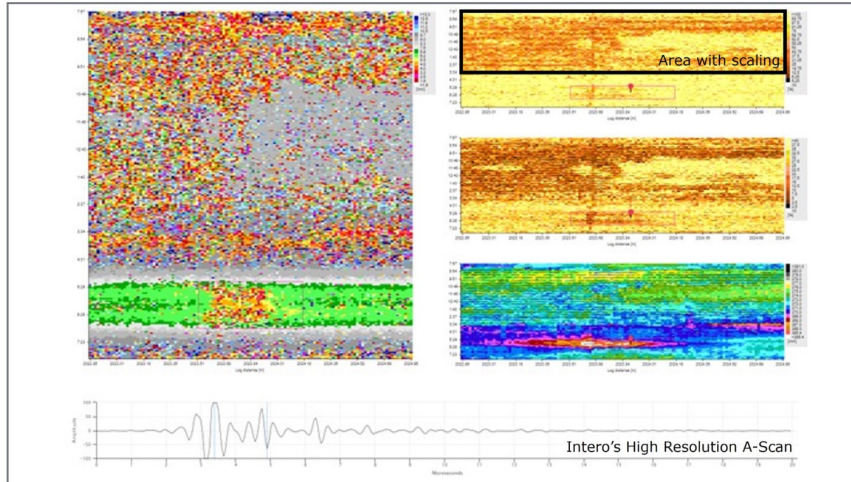
Figure 7: UT data presentation showing effect of scaling presence

The data showed significant loss of material along the entire pipeline. However, it also showed some areas with higher losses than others. These were in sections of higher “up-hill” gradient. It is unknown why the up-hill gradients show much higher material loss than similar downhill gradients. Ultimately given that it is not practical to change the pipeline gradient, no further investigation was conducted. The minimum required pipe thickness was calculated based on the original pipeline design standard B31.11. This is based on the basic hoop stress calculations provided in that standard. As discussed earlier the nature of the material loss results in this being a suitable assessment method. There is no need to

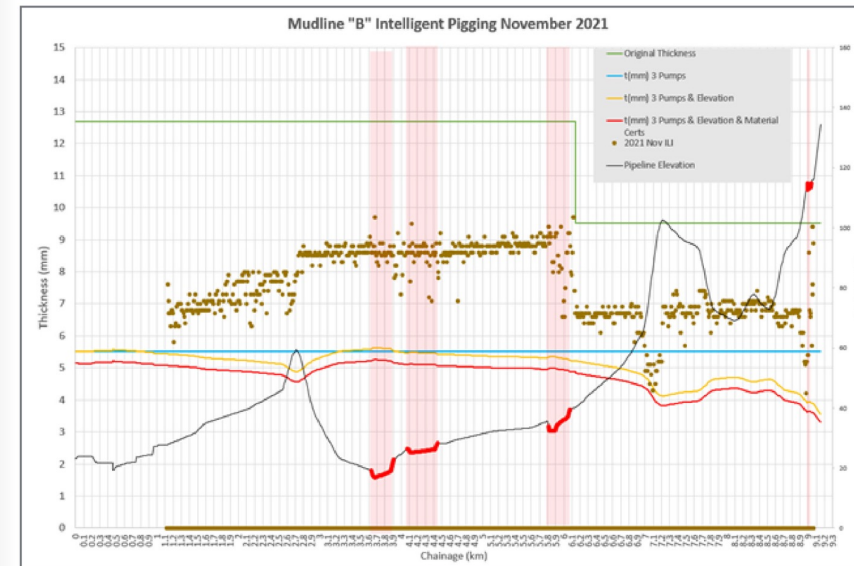
The same calculation was performed again, this time using the specific pipeline elevation to modify the pressure. As a result higher elevation sections of the pipeline have a lower required thickness. This is the “true” minimum required thickness for any section of the pipeline.

Figure 8: Graph with various overlay data showing minimum pipe thickness

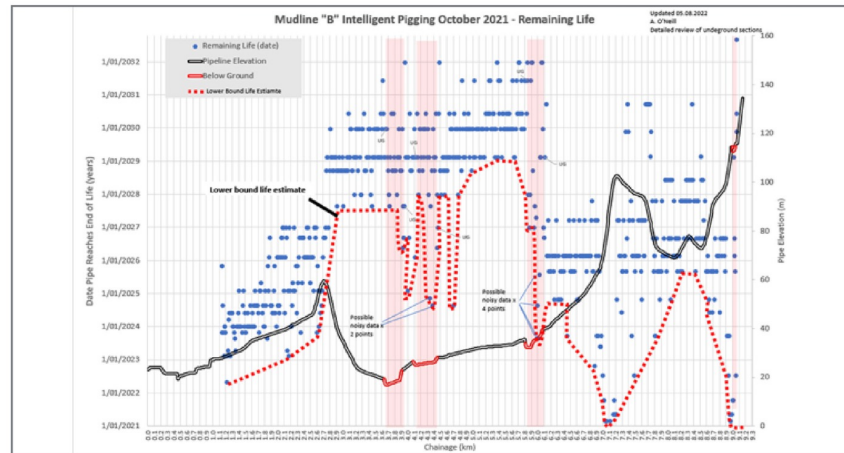
A second graph was produced based to show the “end of life” data along the pipeline. For each datapoint, the measured thickness was compared to the original thickness and a yearly wear rate determined based on linear trend. This was then used to calculate time to reach the required minimum thickness “t(mm) 3 Pumps + Elevation”. A further calculation was conducted to determine the date at which this would occur. The results of this are shown in Figure 9.

To make the data easier to comprehend, a line was manually drawn to show the “lower bound life estimate” on the data (shown as red-dashed).

Figure 9: Graph showing 'End of Life' date

The pipeline was re-designed in preparation for replaced using a much high corrosion allowance based on the expected life of the facility and the more recent design standard B31.4. This resulted in DN750 Schedule 30 pipe being specified, with a corrosion allowance of 10mm.

A combination of pipeline replacement and pipeline rotation is included in the rectification strategy, based on input from piping contractors of what is most feasible in each section of pipeline.

The overall timing of the rectification is staggered based on the End-of-Life graph. This allows cost of rectification to be spread over several years, without creating an increase in risk of pipeline failure.
