Aging of drinking water transmission pipes during long-term operation as a potential source of nano- and microplastics

Joanna Świetlik^{*}, Marta Magnucka

Adam Mickiewicz University, Faculty of Chemistry, Department of Analytical and Environmental Chemistry, Uniwersytetu Poznańskiego 8, 61-614, Poznań, Poland

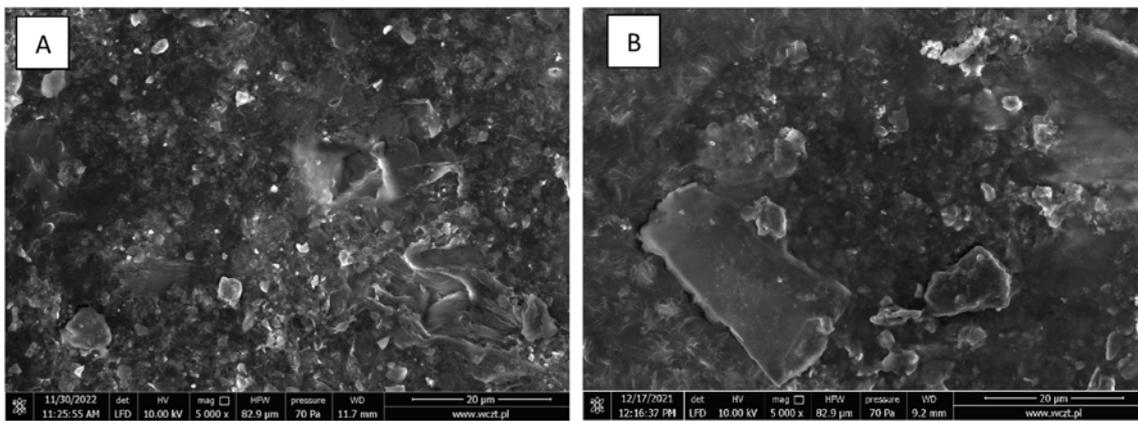
Fig. 1. Flaking and torn PE particles visible on the inner surface of the analyzed materials; A) 4 years of operation, B) 14 years of operation.

Detailed microscopic analysis of the surface of the extracted materials confirmed the occurrence of aging processes, manifested by the formation of numerous exfoliations, cracks and cavities on the PE surface. Microscopic images recorded for all sections, regardless of their age and diameter, showed numerous microfragments, which were associated with the polymer surface to varying degrees. These particles were characterized by different shapes - from irregular plates with sharp edges to threads/fibers. The number, distribution and shapes of microfragments are shown in the photos (Figs. 1 and 2). The SEM images also show microdamage to the PE surface, which may be the source of particles attached to the surface of pipes transporting tap water (Fig. 2C–E). These fragments, once fully detached from the surface, will be classified as nano- and microplastics. The defects, depressions and irregularities observed in the images may also provide excellent sites for the growth of microorganisms and, consequently, biodegradation of the polymer.

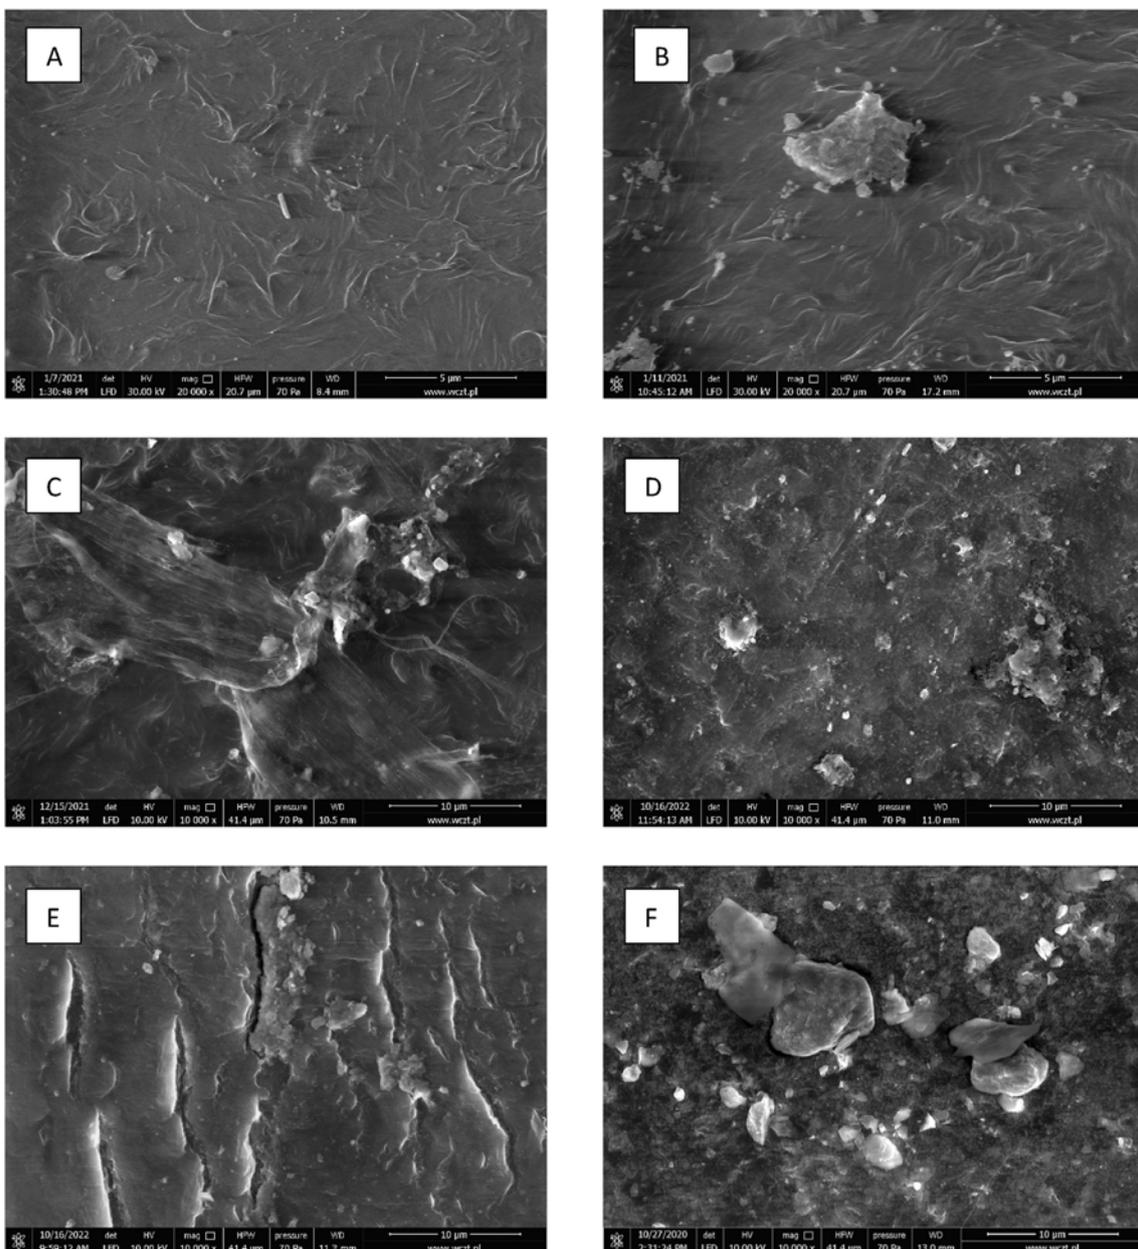
Fig. 2. Changes in the appearance of the inner wall surface of PE pipes during operation after A) 4 years, B) 6 years, C) 14 years, D) 15 years, E) 18 years and F) 20 years of operation.

In-depth analysis of the microscopic images recorded during the study also made it possible to assess the rate and course of degradation processes occurring on the inner surfaces of PE pipes. The wrinkles visible in the images (Fig. 2A and B) are a consequence of the progressive degradation of antioxidant coatings, a layer of which is applied by manufacturers to the internal surfaces of pipes to increase the resistance of the plastic to oxidizing agents. These coatings, as a result of the action of oxidants constantly present in water (dissolved oxygen, disinfectant) during the first few years of operation degrade resulting in wrinkling of the surface layer on the walls, which then flakes off exposing the deeper layers of the polymer (Fig. 2C). In subsequent years of operation, such changes on the PE surface are less pronounced than in pipes with a

shorter service life, but are still visible. Further operation of pipes lacking the antioxidant coating leads to their increasing cracking and peeling, resulting in the release of plastic particles into the water (Fig. 2D–F).

The microscopic images presented earlier (Figs. 1 and 2) show that the degree of degradation of the PE surface clearly increases with elongation of service life. The course of the polyethylene aging process is also significantly affected by the diameter of the pipes in service and the associated flow rate and water pressure [Świetlik and Magnucka, 2024 and references in it]. Fig. 11 clearly shows that in pipes of higher diameters the aging and surface degradation process is more intense than in those of small diameters. Despite the longer service life, the damage visible on the surfaces of small-diameter pipes is shallower and characterized by the coexistence of a smaller number of torn fragments, which is most likely related to the much slower, more laminar flow and lower water pressure acting on the walls. In pipes with large cross sections, the visible damage is deeper, covers larger areas of the surface and has a greater potential to release exfoliated plastic micro-fragments into

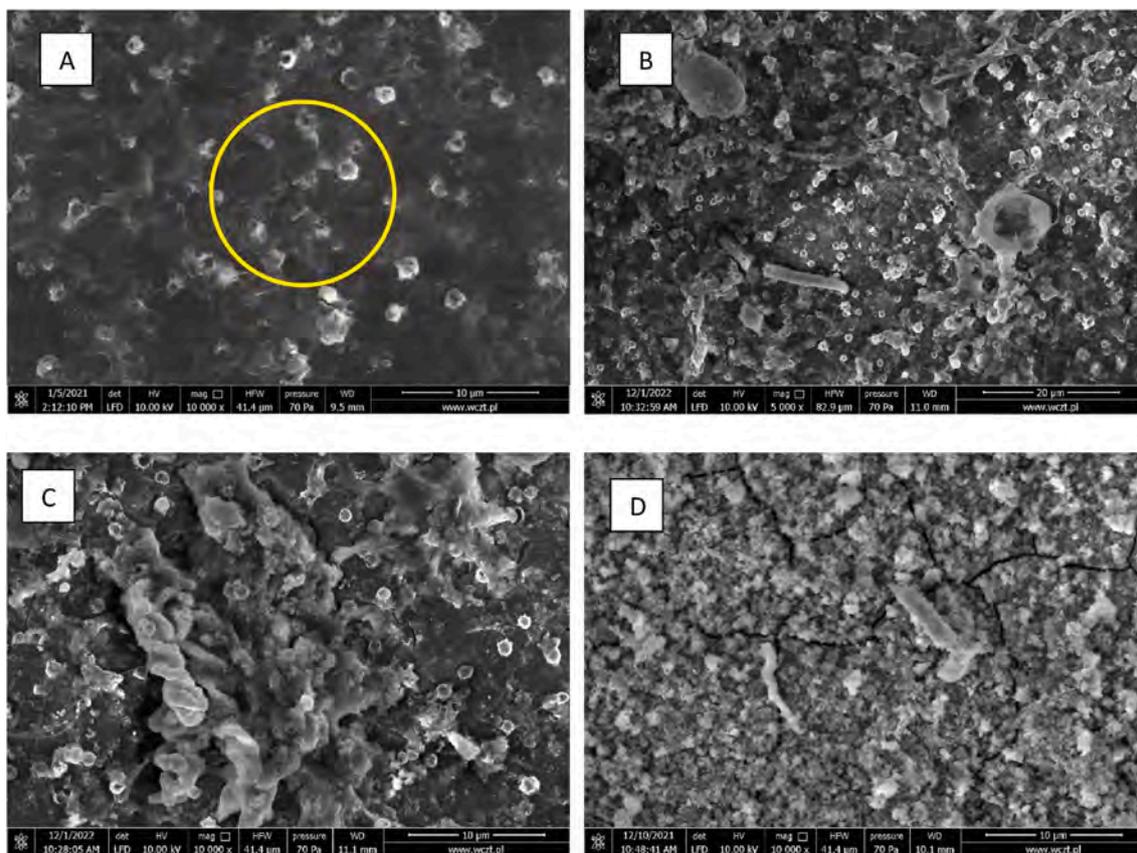
Fig. 5. Mineral and microbial deposits visible on the surface of PE pipes (untreated fragments); A) 4 years, B) 13 years, C) 13 years (iron oxidizing bacteria (Garrison et al., 2019)), D) 14 years of operation.

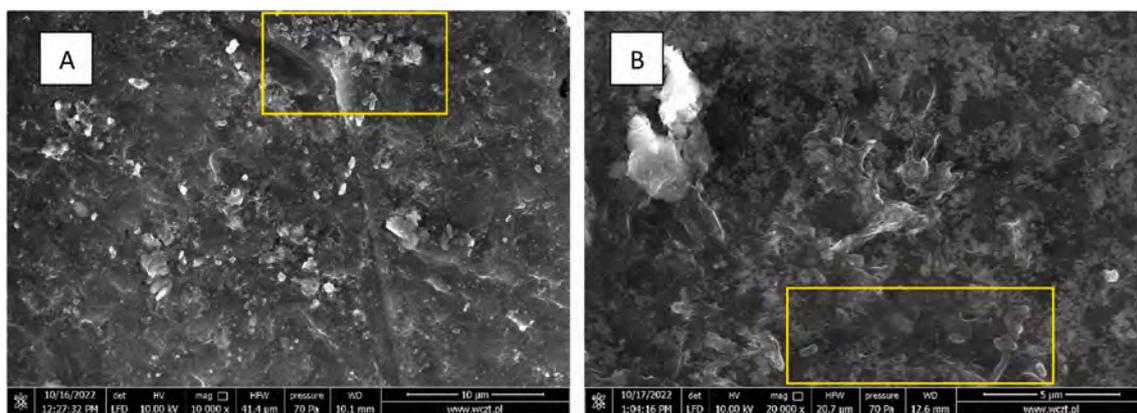
Fig. 6. Bacterial cell residues present on PE surface after cleaning procedure, A) 15 years and B) 20 years of operation.

distribution fluctuates periodically and there are periods of stagnation and/or very low flow, often accompanied by the disappearance of residual disinfectant. Studies by Flemming et al. (2002) and Gulati and Gosh (Gulati and Ghosh, 2017) have shown that about 95% of bacteria in drinking water distribution systems are attached to the inner surfaces of pipe walls, while only 5% are in the aqueous phase and are detected during analysis of water samples (Flemming et al., 2002; Gulati and Ghosh, 2017). Research also confirms that one of the key factors influencing the intensity of biofilm development in water distribution networks is the pipe material. The analysis of actual sections made it possible to observe not only the changes occurring on the inner walls of water pipes as a result of the operation, but also the increasing amount of biofilm developing inside the cavities created (Figs. 5 and 6). Metabolic processes carried out by microorganisms in the developed biofilms aggravate the material degradation process. Some of the microorganisms colonizing porous PE surfaces are so strongly associated with it that even after mineralization processes, bacterial cells are clearly visible on the surface of the plastic (Fig. 6).

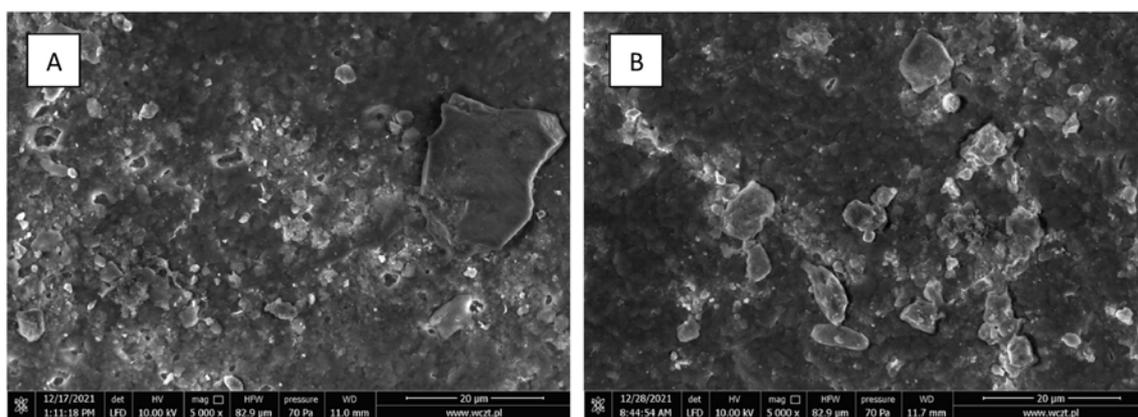
Fig. 7. Flaking and torn PVC particles visible on the inner surface of the analyzed materials; A) 36 years and B) 45 years of operation.

PE samples examined (Fig. 7). This may be related to the longer service life of the plastic than PE, and thus the deeper degradation of the plastic. A significant difference from PE is the presence of numerous deep pits on the PVC surface. The characteristic pits were present on all analyzed sections regardless of their age and diameter. The number, distribution and shapes of the pits, as well as the accompanying numerous microfragments of eroded polymer, are very well illustrated by photos showing the surface of the PVC pipe (Fig. 8). The negative effect of water on the performance of this material has already been reported in the literature, indicating the formation of characteristic pits that promote sediment retention (Cerrato et al., 2006) and colonization by microorganisms. The results obtained in the presented series of studies confirmed the characteristic degradation path of PVC with the formation of depressions, inside which microorganisms can grow to form dense biofilms over time. In addition, analysis of microscopic images recorded for PVC sections after different periods of operation showed the extend damage to the plastic. Basically, the entire surface of long-used PVC is covered with pitting, which significantly increases the porosity of the polymer and the retention of deposits, clearly visible already during the macroscopic evaluation of the tested materials. Wetting angle measurements for these materials showed much more intense degradation of the PVC surface compared to PE. With operation, the CA of PVC decreased to values as high as $49,7^\circ$, with no clear correlation with the age of the pipe. A much clearer correlation was recorded between the wetting angle and the diameter of the tested pipes. In this case, pipes with larger diameters had a higher porosity, while those with $\phi < 90$ mm had a similar CA value ($80,1\text{--}87,7^\circ$) regardless of the length of service. This may be related to the quality of the plastic itself and/or to its lower resistance to the high pressures and higher flow rates prevailing in higher diameter pipes.

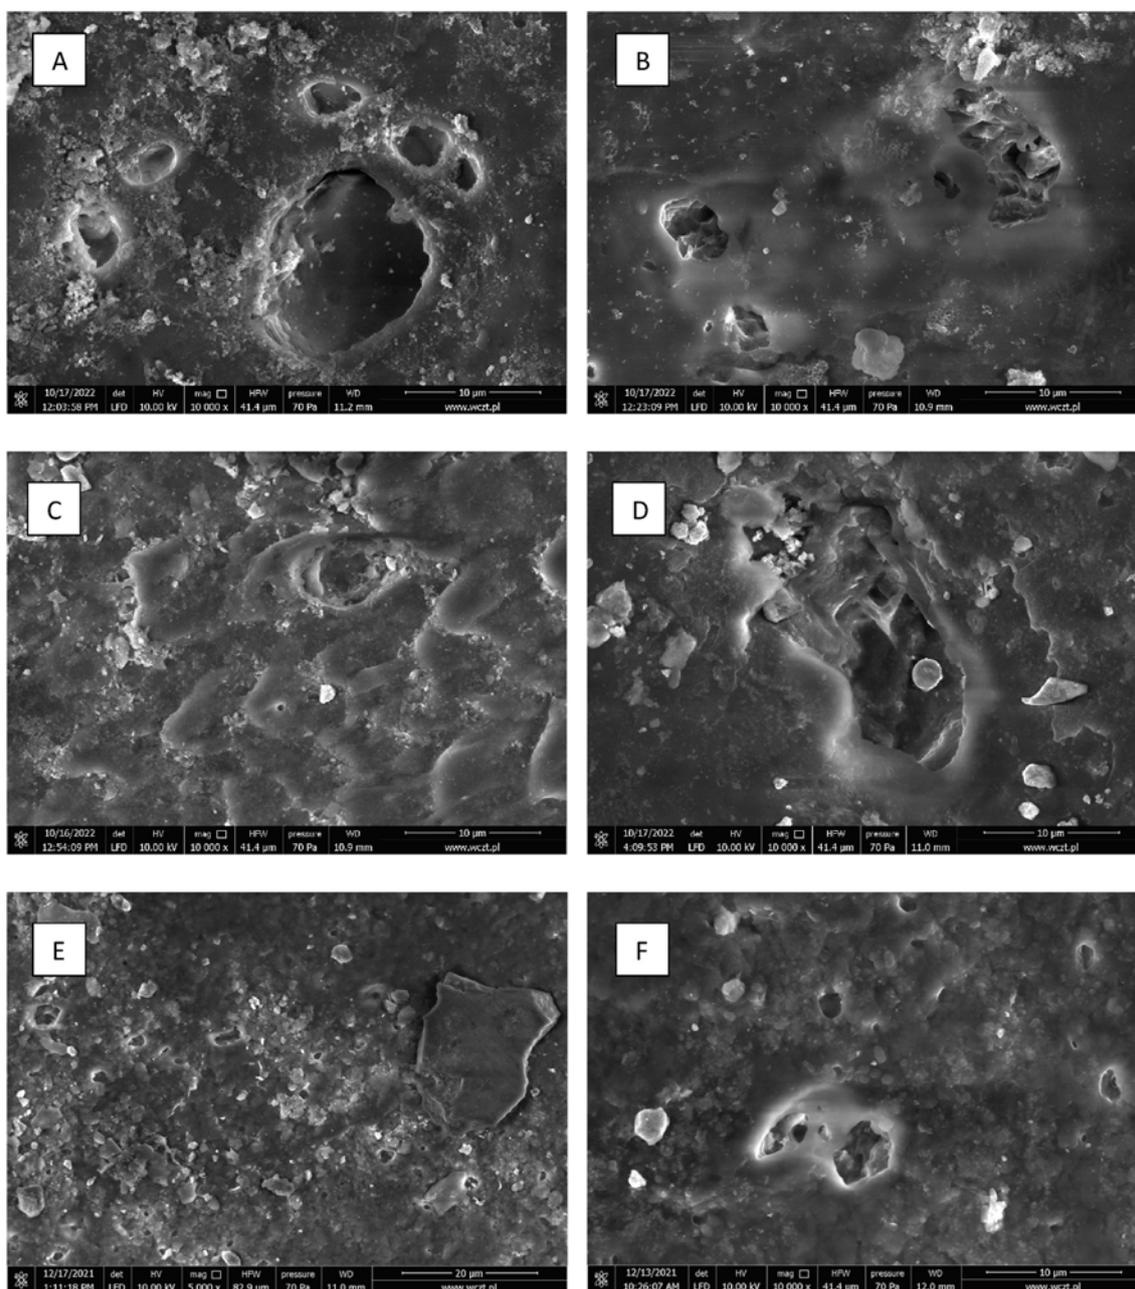
Fig. 8. Changes in the appearance of the inner wall surface of PVC pipes during operation; A) 16 years, B) 26 years, C) 28 years, D) 29 years, E) 36 years and F) 45 years of operation.

The scanning microscopic images of the PVC surface recorded during the analyses indicate the presence of numerous depressions (pits/holes) and fine, torn plastic particles on the inner surface of the water pipe walls. As in the case of PE, the particles present on the PVC materials are characterized by a variety of shapes - from irregular plates with sharp edges to threads/fibers, but their number is higher than in the case of the

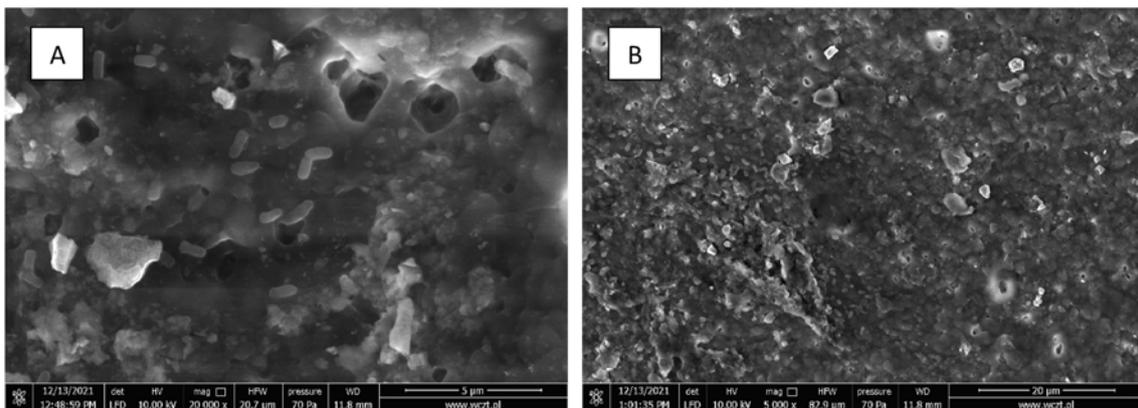
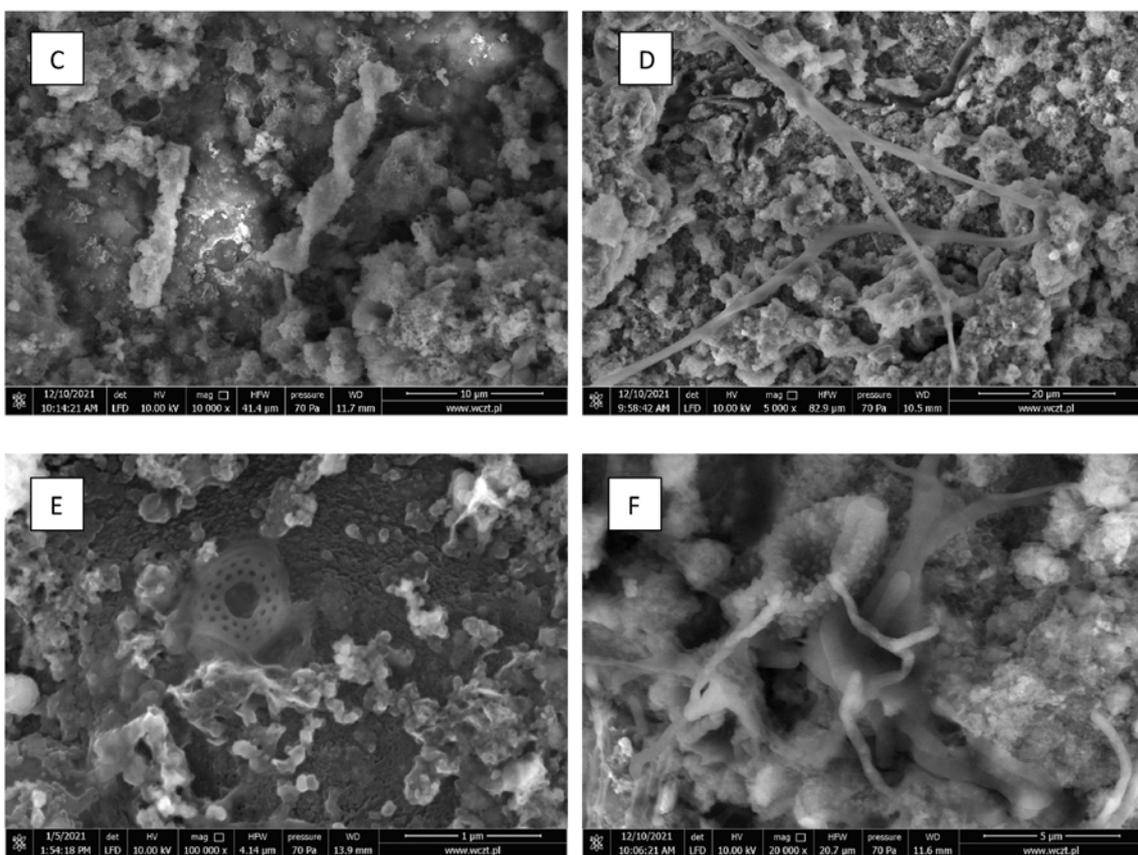
Fig. 10. Mineral and microbial deposits visible on the surface of PVC pipes; A) residual bacterial cells, B) mineral deposits, C) iron oxidizing bacteria (Garrison et al., 2019), D) and F) fungi (Alfonso et al., 2021) and E) representative of diatoms Thalassiosirophyceidae (Kociolek et al., 2015).

Visible defects on the surface of PVC, can provide an excellent place for microorganisms to grow and thus biodegrade the polymer. They are also an extensive reservoir of mineral deposits, which over time can also provide a substantial breeding ground for bacteria. A study by Biedroń et al. (2017) found that the biofilm formed on PVC is thicker and has a more complex structure with multiple channels, compared to the biofilm observed on the surface of pipes made of polyethylene. This may be a consequence precisely of the presence of numerous irregularities on the PVC surface, which favor the undisturbed proliferation of microorganisms in isolated areas with impeded access to flowing water containing active disinfectant. Images showing mineral deposits, individual microorganisms and biofilm fragments on PVC are shown in Fig. 10.

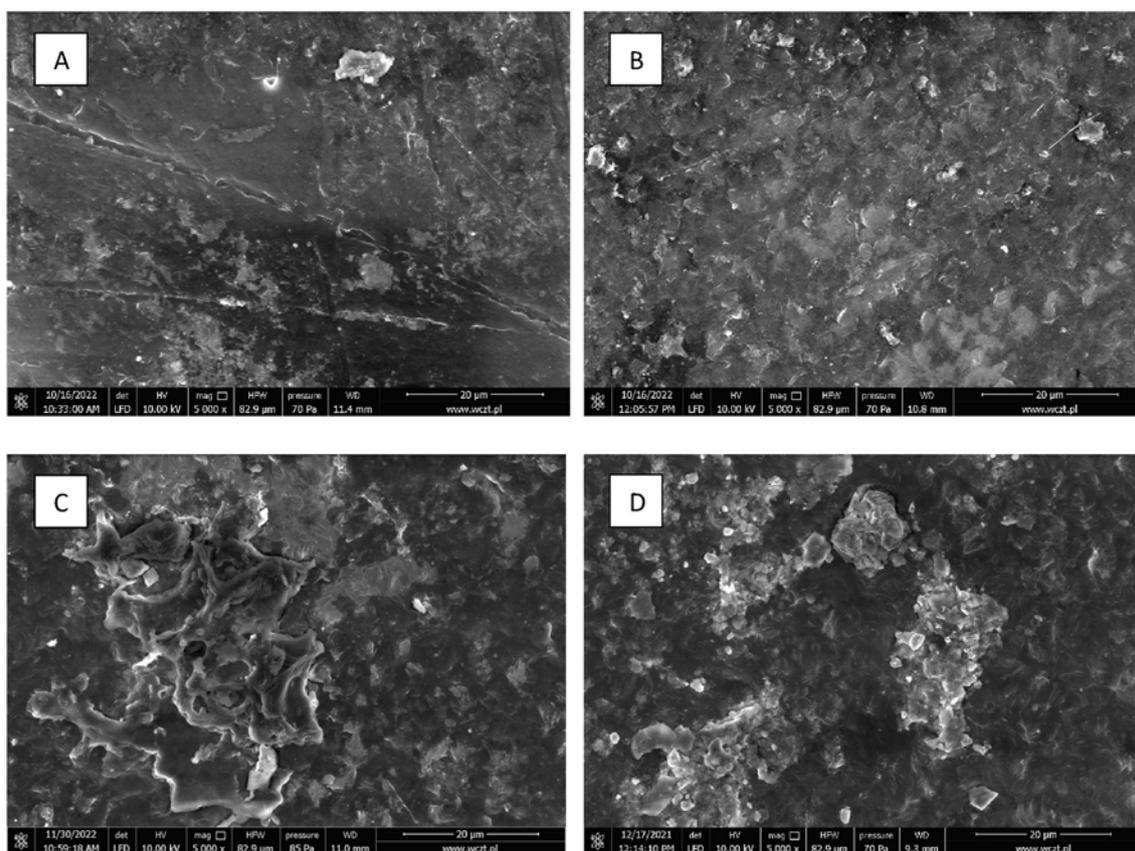
Fig. 11. Changes in the appearance of the inner surface of PE pipes depending on their diameter: A) ϕ 90 mm (13 years), B) ϕ 125 mm (15 years), C) ϕ 180 mm (13 years) and D) ϕ 225 mm (14 years).

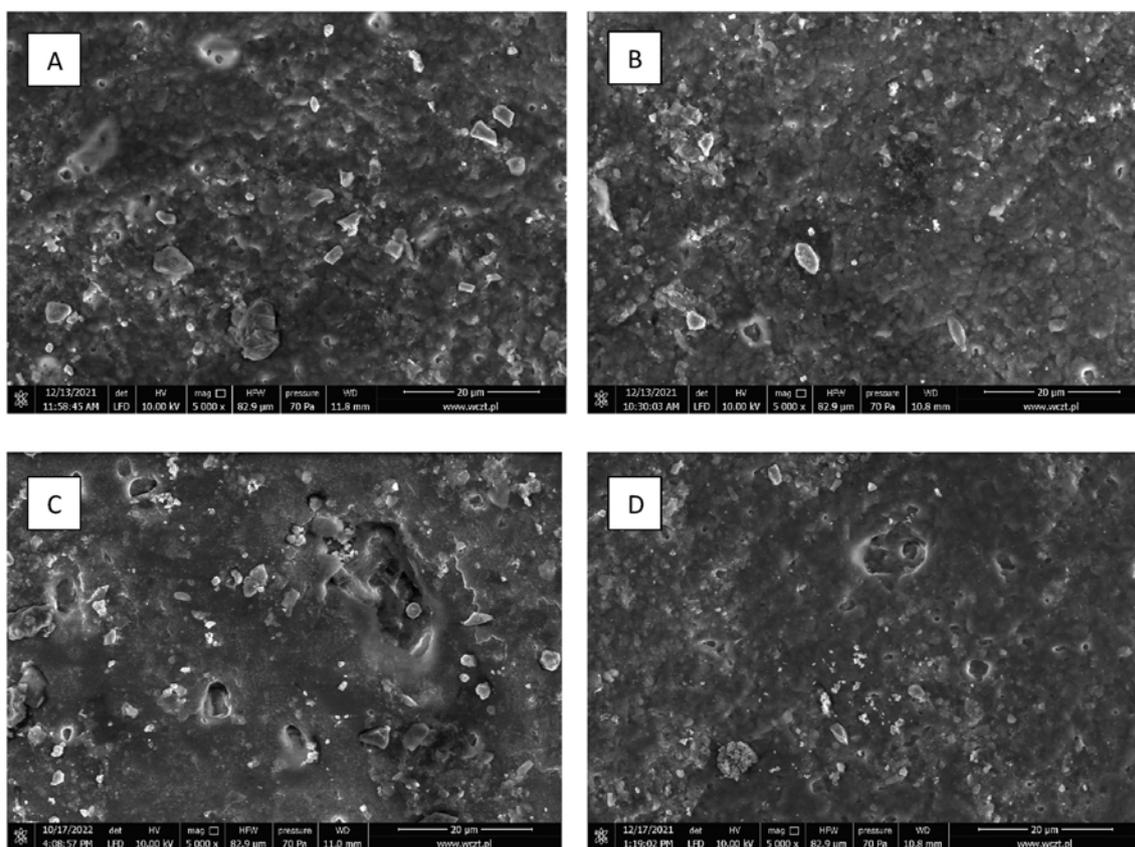
Fig. 12. Changes in the appearance of the inner surface of PVC pipes depending on their diameter: A) ϕ 80 mm (41 years), B) ϕ 100 mm (45 years), C) ϕ 160 mm (29 years) and D) ϕ 200 mm (36 years).

For the analysis of PVC cuttings, similar relationships were observed for PE. Due to the age of the acquired sections (16–45 years), the rate of degradation of this polymer could not be accurately estimated. The microscopic images in Figs. 6 and 7 clearly show the advanced degradation of all the fragments, making the intensification of the process as a function of time difficult to grasp. Analysis of images recorded for larger areas of the surface (not shown) confirmed the progressive nature of the processes in question. On the PVC surface, however, clear changes in the appearance and depth of damage were observed depending on the diameter of the pipe (Fig. 12).

On the surface of small-diameter pipes, numerous particles and fragments of torn material were visible, as well as numerous small pits. Wider pipes, on the other hand, were characterized primarily by the presence of numerous deep pits around which peeling areas and plastic particles were visible. This confirms the degrading effect of flow rate and water pressure on PVC, as was the case with PE. Of concern, however, is the large, increasing number of loose particles present on the PVC surface with small diameters. This is because it indicates that as PVC pipes age, they have an increasing potential to release nano- and microplastic particles into the water. In the case of small diameters, such pipelines are mainly found at the ends of the network and deliver drinking water directly to consumers' homes, significantly exposing them to the introduction of unwanted microplastics into their bodies via tap water as well. A detailed analysis of the observed microplastics will be presented

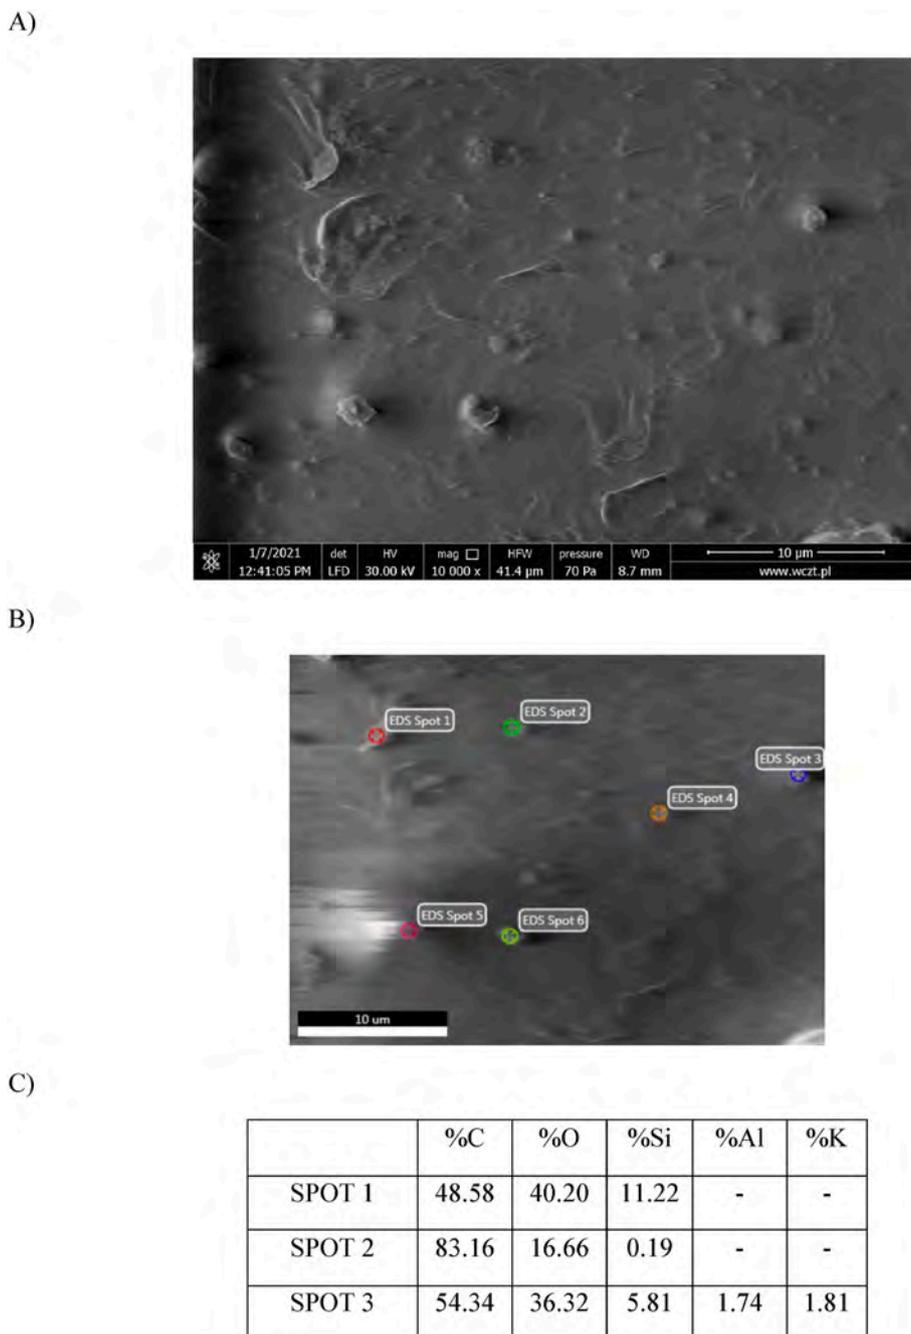
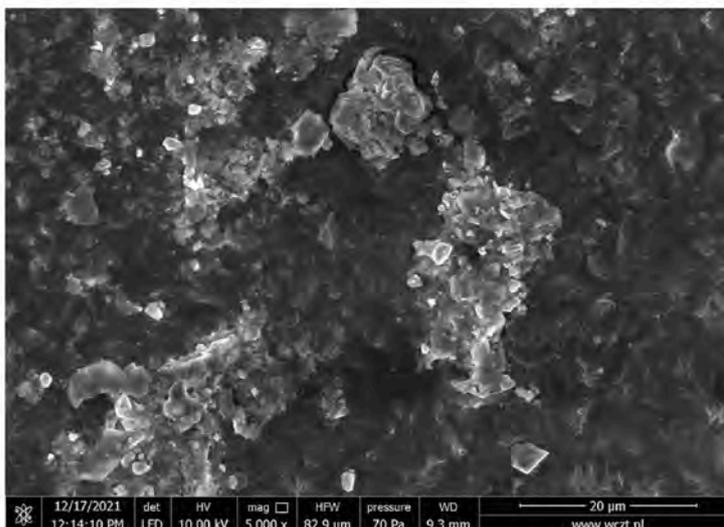
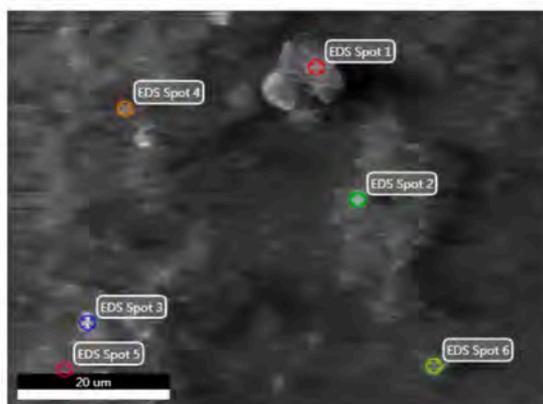
Fig. 13. A) SEM image of the surface of PE after 4 years of exploitation (180 mm), B) and C) EDS analysis of selected particles.

likely torn/separated antioxidant coatings, characterized by high carbon content, reaching up to 80% C in a few cases (Fig. 13), while the content of this element in the unoxidized polymer is about up to 86%. This confirms the earlier hypothesis, according to which the antioxidant coating is first broken/damaged, followed by peeling and exposure of the polymer. As a consequence, its gradual degradation occurs, resulting in the phenomenon of the release of microfragments of plastic into the water. The torn and partially detached PE particles undergo further oxidative processes, as indicated by the increasing percentage of oxygen in the particles most loosely bound to the polymer surface (Figs. 13 and 14).

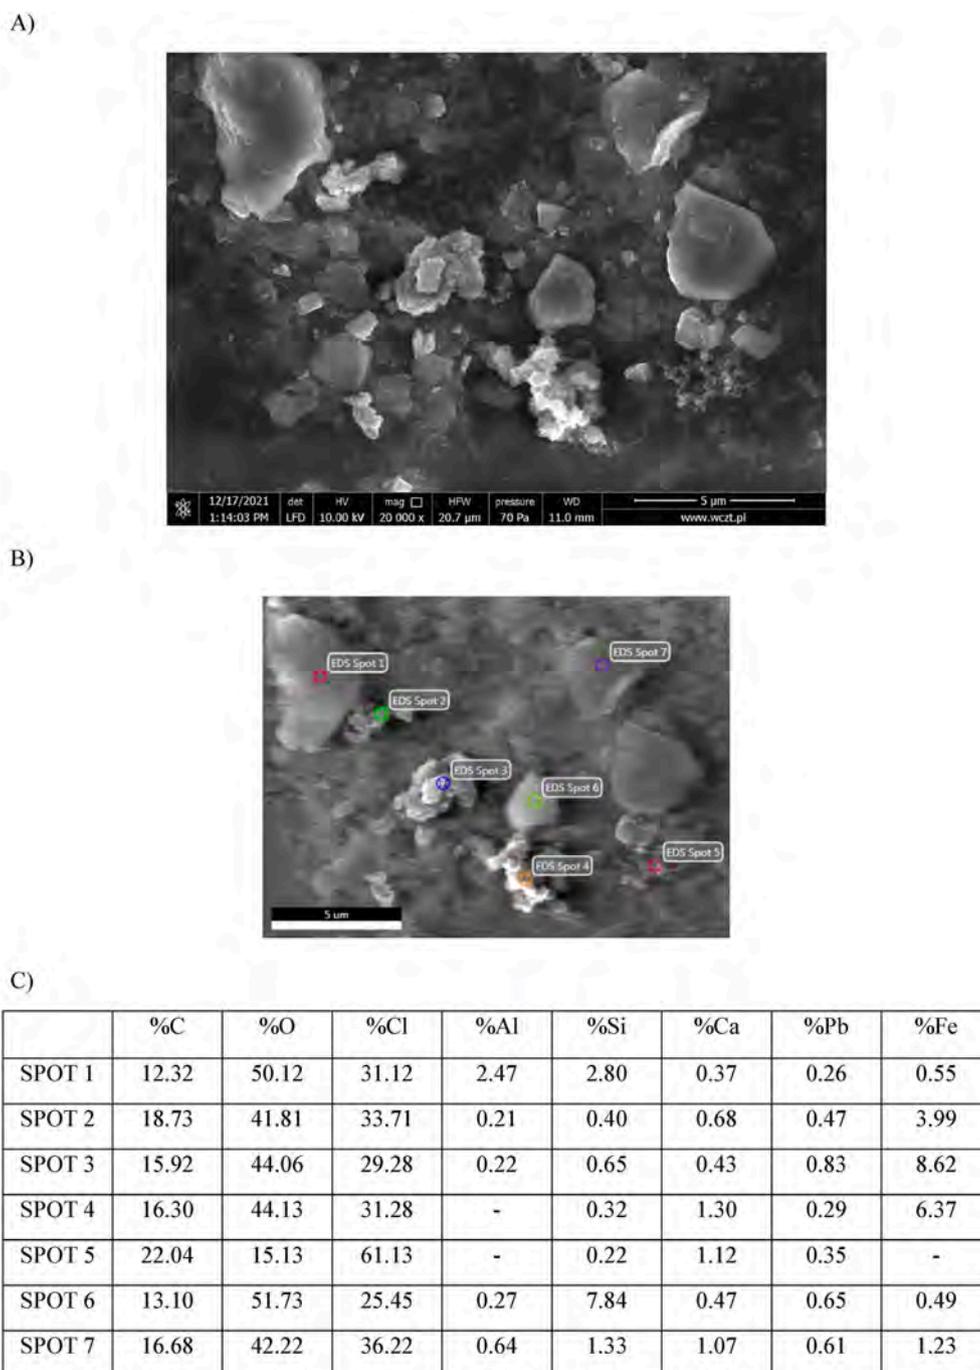
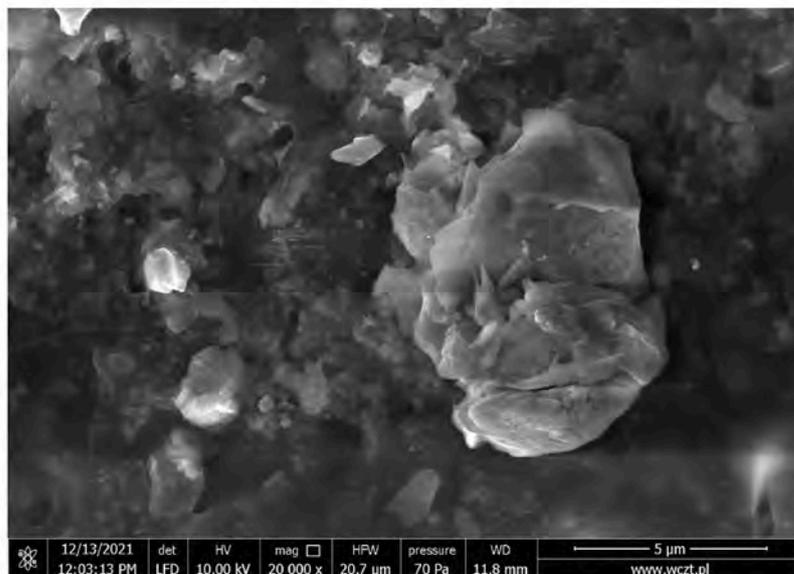
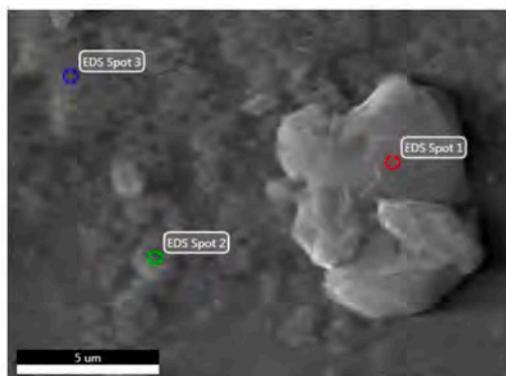
Fig. 16. A) SEM image of the surface of PVC after 36 years of exploitation (200 mm), B) and C) EDS analysis of selected particles.

present a variety of their shapes. Fragments with sharp irregular edges predominate, but the presence of fragments with fibrous shapes was also noted (not shown). The elemental composition of the scales and particles, present on the walls of PVC pipes, subjected to elemental analysis varied with respect to oxygen content, indicating the degree of oxidation of the polymer, as well as with respect to chlorine content. Fragments detached from PVC relatively recently were characterized by a chlorine content of >45% (Fig. 15), while for particles that had been in contact with flowing water for a longer period of time, the % chlorine content decreased depending on the degree of degradation and averaged from 42 to about 25% (Fig. 16). As the chlorine content decreased, the oxygen content of the particles increased, which directly indicates that the fragments detached from the polymer matrix are successively oxidized over time by oxidants present in the flowing water (dissolved oxygen, disinfectants). In addition, almost all analyzed PVC microfragments showed the presence of admixtures of lead, used in the manufacture of PVC pipes to increase the resistance of the plastic to temperature changes. The percentage content of Pb most often ranged from 0 to <1%, but in a few cases it was higher, reaching from 1,2 to 6,6%. Also of great interest were the particles represented by the "Spot 5" visible in Fig. 14, for which a relatively high carbon content and a very high percentage of chlorine, exceeding 60%, were determined, along with a low percentage of oxygen. Given the claimed long life of the pipes (in this case 36 years, Fig. 16), these particles were most likely trapped under a layer of mineral and biological deposits that had accumulated over the years, resulting in limited oxygen/disinfectant access. This proves that in the case of PVC pipes with a very long service life, in addition to particles released systematically into the transmitted water, there is also an accumulation of microplastic fragments permanently bound to the deposits present on the internal surfaces of the pipes. The presence of such microplastic particles trapped in sediments deposited on the inner walls of distribution pipes was confirmed by Chu et al. (2022).
