## An underappreciated mechanism for the failure of tailings dams

Robert Pyke<sup>i)</sup>

### ABSTRACT

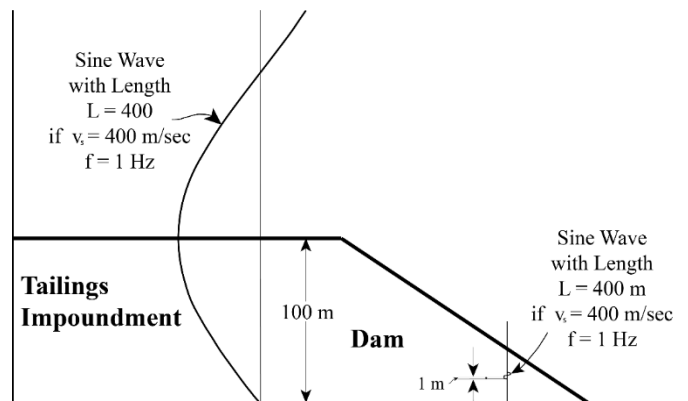
Fig. 1. Sketch to illustrate example calculation.

- Say there is a patch close to or at the point of collapse with a characteristic dimension of 1 m (shown in Figure 1 as the small dot in between the dimension lines towards to the toe of the dam).
- Then the critical wavelength,  $L = 4 \times 1 \text{ m} = 4 \text{ m}$
- And the critical frequency,  $f = v_s/L = 400 \text{ m} / 4 \text{ m} = 100 \text{ Hz}$
- Thus, if this patch sees motions at 100 Hz, those motions will tend to promote resonance and might well trigger local collapse of the soil

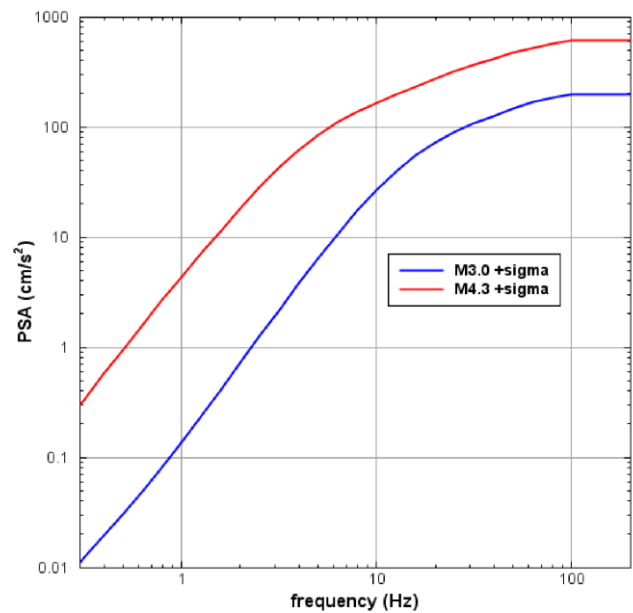
As part of the panel's work on the NTSF Embankment failure, Dr. Gail Atkinson conducted an excellent study of the seismicity of the site. The embankment failure at Cadia was noticed the day after two events of  $M = 3.0$  (10 seconds apart) on March 8, 2018. The response spectrum for an  $M = 4.3$  event that occurred the previous year is shown in the report and the maximum amplitudes occur at frequencies as high as 100 Hz.

Fig. 2. Inferred spectrum in hard rock at the site for magnitude 3.0 and 4.3 earthquakes at a distance of 5 km. From Morgenstern et al. (2019).
