# How to Blooming Affects Welding of HDPE Geomembranes

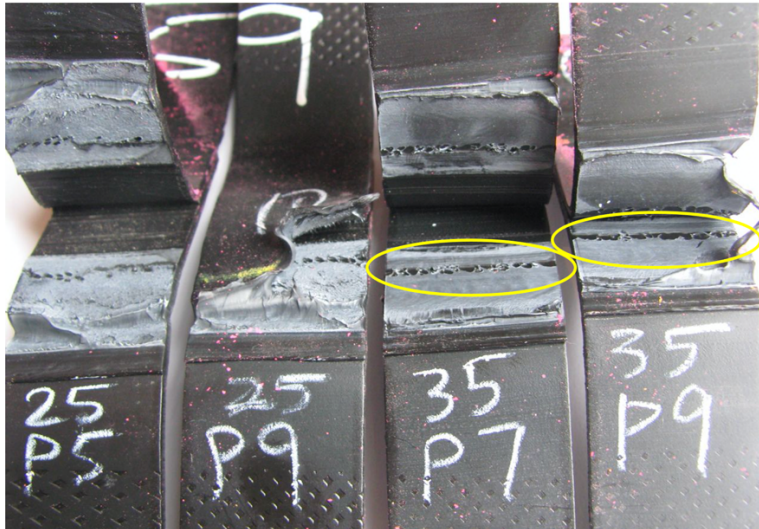
Excess blooming can also cause porosity in the weld zone leading to reduced seam strength.

The volatiles that form from the thermal decomposition of the additive bloom on the brass wedges of the welding machine can get entrapped in the weld interface leading to tracks of bubbles and porosity as shown in the photo below.

- (1) Test the geomembrane before welding for presence of waxy layers of bloomed additives and waxes using the “fingernail test” and the FTIR scan.
- (2) Use ethyl acetate solvent wipes to clean the laps and remove excess bloom and waxes before wedge welding.
- (3) Regular cleaning of the brass wedges but at the expense of welder productivity.

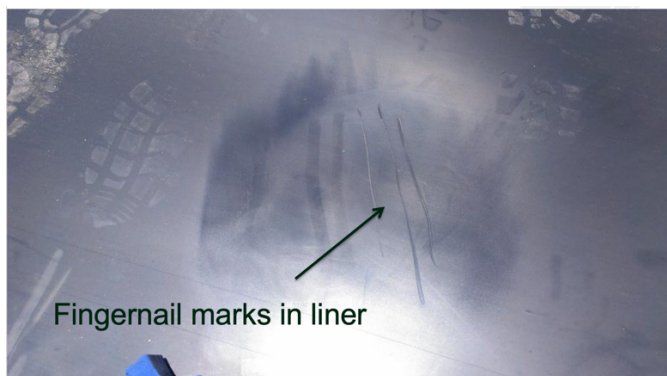
The photograph below shows the bloom on a HDPE geomembrane after removal by a fingernail (image courtesy Wayne Potter).

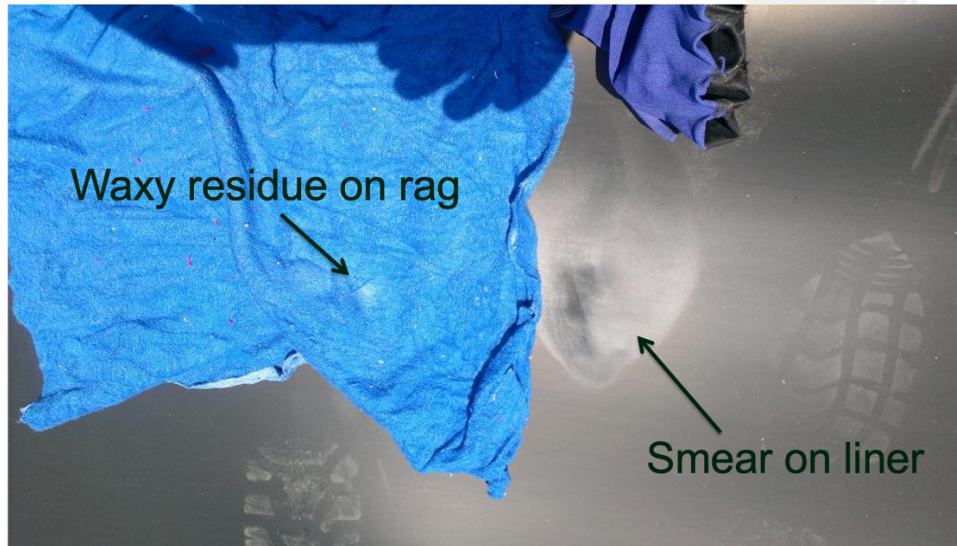
The photograph below shows the bloom on a HDPE geomembrane after removal by a dry rag using the “double rub” test leading to a noticeable smear on the liner and a white waxy residue on the blue rag (image courtesy Wayne Potter).
