RESEARCH ANALYSIS

Non-cladding building defects

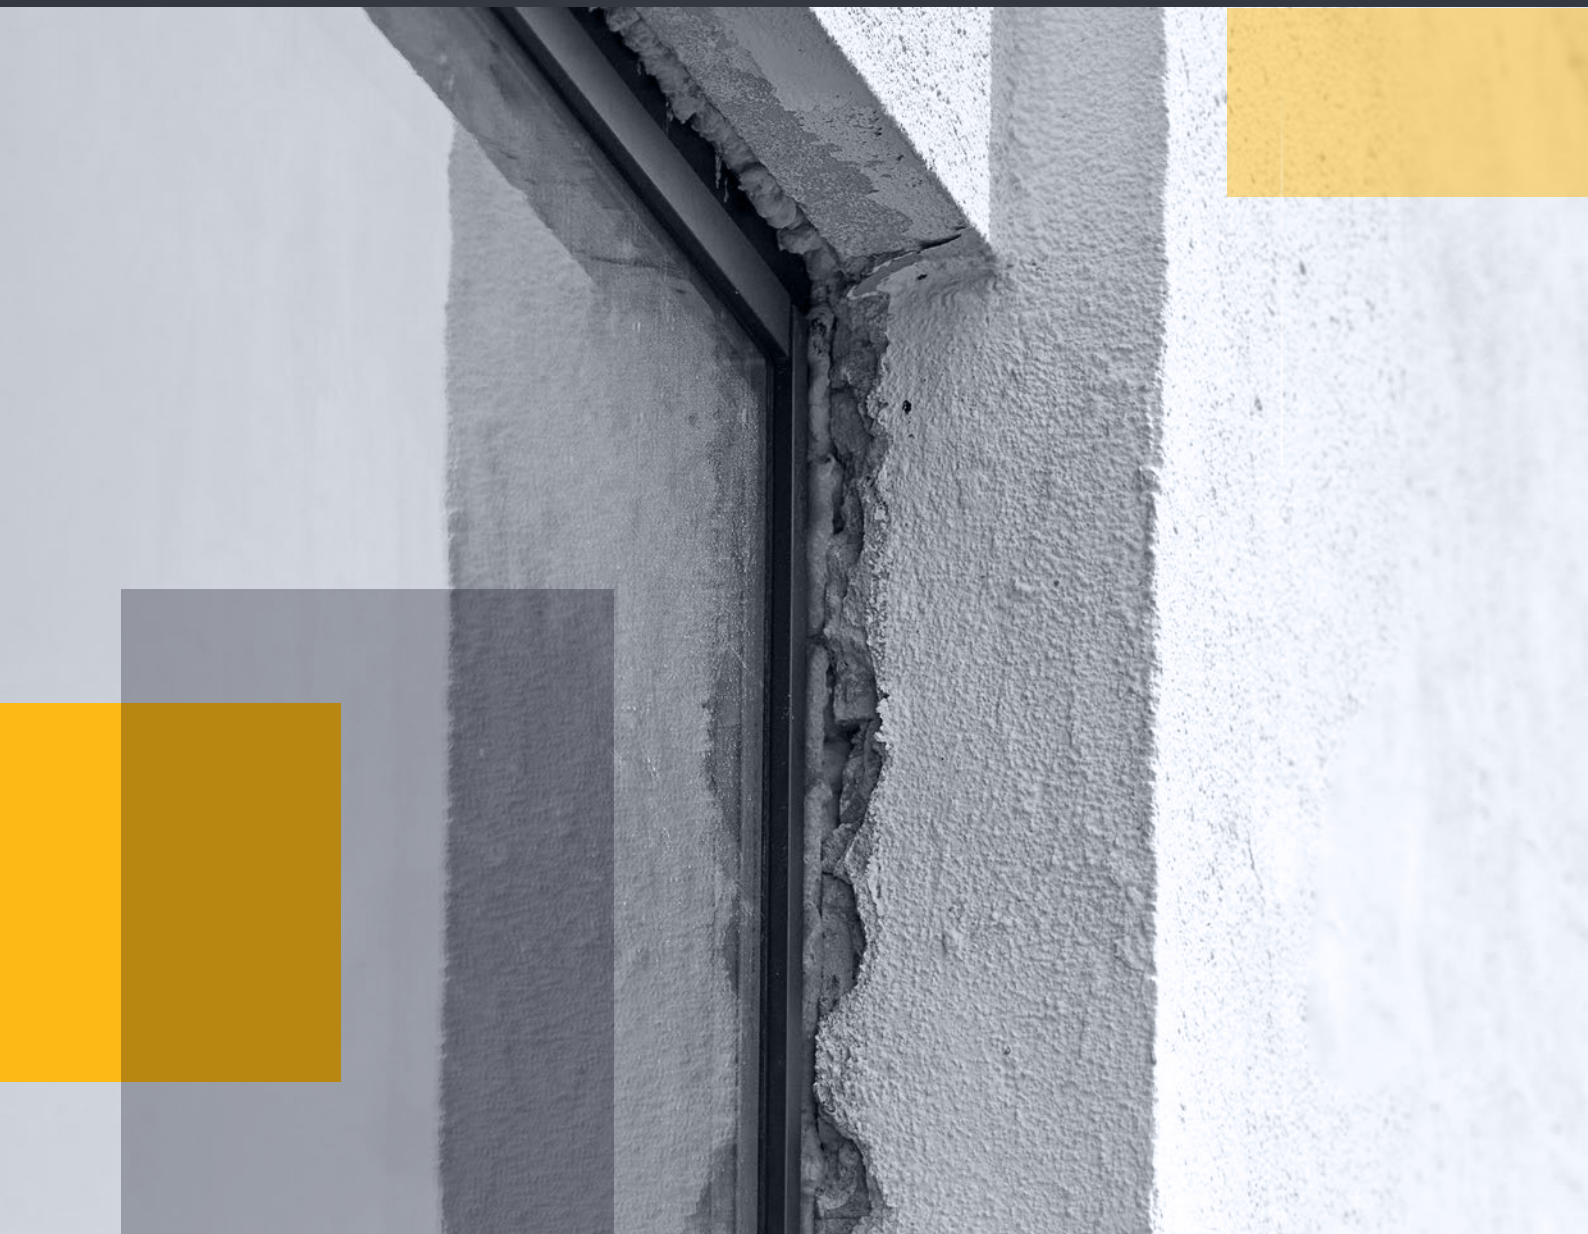
Aboriginal acknowledgement

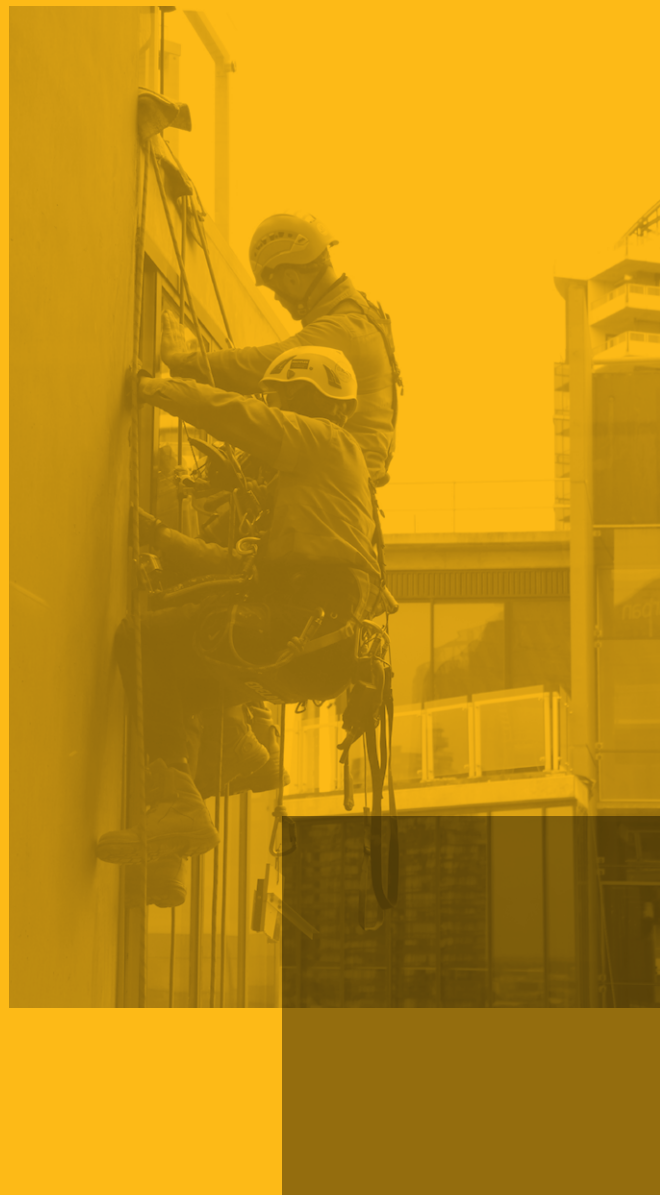
2. Methodology, limitations and assumptions

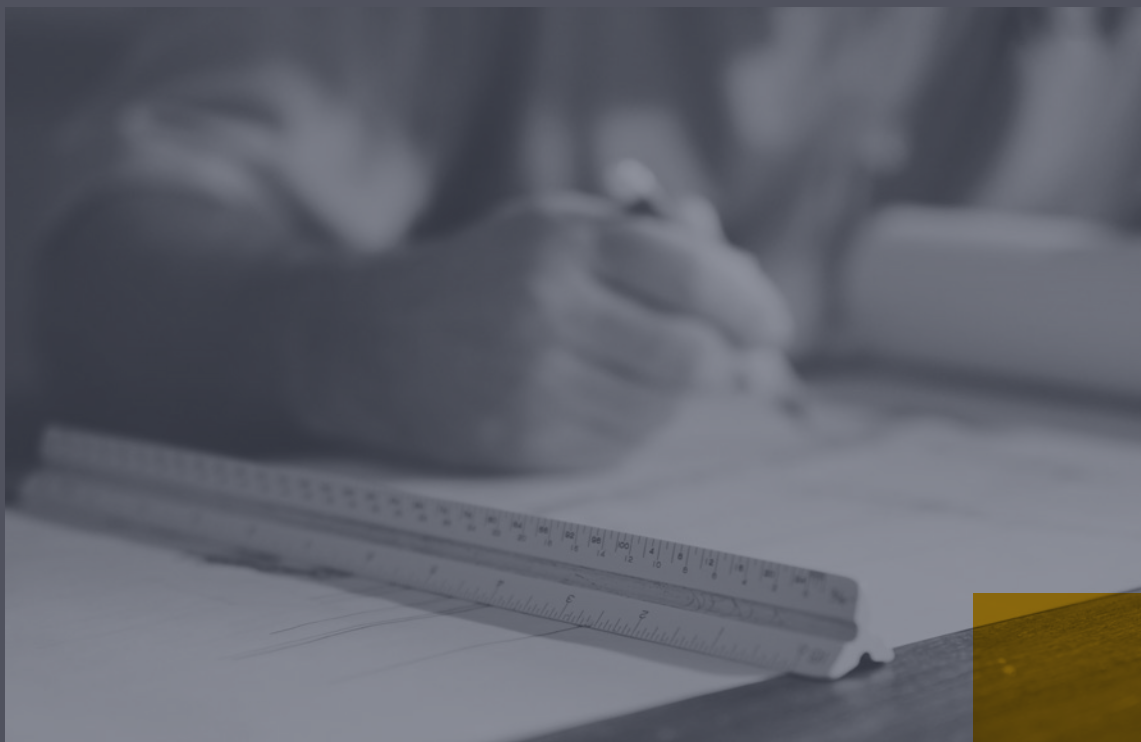
Defects arise from poor architectural design, defective construction by poor workmanship by trades under the supervision of builders or maintenance issues and have the potential to present serious safety risks to residents if not addressed promptly.

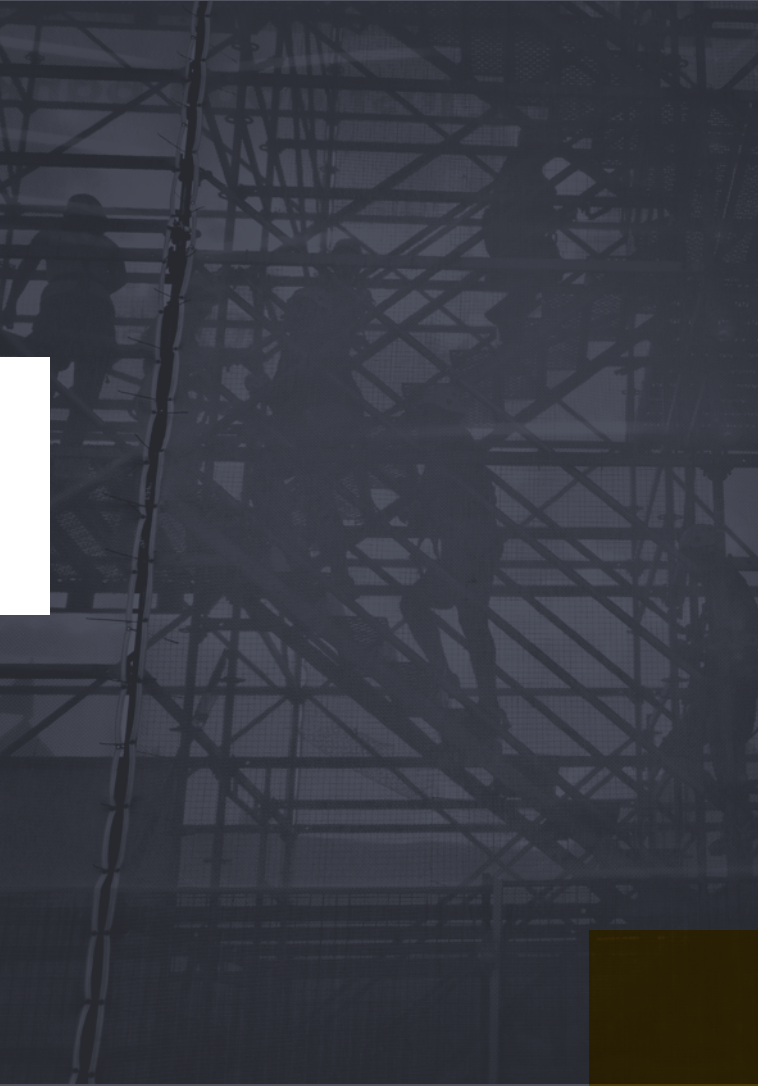
CSV has identified considerable and widespread serious non-cladding building defects on buildings designated to be funded for cladding rectification through CSV's program. These defects include pervasive black mould, framing non-compliance, leaking roof and gutters, balconies, rotten framing and water proofing issues.

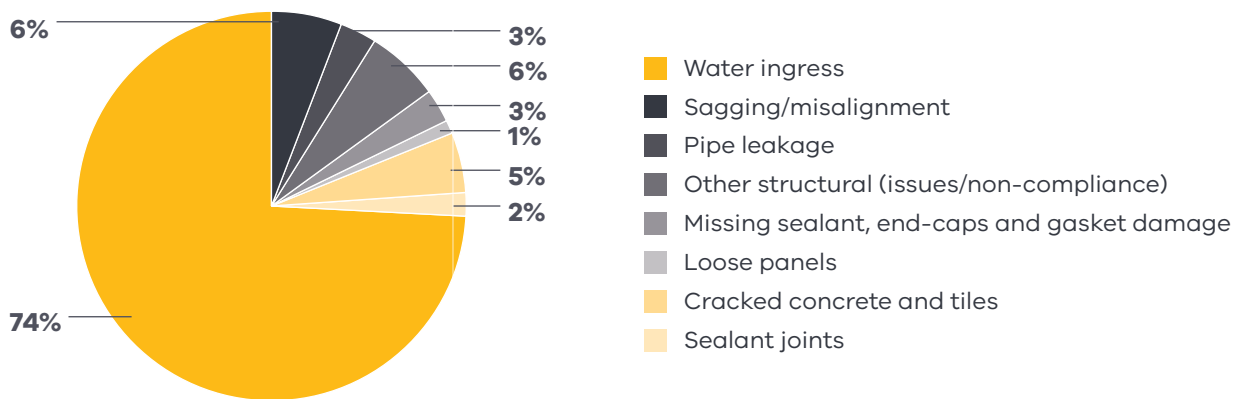
Figure 2 reveals that of the 175 buildings where CSV has been able to assess the cause of the defects (172 in total), a significant number of buildings have balcony defects related to insufficient water proofing and improper drainage systems leading to water ingress issues.

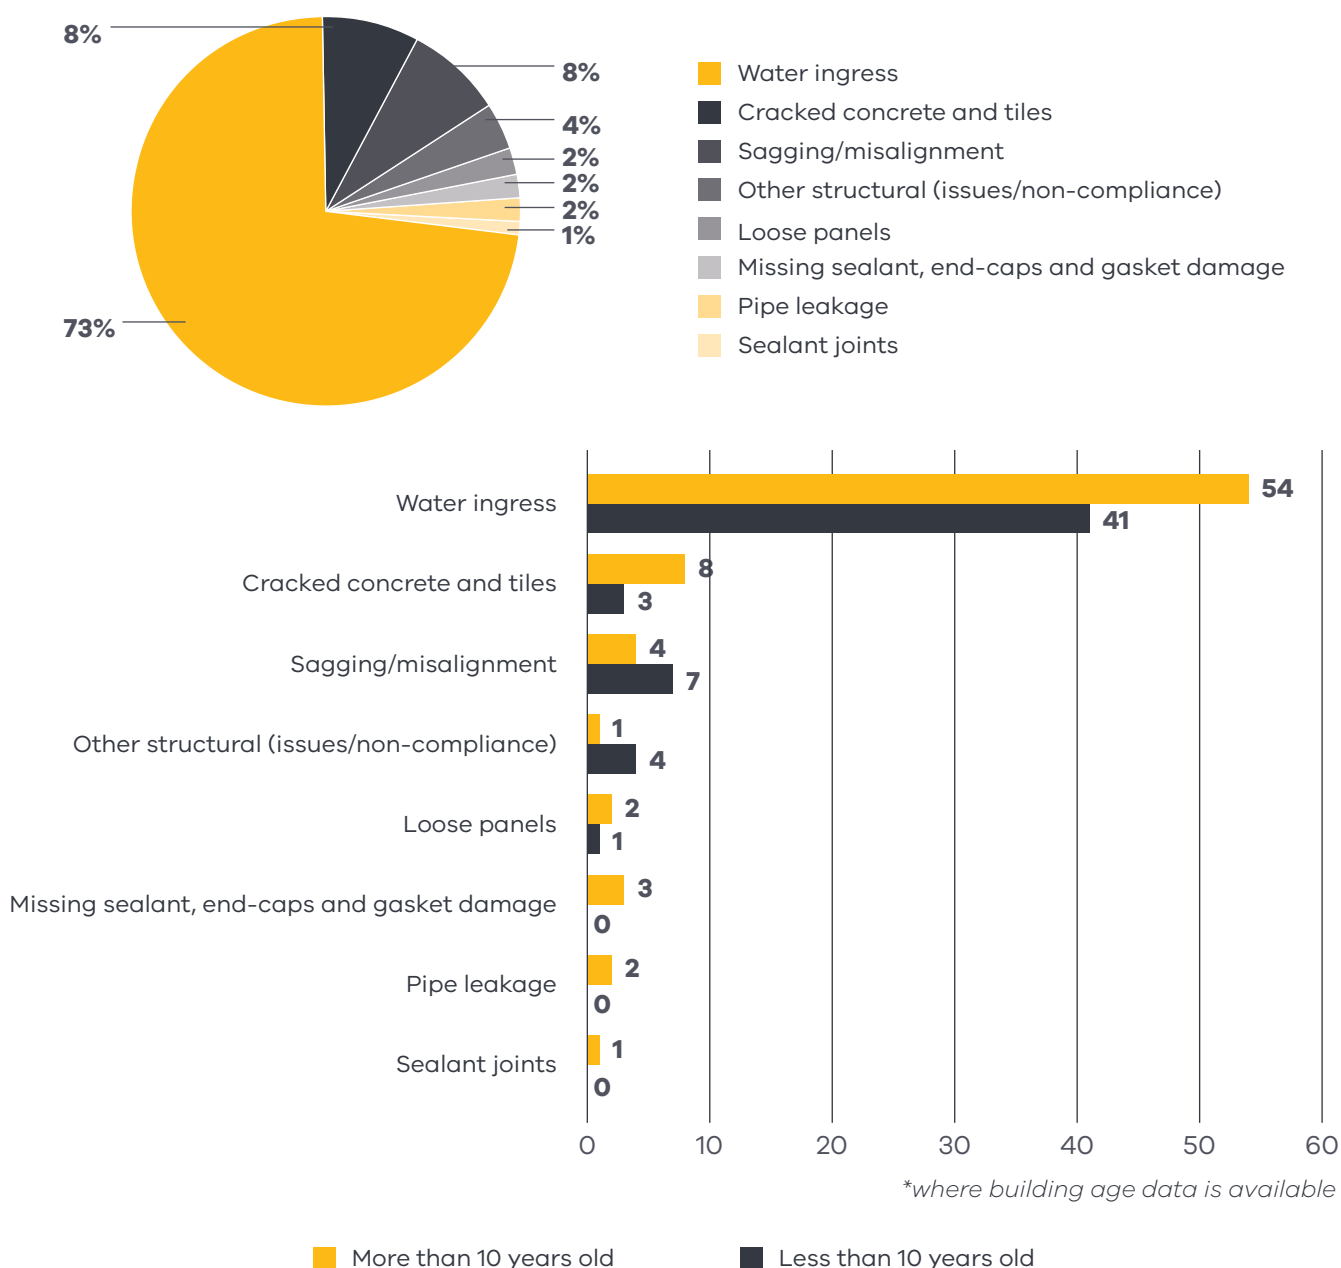
Figure 3. Example of water ingress affecting a balcony on a funded building in CSV's program (comprising 26 sole occupancy units)

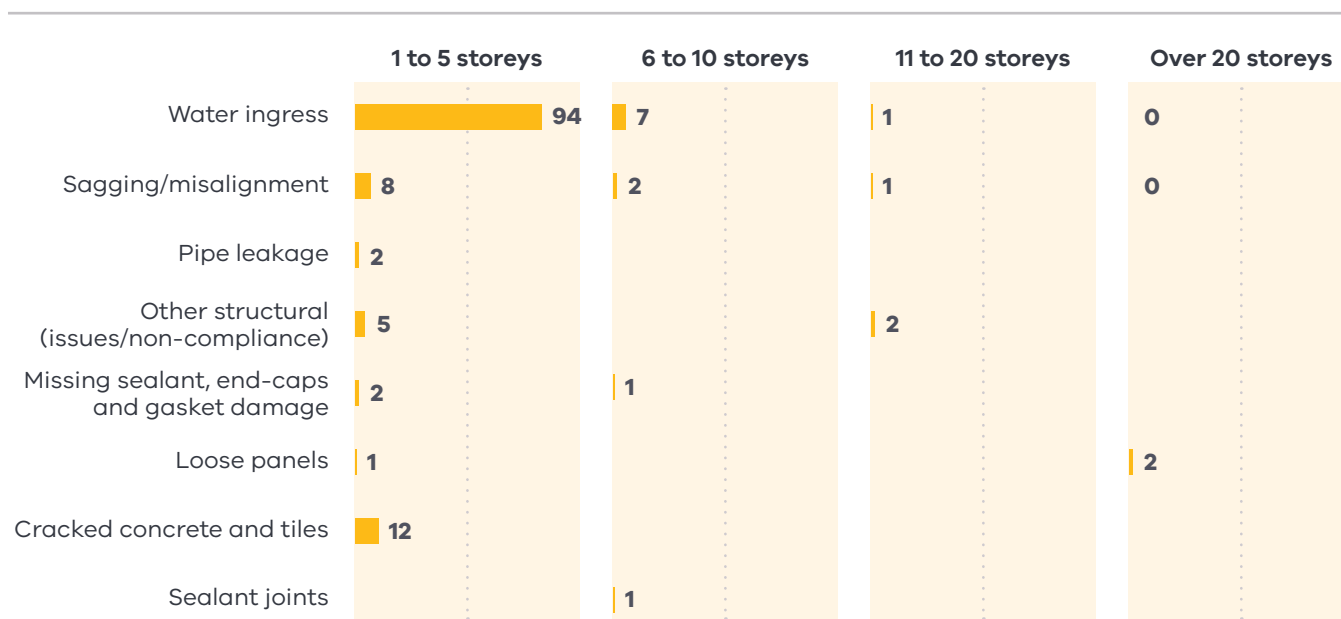
Figure 6. Example of insufficient or no waterproofing affecting a balustrade on a funded building in CSV's program (comprising 12 sole occupancy units)

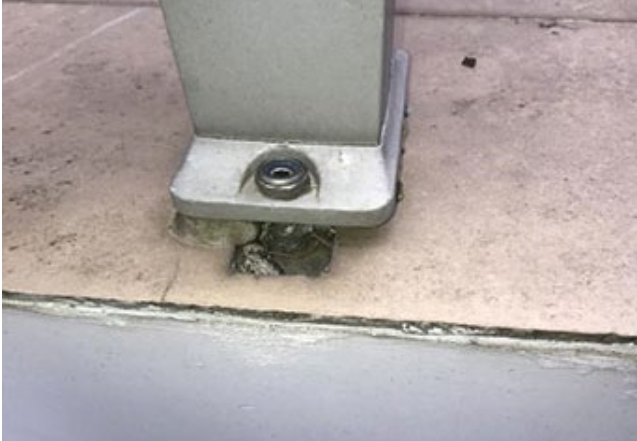
Improper water proofing around balustrade fixing providing areas for water ingress to structural elements.

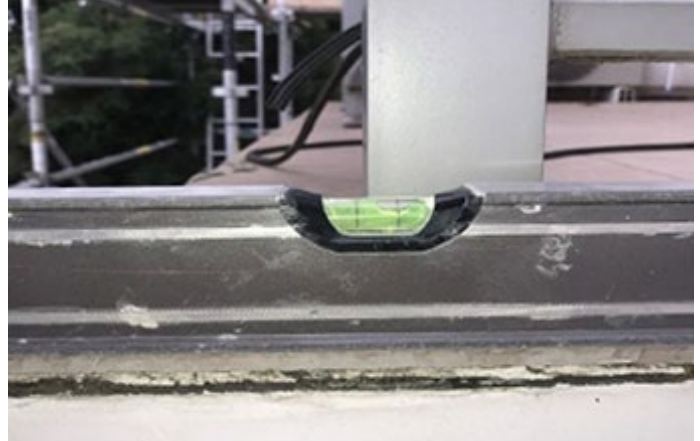
Balcony falling steeply away at edge.

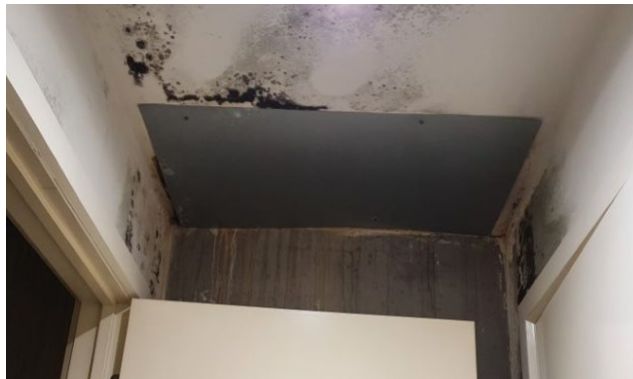
The presence of black mould on parts of the ceiling and walls in this apartment is extensive and widespread.

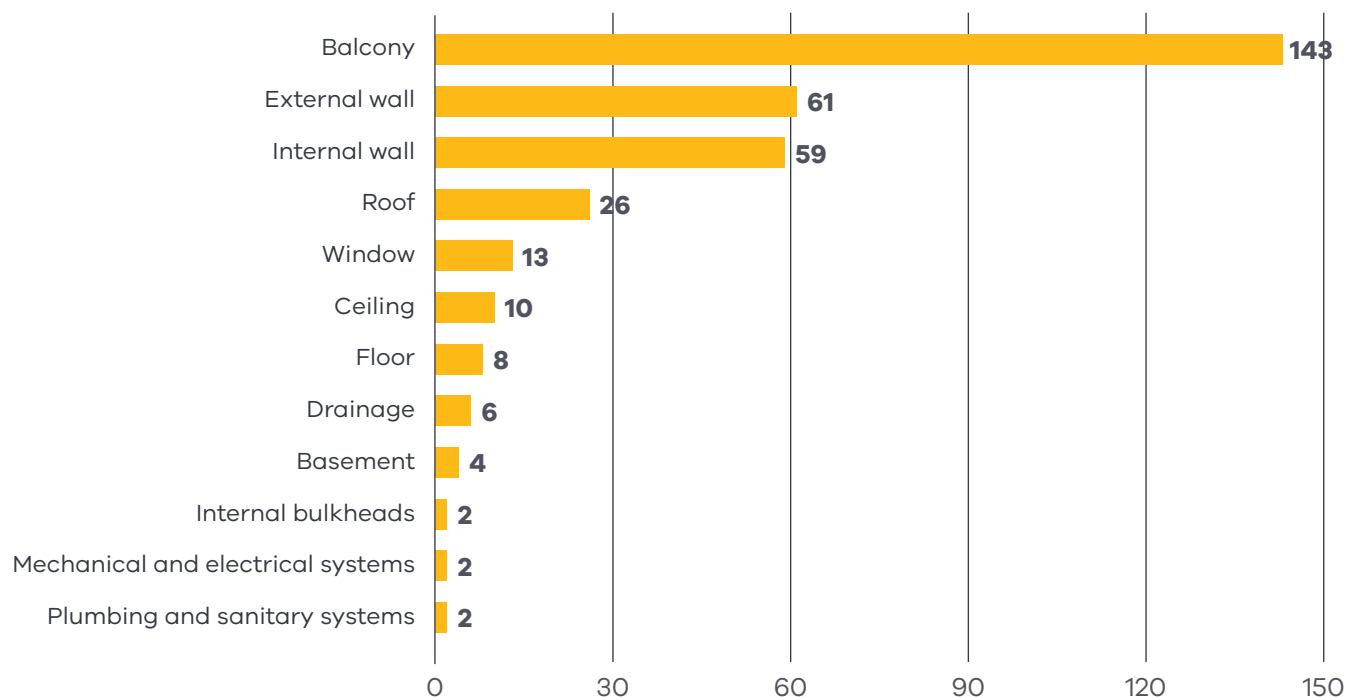
Figure 12. Examples of water ingress in a building in CSV's program

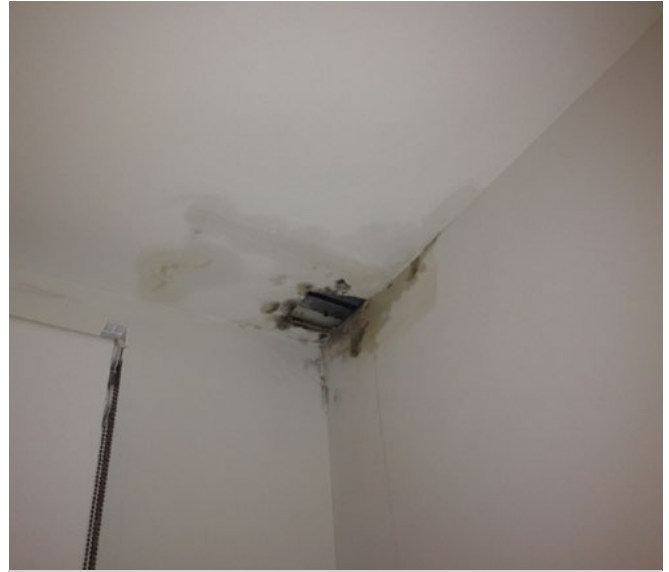
Moisture seeping through plaster walls.

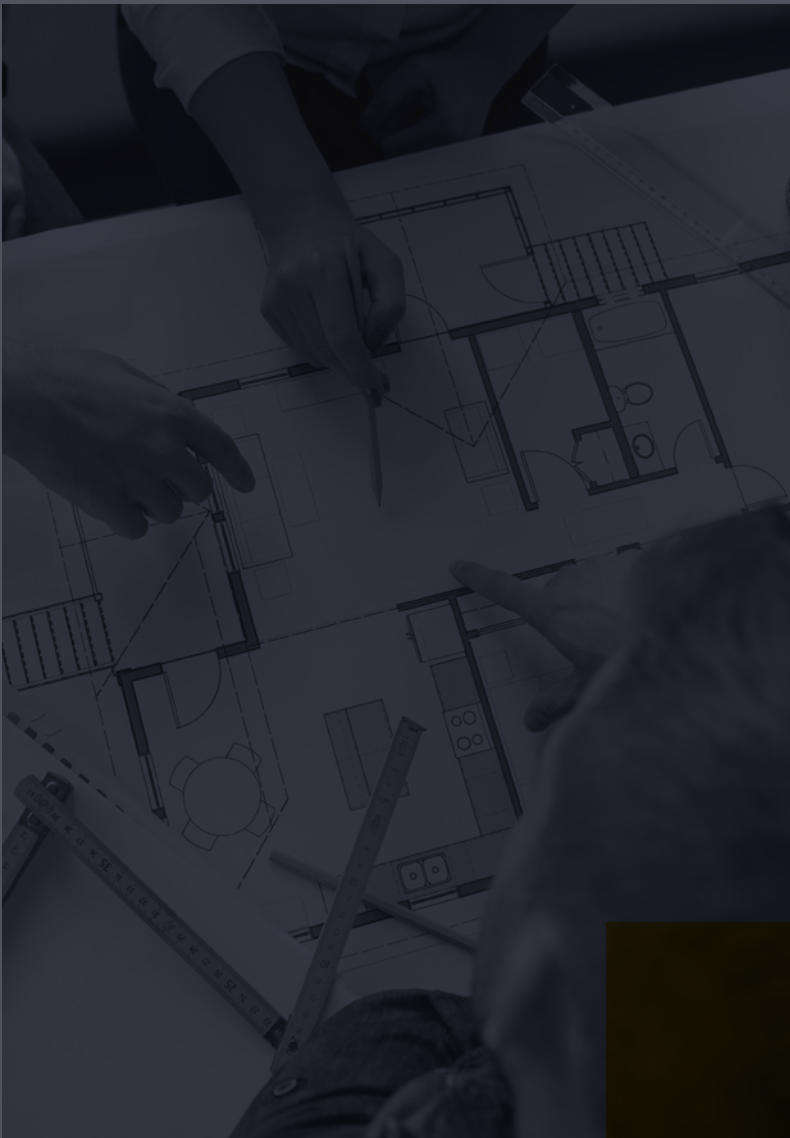
The safety risks to the community posed by building defects caused through poor design, construction or maintenance are considered as unacceptable and have led to fatal outcomes.

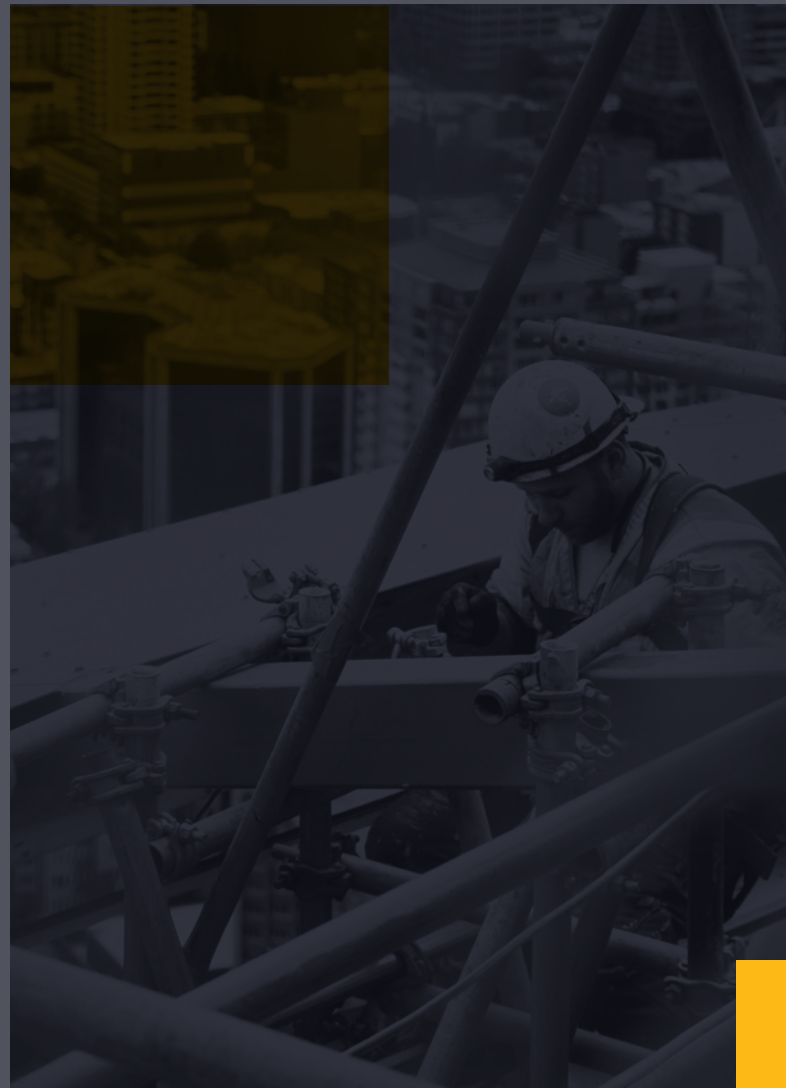
The following two case studies are derived from buildings referred to CSV's Cladding Rectification Program and provide indicative examples of the kinds of issues faced by CSV in addressing cladding on buildings where there are non-cladding defects identified.
