# CORROSION PROTECTION LININGS FOR THE STRATEGIC TUNNEL ENHANCEMENT PROGRAM, ABU DHABI

T. Krause <sup>1\*</sup>, S. Orakzai <sup>2</sup>, R. Marshall <sup>3</sup>, J. Sickling <sup>4</sup>

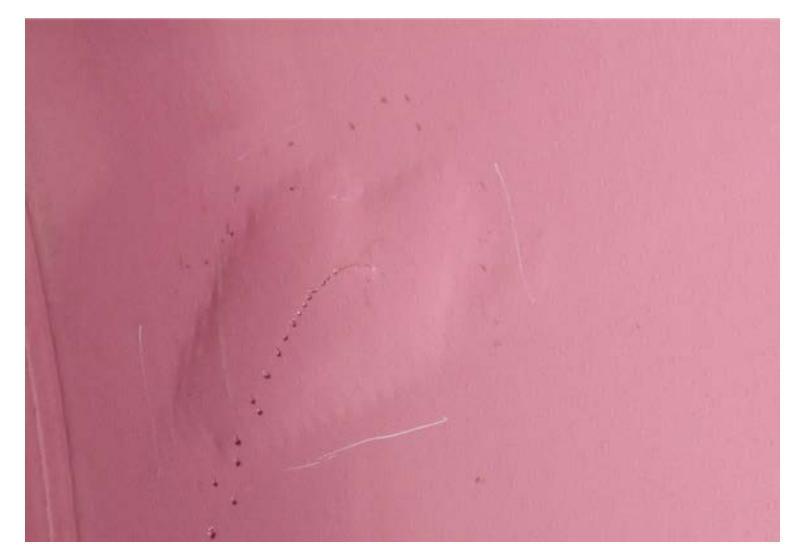
Figure 7. Typical Bulge Defect Being Drained for Repair

The defect of most concern that was encountered was the inward bulging of the anchored HDPE membranes, usually in isolated sections. The extent of the bulging ranged from 'fist sized' up to  $1.0 \text{ m}^2$ , but typically bulges were observed to be less than  $0.5 \text{ m}^2$ . Bulges were usually elliptical in shape, with the long axis parallel to the tunnel. Occasional observations showed bulges running diagonally along a linear feature, presumably an unintended cold joint in the secondary concrete. A typical bulge is shown in Figure 7.

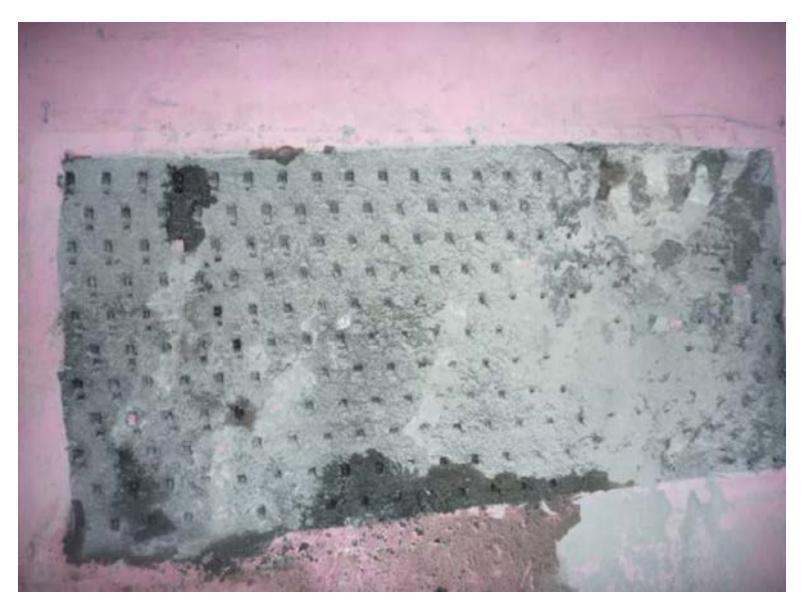
Figure 8. Typical Bulge Defect after Removal of HDPE

Upon cutting and removal of the HDPE membrane at bulges, it was observed that either the HDPE anchorages were not embedded into concrete (due to voids or honeycombing) or had pulled out of an aggregate-deficient cement paste without shearing the concrete, with a typical example of this latter situation shown in Figure 8. This zone was observed to be typically 10-20 mm deep, as schematically indicated in Figure 9.

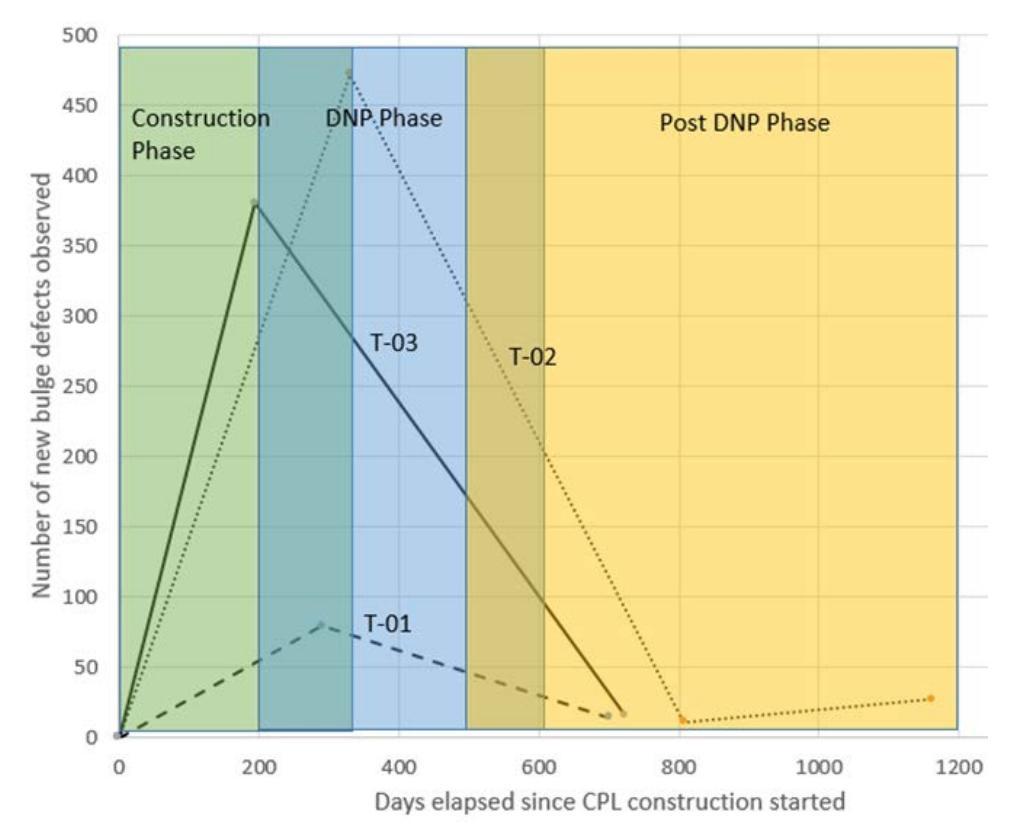
Figure 10. Graphical Summary of New Bulge Occurrence Over Time

Approximately four hotspots of concern were evident in Contracts T-02 and T-03, each approximately 110 m in length. In total this is 0.01 % on a lineal metre basis. These hotspots are further discussed below.

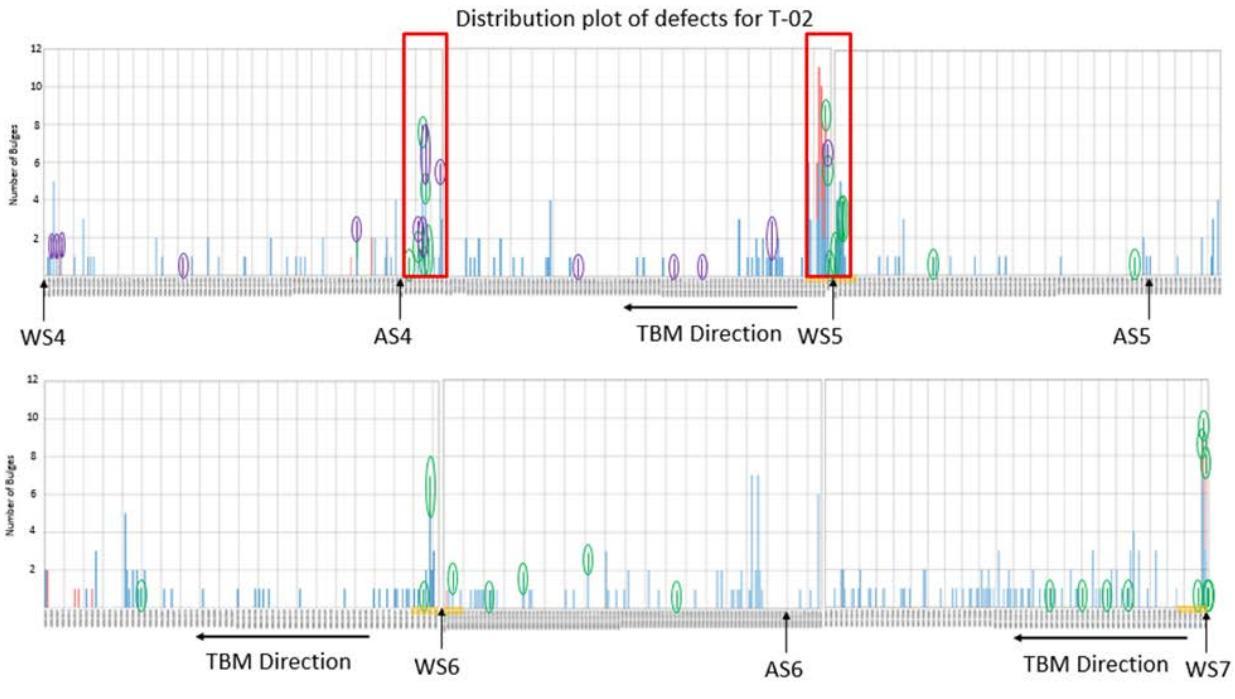
Figure 11. Contract T-02 Hotspots (highlighted in red)

• Hotspots tend to be associated with the launch and backshunt/reception tunnels. In these areas, the permanent structural lining was provided by cast-in-place concrete cast integrally with the CPL secondary concrete and liner. These areas were heavily reinforced, as compared to the TBM tunnel sections (supported by precast segmental lining) for which the secondary concrete was unreinforced. Quality observations indicated that concrete placement in and around the reinforcement was problematic, whether due to placement, compaction, or close spacing of reinforcement, or a combination of the preceding factors.

• A hotspot is evident immediately downstream of Access Shaft AS4. This location coincides with the 'learning curve' area for the first CPL installation on Contract T-02 in the Work Shaft WS4-WS5 section.
