Geotechnical Stability of Waste Fills: Lessons Learned and Continuing Challenges

Rudolph Bonaparte, F.ASCE¹; Robert C. Bachus, M.ASCE²; and Beth A. Gross, F.ASCE³

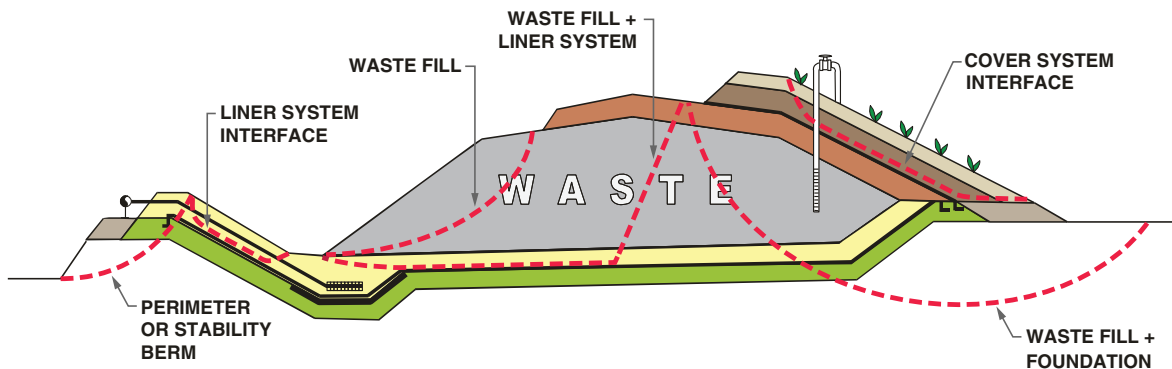
Fig. 1. (Color) Typical configuration of modern US landfill showing potential waste fill stability failure modes.

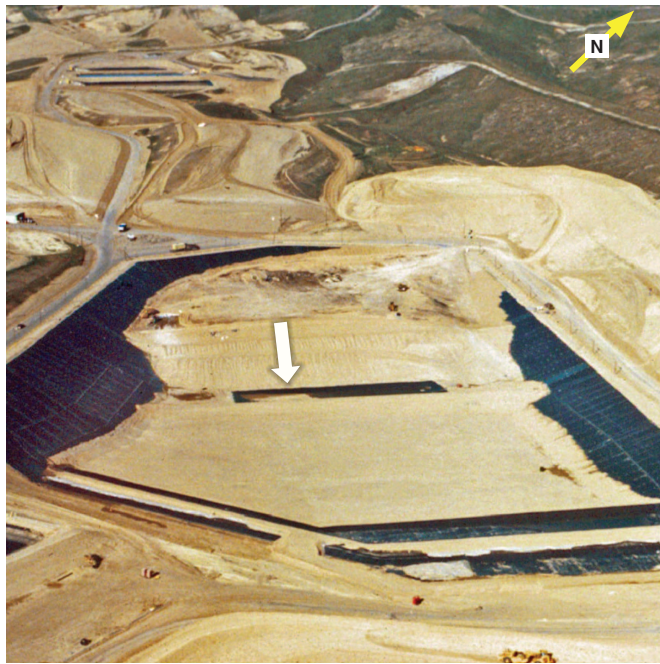
Fig. 2. (Color) Aerial view of Kettleman Hills Landfill Unit B-19, Phase 1A, showing the interim waste configuration prior to failure and the direction of waste movement (arrow). (Reproduced from Mitchell et al. 1990a, © ASCE.)

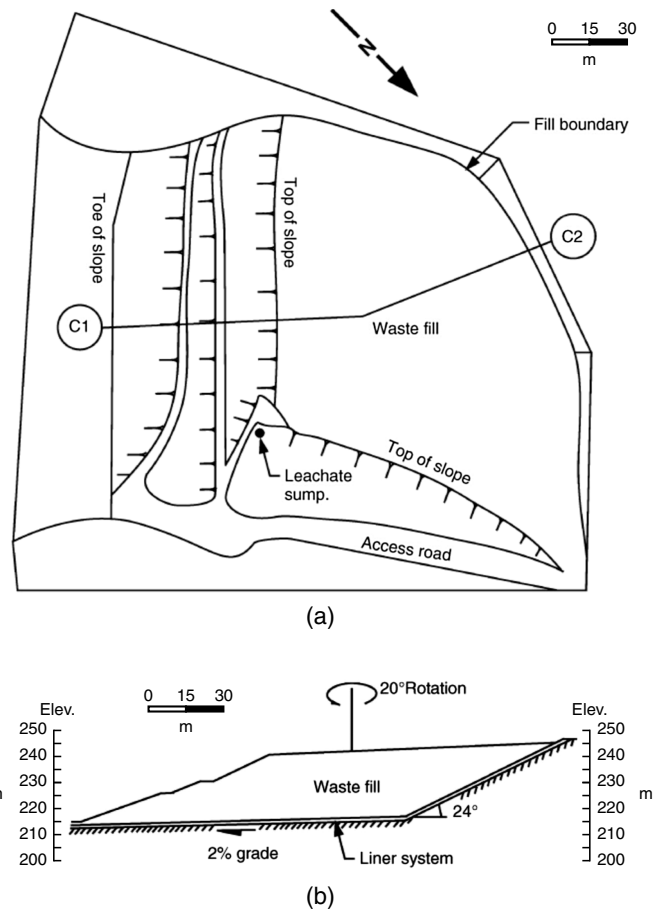
Fig. 3. (a) Preslide topography; and (b) cross section, Kettleman Hills Landfill Unit B-19, Phase 1A. (Reproduced from Mitchell et al. 1990a, © ASCE.)

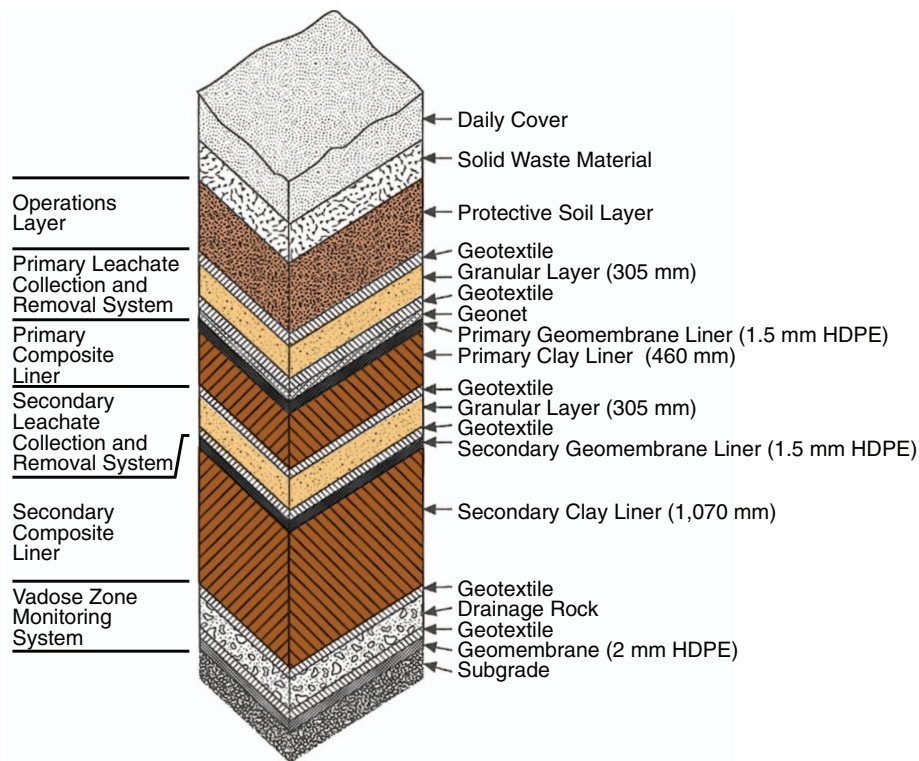
Fig. 4. (Color) Double-composite liner system for base portion of Kettleman Hills Landfill Unit B-19, Phase 1A. On the sideslope, primary CCL thinned out, a geonet was used for the primary and secondary LCRSs, and a vadose zone monitoring system was absent. (Adapted from Byrne et al. 1992)

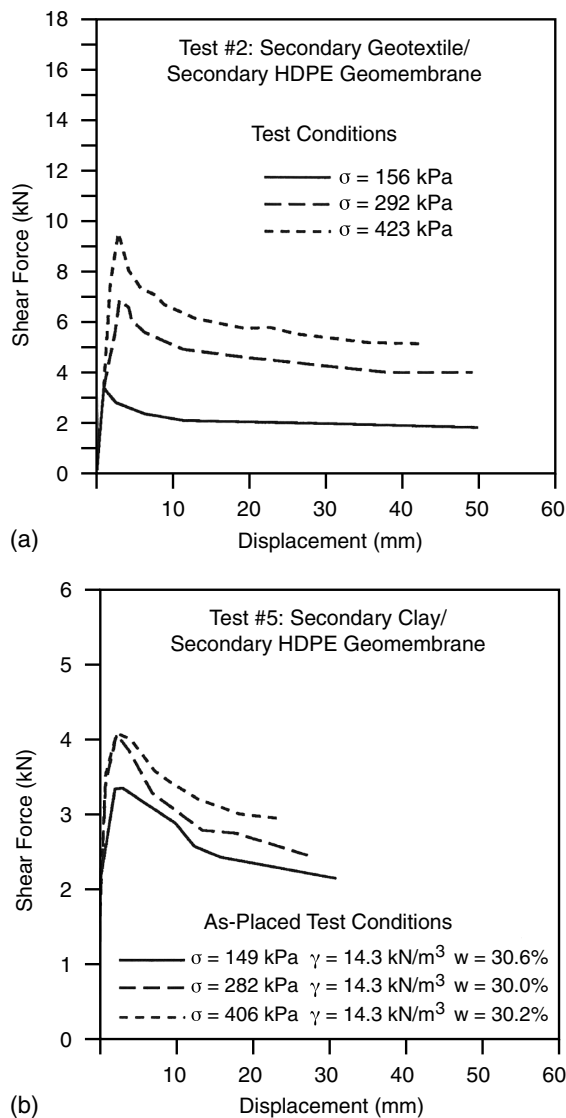
Fig. 6. Representative interface direct shear test results for Kettleman Hills Landfill Unit B-19, Phase 1A. (Reproduced from Geosyntec 1991, with permission from Waste Management, Inc.)

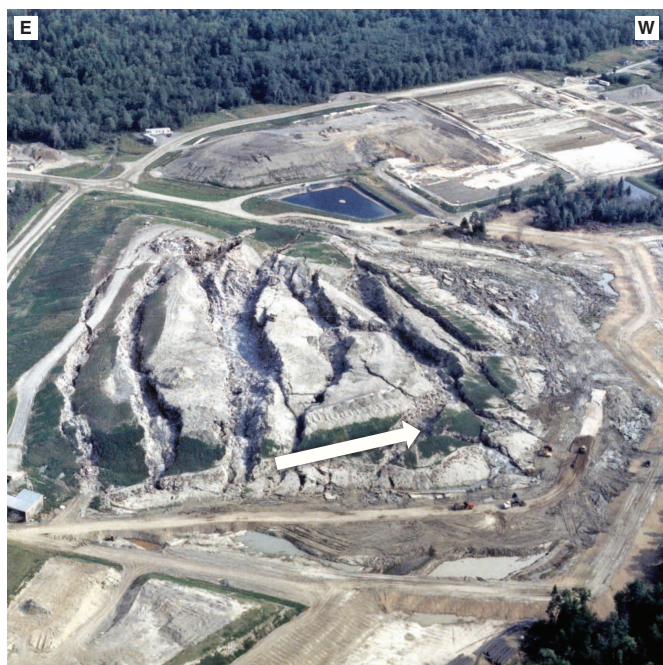
Fig. 7. (Color) Aerial view of 1989 failure of Crossroads Landfill caused by west–east retrogressive foundation failure; arrow shows direction of waste movement. (Reproduced from Luetlich et al. 2015, with permission of University of Maine.)

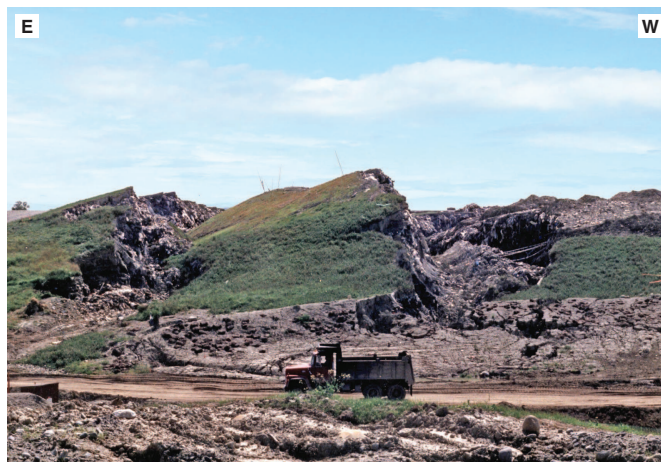
Fig. 8. (Color) Close-up view of Crossroads Landfill failure showing intact waste blocks and scarps caused by retrogressive foundation failure. (Reproduced from Luetlich et al. 2015, with permission of University of Maine)

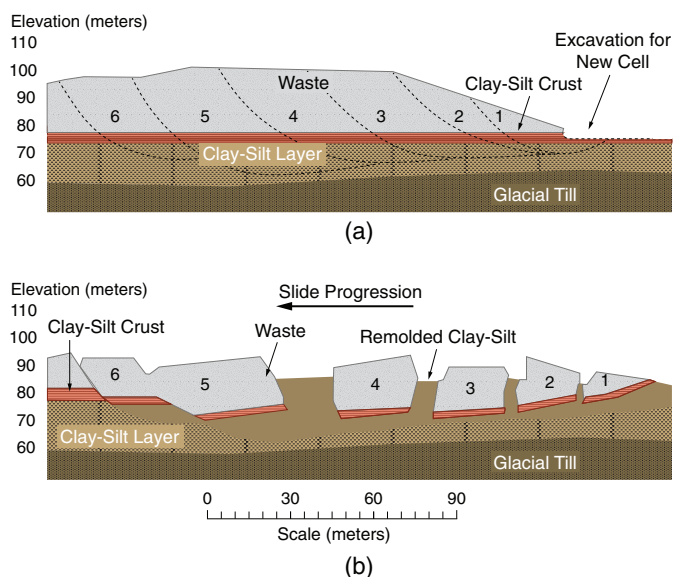
Fig. 9. (Color) Crossroads Landfill: (a) condition prior to failure showing overconsolidated clay-silt crust transitioning to underlying normally consolidated clay-silt layer and excavation of the crust at the western toe; and (b) condition after failure with intact MSW blocks and crust material displaced on the remolded clay-silt layer. (Reproduced from Reynolds 2015, with permission of University of Maine.)

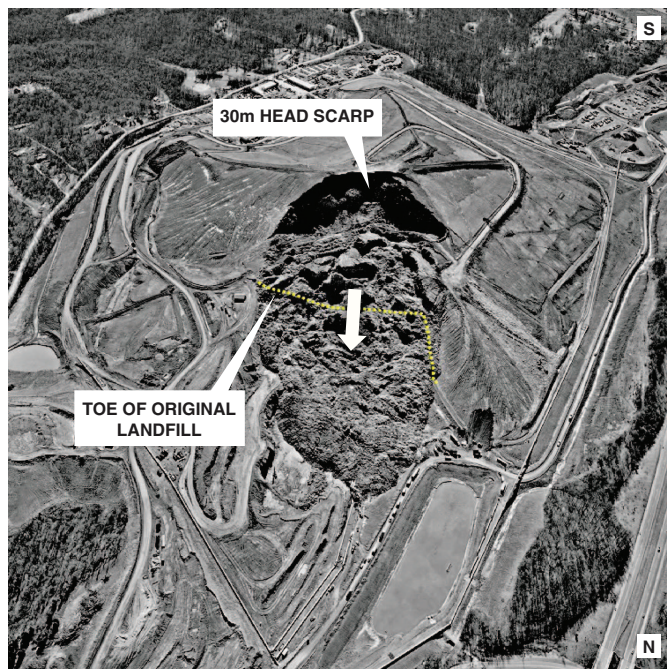
Fig. 10. (Color) Aerial postfailure view of Rumpke Landfill landslide; arrow shows direction of waste movement. (Reproduced from Stark et al. 2000, © ASCE.)

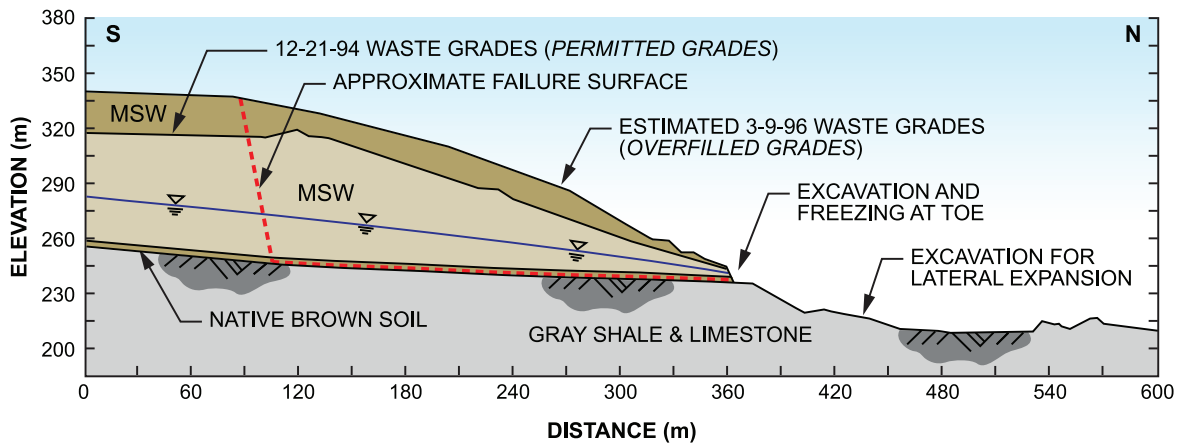
Fig. 12. (Color) Idealized, representative cross section through Rumpke Landfill showing prefailure geometry, extent of overfilling, and location of failure surface. (Adapted from Stark et al. 2000.)

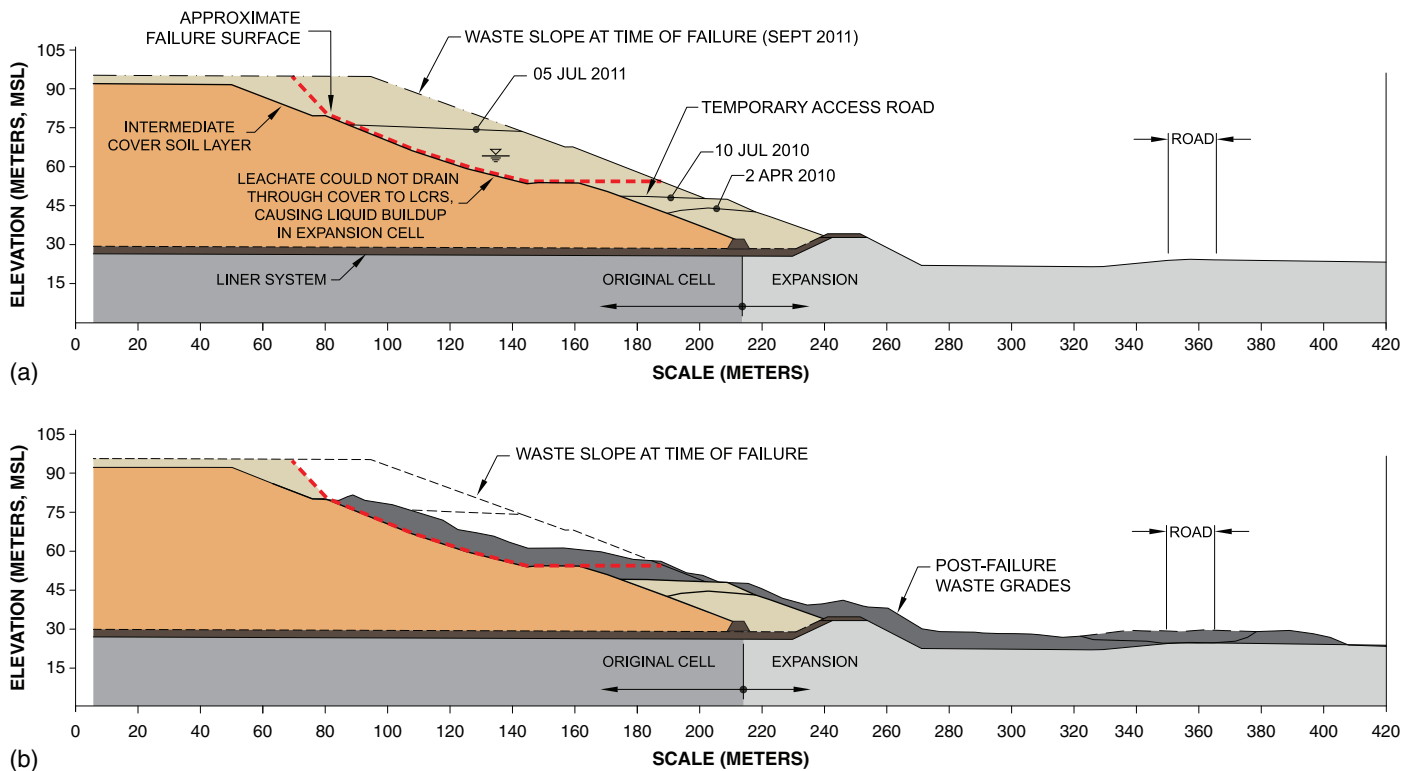
Fig. 13. (Color) (a) Prefailure; and (b) postfailure conditions for representative cross section through confidential eastern US MSW landfill. (Reproduced with permission.)

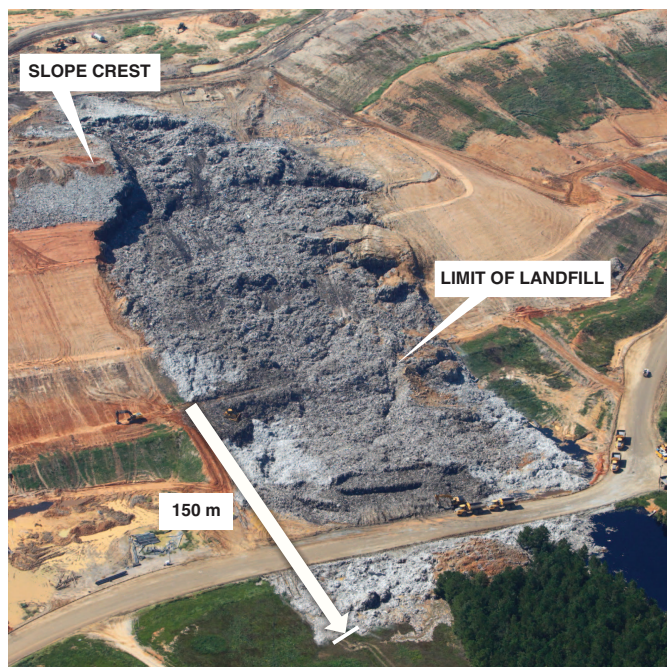
Fig. 14. (Color) Aerial view of landslide at confidential eastern US MSW landfill showing 150-m waste flow beyond landfill limit (from project files). (Reproduced with permission.)

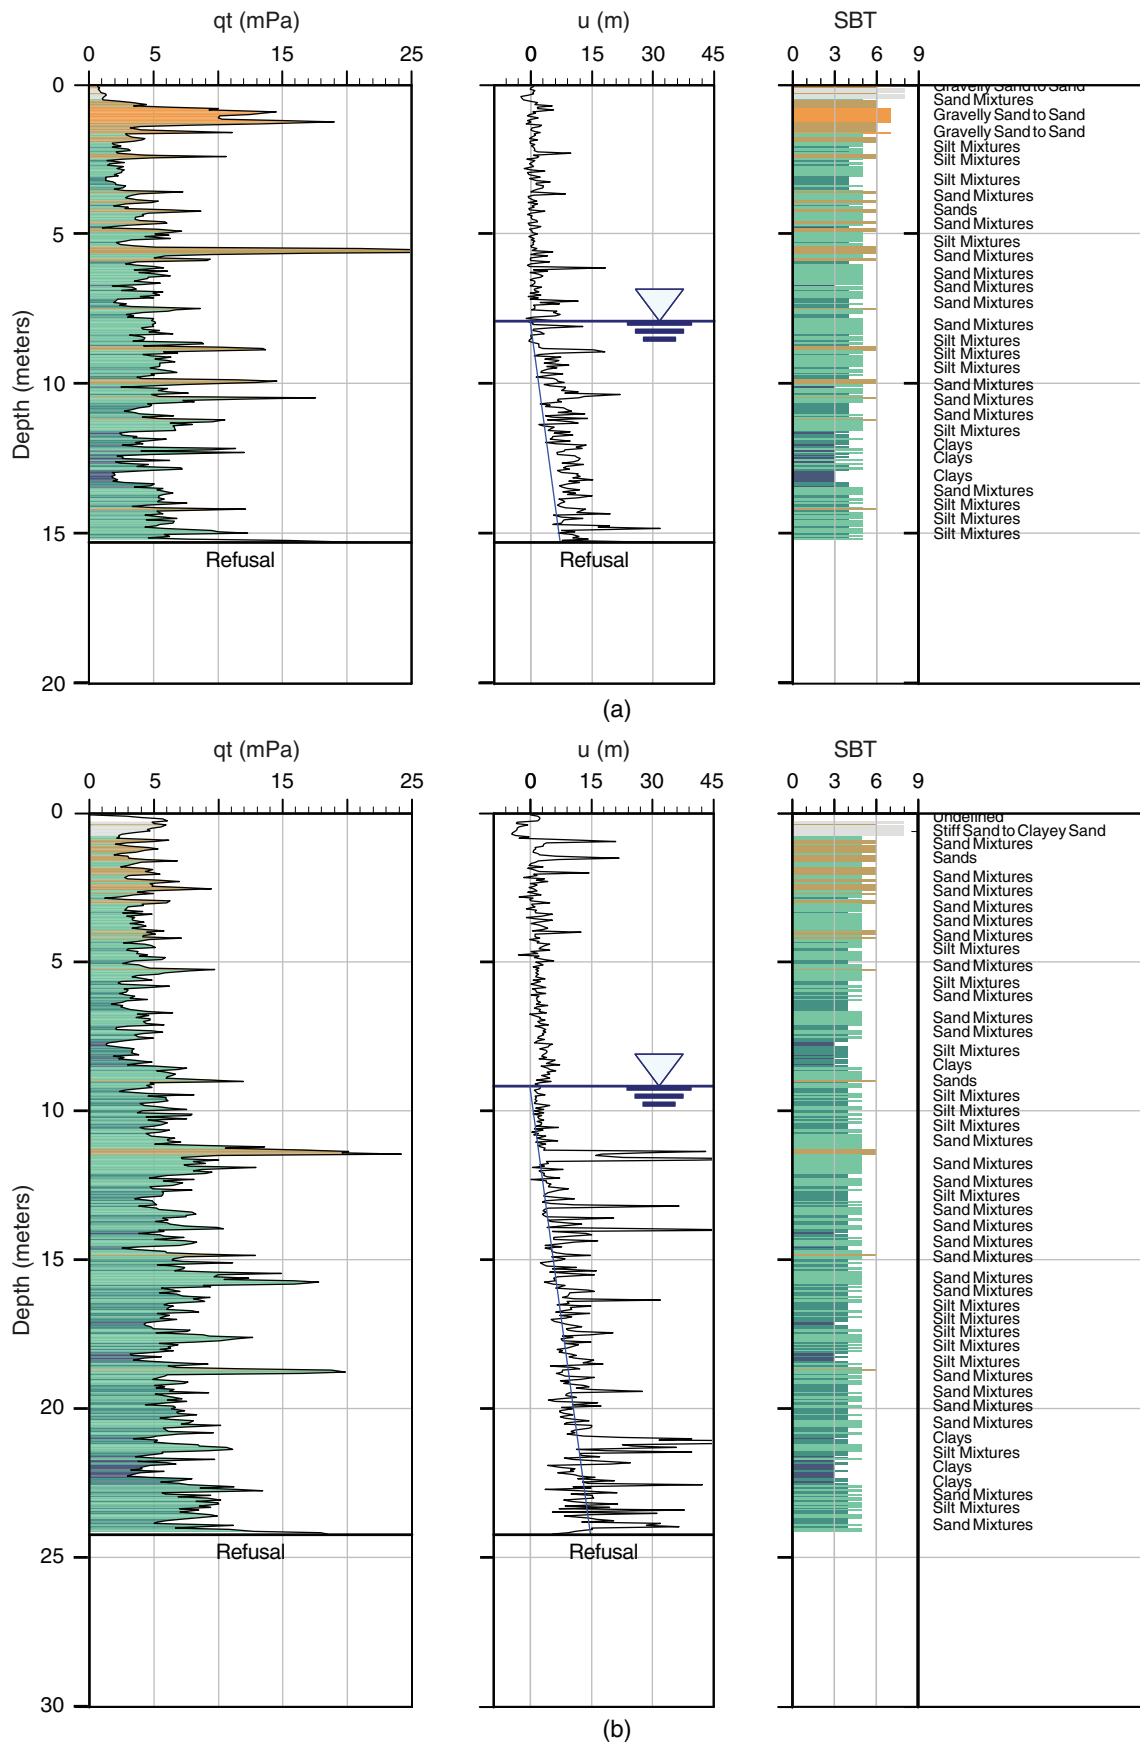
Fig. 16. (Color) Representative CPTu logs for areas adjacent to the slide zone: (a) midslope location; and (b) head scarp regions (from project files). (Reproduced with permission.)

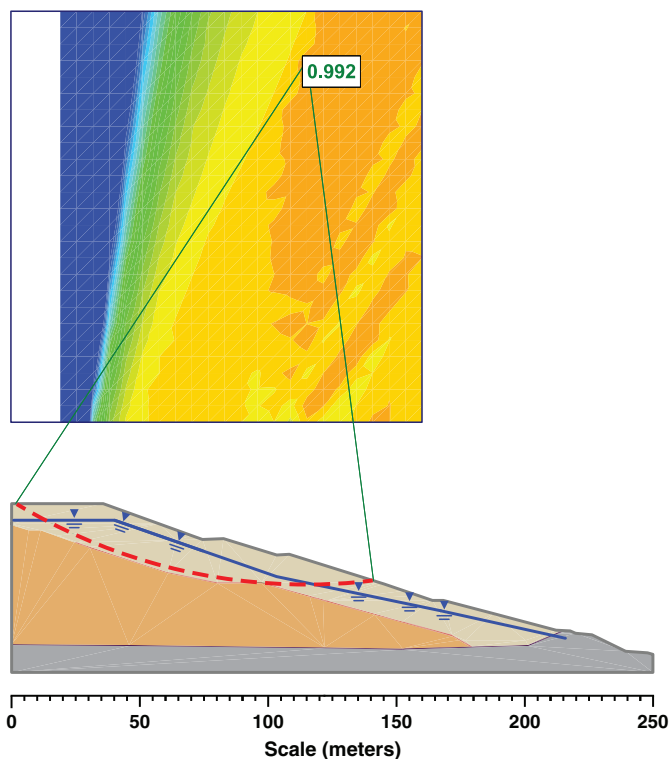
Fig. 17. (Color) Slope stability back analysis to investigate average operative shear strength of in-place MSW–sludge mixture at the time of failure (from project files). (Reproduced with permission.)

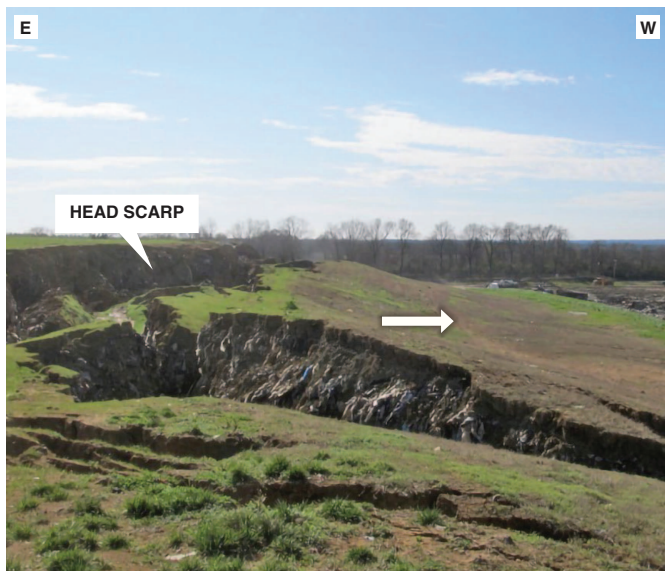
Fig. 18. (Color) Slope failure at confidential southern US MSW landfill; translational movement was from east to west (photo from project files, taken on February 7, 2012). (Reproduced with permission.)

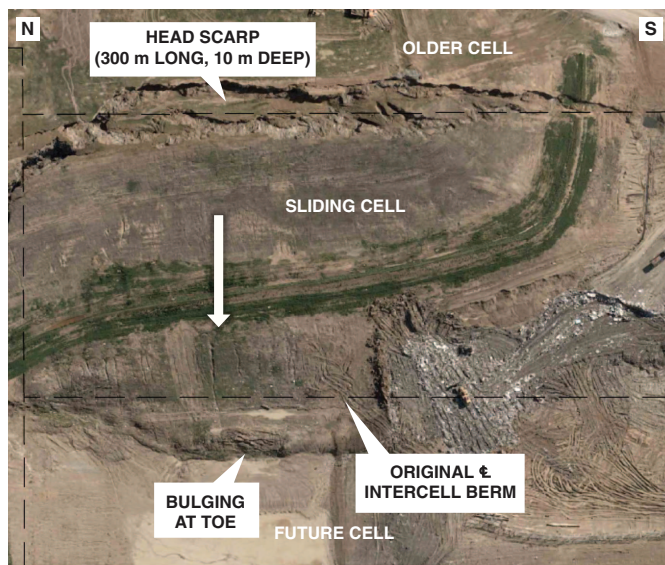
Fig. 19. (Color) Aerial view of confidential southern US MSW landfill showing several features of the waste fill slide; construction equipment at intercell berm provides sense of scale (photo from project files, taken on February 9, 2012). (Reproduced with permission.)

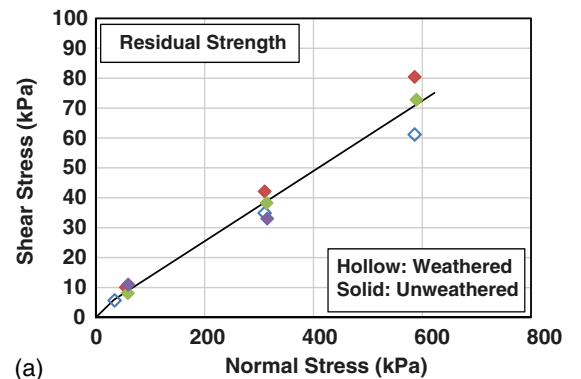
(a) **Residual Strength**
 ◆ TRS (SB-1 ST-4) RESIDUAL ◆ TRS (SB-1 ST-10) RESIDUAL
 ◆ TRS (SB-1 ST-11) RESIDUAL ◆ TRS (SB-1 ST-7) RESIDUAL
 — Design Fit

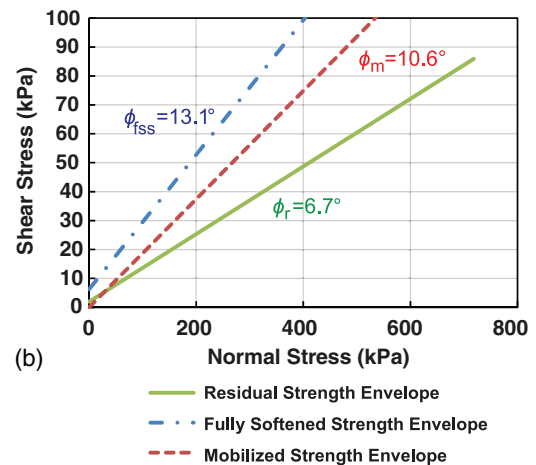
(b) **Native clay strengths** at confidential southern US MSW landfill: (a) residual strengths obtained from torsional ring shear (TRS) testing; and (b) residual (ϕ_r) and fully softened (ϕ_{fss}) shear strength envelopes from testing along with mobilized shear strength (ϕ_m) at incipient failure obtained from back analyses (from project files). (Reproduced with permission.)

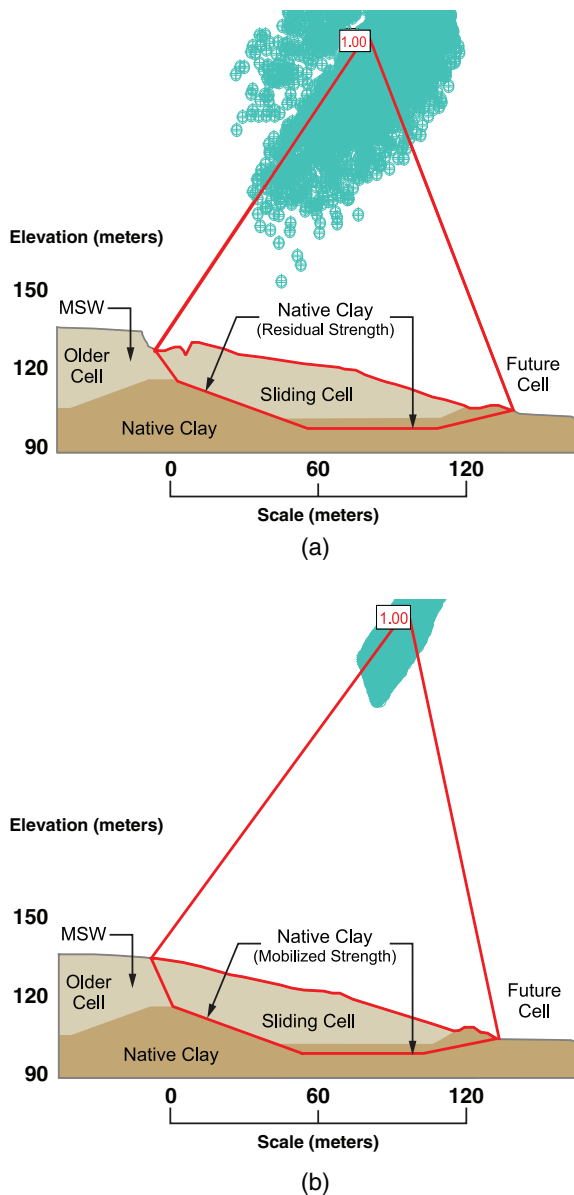
Fig. 21. (Color) Results of back analyses: (a) analysis using postfailure slope geometry and residual strength to obtain average operative pore pressure coefficient (r_u) along slip surface; and (b) analysis using prefailure geometry and average operative r_u to estimate the average mobilized shear strength at incipient failure (from project files). (Reproduced with permission.)

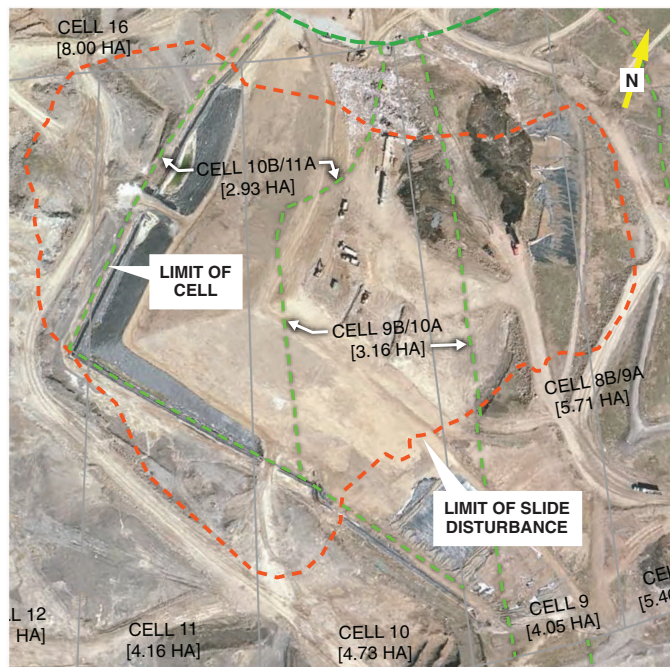
Fig. 22. (Color) Close-up view of confidential northeast US MSW landfill Cell 10B/11A prior to failure (April 2016) showing wedge-shaped slope face; note, light gray lines represent “as-designed” cell boundaries and green dashed lines represent “as-constructed” cell boundaries (from project files). (Reproduced with permission from Geosyntec Consultants, Inc.)

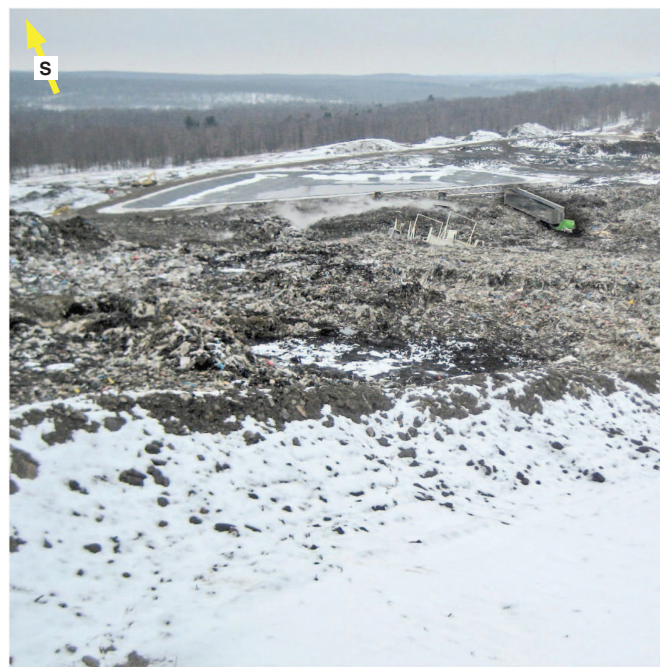
Fig. 23. (Color) Postfailure condition of confidential northeast US MSW landfill Cell 10B/11A, looking south; green truck cab in upper right portion of photo provides sense of scale (photo from project files, taken March 20, 2017). (Image by David J. Bonnett, reproduced with permission from Geosyntec Consultants, Inc.)

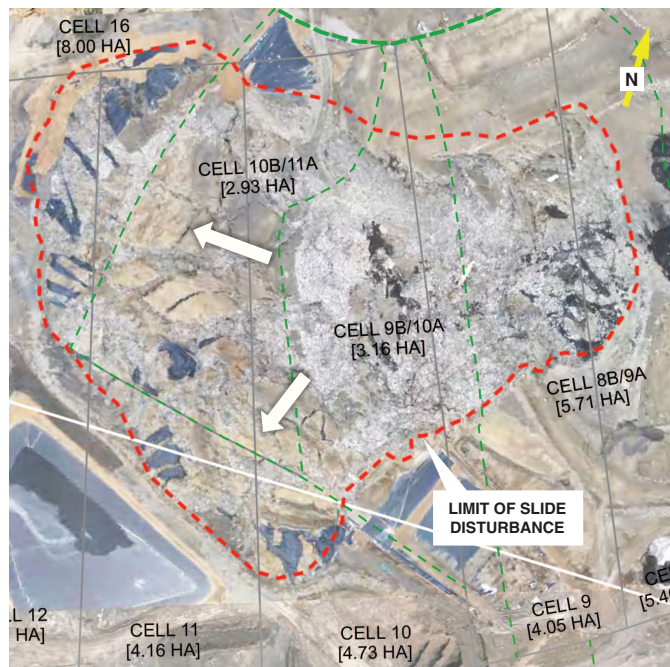
Fig. 24. (Color) Aerial view of confidential northeast US MSW landfill showing waste fill slide area and cell configurations (from project files). (Reproduced with permission from Geosyntec Consultants, Inc.)

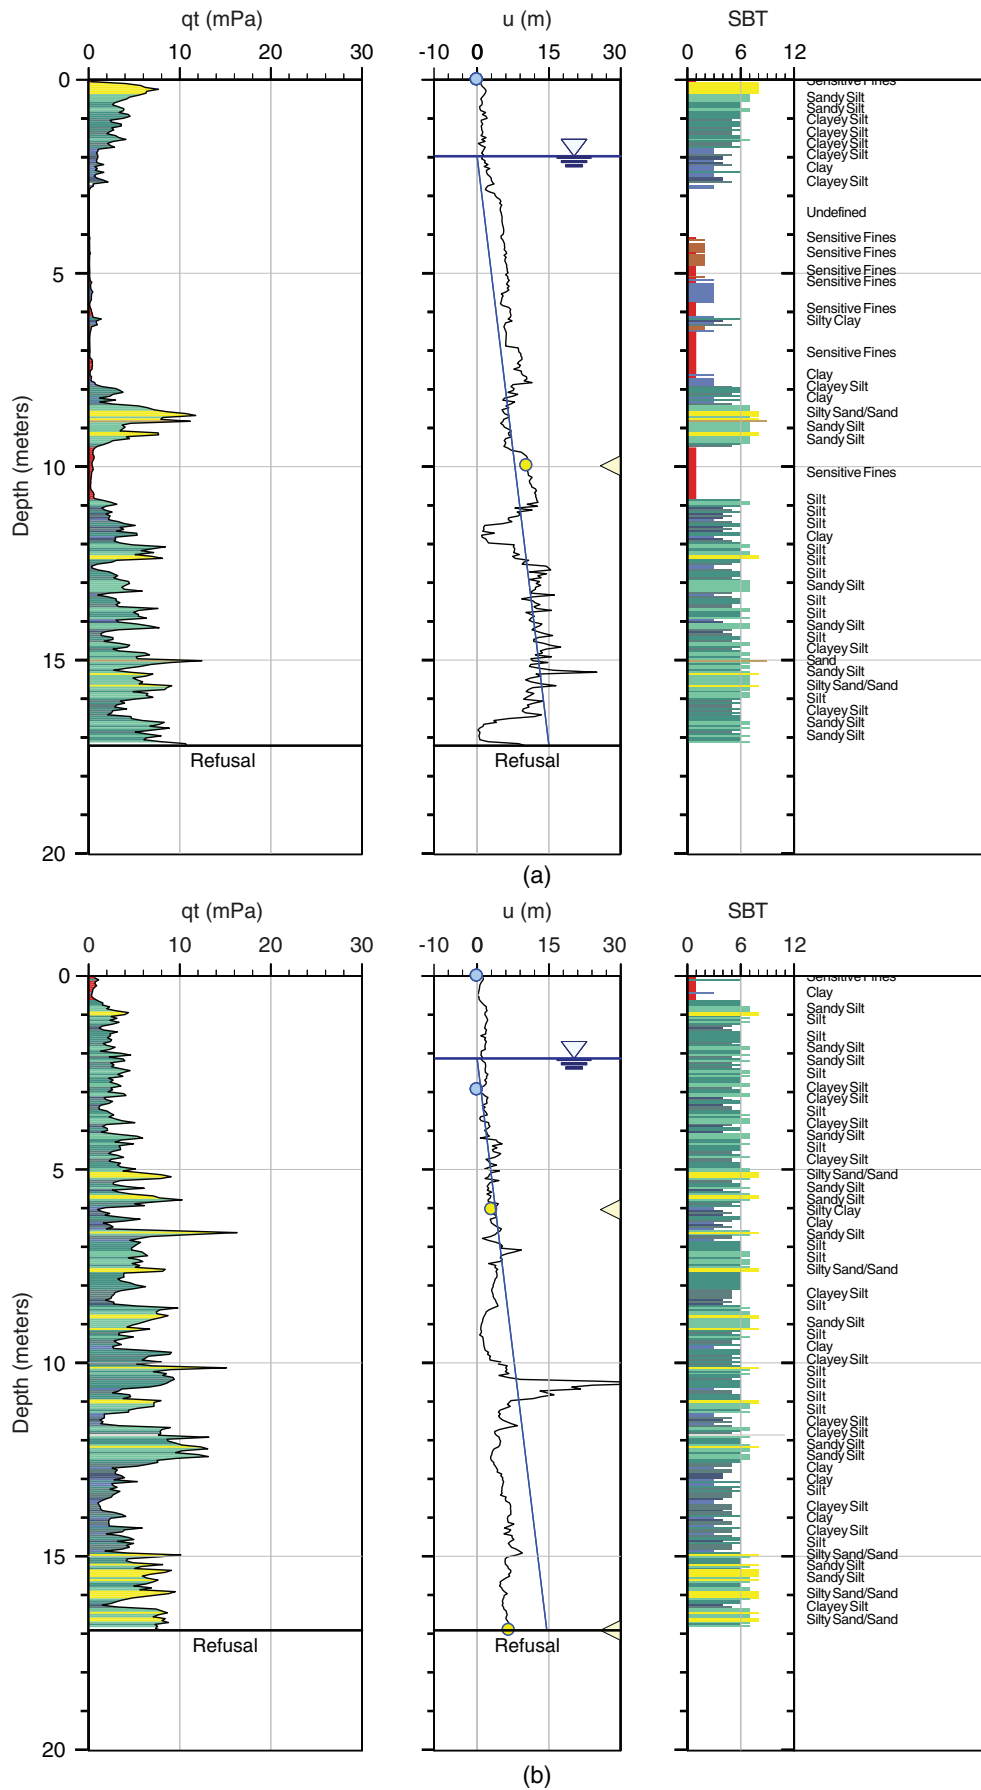
Fig. 25. (Color) Representative CPTu logs for areas within the slide zone: (a) midslide showing substantial amounts of LSSW; and (b) top of slide showing relative absence of LSSW (from project files). (Reproduced with permission from Geosyntec Consultants, Inc.)

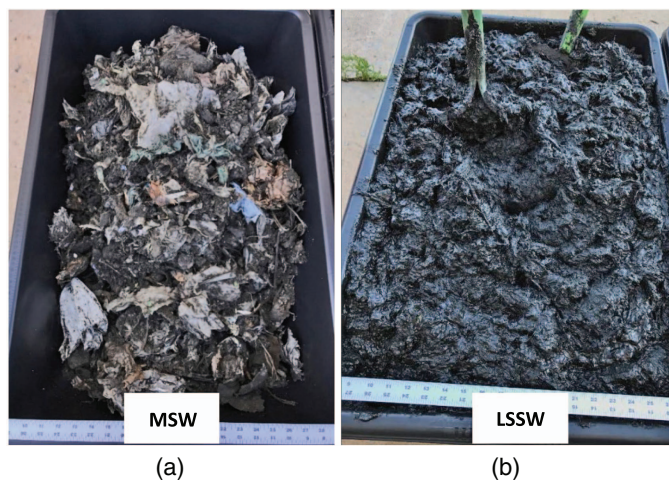
Fig. 26. (Color) Sampled waste materials from Greentree Landfill: (a) degraded MSW; and (b) LSSW. (Images by Craig Benson, with permission.)

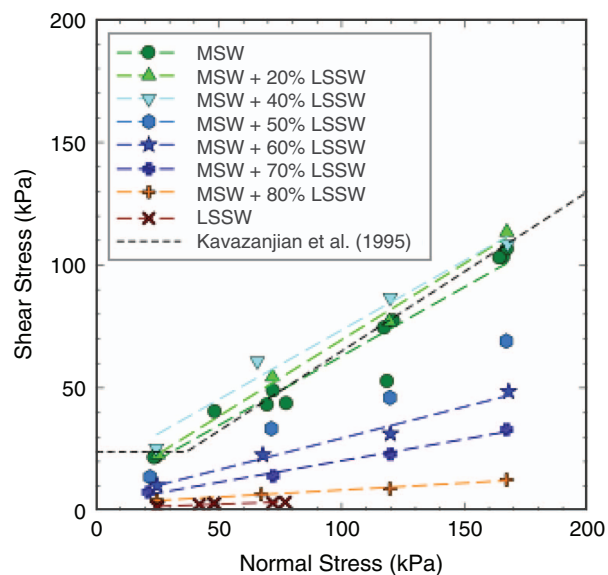
Fig. 27. (Color) Direct shear test results for MSW, LSSW, and mixtures (wet weight) of MSW and LSSW; testing conducted at Colorado State University. (Reproduced with permission from Geosyntec Consultants, Inc.)

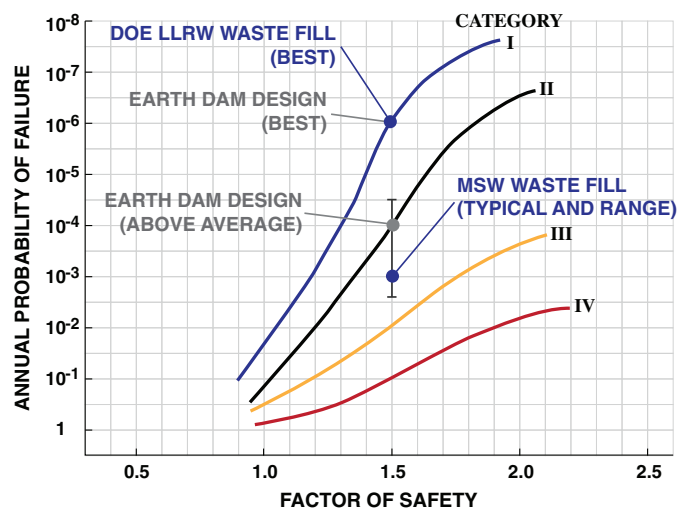
Fig. 28. (Color) Annual probability of failure versus factor of safety for categories of engineering: earth dam failure probabilities shown on plot are from Silva et al. (2008); waste fill failure probabilities are from the authors.
