Professional practice paper

Lessons learned from geotextile filter failures under challenging field conditions[☆]

Robert M. Koerner^{a, b, *}, George R. Koerner^b^a Drexel University, USA^b Geosynthetic Institute, 475 Kedron Avenue, Folsom, PA 19033, USA

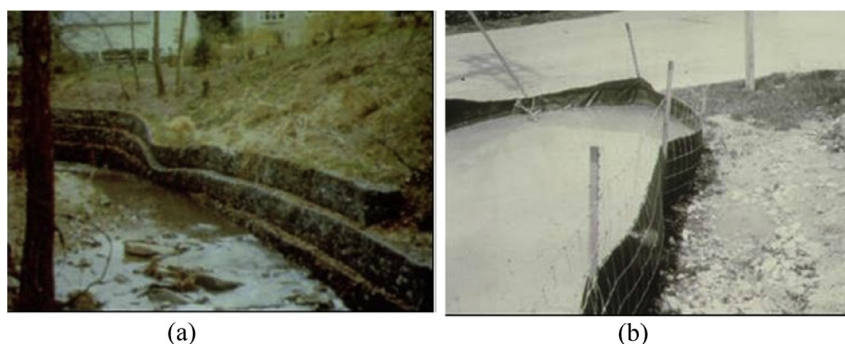
Poor fabric selection has been the cause of at least one failure evaluated by the authors. It was the filter used behind a small gabion

wall as seen in Fig. 2a. In this case the geotextile selected was a woven slit film type, recall Fig. 1a, which has poor control over its opening size due to nonbonding of its intersecting fibers. Data from the 2014 proficiency testing program of the Geosynthetic Accreditation Institute's-Laboratory Accreditation Program (GAI-LAP) shows that the statistical coefficient of variation (c_v) is 33% for the permittivity of this type of geotextile (mean value is 0.21 s^{-1} and standard deviation is 0.07 s^{-1}). This relatively high value was the average of twenty participating geosynthetic testing laboratories. Note that at the minimum (e.g., $\mu - 3\sigma$), the permittivity is negligible and, as such, this type of fabric is often used as a silt fence (thereby trapping turbid water to form a small dam) as shown in Fig. 2b. The *lesson learned* in this regard is one of poor fabric selection highlighted by the use of woven slit film fabrics which should not be used for critical filtration applications.

Fig. 2. Improper and proper use of woven silt film fabrics (GSI photos). (a) Gabion wall failure, (b) Silt fence success.

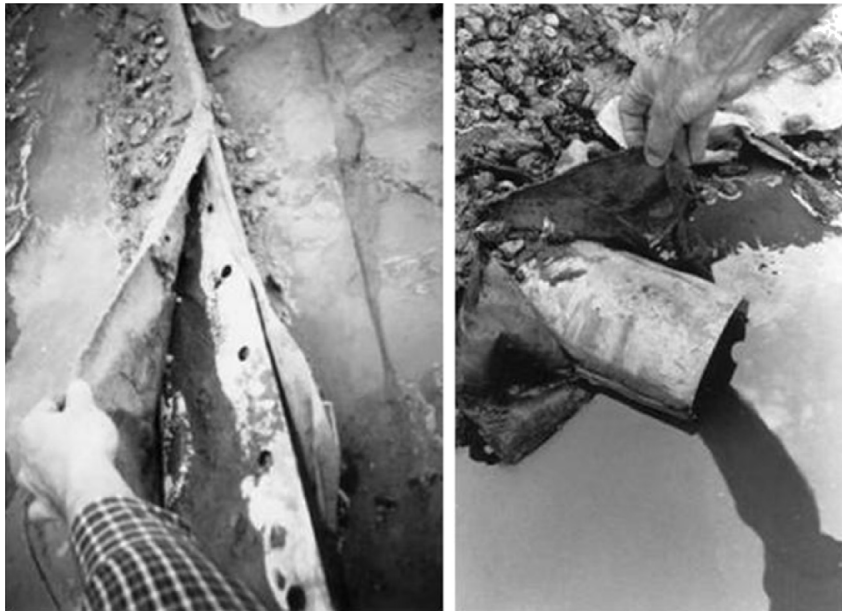
Geotextile wrapped drainage pipes have often failed when the pipe holes or slits are inadequate to accept the incoming flow. Fig. 4 shows a clogged drainage system which after being stripped of its geotextile filter, allowed the flow to readily pass. Designers must recognize that the flow rate factor-of-safety is greatly diminished by downstream drainage core or pipe restrictions. Koerner (1993) proposed the following modification to the conventional flow rate factor-of-safety formula:

Fig. 4. Geotextile wrapped perforated pipe failure (GSI photos).

- full footprint coverage; DCF = 1.0, i.e., there is no adverse effect
- geotextile wrapped gravel encapsulating drainage pipe; DCF = 10–40
- geotextile covered geonets and geocomposites; DCF = 10–50
- geotextile wrapped corrugated drainage pipe; DCF = 60–260
- geotextile wrapped solid perforated drainage pipe (as in Fig. 4), DCF = 7500–24,000

Because the DCF can vary widely for common engineering applications using geotextile filters, the selection of the site-specific value is a critical design feature. The *lesson learned* in this regard is that geotextile wrapped, or socked drainage pipe; should not be used particularly solid-wall (non-corrugated) drainage pipe due to extremely high drainage correction factors.

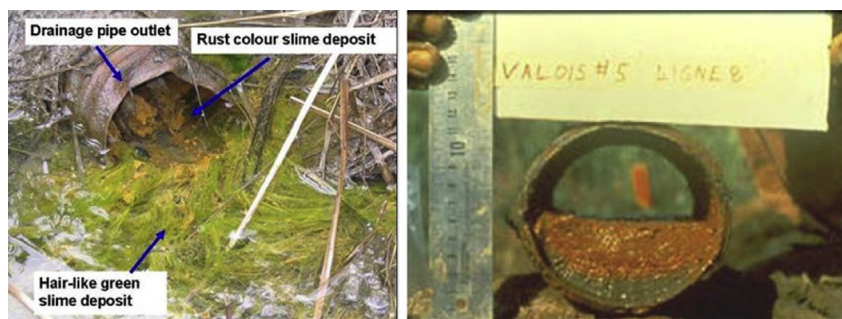
Ferrous iron laden soils leading to *ochre* has resulted in excessive clogging of filters (and to their downstream pipes) on numerous occasions. Ochre is an orange substance rich in organic matter and high concentration of iron oxides that is often found sticking to solid surfaces of many different drainage systems (Forrester, 1995). While ochre is not a soil, per se, it results from certain soil chemistry and is troublesome to say the least (Fig. 5).

Fig. 5. Ochre deposits around drainage pipes and filters.
After Mendonca and Ehrlich, 2008.

Cases of ochre formation in geotextiles are associated with deep horizontal drains (Ford, 1982), the drainage system of a dam (Scheurenberg, 1982), the drainage system of an earth dike (van Zanten and Thaket, 1982), agricultural drainage pipe in France (Puig et al., 1986), land drainage in Holland (Stuyt and Oosten, 1987), and an erosion control system in Germany (Abromeit, 2002). This latter case history described a needle punched nonwoven filter beneath a light armoring system on a tidal river. After eight years of service the geotextile was ochre-clogged reducing its flow capacity by 99.5% of the original. The *lesson learned* in this regard is that a major threat to geotextile filters, as well as with soil filters and all other components of drainage systems, is ferrous iron soils leading to the formation of *ochre*. If ochre cannot be avoided or remediated once it occurs both geosynthetic and natural drainage systems are likely to excessively clog. Laboratory testing in this regard is available and should be considered; see GRI-GT1, ASTM D5105, ASTM D5567 and ASTM D1987 although proper laboratory simulation will be difficult to configure.

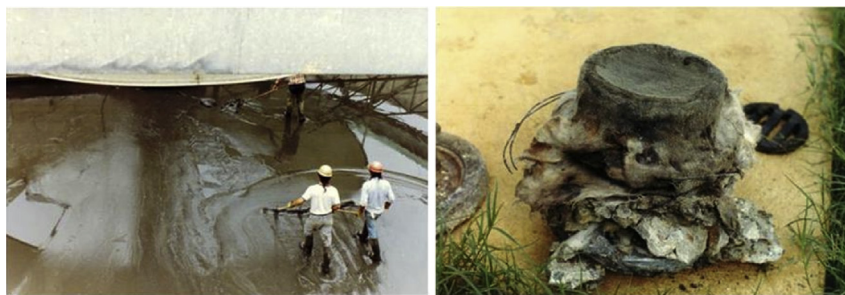
In 1988 the authors evaluated several clogged needle punched nonwoven geotextiles placed over outlet drains as shown in Fig. 6. No liquid entered the pipes even though it was under 1.5 m of hydraulic head. This same excessive clogging situation has also occurred in vacuum removal of oil spills in rivers, lakes and oceans but there are no published citations to our knowledge. The *lesson learned* in this regard is that the candidate geotextile(s) must be laboratory evaluated against the site-specific liquid permeant. The permittivity test per ASTM D4491 could easily be configured as a long-term circulating flow test.

Fig. 6. Oily wastewater sludge clogging geotextile covered drains (GSI photos).
