# Interface Shear Damage to a HDPE Geomembrane. II: Gravel Drainage Layer

Patrick J. Fox, M.ASCE<sup>1</sup>; and Stuart S. Thielmann<sup>2</sup>

**Abstract:** An experimental program of large-scale direct shear tests has indicated that shear displacement of a gravel drainage layer and nonwoven geotextile protection layer over a high-density polyethylene (HDPE) geomembrane under moderate to high normal stress conditions can cause much greater damage to the geomembrane than static pressure alone. Essentially, no damage was observed at low normal stress. The greatest damage occurred at high normal stress (1,389 kPa) using a lightweight geotextile (335 g/m<sup>2</sup>) and yielded an average of 31 holes/m<sup>2</sup>, with a maximum hole size of 29 mm. Surprisingly, geomembrane damage measured using a lightweight geotextile was greater than that measured using no geotextile due to a change in failure surface location. For the same conditions, shear-induced damage was slightly less for a geomembrane placed on a compacted sand subgrade than on a compacted clay subgrade. Interface shear strength increased significantly with decreasing geotextile mass/area due to greater out-of-plane de

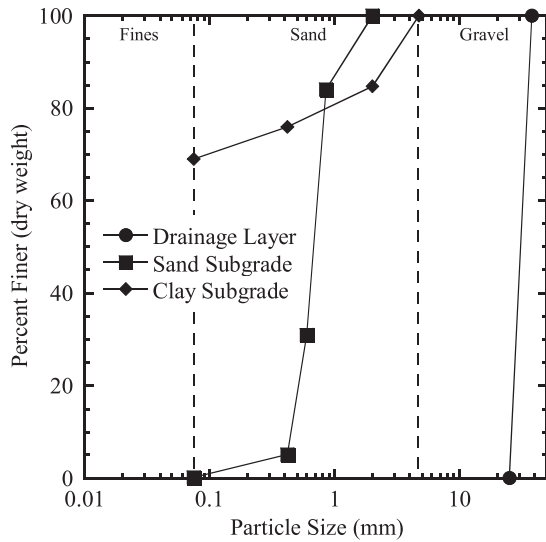
**Fig. 1.** Particle size distribution curves

respectively. Material properties for the geotextiles are given in Table 2. The overlying coarse drainage layer consisted of hard angular gravel (crushed rock), with particle sizes ranging from 25 to 38 mm. The soil subgrade consisted of compacted clay or compacted clean angular sand (S). The clay soil was taken from a borrow source for CCL construction at a currently operating municipal solid waste landfill in southern California and is described as Soil #2 in the companion paper (Fox et al. 2014). This material had a liquid limit of 56 and plastic limit of 29, and was passed through a 4.75-mm sieve to remove the gravel fraction. The optimum moisture content (OMC) and maximum dry unit weight were 23.0% and 14.9 kN/m<sup>3</sup>, as measured by the standard Proctor test. Fig. 1 presents particle size distributions for the drainage layer, sand subgrade, and clay subgrade, and Fig. 2 shows a photograph of typical gravel particles for the drainage layer.

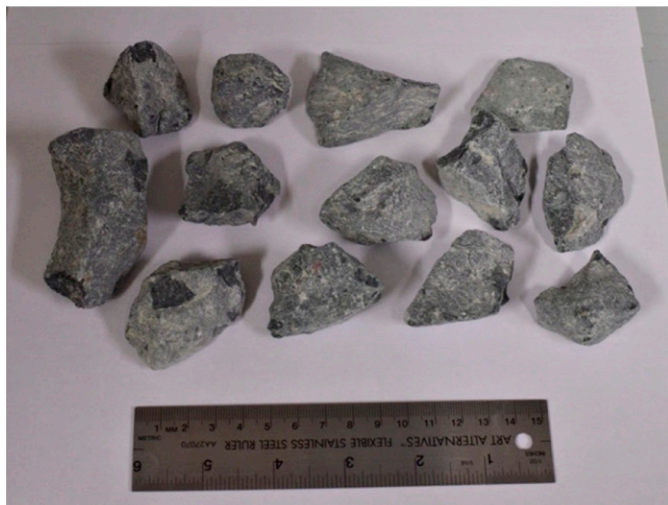
**Fig. 2.** Gravel particles for drainage layer (scale length = 152.4 mm)

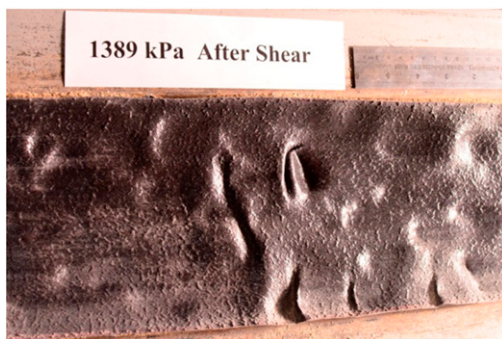
Fig. 17. Geomembrane for DL/GT/GM/S Test P10 after shearing stage

geotextiles, respectively. Similar to Tests P5 and P6, interface shear caused significantly more geomembrane damage than static pressure alone, and the amount of shear-induced damage decreased with increasing geotextile mass/area. Although no holes were created in either geomembrane, the amount of damage is significant. A close-up view of Geomembrane P10, shown in Fig. 17, indicates that substantial wrinkle damage occurred even when using the heavy-weight geotextile at this normal stress level.
