Interface Shear Damage to a HDPE Geomembrane. I: Gravelly Compacted Clay Liner

Patrick J. Fox, M.ASCE¹; Stuart S. Thielmann²; Alexander N. Stern, A.M.ASCE³;
and Chris Athanassopoulos, M.ASCE⁴

Abstract: An experimental program of large-scale direct shear tests has indicated that shear displacement of a high-density polyethylene (HDPE) geomembrane (GM) over a gravelly compacted clay liner (CCL) under moderate to high normal stress conditions can cause much greater damage to the geomembrane than static pressure alone. Essentially, no damage was observed at low normal stress. The greatest geomembrane damage occurred at high normal stress (1,658 kPa) and yielded an average of 169 holes/m², with a maximum hole size of 23 mm. Size, angularity, and hardness of the gravel particles are also important factors with regard to potential damage. Geomembrane damage was greatly reduced when a needle-punched geosynthetic clay liner (GCL) was placed between the geomembrane and gravelly CCL, including one test conducted at very high normal stress (4,145 kPa). The findings suggest that gravelly soils should be viewed with caution for the construction of GM/CCL composite liners for landfill bottom li

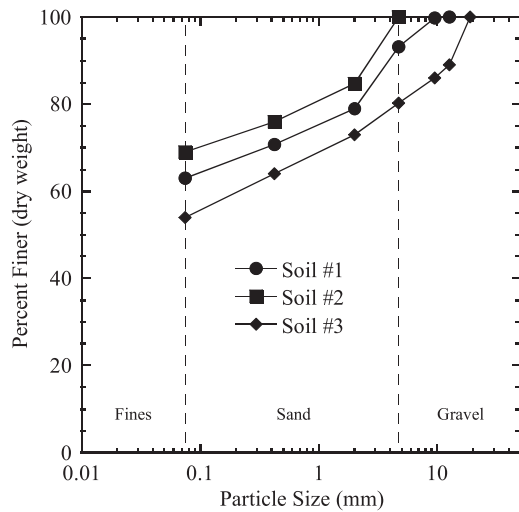
Fig. 1. Particle size distribution curves for three CCL soils

Clay soil for the CCL specimens was obtained from a borrow source for CCL construction at a currently operating municipal solid waste landfill in southern California. This material had a liquid limit of 56 and a plastic limit of 29, and was processed to yield three different soils with the particle size distributions shown in Fig. 1. Soil #1 represents the raw borrow clay with 7% subangular gravel and a maximum particle size of 10 mm. The natural gravel particles in Soil #1 consisted of soft shale. Soil #2 was passed through a 4.75-mm sieve and represents the clay with no gravel. Soil #3 was used for most of the tests and represents the clay with 20% gravel. To prepare Soil #3, the clay was passed through a 4.75-mm sieve and then mixed with angular crushed rock having a maximum particle size of 19 mm. The Unified Soil Classification for Soils #1 and #2 is CH, Sandy fat clay, and the Unified Soil Classification for Soil #3 is CH, Sandy fat clay with gravel. Fig. 2 shows the standard and modified Proctor compaction curves for Soils #1 and #3. The addition of gravel to the clay yielded an increase in dry unit weight and a decrease in optimum moisture content (OMC) for both compaction methods. The zero-air-voids (ZAV) curve corresponding to a specific gravity of 2.8 is also shown.

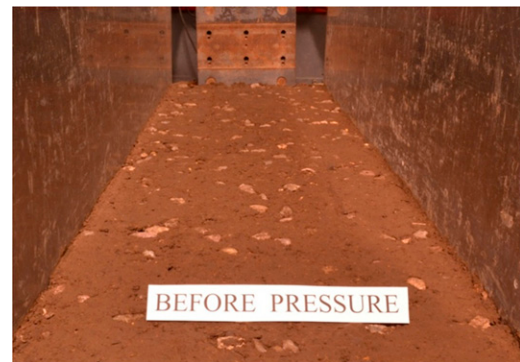
Fig. 4. Surface of gravelly CCL after compaction for Test 5H1

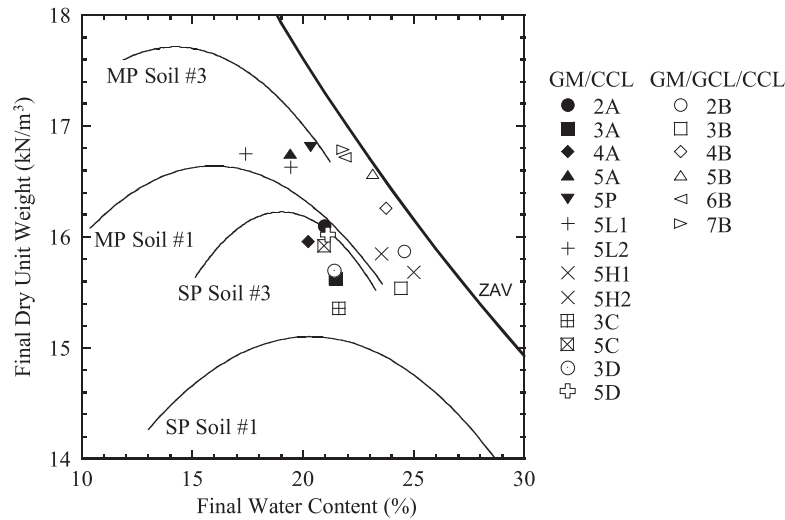
Fig. 5. Final dry unit weight versus final water content for CCL specimens

Tables 2 and 3 provide key results from the experimental program. Fig. 5 presents the final dry unit weight versus final water content (after shearing) for the CCL specimens. The compaction curves from Fig. 2 are also included for comparison. Final CCL conditions, as a whole, lie to the wet side of optimum. Excluding the 5L and 5H tests, which were compacted at different water contents, final CCL water contents for the GM/CCL tests fall in a narrow range from 19.4 to 21.6%. These data also show a general trend of increasing dry unit weight with increasing normal stress level. The 5L and 5H tests yielded lower and higher water contents, respectively, and corresponding higher and lower dry unit weights. The lowest final water content for the experimental program, measured for Test 5L1, falls on the line of optimums for Soil #3. Final CCL water contents for the GM/GCL/CCL tests were consistently higher than for the GM/CCL

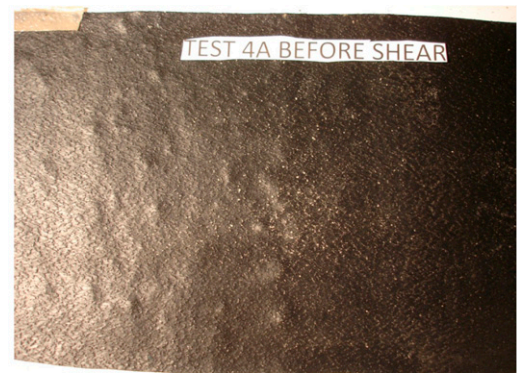
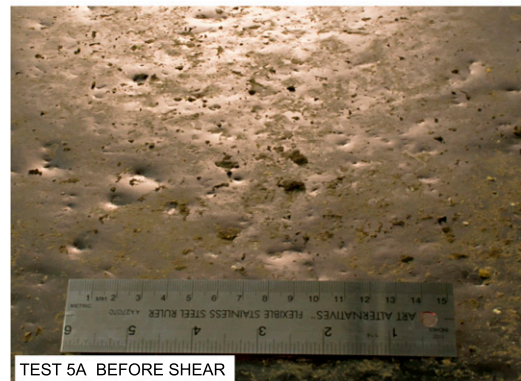
Fig. 7. Geomembranes after static pressure stage for GM/CCL tests: (a) 4A, textured side; (b) 5A, smooth side (scale length = 152.4 mm)

Inspection of geomembrane specimens following the initial 24-h static pressure stage indicated relatively little damage and, in some cases, no damage. For the GM/CCL tests, no damage was observed at the lowest normal stress level for Geomembrane 1A ($\sigma_n = 72$ kPa). Damage then increased with increasing normal stress for Geomembranes 2A–5A. Similar to the findings of Brachman and Sabir (2010), application of higher normal stress to the CCL specimens caused greater compaction of the clay matrix around the gravel particles, which in turn caused these particles to protrude outward from the CCL surface and the geomembrane to experience more significant local indentations (dimples). Fig. 7 presents Geomembranes 4A and 5A after the static pressure stage and shows minor to moderate indentations. These tests were conducted at high normal stress using Soil #3 (20% hard angular gravel; particle size ≤ 19 mm) and produced the most significant geomembrane damage due to static pressure alone. Much less damage was observed for GM/CCL tests using Soil #1 (7% soft subangular gravel; particle size ≤ 10 mm), and no damage was observed for GM/CCL tests using Soil #2 (no gravel). Geomembranes for the GM/GCL/CCL tests, all of which were conducted using Soil #3, displayed a few shallow indentations at high normal stress but overall experienced essentially no damage as a result of the protection provided by the GCL. Bright light tests indicated that no holes were created in the geomembranes for any of the static pressure tests.

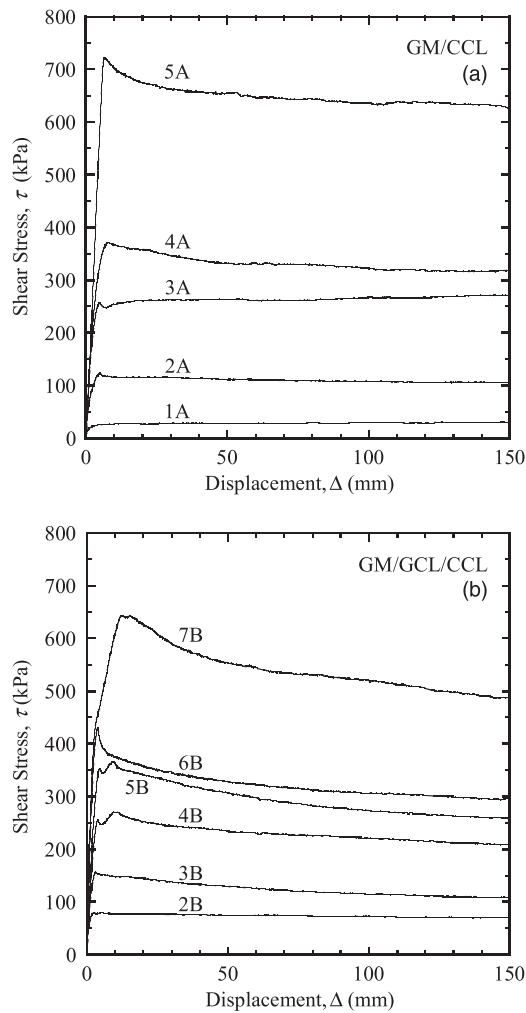
Fig. 8. Shear stress-displacement relationships for (a) GM/CCL tests and (b) GM/GCL/CCL tests

Fig. 8 presents the shear stress, τ , versus shear displacement, Δ , relationships measured during the shearing stage for GM/CCL Tests 1A–5A and GM/GCL/CCL Tests 2B–7B. Tables 2 and 3 list the peak τ_p and large displacement τ_{150} shear strengths, and Fig. 9 presents the postpeak strength ratios, τ_{150}/τ_p . Failure occurred at the GM/CCL interface for the GM/CCL tests and at the GM/GCL interface for the GM/GCL/CCL tests. Internal GCL failures might have occurred for the GM/GCL/CCL tests at the higher normal stress levels if the geomembrane specimens had been textured on both sides (Fox and Ross 2011). The stress-displacement relationships generally show a similar response consisting of a rapid rise to peak strength at $\Delta = 3$ –12 mm followed by a gradual postpeak strength reduction. Most tests, including all of the GM/GCL/CCL tests, did not reach a residual shear condition at $\Delta = 150$ mm. Shear stress for Tests 1A and 3A gradually increased throughout the shearing process and yielded $\tau_p \approx \tau_{150}$. Postpeak strength ratios for the GM/GCL/CCL tests were lower than for the GM/CCL tests and those

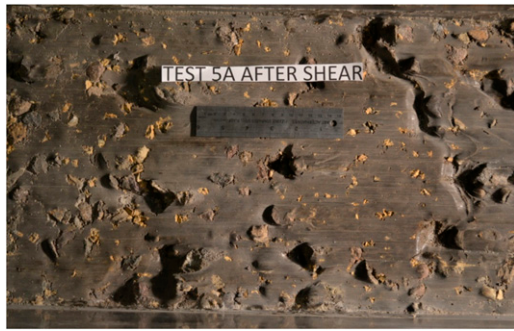
Fig. 12. CCL surface after shearing stage for GM/CCL Test 5A (shear direction is to the right)

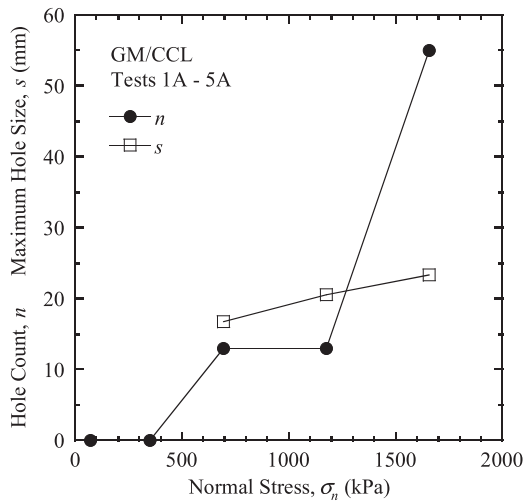
Fig. 13. Geomembrane damage after shearing stage for GM/CCL tests

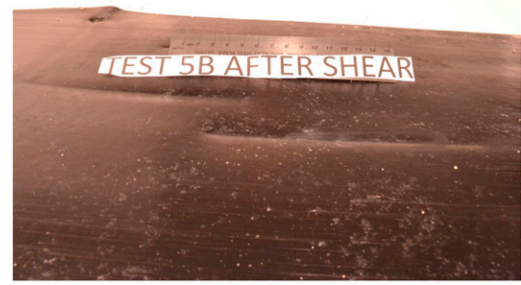
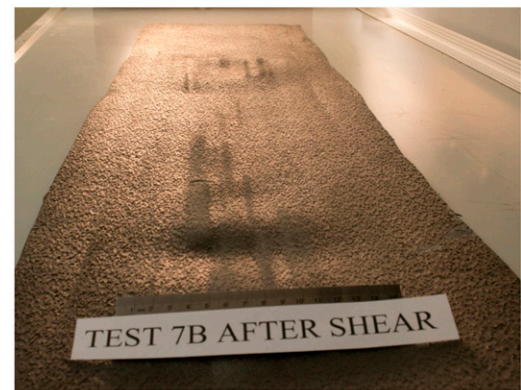
Fig. 14. Geomembranes after shearing stage for GM/GCL/CCL tests: (a) 5B, smooth side; (b) 7B, smooth side; (c) 7B, textured side

Relative to their GM/CCL counterparts, geomembrane specimens from GM/GCL/CCL Tests 2B–5B experienced much less damage due to interface shear. Essentially, no damage was observed for low and moderate normal stress conditions and only minor damage was observed for high normal stress. As an example, Geomembrane 5B is shown in Fig. 14(a) and displays several shallow longitudinal indentations. Based on these positive results, GM/GCL/CCL Tests 6B and 7B were conducted at higher normal stress levels of 2,146 and 4,145 kPa. The most significant damage occurred for Geomembrane 7B, which is shown in Figs. 14(b and c). One section of Geomembrane 7B displayed longitudinal indentations with some gouging; however, no holes were discovered and the overall condition was good. Fig. 15 shows that the final condition of the GCL for Test 7B was also good, with no evidence of wrinkles or holes. If geomembrane holes were to develop in a GM/GCL/CCL liner system, the GCL would be expected to seal around the protruding gravel particles and provide additional protection (Shan and Daniel 1991; Fox et al. 2000).

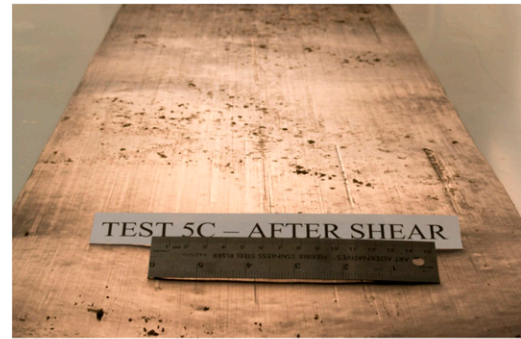
Fig. 16. Geomembranes after shearing stage for GM/CCL tests: (a) 5C, smooth side; (b) 5D, smooth side

Effect of Gravel Content. Much less geomembrane damage was observed for GM/CCL tests conducted using the CCLs with lower gravel contents. Fig. 16 shows two geomembranes tested at high normal stress ($\sigma_n = 1,658$ kPa). Geomembrane 5C was sheared

over a CCL compacted using Soil #1 and displays deep scratches and gouges. Geomembrane 5C experienced much less damage than Geomembrane 5A due to the lower percentage and less aggressive gravel in Soil #1 as compared with Soil #3. All else being equal, geomembrane damage would be expected to scale with the

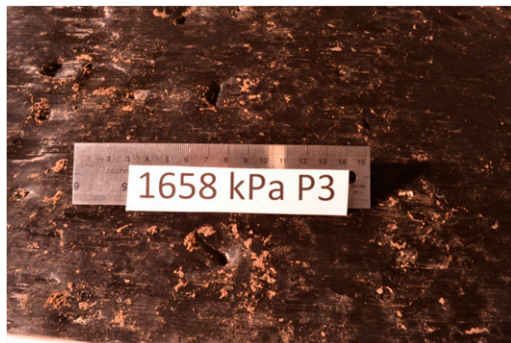
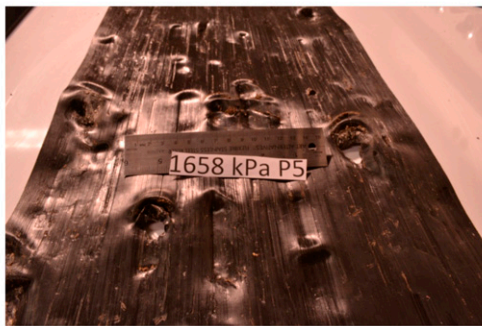
Fig. 19. Geomembrane for GM/CCL Test 5P: (a) at peak strength; (b) after shearing stage completed; labels P3 and P5 indicate the third and fifth shearing increments

and at the end of shearing. In addition to the development of one hole, considerable indentation and gouging damage was observed at peak strength. The final condition indicates severe damage similar to Geomembrane 5A and yields an average of 98 holes/m²
