**Effect of Wrinkles on Geomembrane Performance**

**R. Kerry Rowe**  
 Professor and Canada Research Chair in  
 Geotechnical and Geoenvironmental  
 Engineering, Queen's University

The Geo  
Engineering  
Centre  
at Queen's-RMC

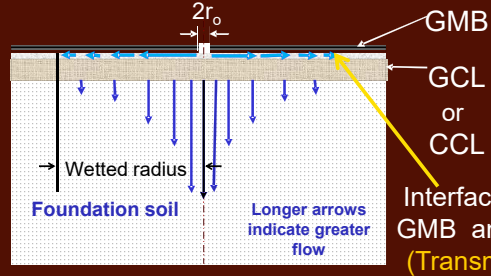
**Leakage through GMB in Direct Contact with Clay Liner**

$2r_w$   
 GMB  
 GCL or CCL  
 Foundation soil  
 Wetted radius  
 Longer arrows indicate greater flow  
 Interface between GMB and clay liner (Transmissivity,  $\theta$ )

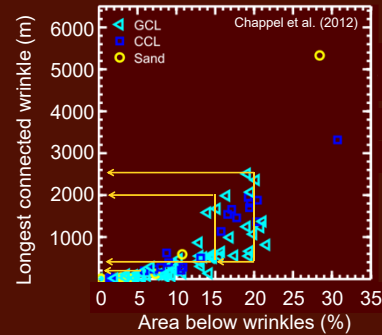
**Longest Length vs Area of Wrinkles**

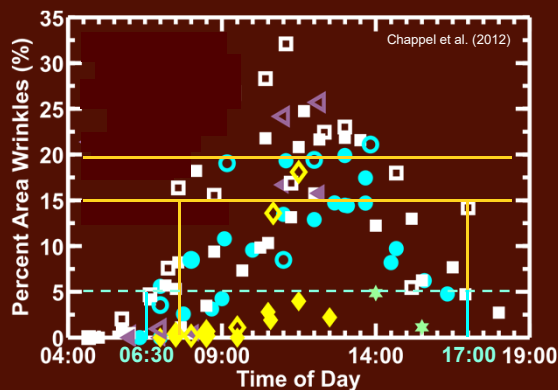
**Wrinkled Area**

- Wrinkling related to solar radiation and GMB temperature (may be 20-40°C > ambient)
- Typical wrinkle width about 0.2 - 0.3 m
- Typical wrinkle height about 0.06m (up to 0.2m)
- Wrinkles could range from a few % to more than 30% depending on time GMB is covered
- Even on a "small" area (0.15-0.17 ha), wrinkle length exceeded 200m once more than about 5% of area was wrinkles

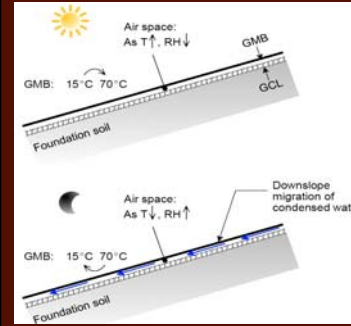
**Moisture cycle from thermal cycle when exposed**

- GCL hydrates with moisture from subsoil
- on heating:
  - GCL loses moisture to GMB/GCL interface
  - vapour migrates towards wrinkles
- on cooling:
  - vapour condenses on underside of GMB
  - condensed moisture trickles downslope

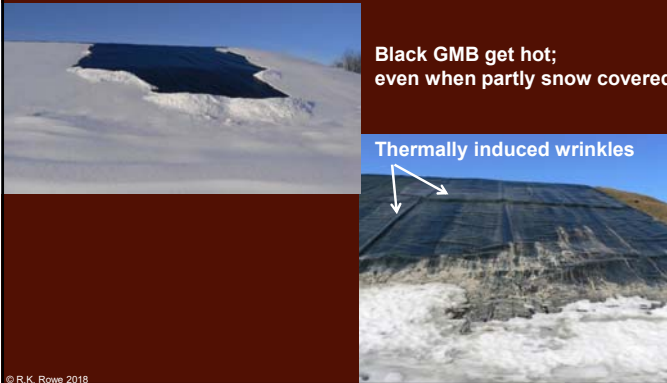
**Differential exposure**

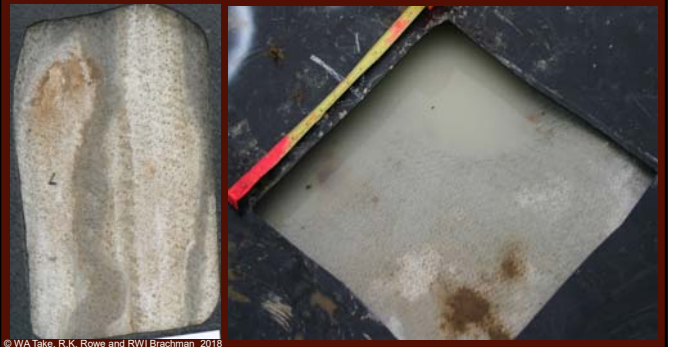
**The first hint of a problem QUELTS I**

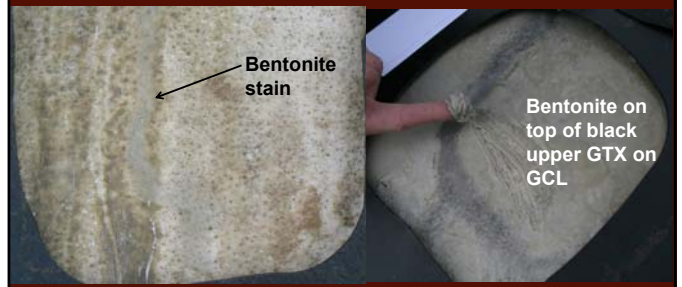
**A bigger clue**

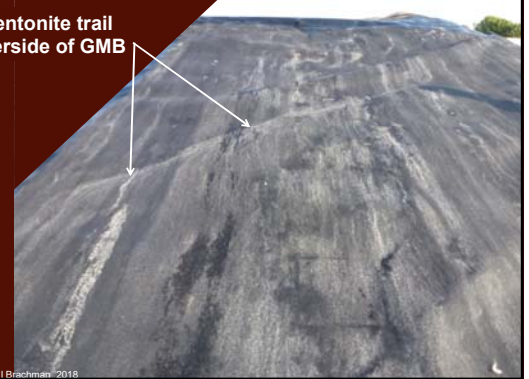
### Bentonite: underside of slope GMB

Dried bentonite trail on underside of GMB

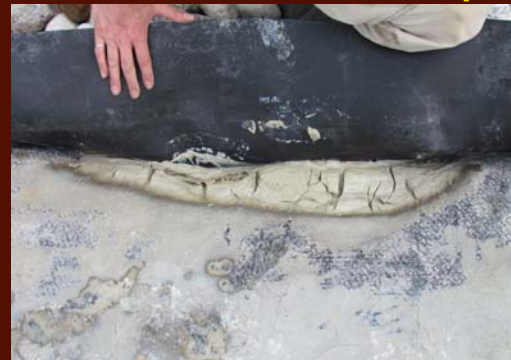
### Bentonite at bottom of slope

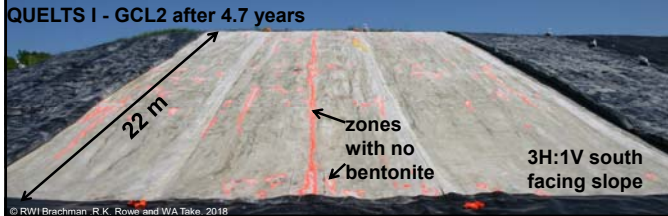
### Features on slope and base

- more features detected on slope than base
- after 4.7 years, most significant feature on base was:
  - maximum 50 mm wide, nearly 20 m long
- features big enough such that they will not heal from swelling or stress effects once covered
