# Large-Scale Controlled Testing of Geotextile Puncture Resistance for Rock Impact

**ABSTRACT:** The puncture resistance of a range of geotextiles was measured using a method designed to represent large-scale field conditions without sacrificing repeatability or experimental control. The test method simulates rock impacts on a subgrade overlain by a geotextile, a very common condition encountered during the installation and construction of bund walls and revetments. The test apparatus allows controlled and repeatable testing of rock impacts up to 1 tonne in mass, dropped from heights of up to 2.5m. Variables such as geotextile anchorage, subgrade consistency, and rock shape were controlled. The extent of geotextile damage was inspected, measured, and analysed. Two types of polyester non-woven geotextiles were tested: staple fibre (SF) and continuous filament (CF). It was found that the staple fibre geotextile performed remarkably better than the continuous filament geotextile in the same test conditions. The paper discusses the development and key features of the testing apparatus as well as the damage results measured from a range of geotextiles. The test regime described in this

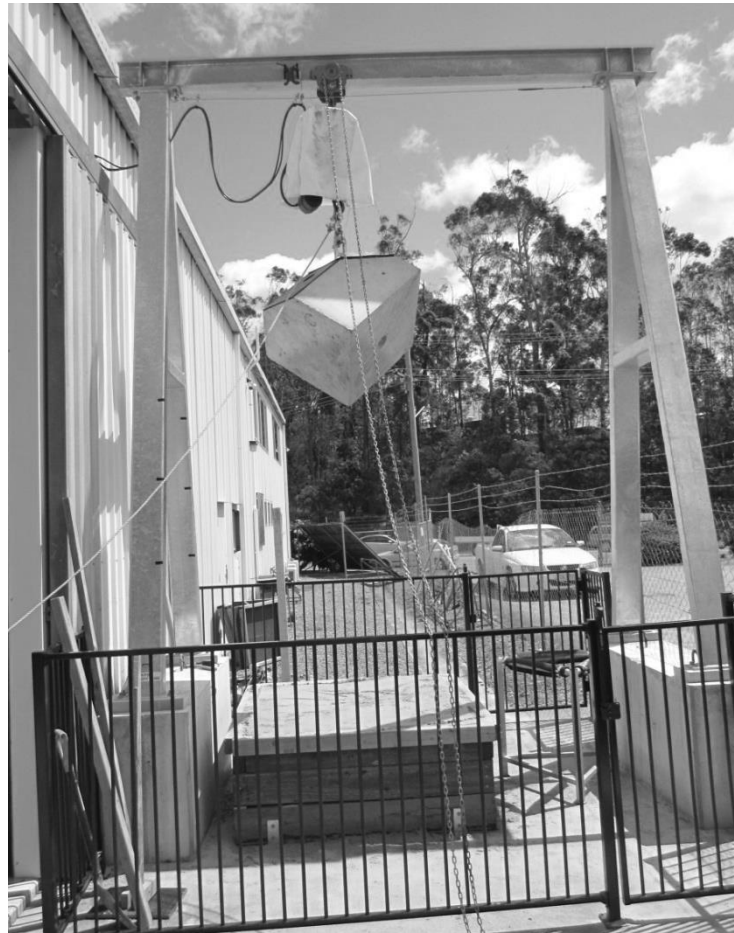
Figure 1 shows the equipment used in this testing. It can be seen that a gantry crane is used to suspend a trolley, and electric hoist, a quick release mechanism and the suspended load. The rock armour stone used in the tests was a concrete cube with sides measuring 750mm and weighing approximately 1000kg. The cube was dropped on a corner point giving it consistent and repeatable angularity. The concrete cube was dropped onto the subsoil which was overlain with a geotextile. No secondary armour was used. The dimensions of the contained subgrade onto which the cube was dropped were 1580mm x 1350mm x 600mm (LxWxH). The subgrade is contained by hardwood sleepers which were reinforced with steel plates and anchored to the underlying concrete base slab.

Figure 1. Concrete test cube suspended over the subgrade container with no geotextile in place.

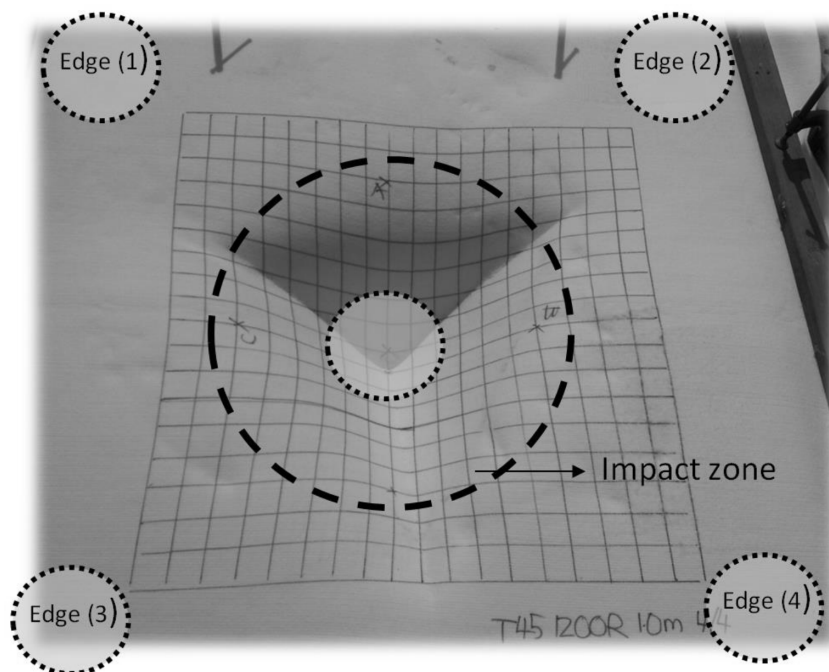
The geotextile was securely clamped to the entire perimeter of the subgrade container to ensure that no slippage occurred between the geotextile and the subgrade container. The geotextile samples were further prepared by drawing a grid with 50mm square cells in the impact area. This would be used to measure the resulting elongation of the geotextile post impact. Eight mass samples and four CBR samples were collected around the unaffected edges of the specimen. These would be used to measure mechanical properties of the specimen locally to ensure accurate comparisons with the damaged areas of the geotextile could be made. The CBR burst test consists of a 50mm diameter steel plunger which is pushed at a constant rate through a 150mm diameter specimen until a peak load is reached. Strains and loads and loads can be measured thus.

Figure 2. Impact zone and CBR specimen locations.

Each specimen that did not puncture was also tested for residual strength via a CBR burst test taken from the center of the impacted area. As mentioned, this value was compared to the average of 4 unaffected specimens around the perimeter of the geotextile. The results of these tests can be seen in Table 2. It is interesting to note that only one of the specimens showed a residual CBR strength of less than 50%. All but one indicated failures are therefore due to the visible puncture criteria. Residual strength does not appear to be a clear indicator of whether the damaged specimen was at the threshold of a puncture for a given drop height. Additionally, it is interesting to note that for a given drop height and geotextile grade, the occurrence of a puncture has an element of randomness. In the five repeat tests, it often happened that some specimens would fail, and some would not.

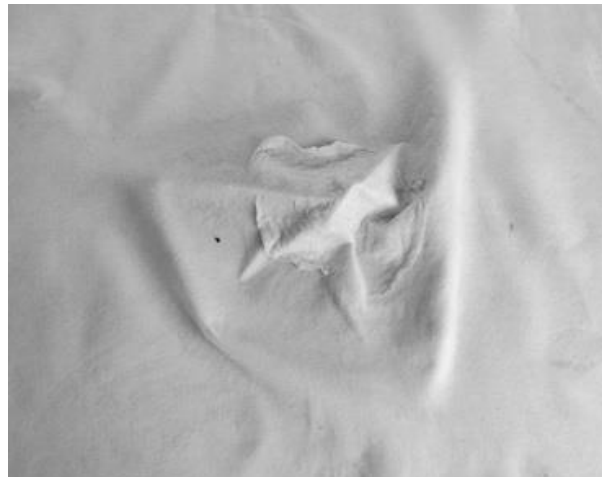
A mode of failure not previously described by other researchers was observed. Damage to the geotextile can be induced by the impacting object as well as the subgrade. Once the test rock makes contact with the geotextile it loses speed and quickly comes to a stop. During this interval a number of potentially damaging things occur. Firstly, the geotextile strains and elongates to accommodate the object as it decelerates. This strain occurs along the contours of the object. The object in this case was a concrete cube with flat surfaces as well as rough edges not unlike a recently quarried rock. As expected, the rough edges often caused cutting failures. Interestingly, noticeable damage frequently occurred on the subgrade-geotextile interface along the flat surfaces of the cube. This damage, seen in Figure 3, appears to be the result of friction as the geotextile moves in a downward direction relative to the subgrade. It can also be seen that fibre layers of the geotextile were sheared away as it slid against the subgrade. “Abrasive shearing” was taken to be a descriptive terminology for this type of damage. The abrasive shearing was seen to reduce the thickness of the geotextile and was occasionally evident in the punctured specimens. It can be inferred that this damage is directly related to the depth that the test rock travels as it decelerates. Therefore, a greater amount of “abrasive shearing” damage can be expected from higher

drop heights and weaker soil subgrades. This additional damage mode adds complexity to attempts to build a model for puncture failures.

Figure 3. Specimen showing the effects of abrasive shearing on the subgrade side of the geotextile. This specimen had no puncture and appeared relatively undamaged on the opposite side.
