Design and Installation of Distributed Fiber Optic Sensing Technology to Monitor HDPE Pipelines at an Earthquake Fault Crossing

ABSTRACT

The Summit Pressure Zone South Pipeline Replacement, Phase 1 project included approximately 5,000 linear feet (LF) of 24-in. steel pipeline in various streets in Berkeley, California, in addition to 700 LF of 36-in. high density polyethylene (HDPE) and 500 LF of 22-in. HDPE pipelines to cross the Hayward Fault in Claremont Avenue on the Oakland/Berkeley border. The transmission pipelines cross the Hayward Fault in an area which experiences significant ground movement resulting in several previous pipeline failures. East Bay Municipal Utility District (EBMUD) worked with researchers at University of California, Berkeley (UCB), to develop a system that would be able to monitor and measure pipeline strain in a robust, sensitive, distributed, and accurate way. The team explored various technologies and applications to determine which were most viable. The distributed fiber optic sensing (DFOS) system was selected as the most appropriate method to achieve the goals. Installation of the HDPE pipelines in this area was difficult due to field conditions

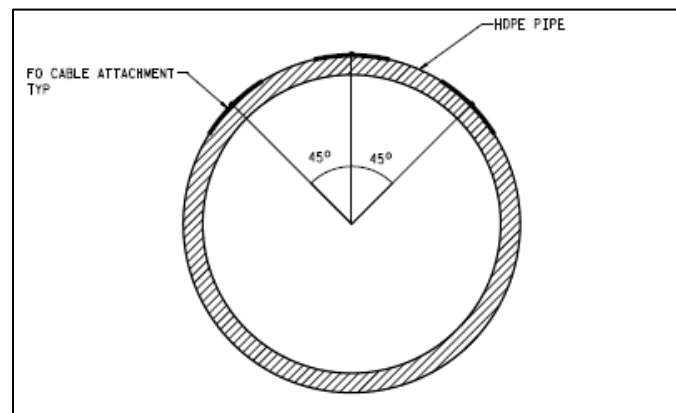
Figure 3. Cable Orientation on Pipe

The proposed system included installation of four strain sensing cables and one temperature sensing cable with each HDPE pipeline. Three of these strain sensing cables were installed directly on the pipe, parallel to the pipe longitudinal axis. Figure 3 shows the design detail for the cable configuration on the pipe. One cable length was attached at the crown of the pipeline and two additional lengths were placed at 45 degrees from the crown in either direction for adequate bending measurement. The cables were not to deviate more than five degrees from their

prescribed orientation and not more than two-and-a-half degrees over any 20-foot length of pipe. The fourth strain sensing cable and the temperature sensing cable were laid loose longitudinally within the pipe trench. This strain sensing cable is to measure trench soil strain and the temperature sensing cable measures soil temperature in order to quantify the contribution of temperature-induced strain to the measured pipeline strain data (Hubbard, et al., 2021).

The new HDPE pipelines were installed by contractor. The contract drawings included the details shown in Figures 3 through 5. Fiber optic cables were installed longitudinally at the top of pipe and at 45 degrees offset from the top on each shoulder as designed. The temperature cable and a strain cable were laid longitudinally in the trench. The contract specifications included details for pipe surface preparation to ensure a good bonding of the cables as well as the specific tolerances allowed for the cable installation. The specifications also included a requirement to

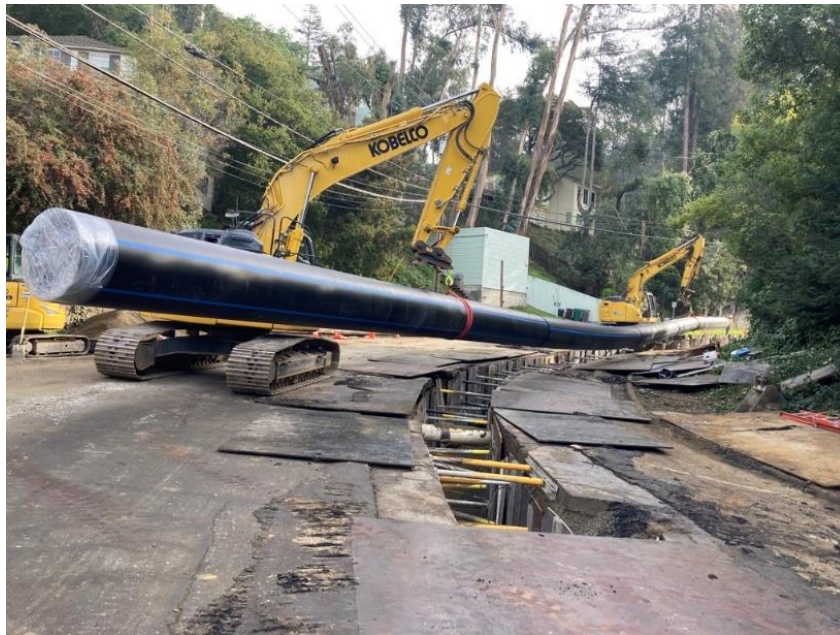
Figure 6. Walking the 36-inch HDPE Pipeline into Position

The HDPE pipeline was fused above-ground, then moved to one end of the trench to be pushed and pulled into place. Figure 6 shows excavators “walking” the fused HDPE pipe to be pulled in, and Figure 7 shows the pipeline being pushed into the trench.

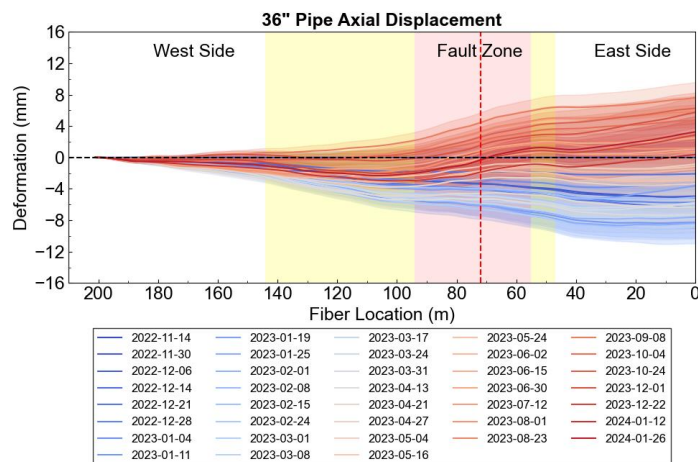
Figure 11. Axial Displacement along 36-inch Pipeline

This average strain error was included in the integration calculation for both axial displacement and lateral deflection to compute the estimated pipeline deformation. Figures 11 and 12 show the resulting estimated axial displacement and lateral deflection along the pipeline. In this case, estimated pipeline deformations include approximately 4 to 5 mm (0.16 to 0.2 in) of axial displacement along the fault zone and within approximately 1 to 1.5 mm (0.04 to 0.06 in) of lateral deflection across the fault zone. Note, both pipeline deformation estimates exhibit noticeable fluctuations which can be attributed to seasonal water temperature cycles, as well as potentially other environmental factors. Further analysis is ongoing to better characterize these effects. Nonetheless, pipeline deformation behavior is dominated by axial displacement.
