Contamination of the Shore of the Southeast Baltic (Kaliningrad Oblast, Russia) with the Debris of Geosynthetic Materials for the Survey Period 2018 - 2020

Contributors: Alexander Kileso, Boris Chubarenko, Elena Esiukova, Vasiliy Pinchuk and Franz-Georg Simon
Published: 14 Dec 2021

1. List of types of geosynthetic material residues

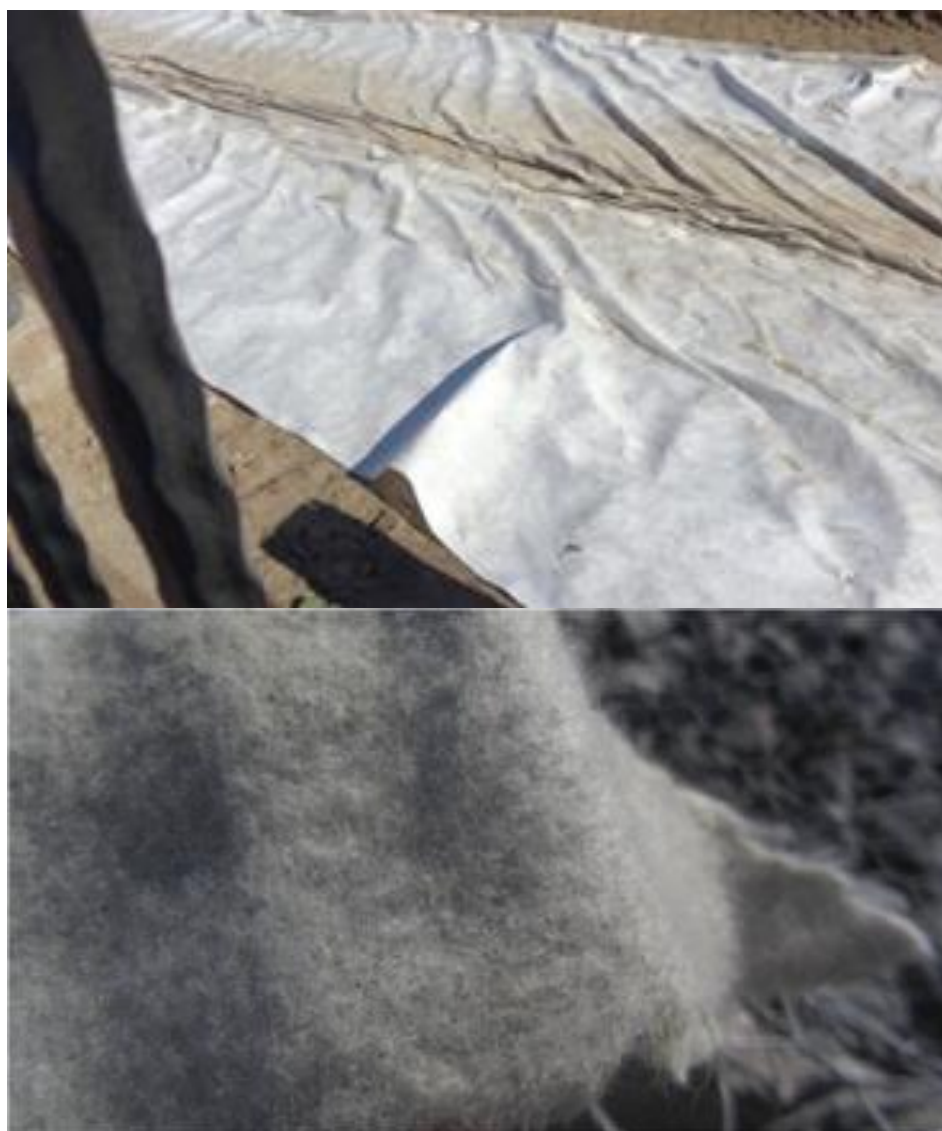
Figure 1.1. Nonwoven geotextile (PP, PET) is used in coastal protection constructions.

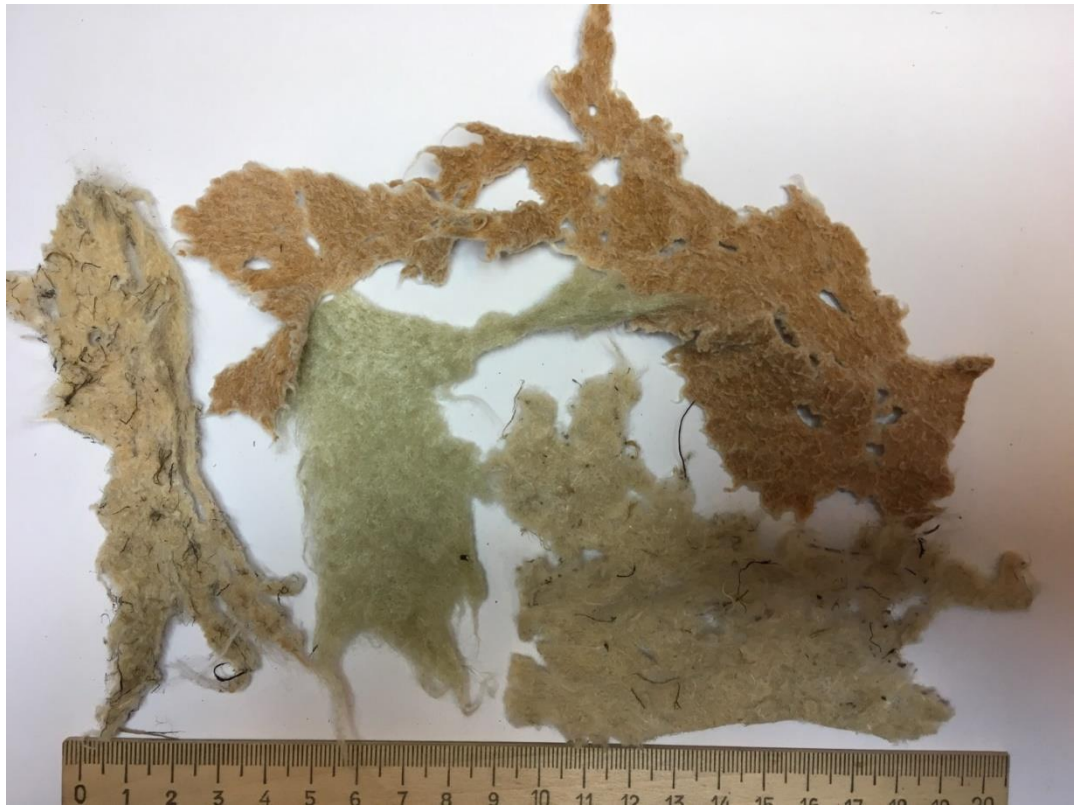
Figure 1.2. Fragments of nonwoven geotextile (PP, PET). All pieces are not fresh; they were a long time in natural conditions.

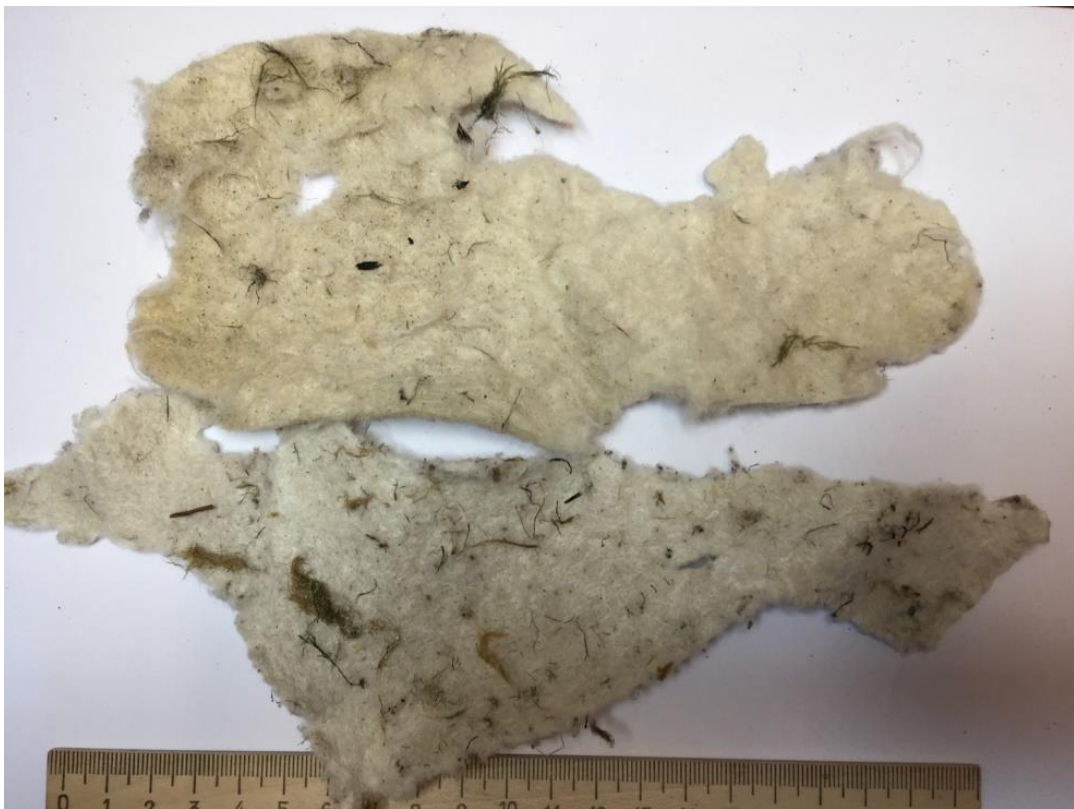
Figure 1.3. Fragments of white nonwoven geotextile (PP, PET). Pieces are not fresh; they were a long time in natural conditions.

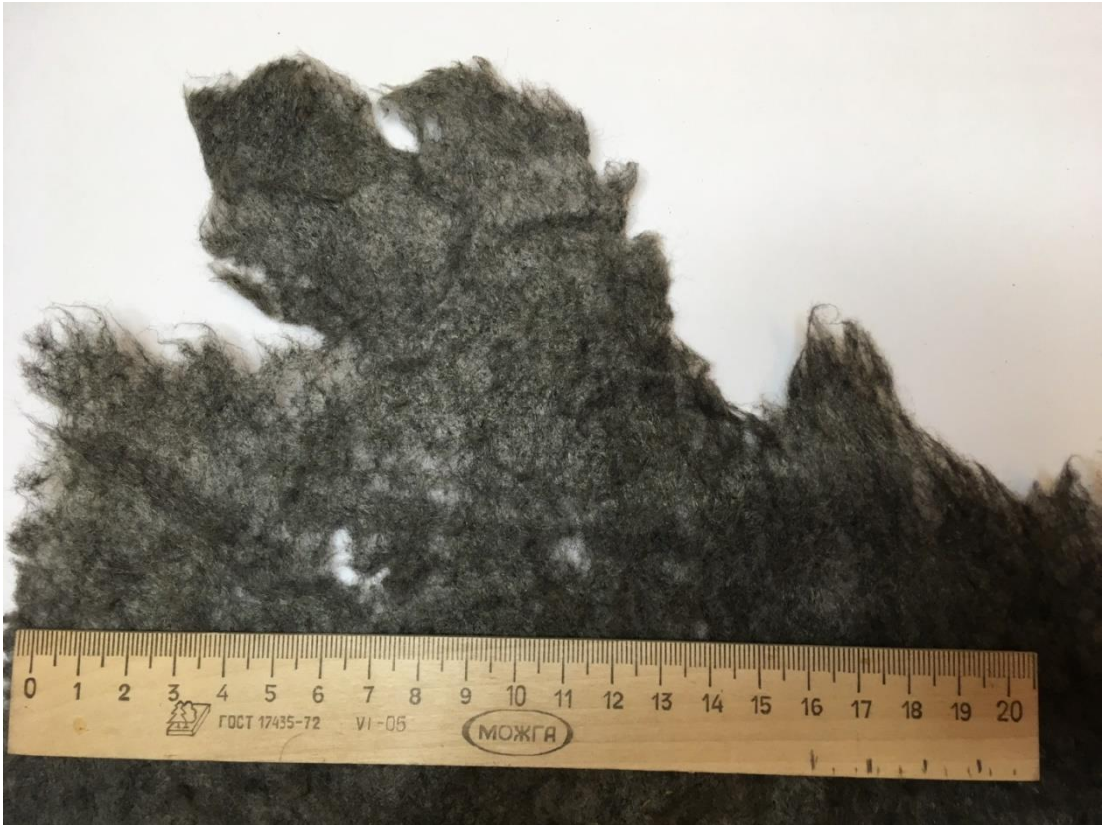
Figure 1.4. The Fragment of black nonwoven geotextile (PP, PET)). Pieces are not fresh; they were a long time in natural conditions.

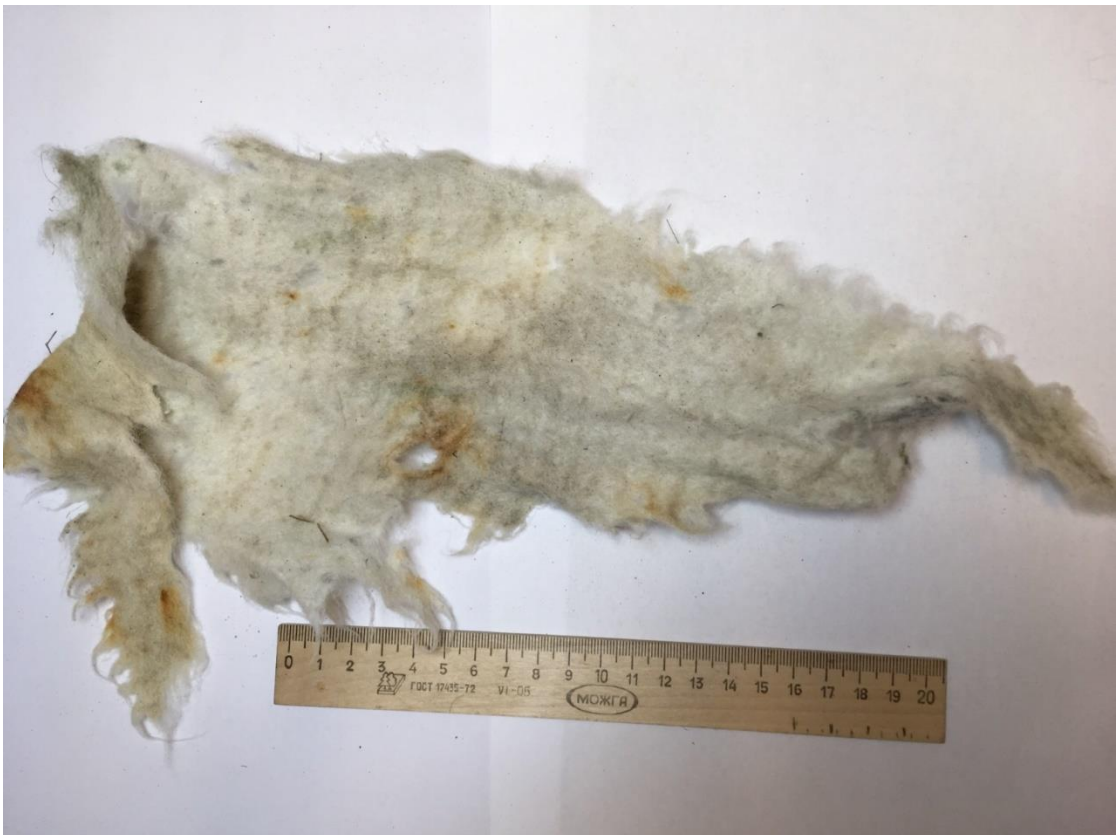
Figure 1.5. The Fragment of white nonwoven geotextile (PP, PET) with reinforcing stitching. The pieces is not fresh; it was a long time in nature.

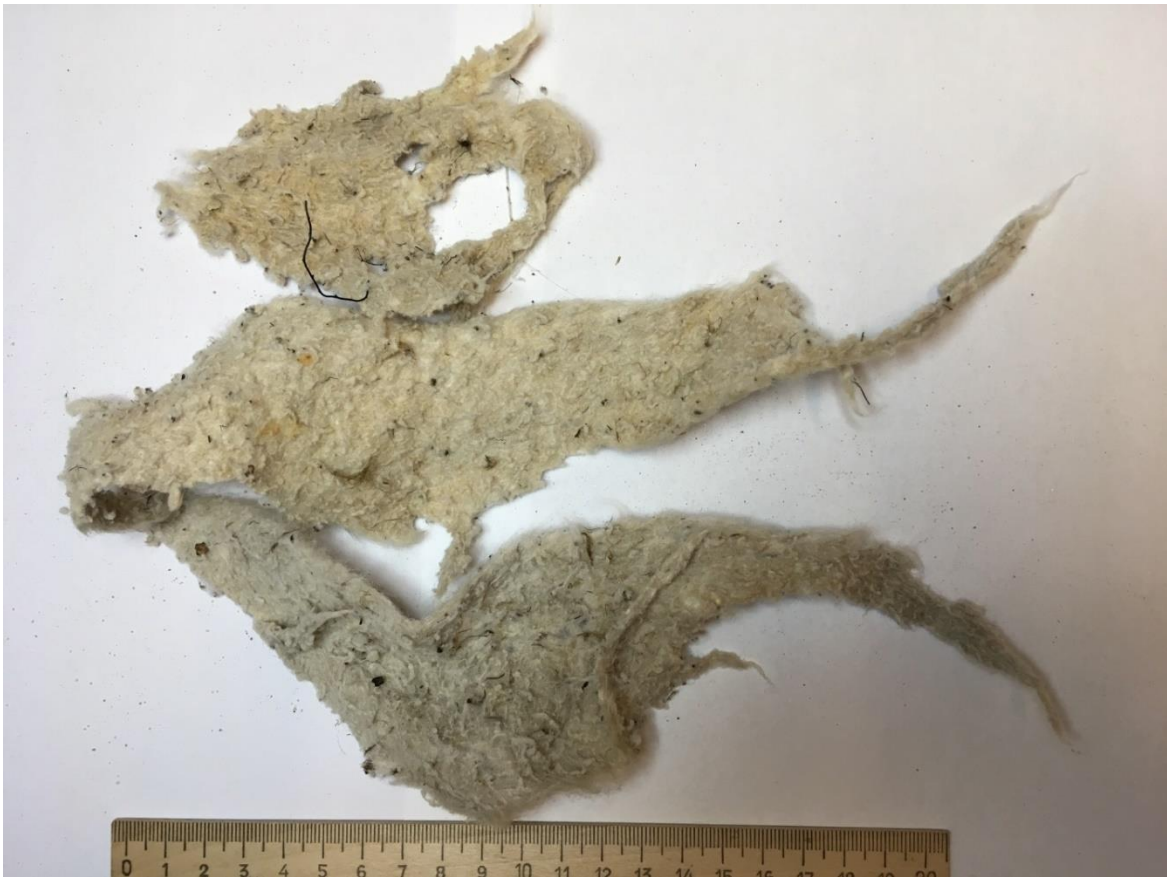
Figure 1.6. The Fragment of white nonwoven geotextile (PP, PET)). Pieces are not fresh; they were a long time in natural conditions.

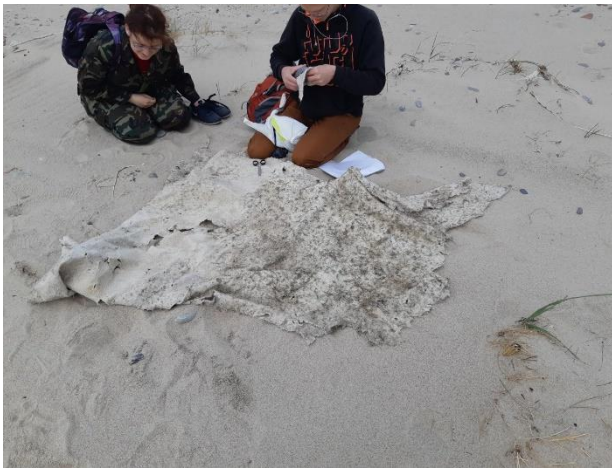
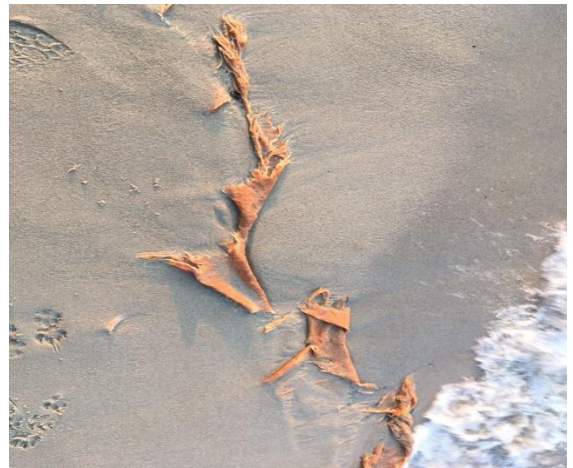
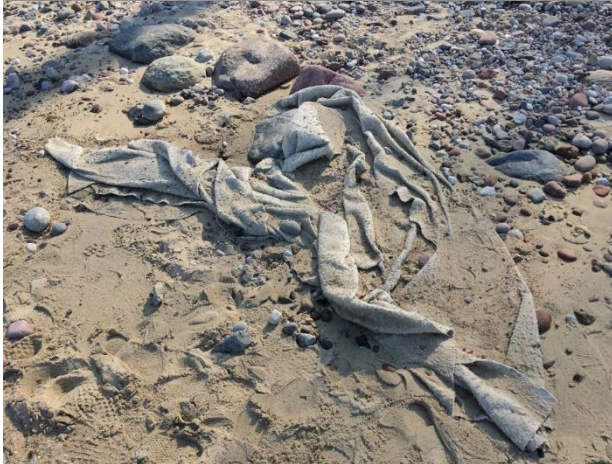
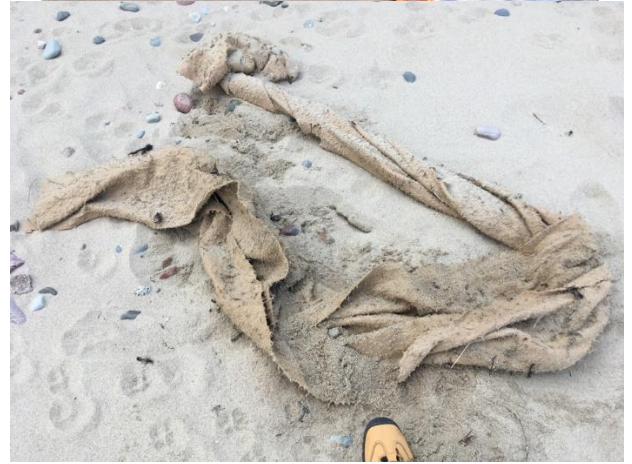
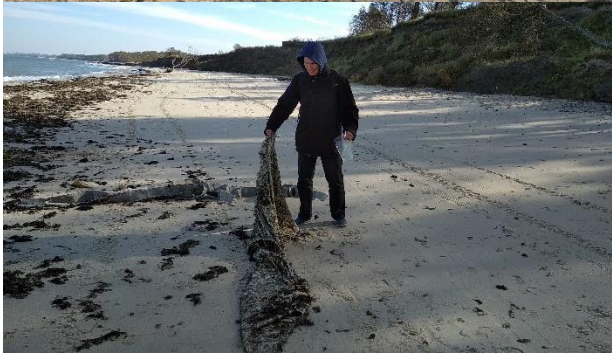
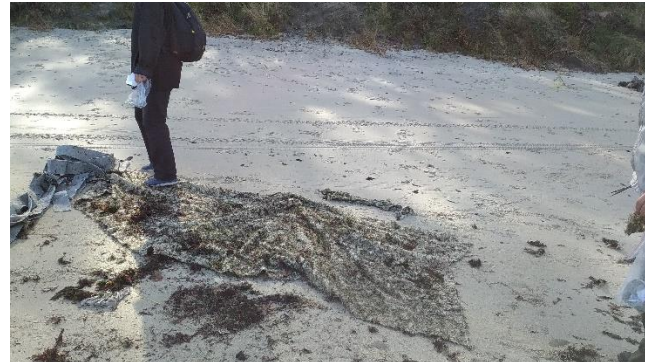
Figure 1.7. Examples of the geotextile debris on the beaches of the Kaliningrad Oblast, Russia.

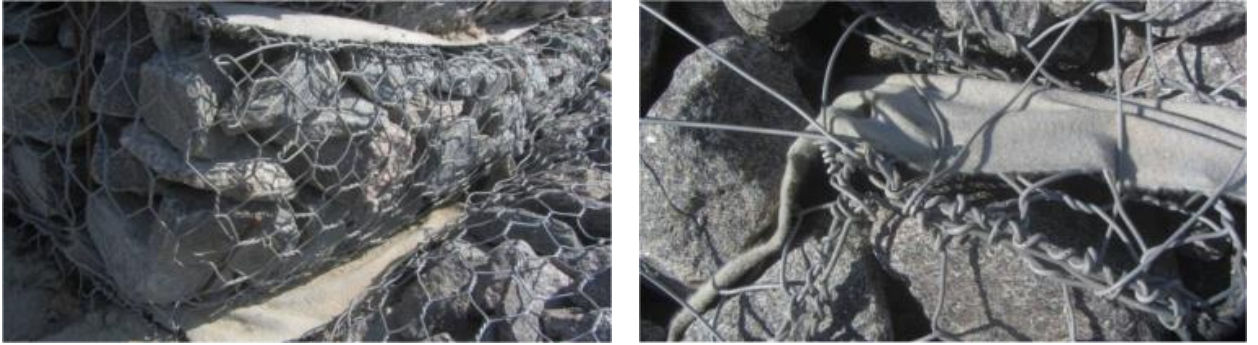
Figure 1.8. Gabion wire braid.

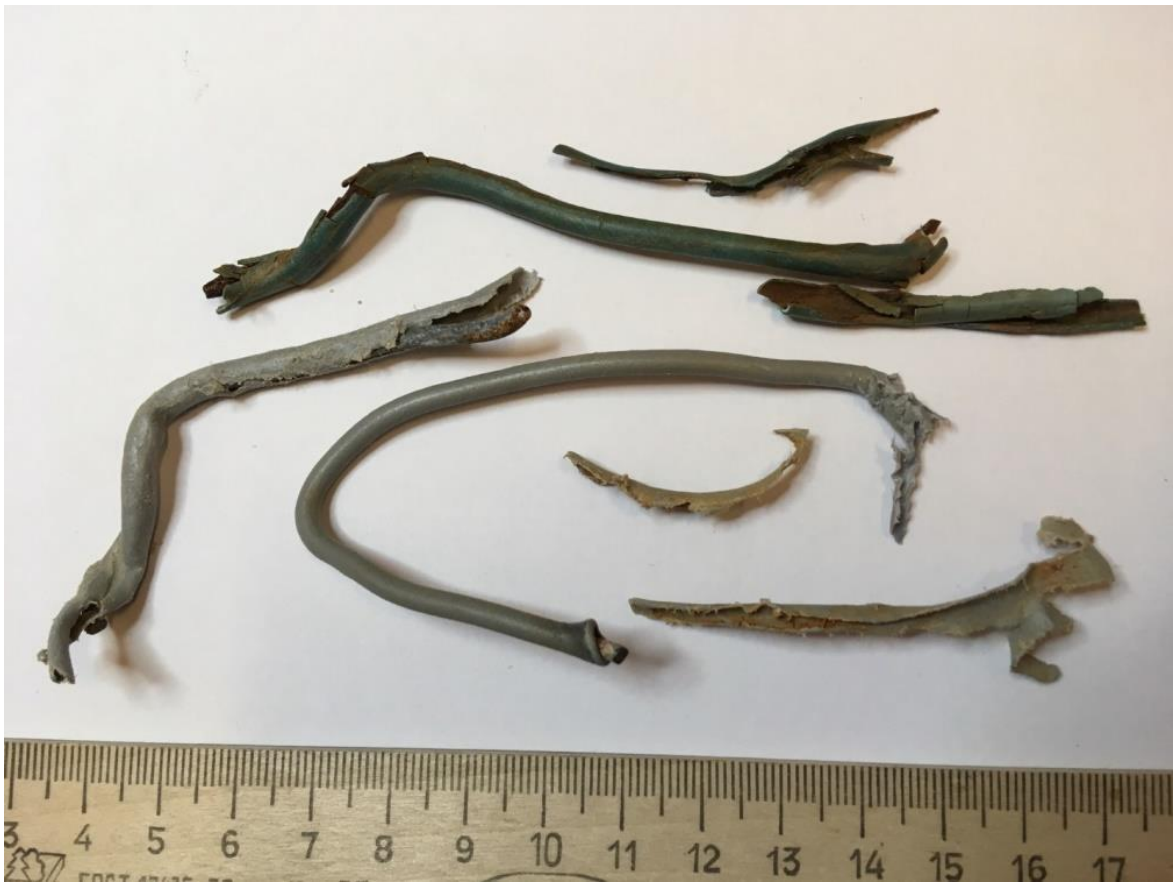
Figure 1.9. Usually, only fragments of plastic coating for gabion wire are present on the beach, but sometimes the pieces contain the wire (two pieces in the figure).

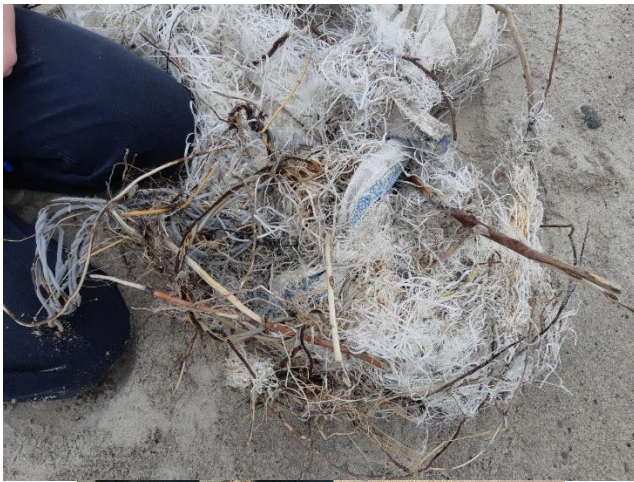
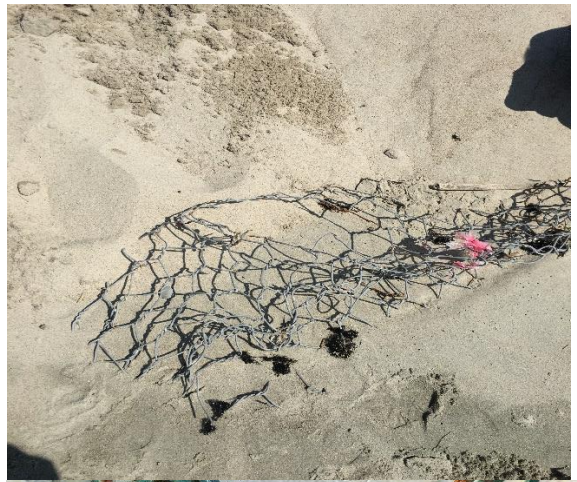
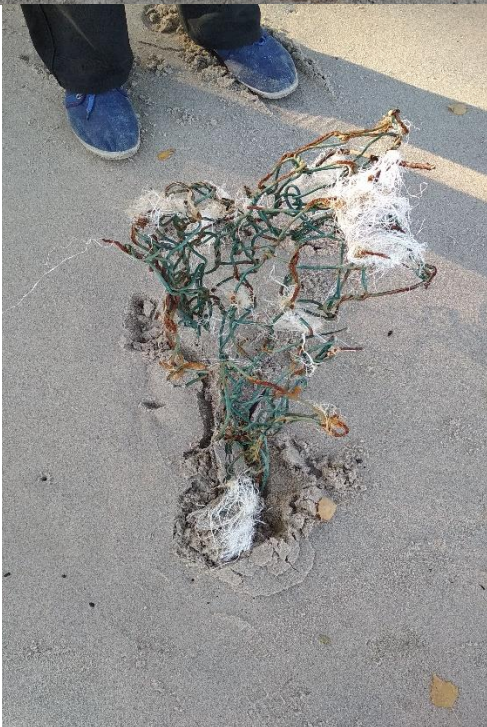
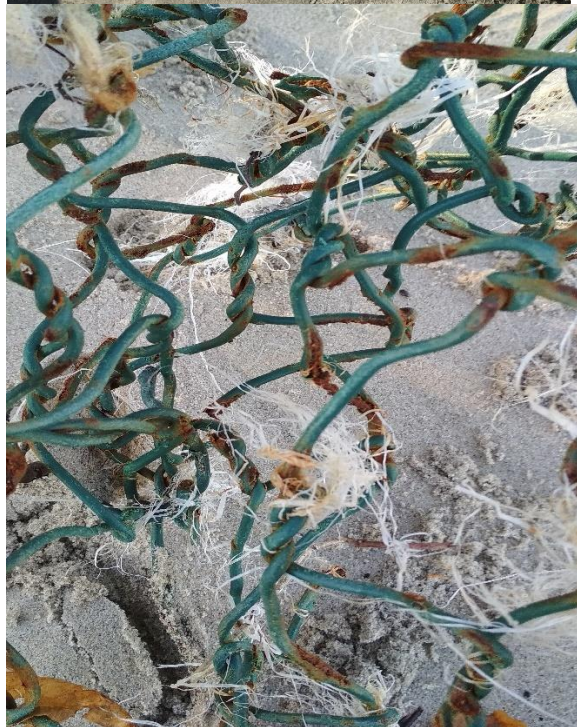
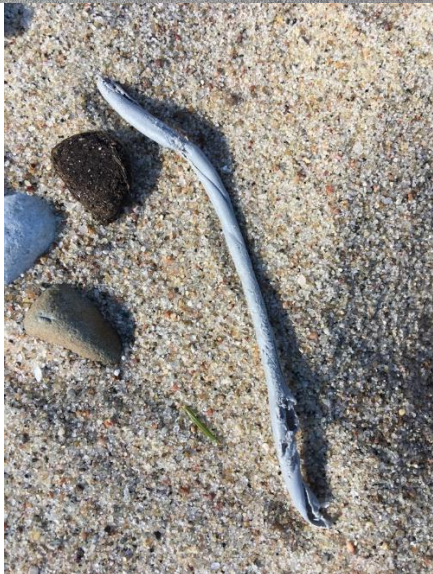
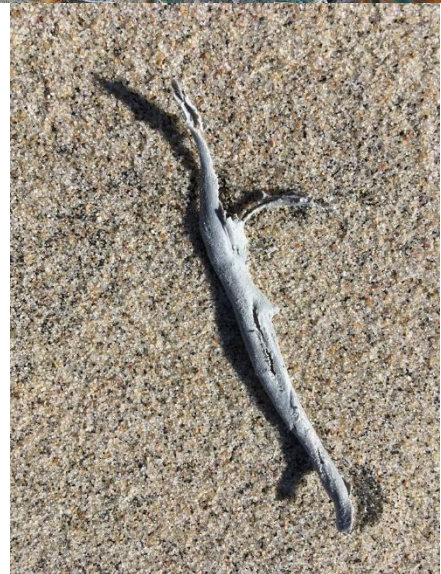
Figure 1.10. Examples of the gabion fragments on the beaches of the Kaliningrad Oblast, Russia.

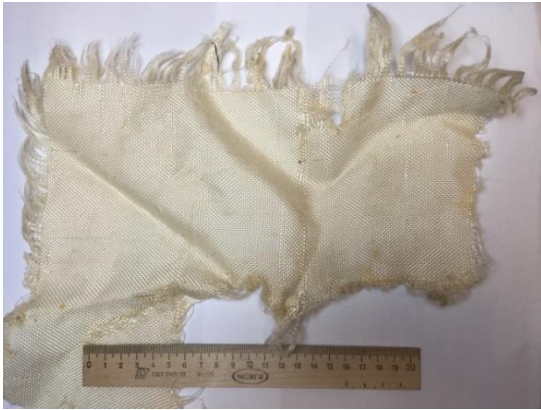
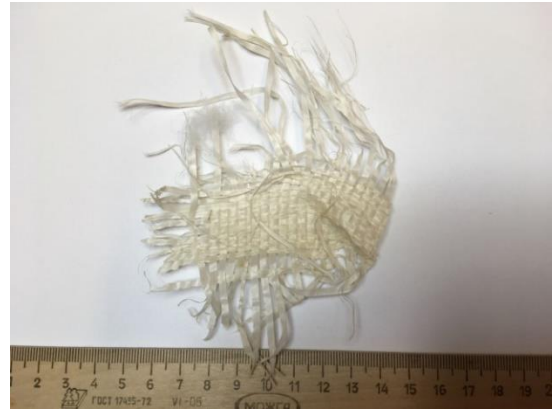
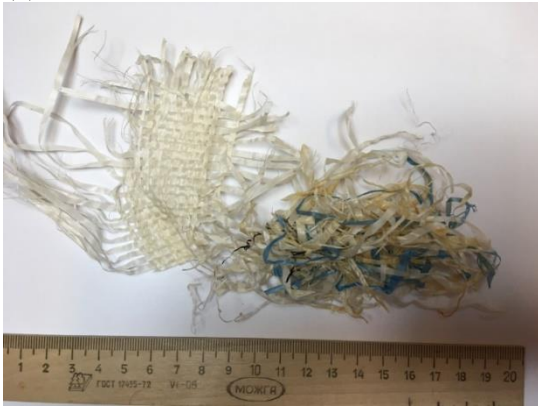
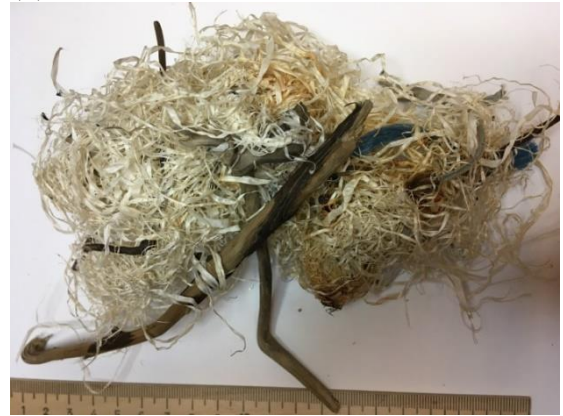
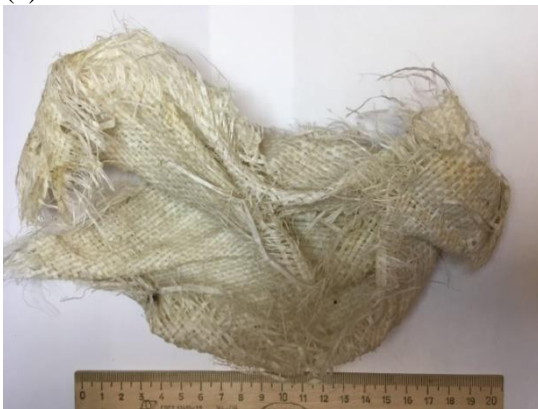
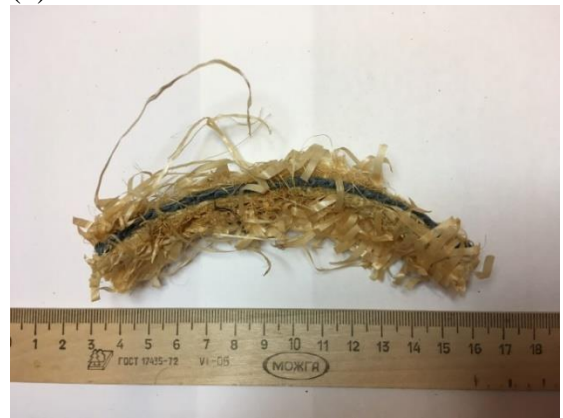
Figure 1.11. Fragments of woven material.

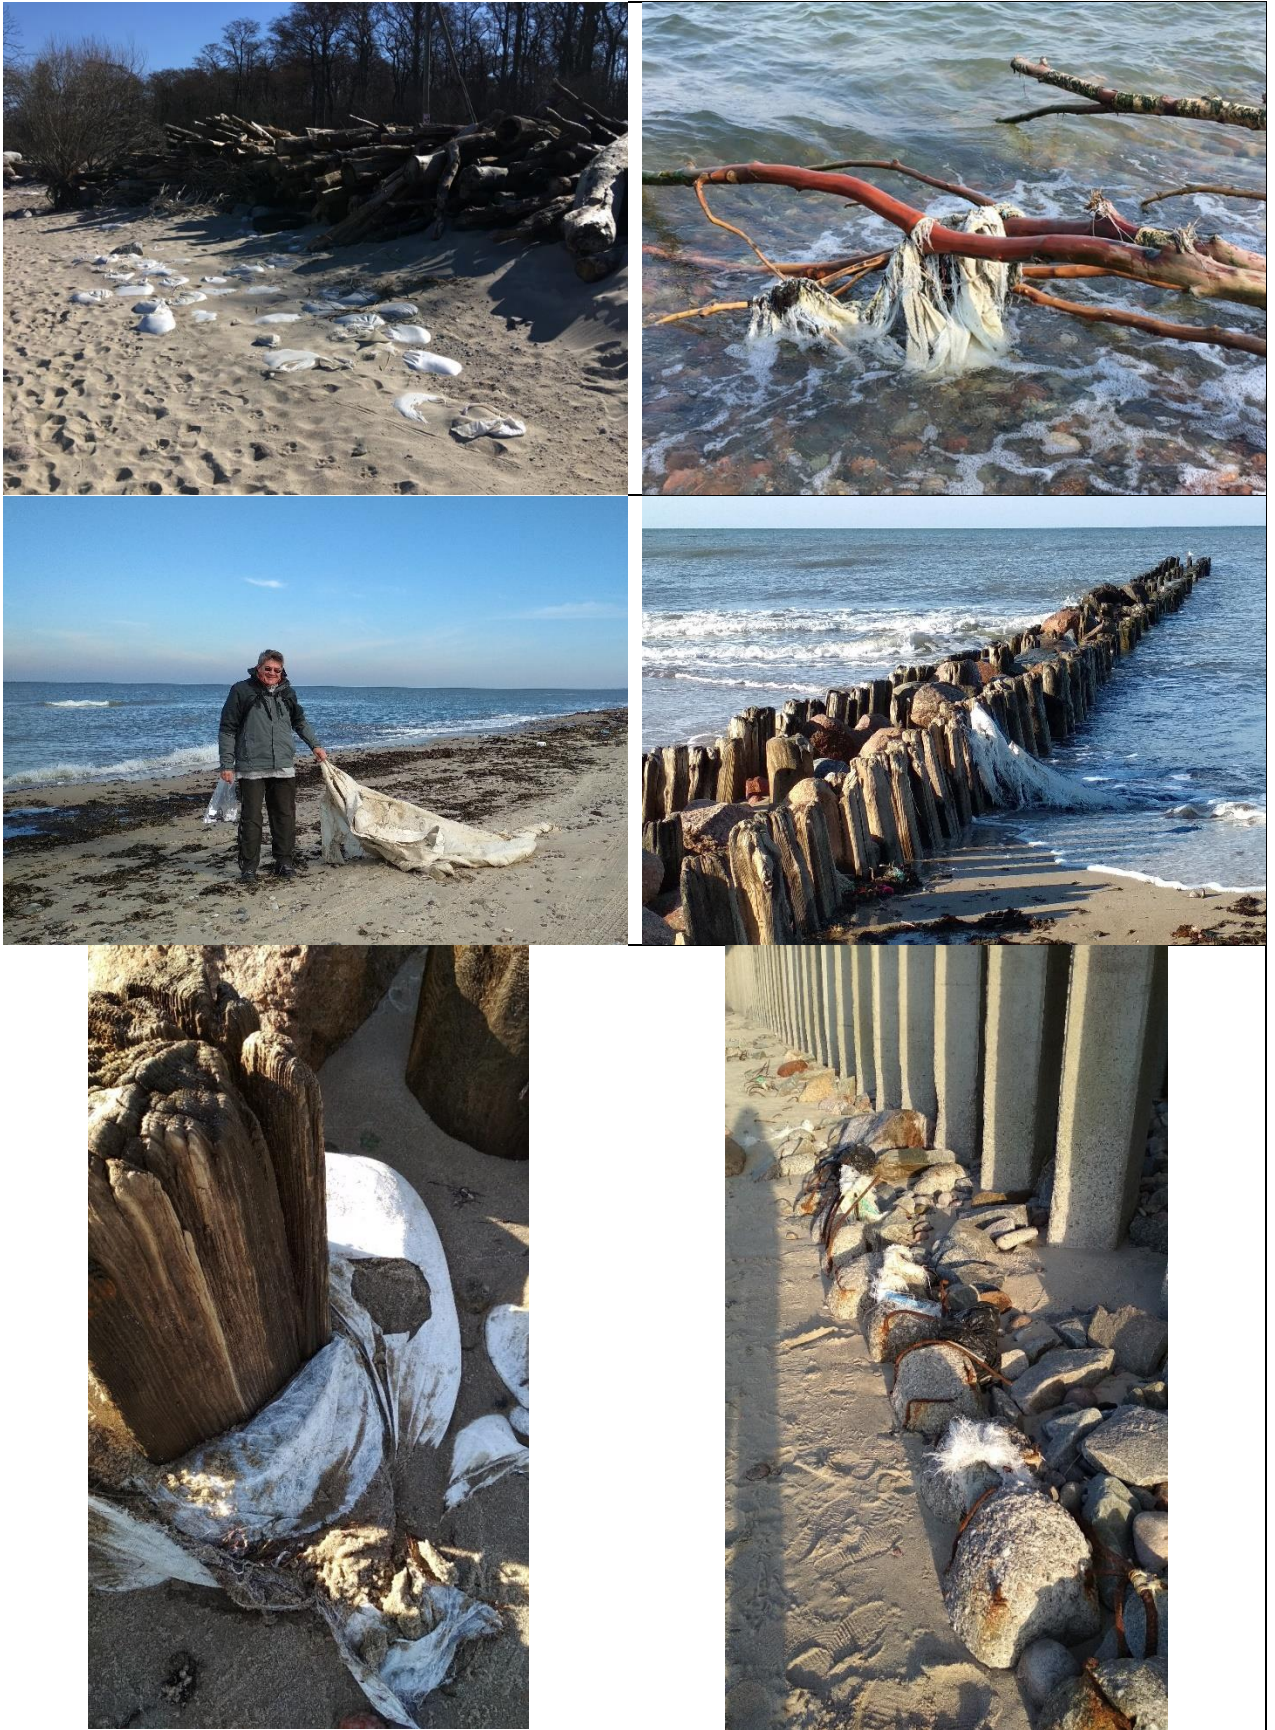
Figure 1.12. Examples of the geocontainer fragments on the beaches of the Kaliningrad Oblast, Russia.

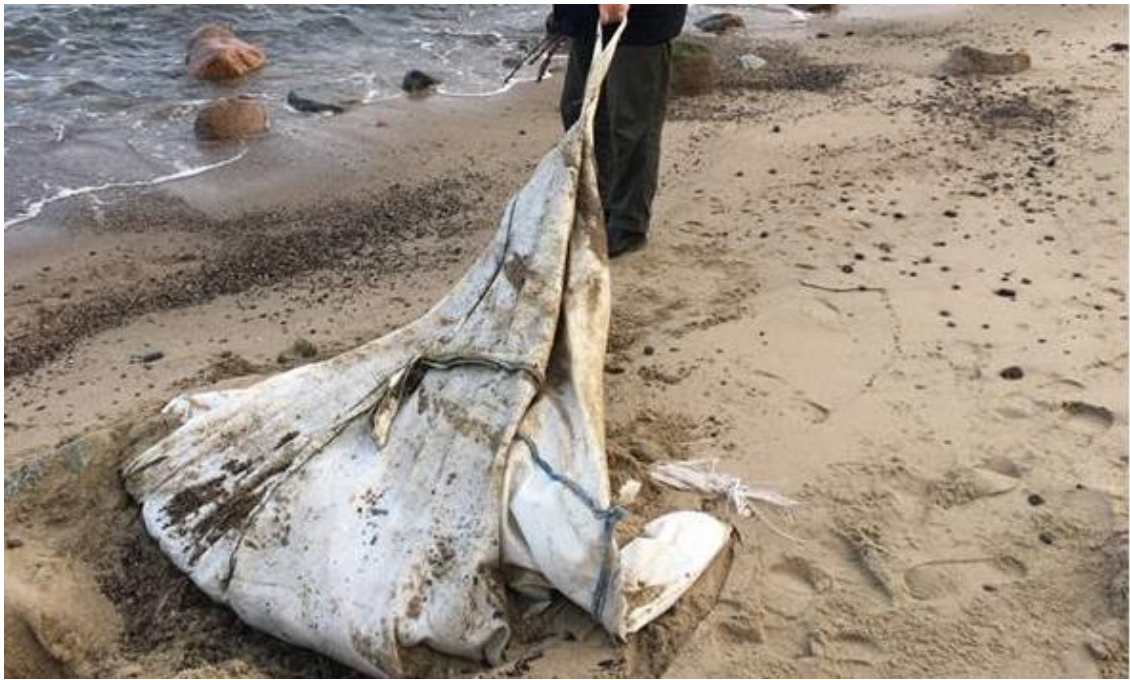
Figure 1.13. Used geotextile (a woven bag, HDPE, PP).

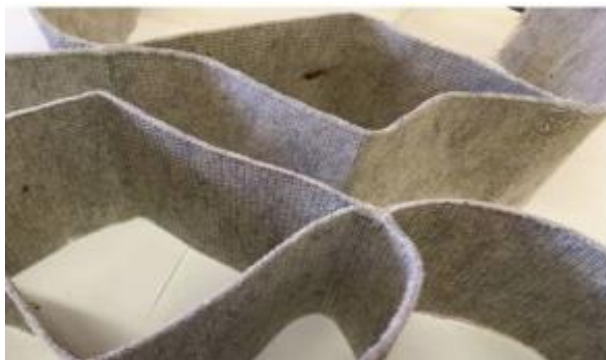
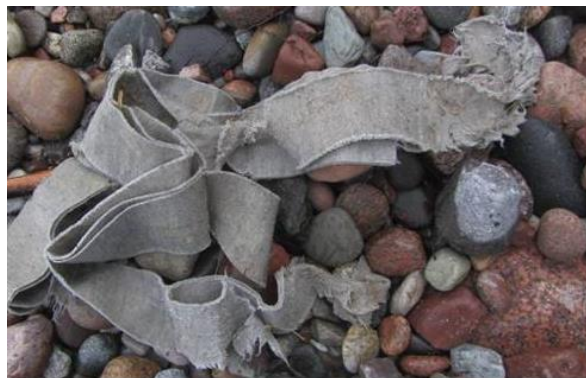
Figure 1.14. Geocells are made from PP, HDPE or PE fibres.

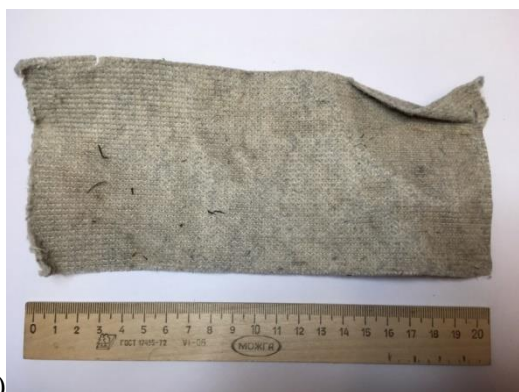
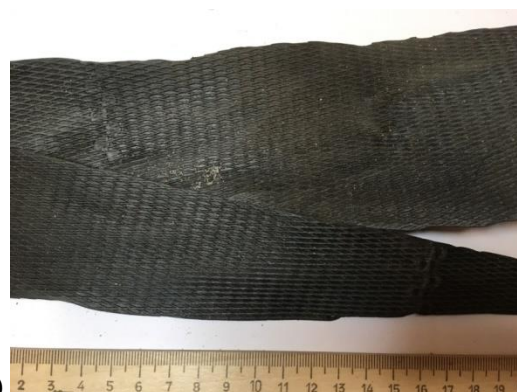
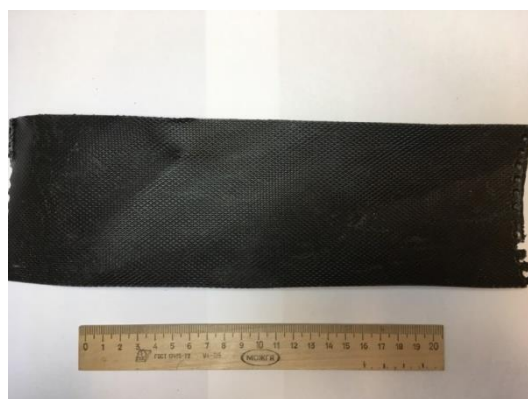
Figure 1.15. Fragments of the tape from which geocells are produced.

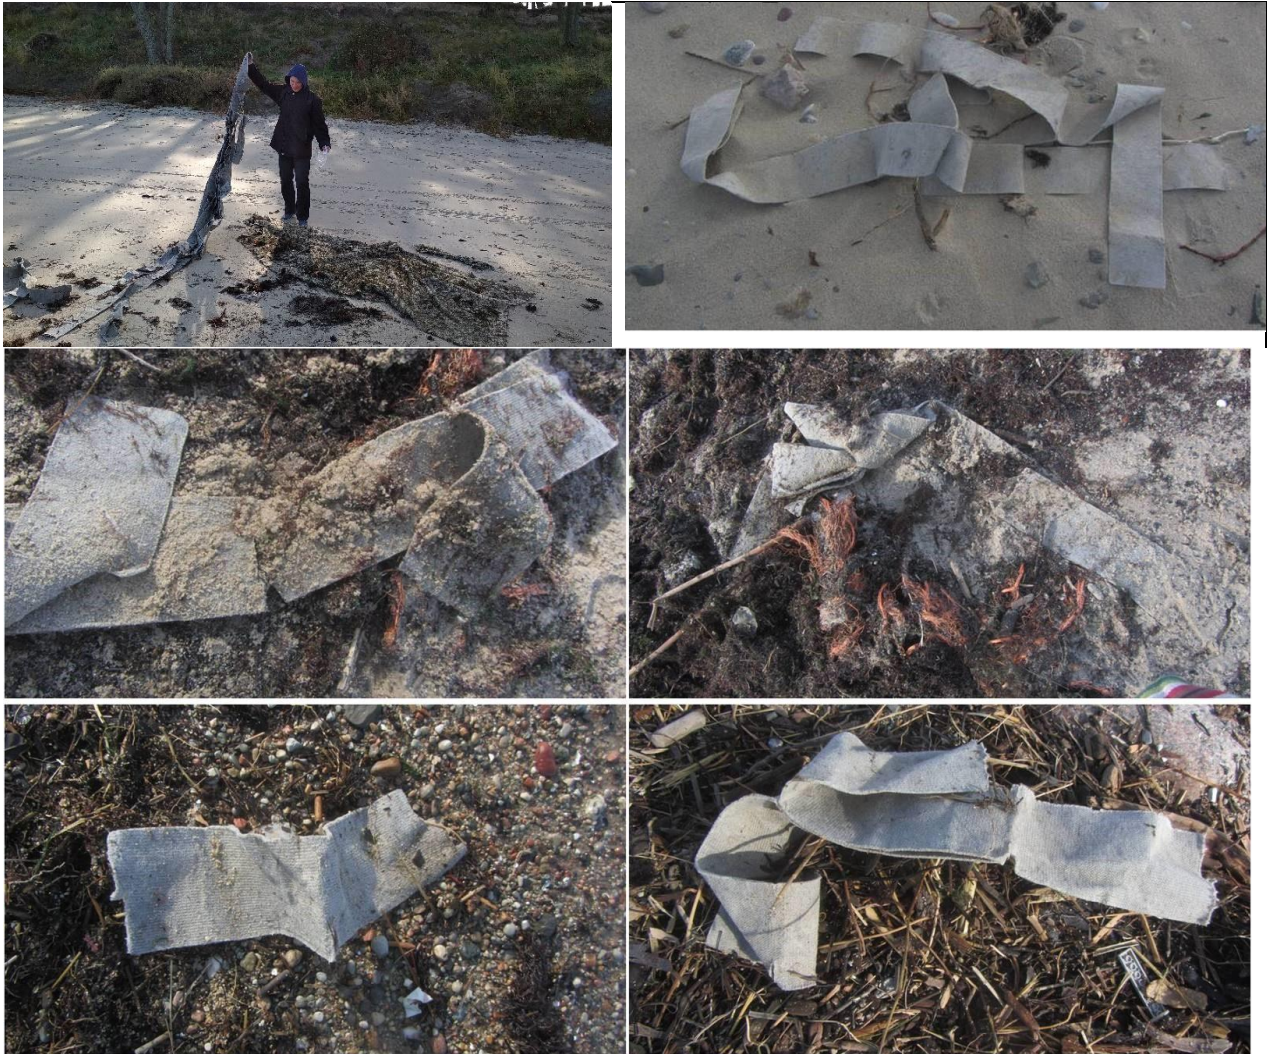
Figure 1.16. Examples of the geocell fragments on the beaches of the Kaliningrad Oblast, Russia.

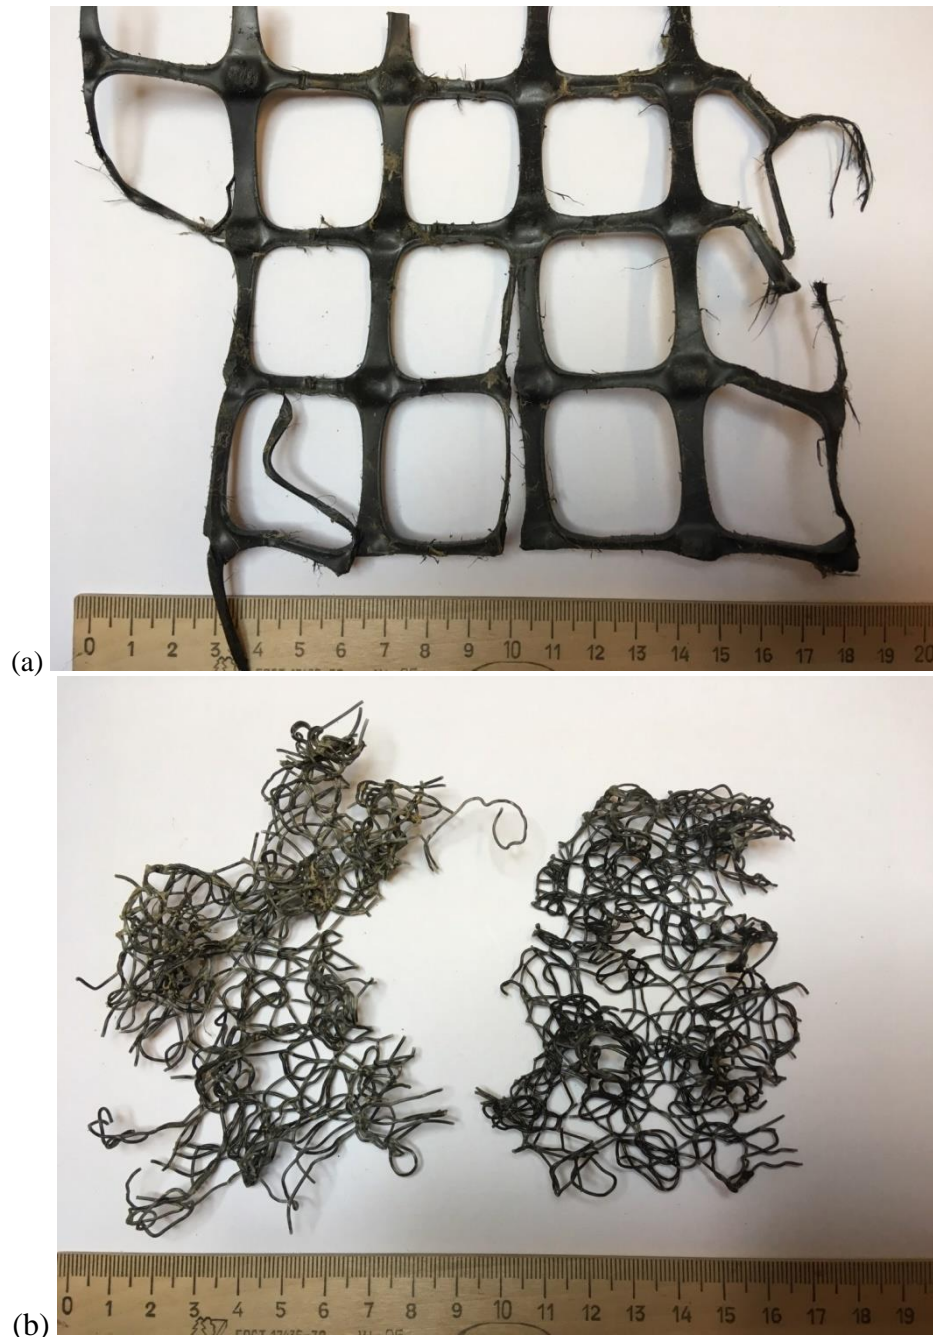
Figure 1.17. Fragments of the geomat.

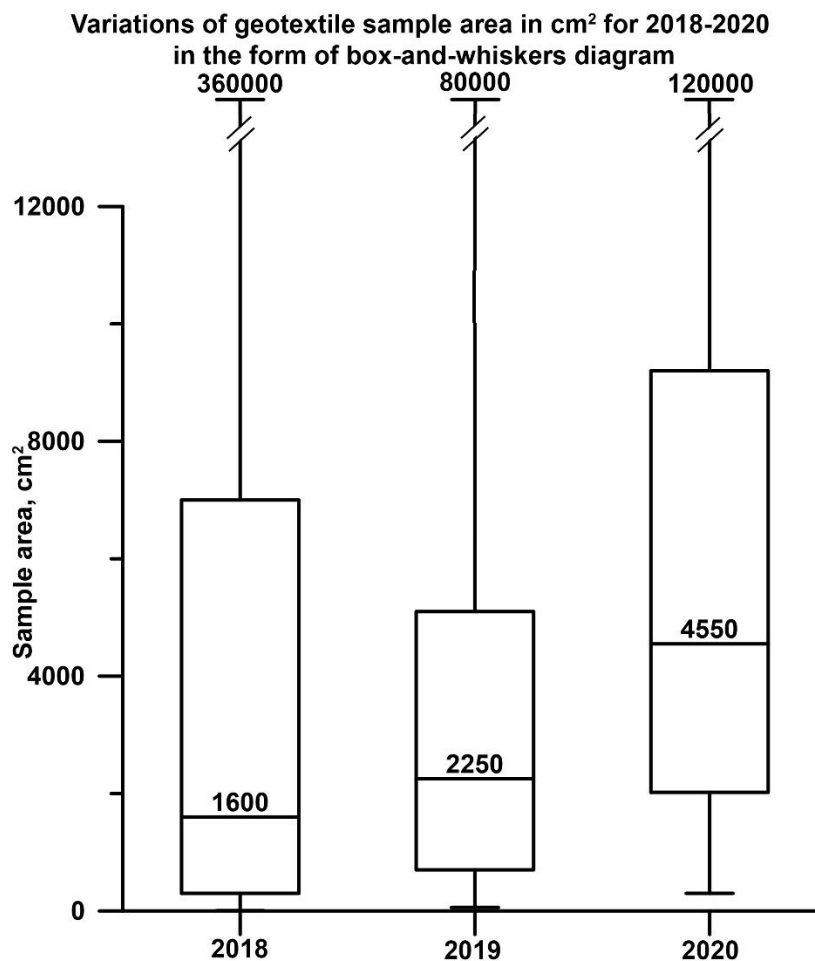
Figure 3.1. Variation of geotextile sample area in cm² for 2018-2020 in the form of a box-and-whiskers diagram. The label inside the box is the median value, the label above the upper whisker is the maximum value.

The statistics on sample size are presented in the form of a box-and-whisker diagram for debris of geotextile (Fig.3.1), geocontainer (Fig.3.2) and gabion plastic coating (Fig.3.3) for each monitoring year. For geotextile and geocontainer, variations of a sample area (cm²) are presented (Figs 3.1 and 3.2), while for gabions, the variations of a sample length (cm) are presented (Fig. 3.3).

On each box-and-whisker diagram, the label inside the box indicates the value of the median sample size. Upper and lower whiskers correspond to the maximum and minimum values. The upper whiskers are also labelled.

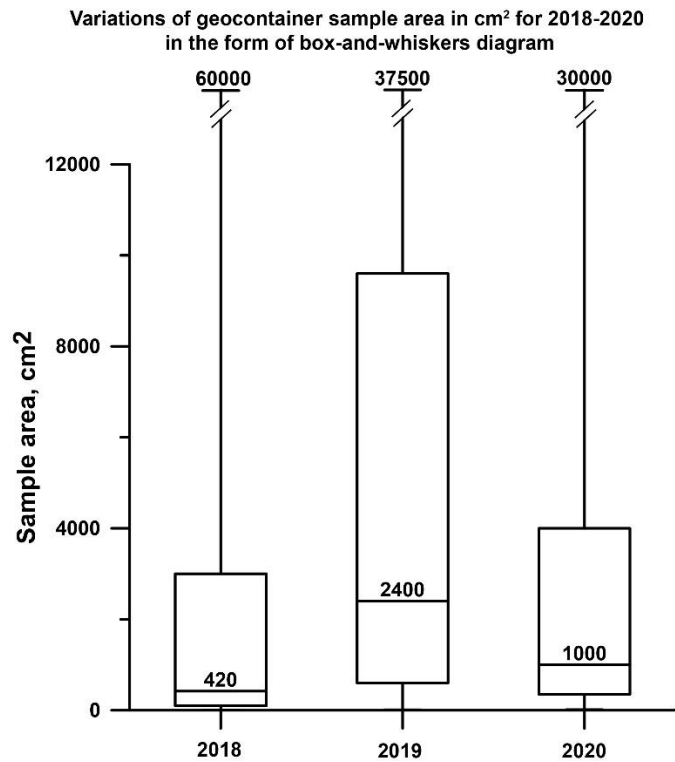
Figure 3.2. Variation of geocontainer sample area in cm² for 2018-2020 in the form of a box-and-whiskers diagram. The label inside the box is the median value, the label above the upper whisker is the maximum value.

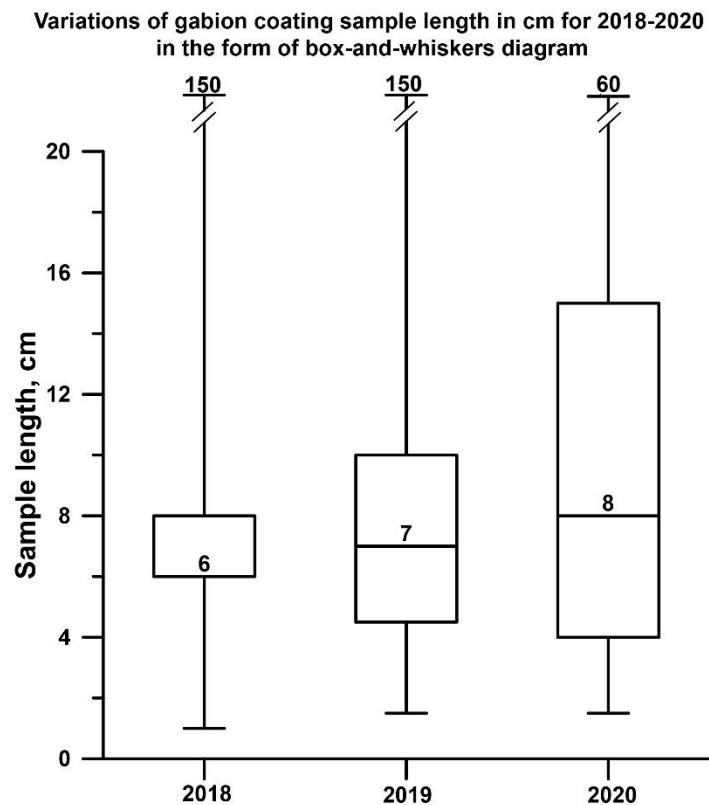
Figure 3.3. Variation of gabion plastic coating sample length in cm for 2018-2020 in the form of a box-and-whiskers diagram. The label inside the box is the median value, the label above the upper whisker is the maximum value.
