Evaluating the Performance of MCU-Coatings' Penetrating Chemical Cleaner & MCU-Aluprime Coating Over Micro-Cracked Phenolic Epoxy

TESTING MCU-COATINGS ECOCLEANER & ALUPRIME PROTECTIVE COATINGS OVER WEATHERED PHENOLIC & NOVOLAC EPOXY RESIN COATINGS

DATE: 1st February 2022

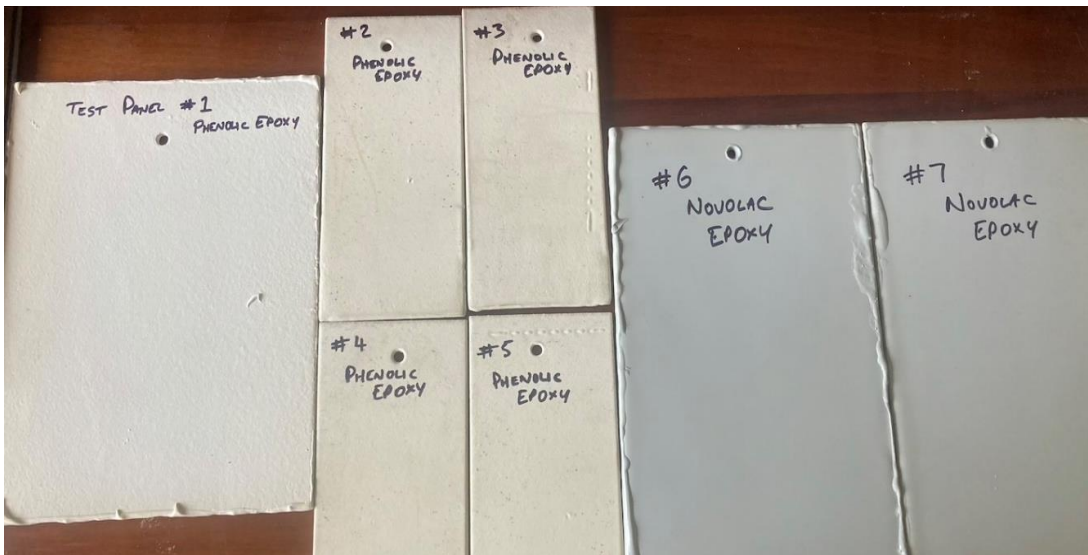
Seven test panels have been coated Numbers 1 to 5 are phenolic epoxy with Nos 6 & 7 are epoxy novolac.

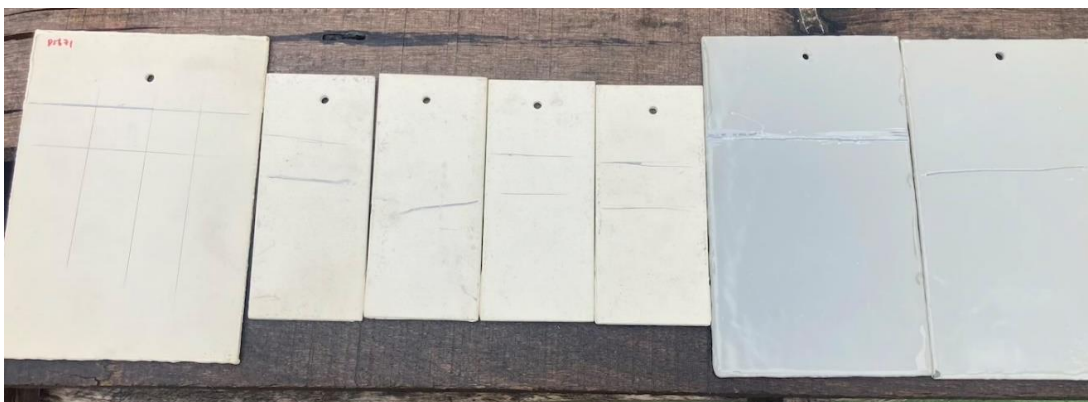
On the 19th of October these test panels were scribed to simulate cracking and then placed outside to weather. They were periodically wetted with salt water to accelerate their corrosion.

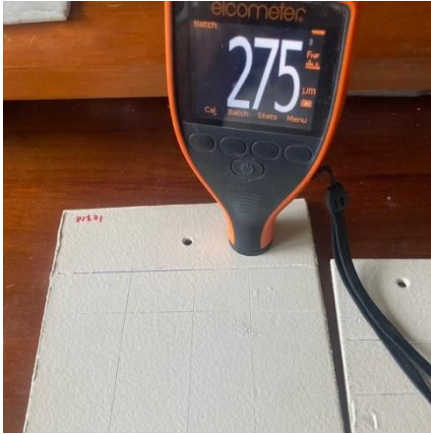
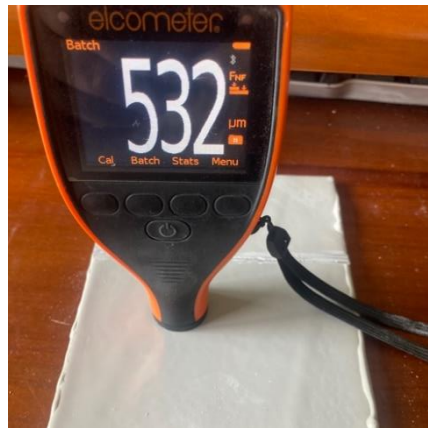
The dry film on test panels varied from 275µm (Phenolic Epoxy) to 532µm (Novolac Epoxy)

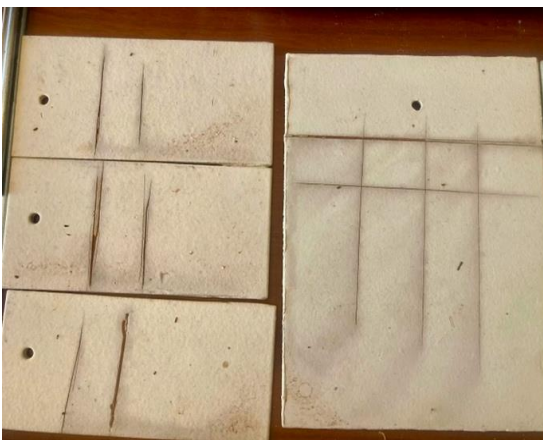
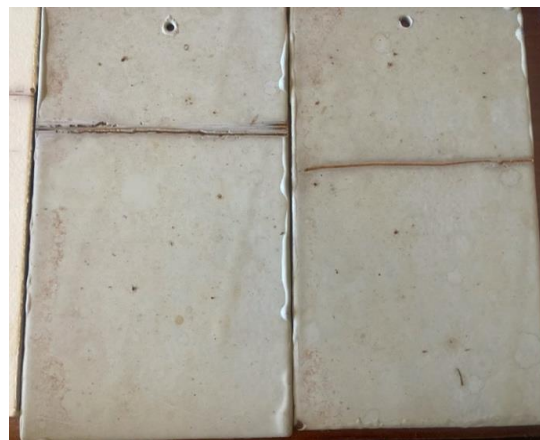
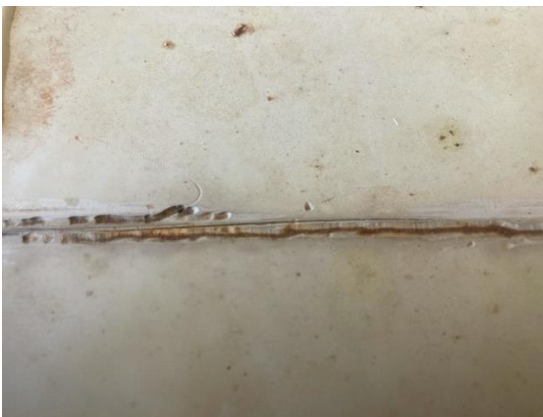
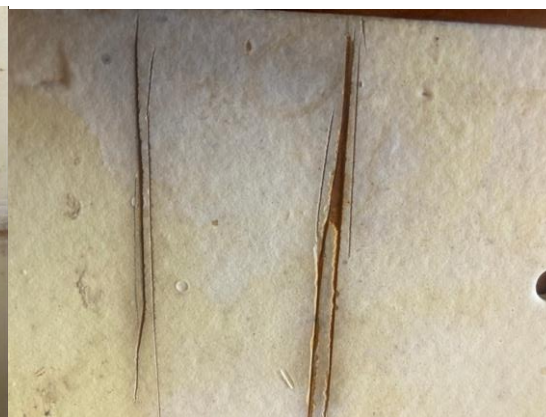
The panels were collected on the 7th of January 2022, after two and a half months, with results shown below

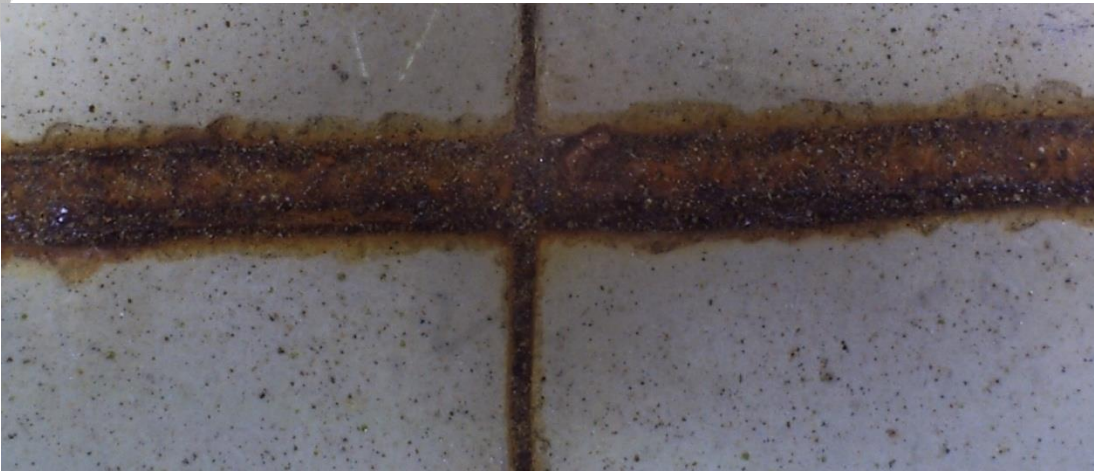
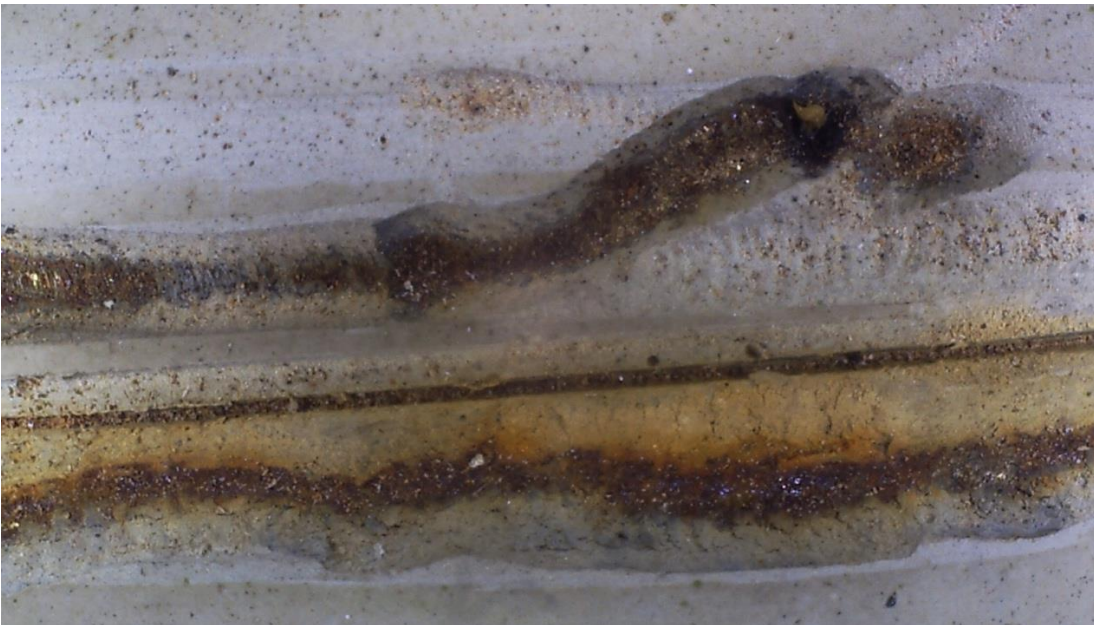
Above - Corrosion shown under 3.5x magnification

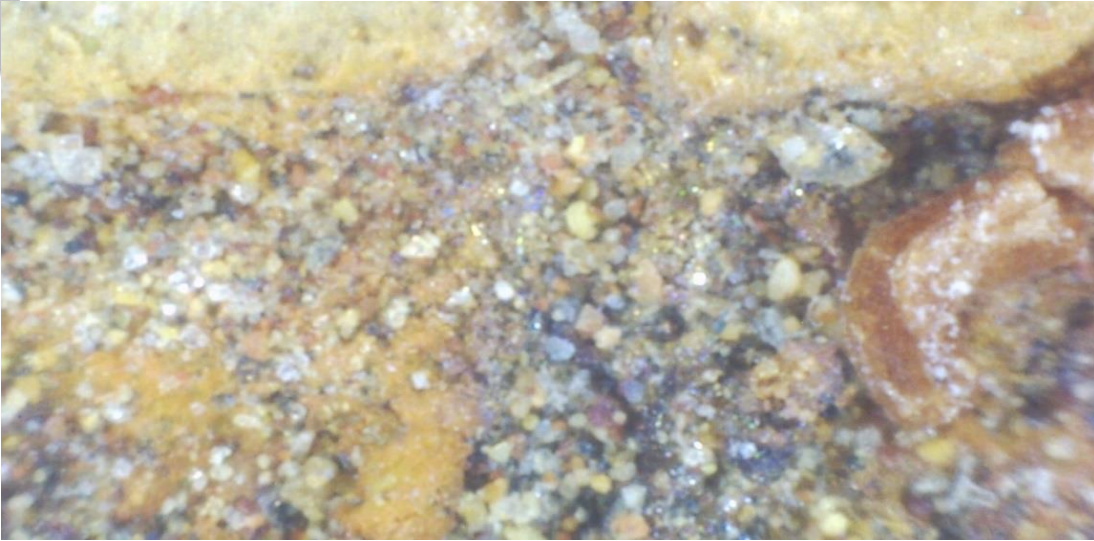
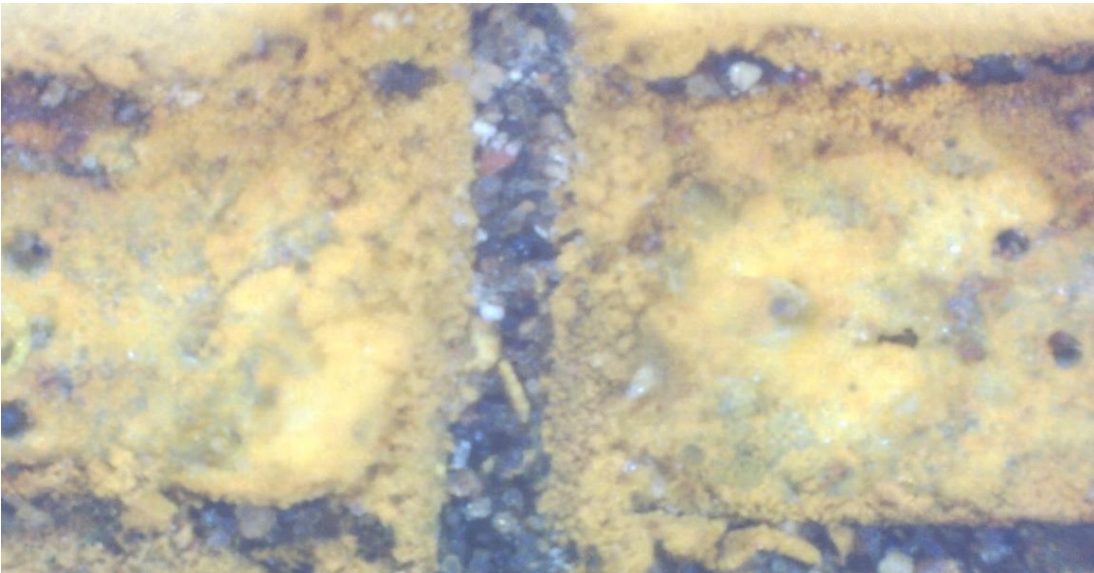
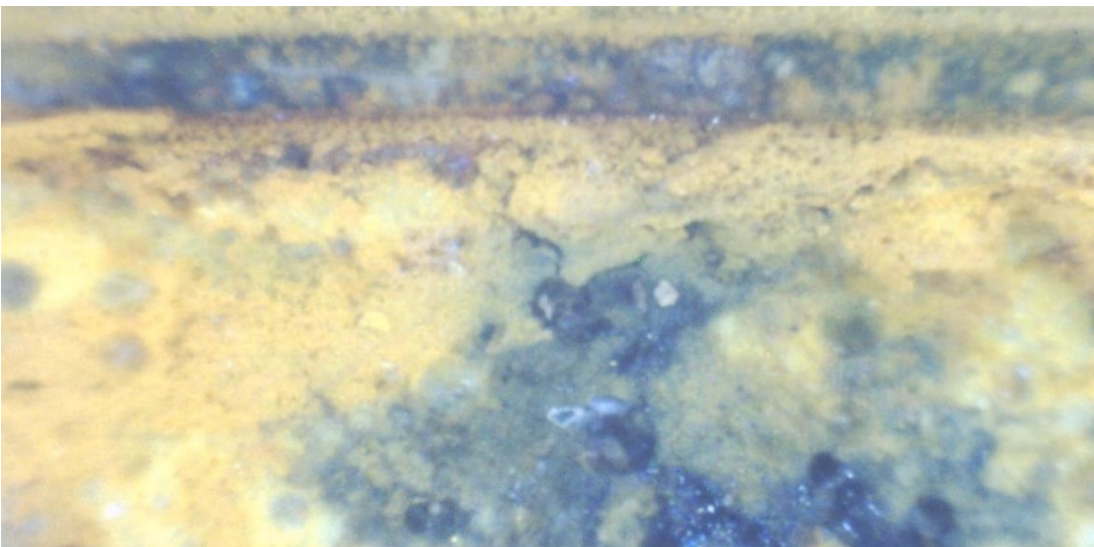
Above: - Corrosion shown at 35x magnification

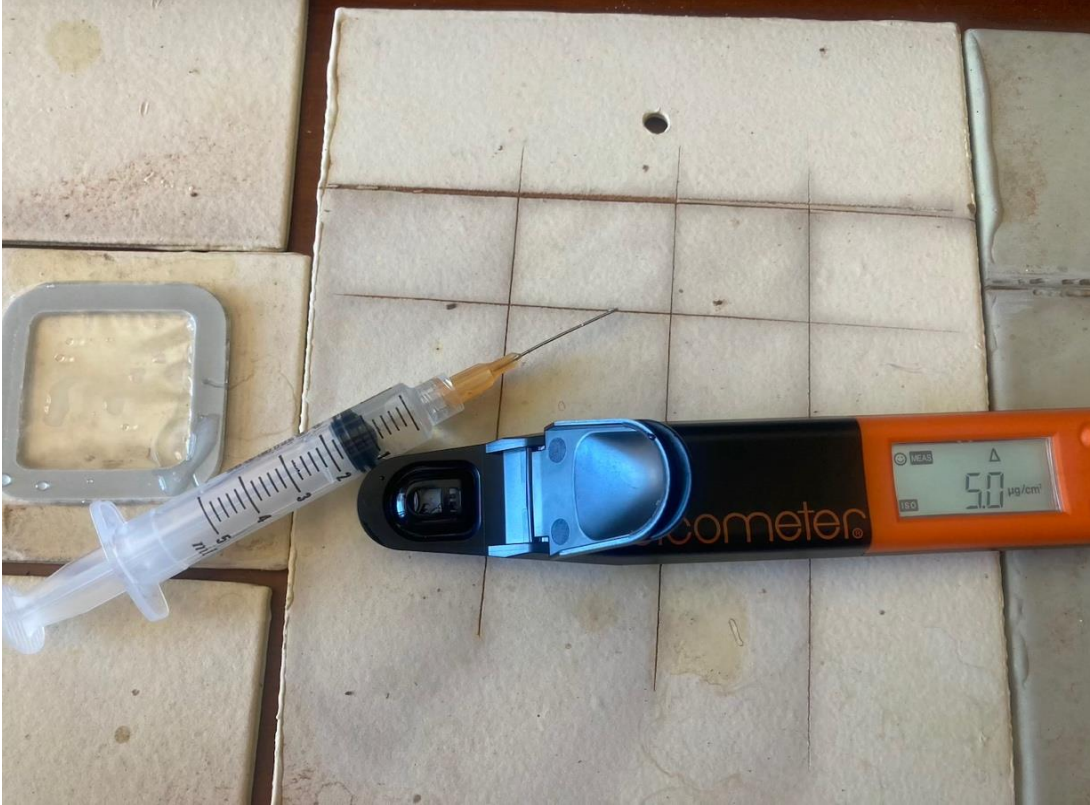
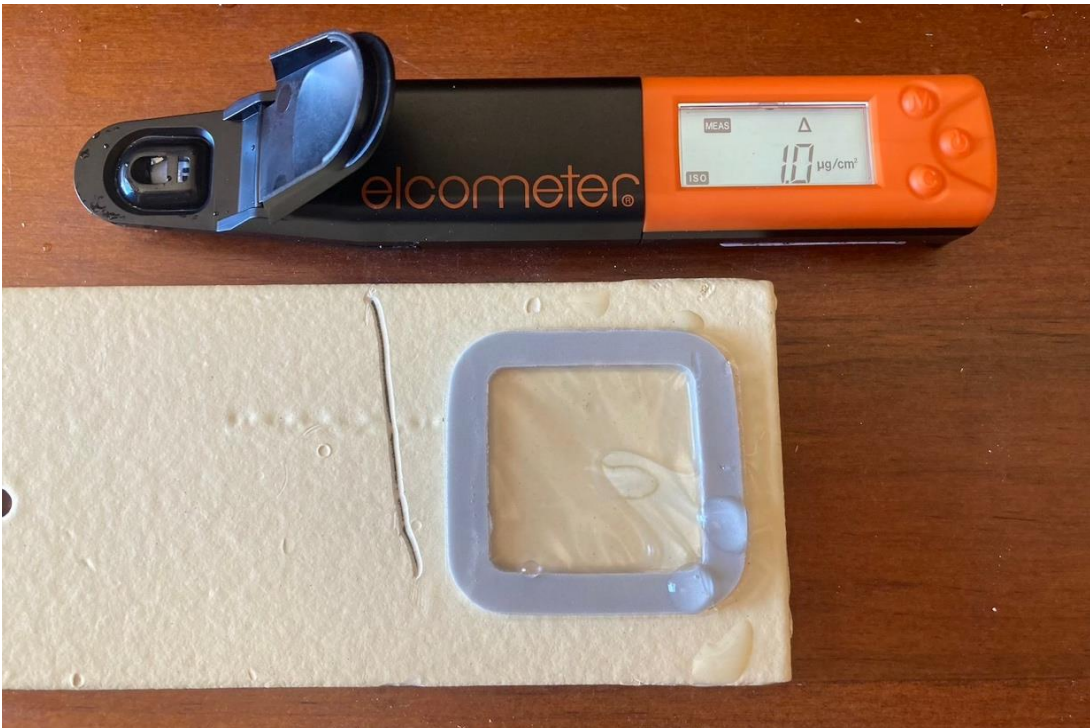
To ascertain the cleaning characteristics of MCU-Ecocleaner Gel, chloride testing using ISO 8502-9, test measurement is in $\mu\text{g}/\text{cm}^2$

Above - Confirmation of a reduction in chlorides from $5.0 \mu\text{g}/\text{cm}^2$ to $1.0 \mu\text{g}/\text{cm}^2$

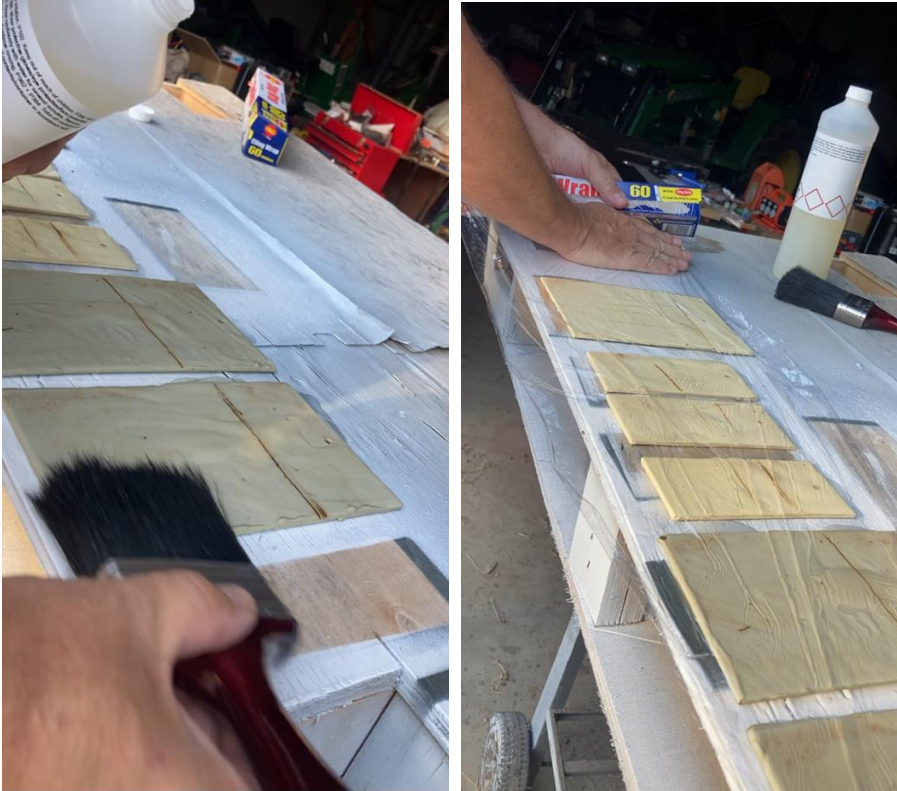
A single coat of MCU-Ecocleaner Gel applied approximately 800µm then covered with plastic film to minimise evaporation and prevent the gel from drying out.

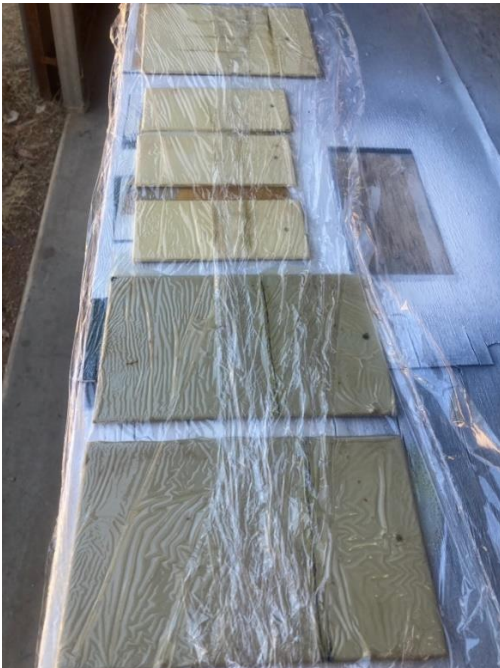
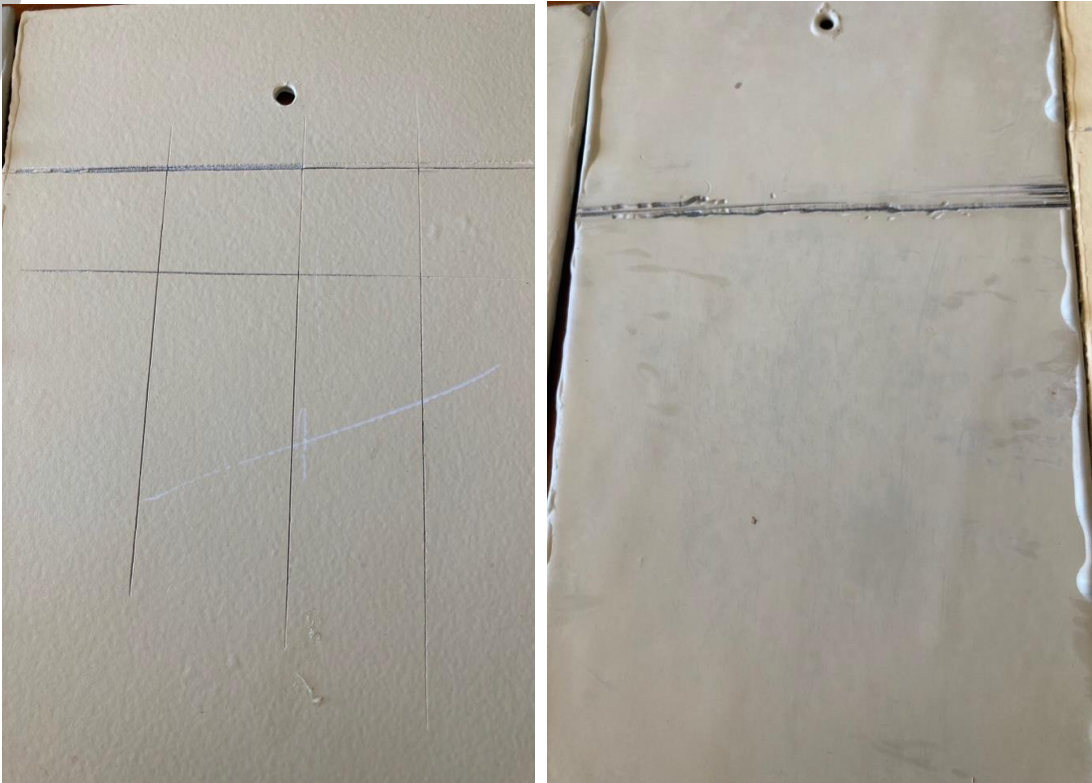
MCU-Ecocleaner Gel then left for 14 hours

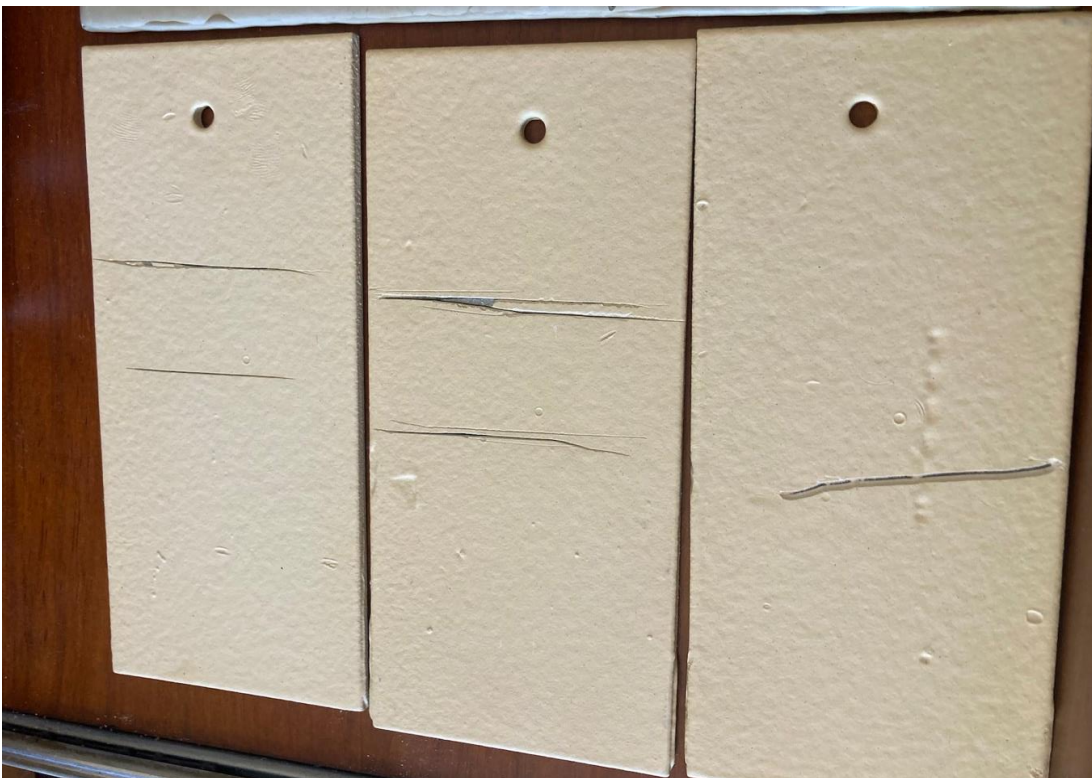
After 15 hours the panels were brushed clean with tap water

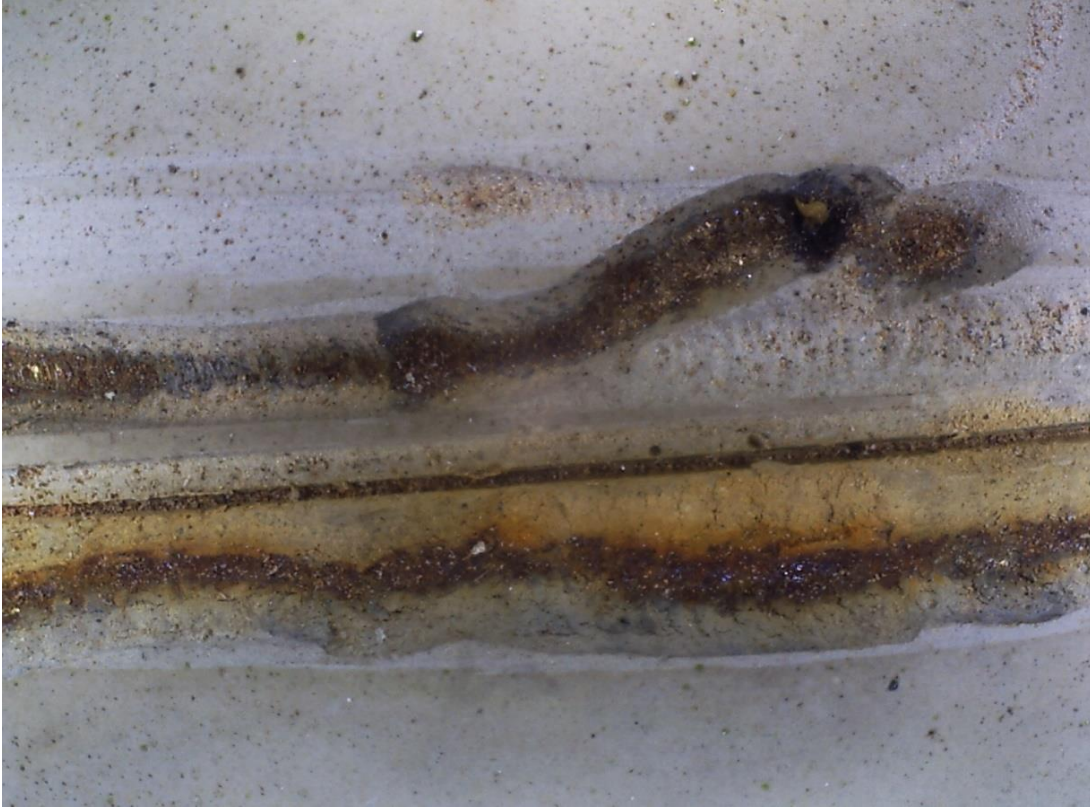
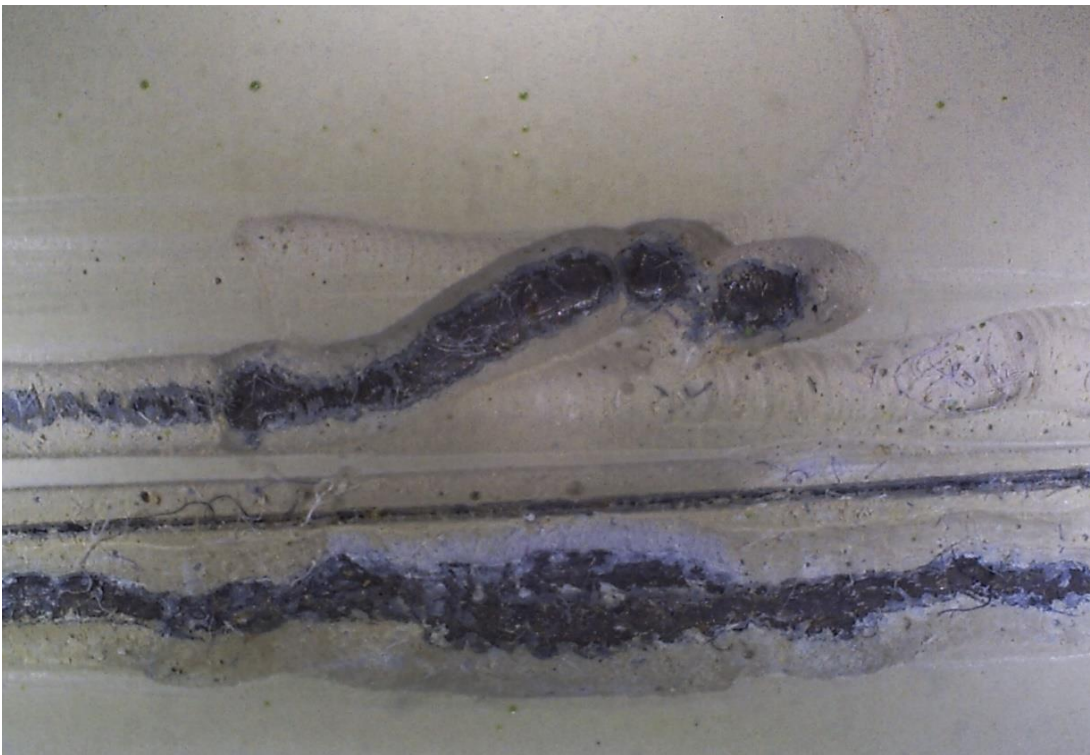
Before and after cleaning at 3.5x magnification

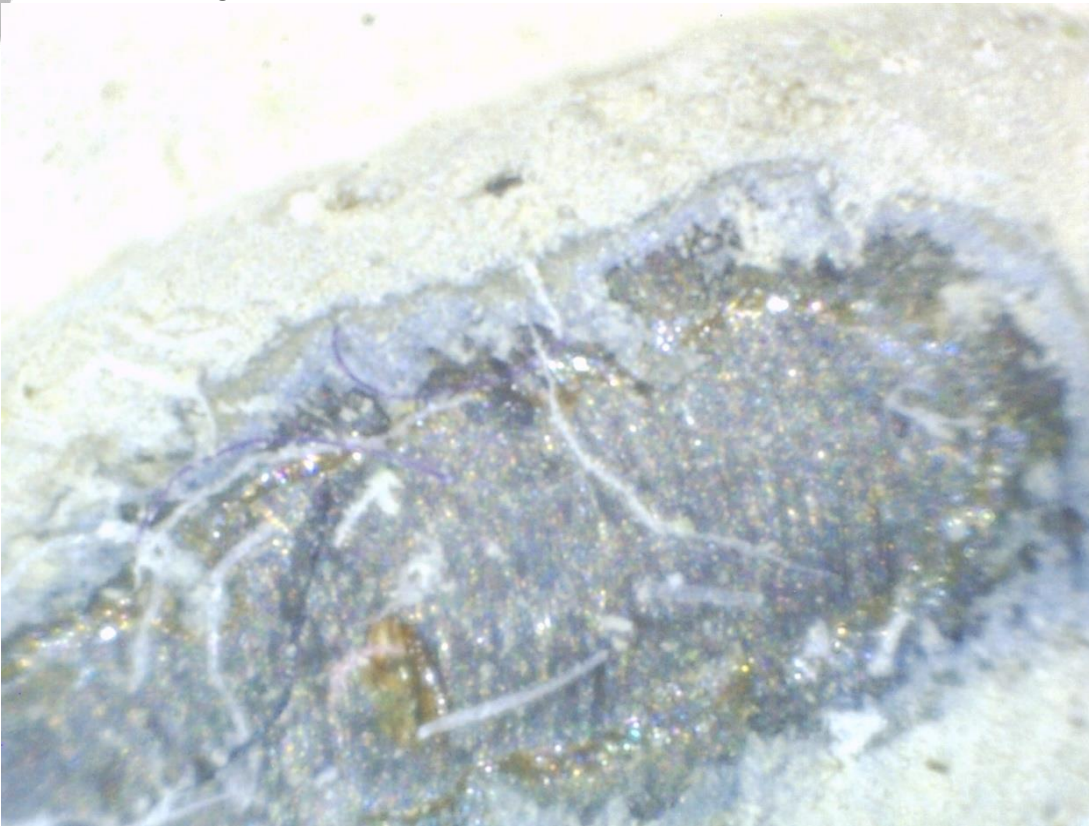
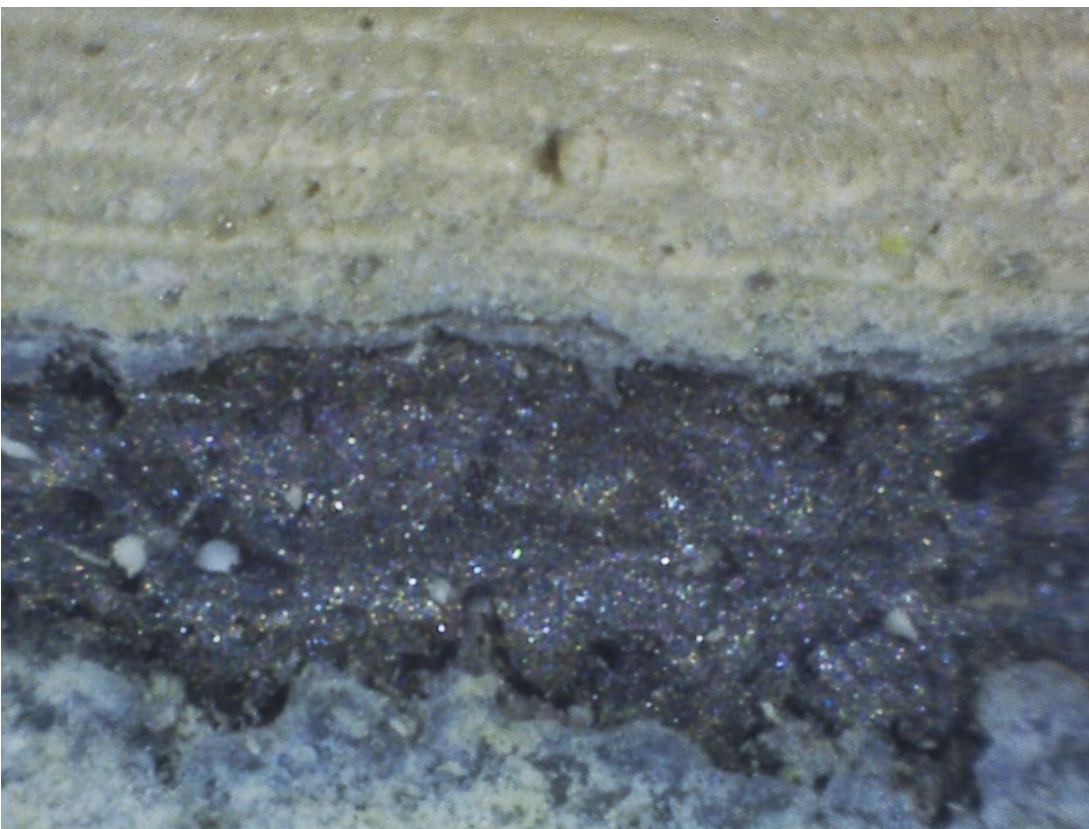
Below: At 35x magnification – resultant corrosion reduction and near elimination.

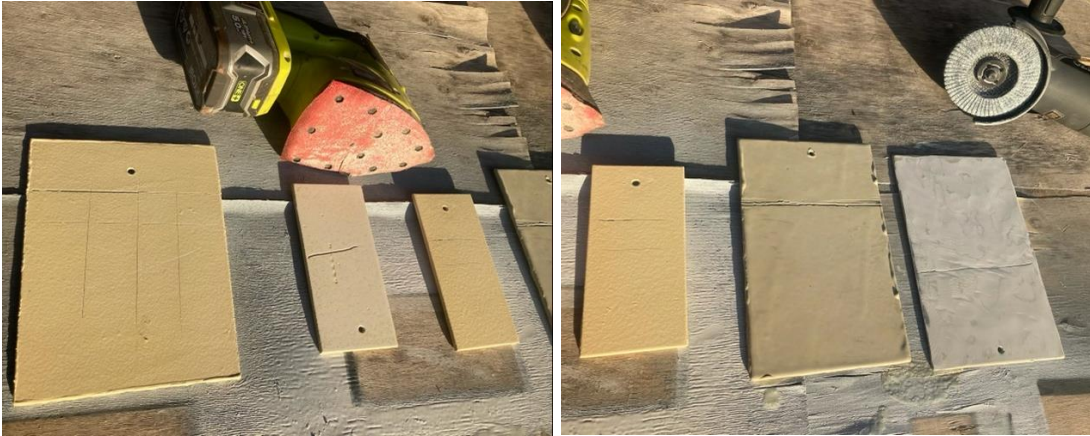
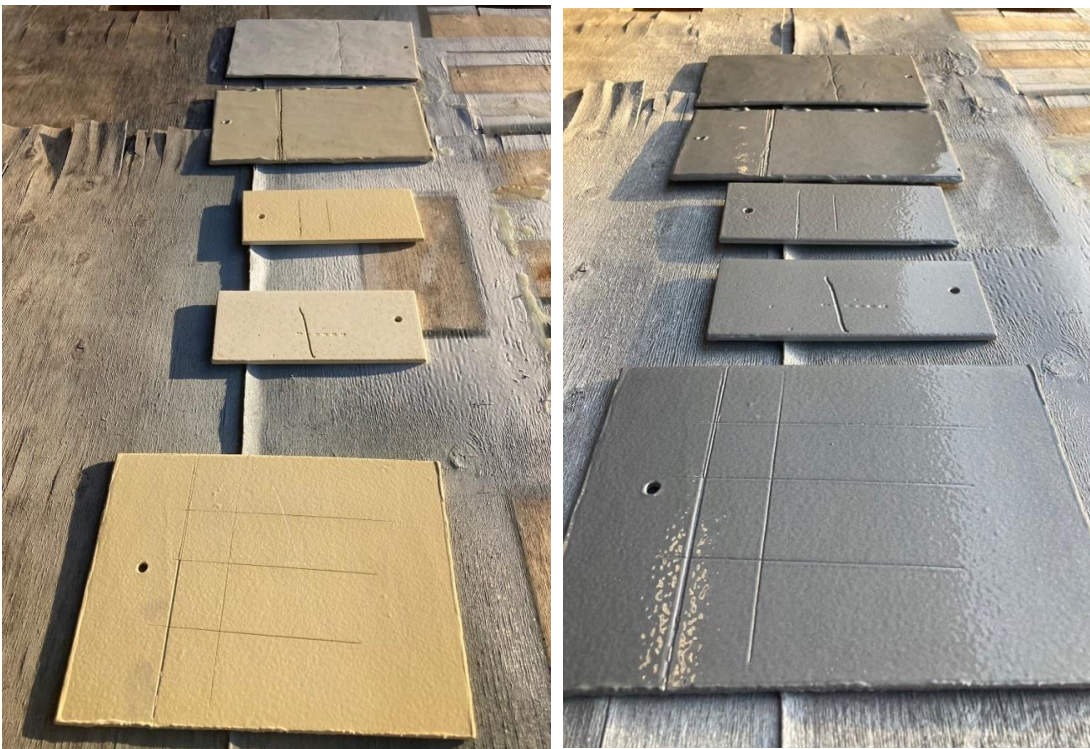
Panels #2 and #7 were power tool cleaned using 40 grit on an orbital sander (#2 Phenolic Epoxy) and 40 grit flappy wheel (#7 Novolac Epoxy)

Bottom right: After applying a single coat of MCU-Aluprime - 75 μ m WFT

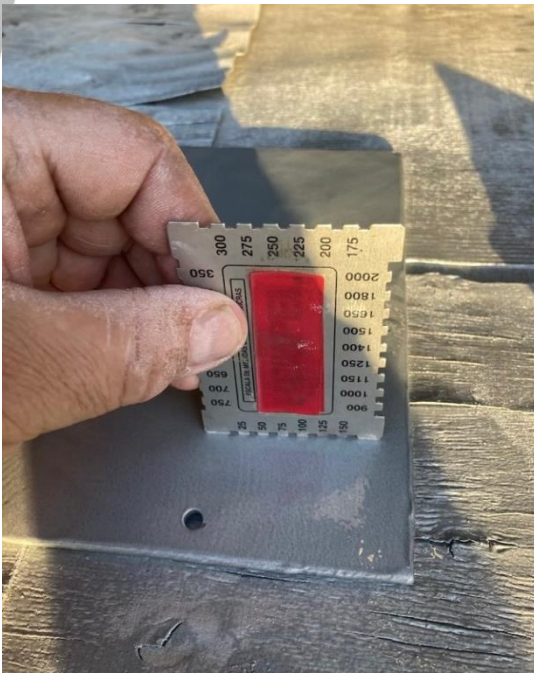
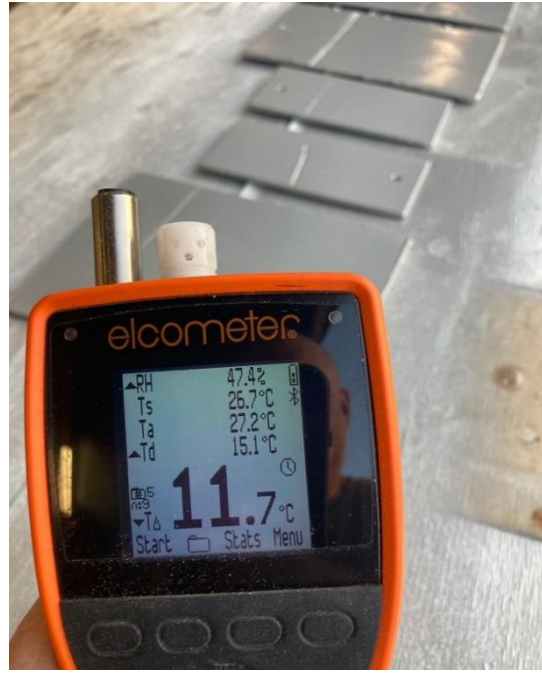
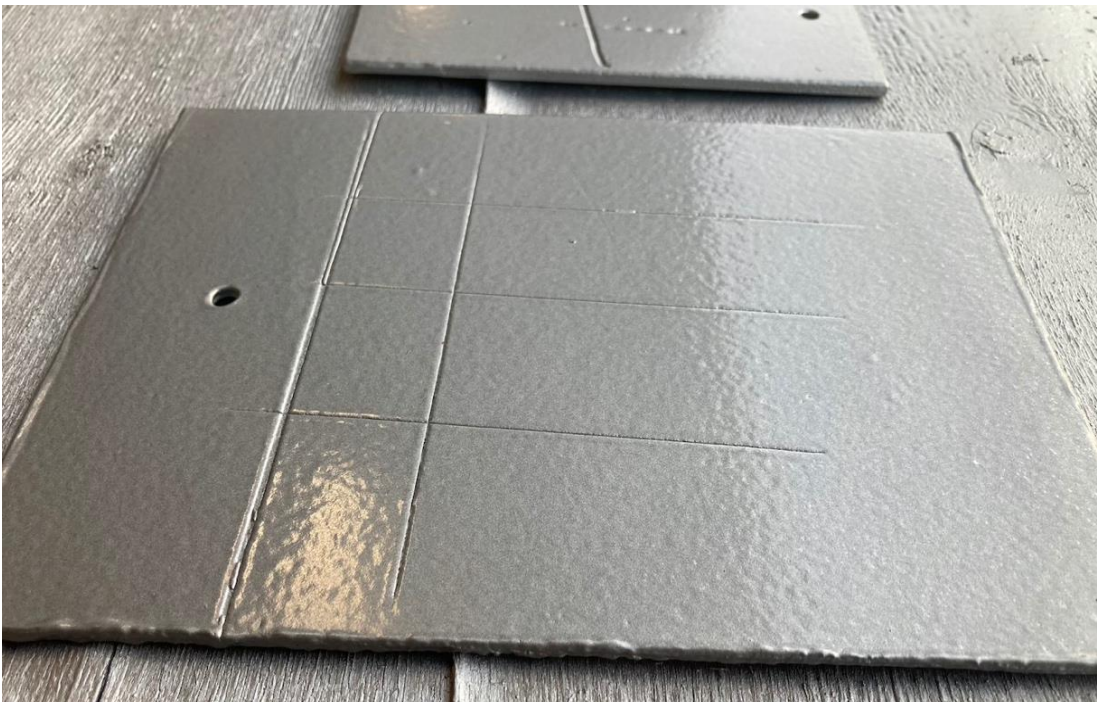
Application atmospherics were RH = 47%. Surface temperature of 26.7°C (11.7°C above dew point)

MCU-Aluprime – Applied with a conventional gravity feed spray gun using a 1.3mm fluid tip.

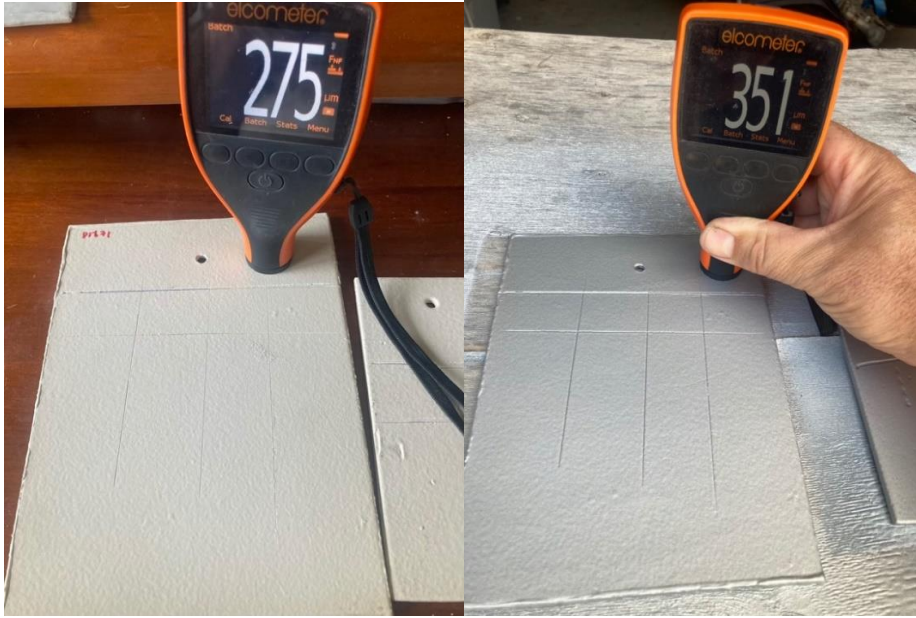
MCU-Aluprime DFT averaged 65µm

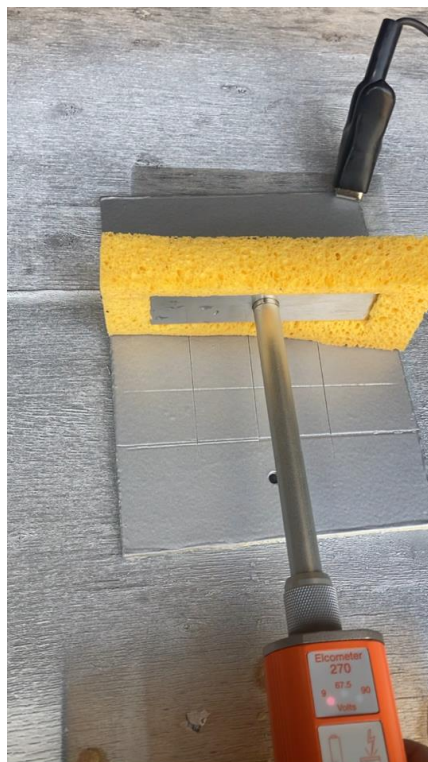
Using an Elcometer 270 Pinhole Detector to NACE SP 0188 set at 9v DC (for up to 300µm as film to be measured is below 70µm), no porosity was detected over the scribed areas.

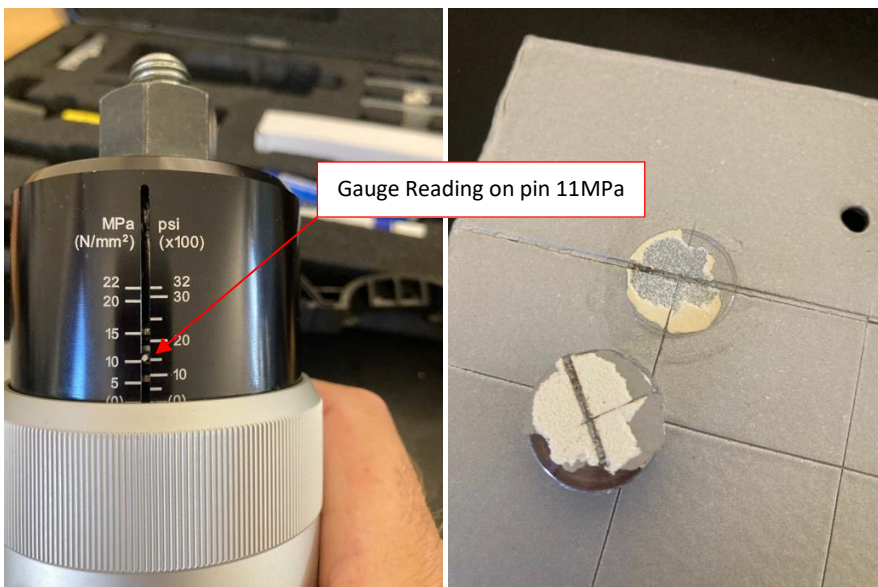
Panel # 1: Adhesion pull test value recorded was 11MPa with the failure occurring between the blasted steel panel and the phenolic epoxy. This panels surface preparation was using MCU Ecocleaner Gel only showing the Gel can clean and prepare a coated substrate to allow high levels of adhesion saving significant labour times in power tool or hand cleaning, with a simple chemical surface treatment.

Above: Adhesion measured at 11MPa on Elcometer 106 and dolly illustrating the nature of the adhesion failure

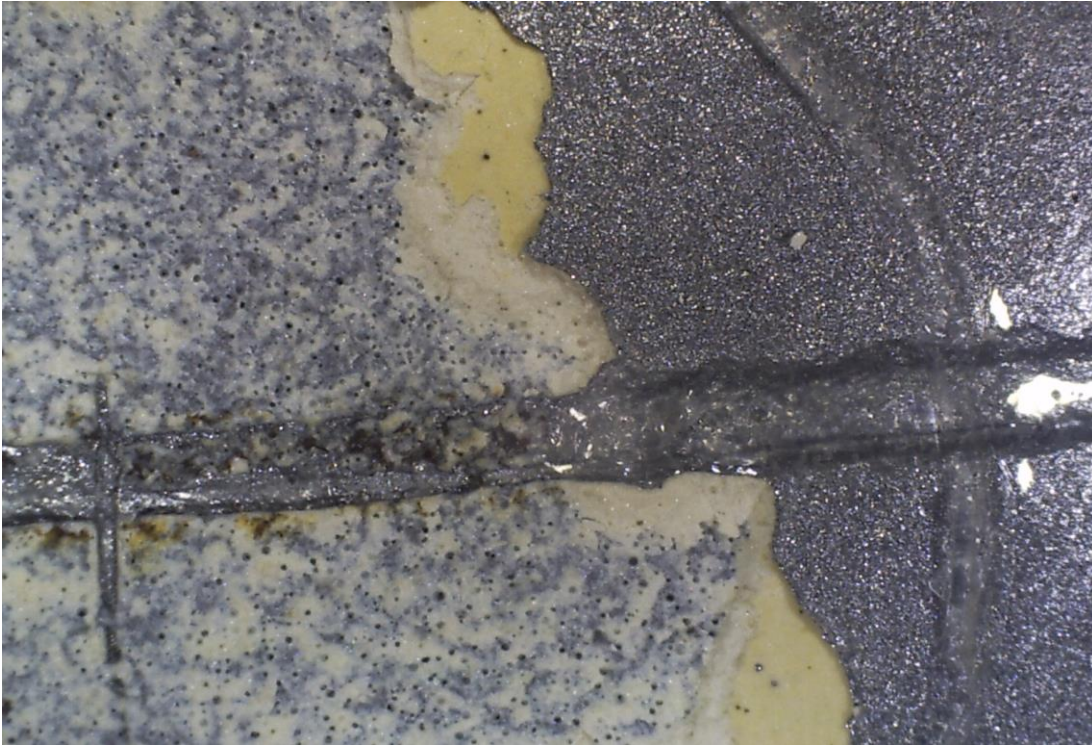
Below: Surface under 3.5x magnification showing the scribed damaged area, weathered, and corroded then treated with MCU-Ecocleaner Gel. The steel surface was clean, with the edge rust from the "rust creep" under the phenolic epoxy as it weathered.

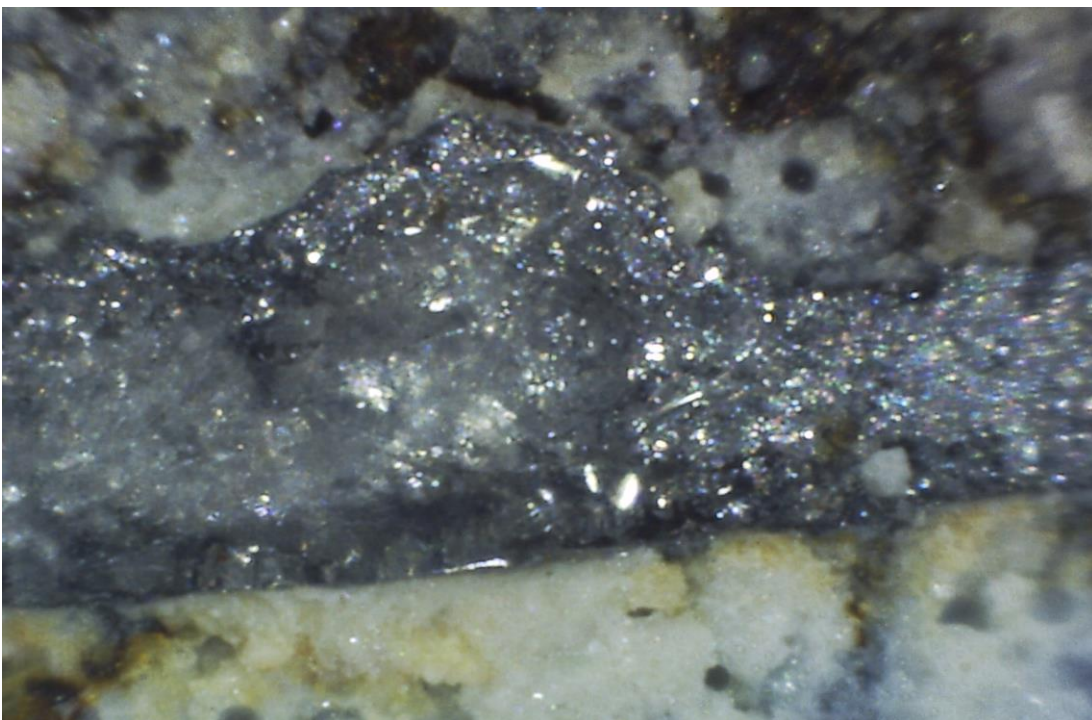
Below under 35x magnification

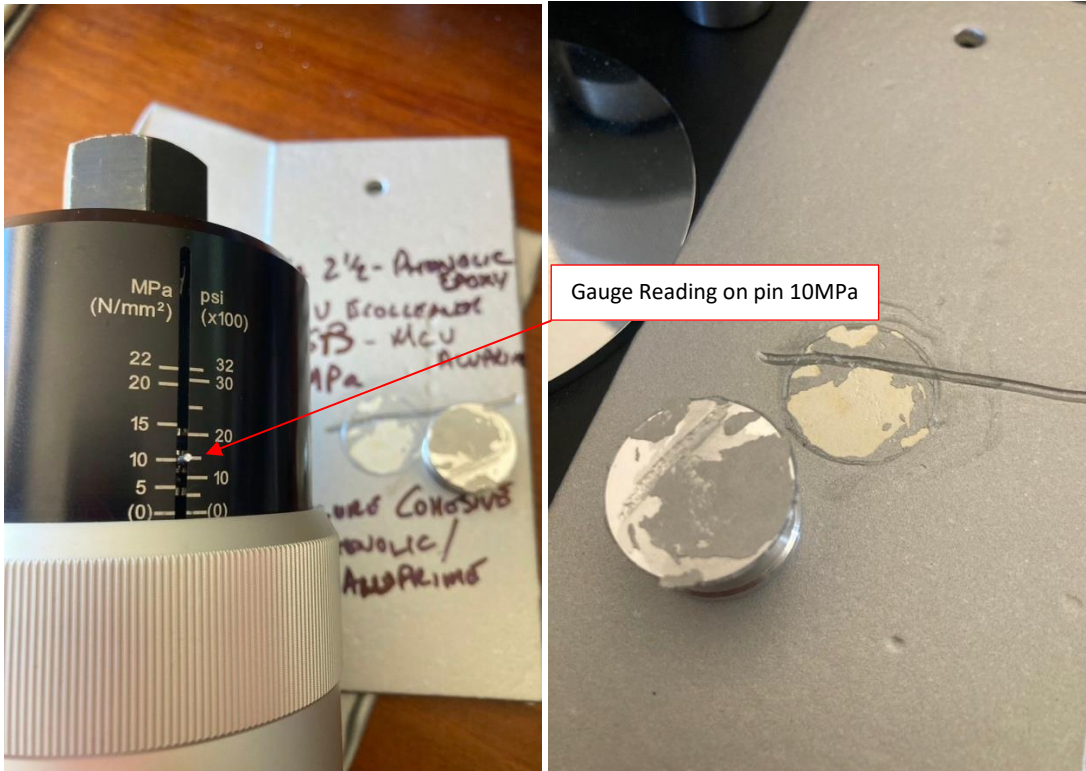
Panel # 3: Adhesion pull test value recorded was 10MPa with the failure occurring between the phenolic epoxy and the MCU-Aluprime, this panel was surface treated with MCU-Ecocleaner Gel followed by a power tool cleaning, highlighting that adding surface treatment of ST3 does little to improve adhesion. Observation to note that the scribed area weathered, corroded then cleaned with MCU-Ecocleaner Gel the MCU-Aluprime adhered while the phenolic epoxy has fractured along this transition line.

Above: shows the 10MPa adhesion value on Elcometer 106 and the nature of the failure

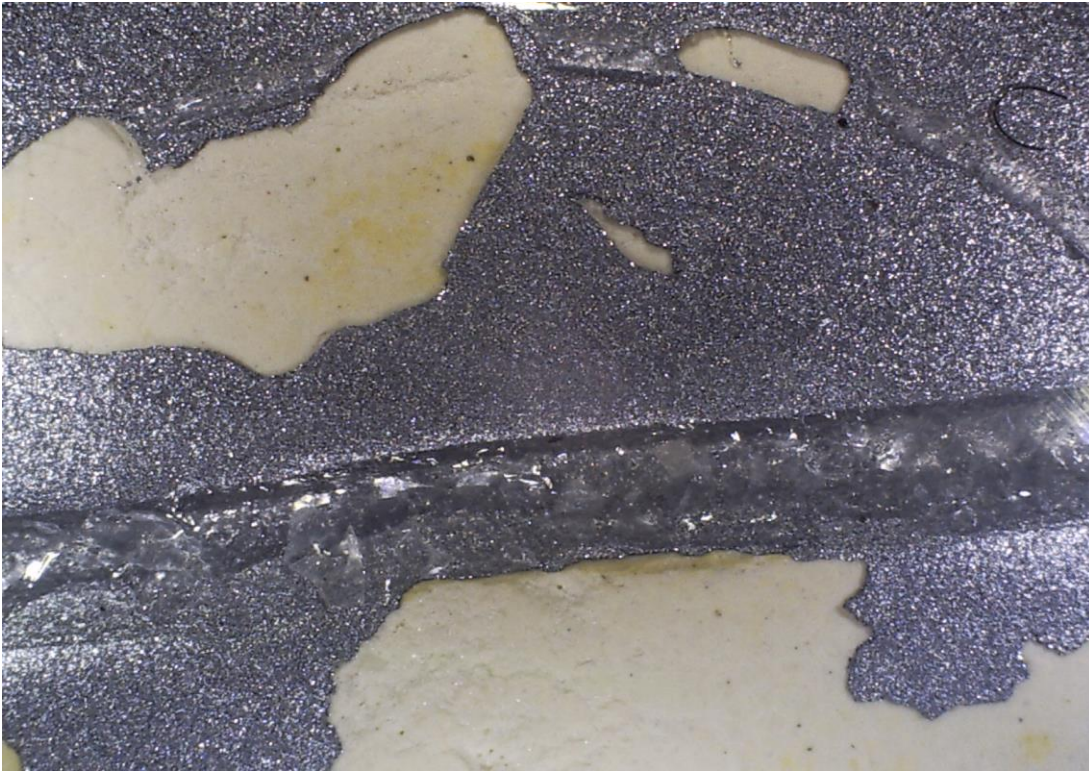
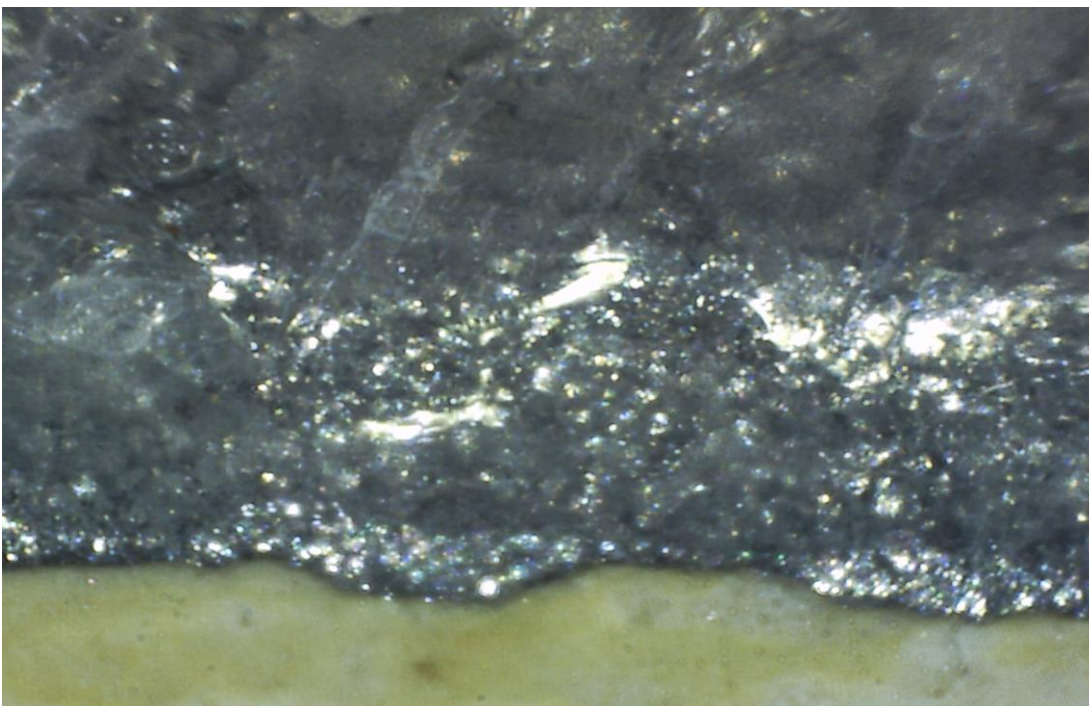
Below, at 3.5x and 35x magnification you can see the transition between scribed area filled with MCU-Aluprime is intact. This proves that MCU's adhesion on the chemically treated surface is better than the adhesion achieved by the old phenolic epoxy coating. Previously there was no method to adequately clean the micro-cracked surface.
