Evaluating the Performance of MCU-Coatings' Penetrating Chemical Cleaner & MCU-Aluprime Coating Over Micro-Cracked Phenolic Epoxy

TESTING MCU-COATINGS ECOCLEANER & ALUPRIME PROTECTIVE COATINGS OVER WEATHERED PHENOLIC & NOVOLAC EPOXY RESIN COATINGS

DATE: 1st February 2022

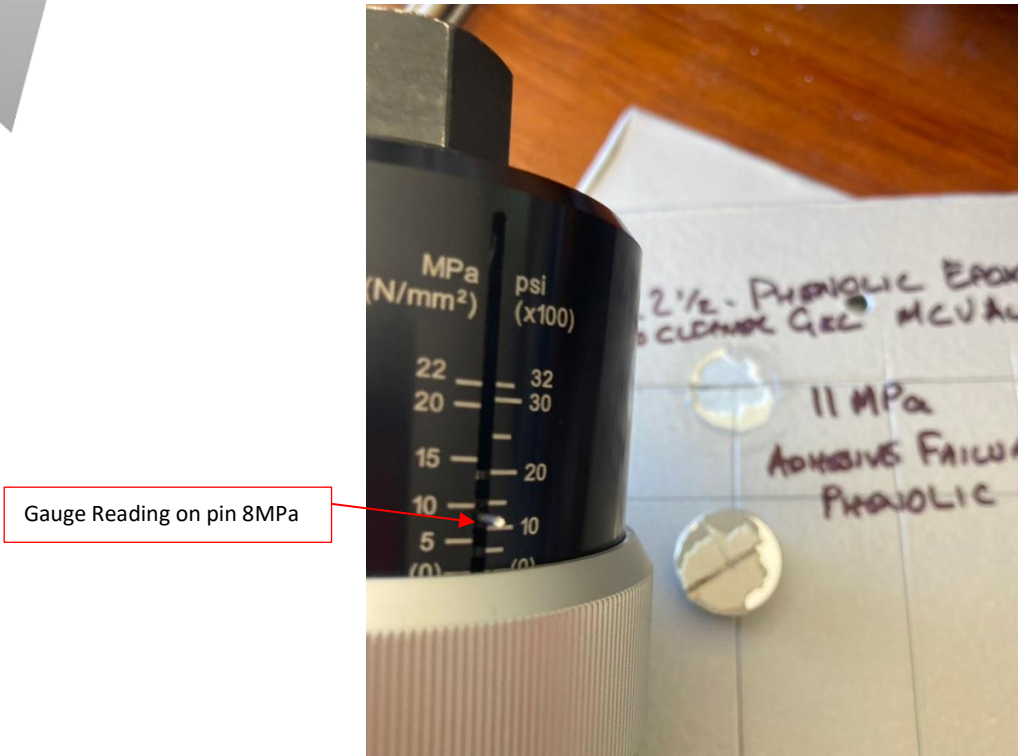
Below: Panel # 7 Adhesion pull test value recorded was 8MPa with a cohesive failure within the epoxy zinc. This was on an MCU-Ecocleaner Gel prepared surface, highlighting the solid MCU-Aluprime adhesion.

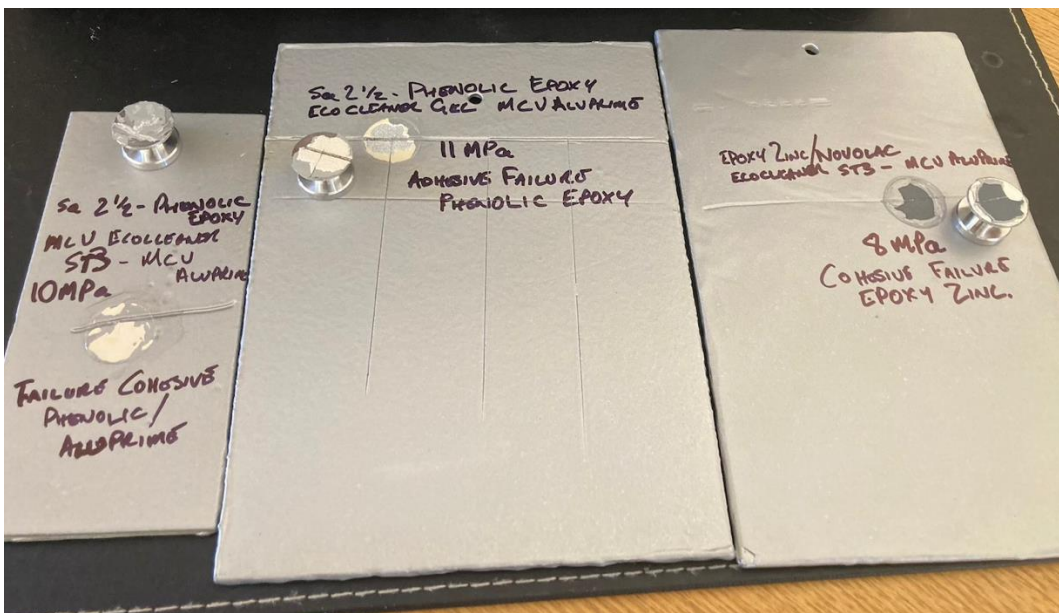
Below: Summary of the adhesion results:
