The Practical Limits of Cold Temperature Geomembrane Installation in Northern Canada

Mills, A., Fraser, B., Gulati, D.
Layfield Canada Ltd, Edmonton, Alberta, Canada

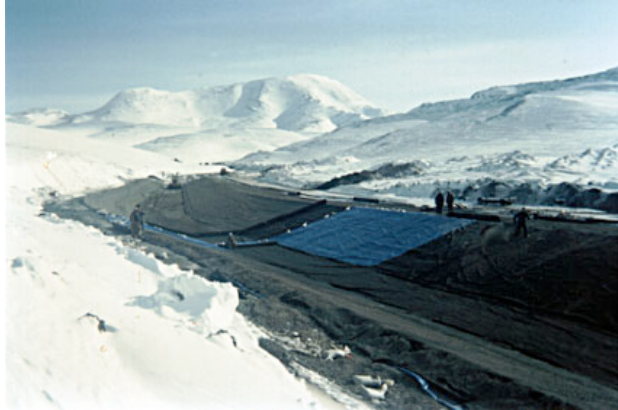
Figure 1. Winter install of RPE stream diversion in Alaska

Since the 1980s a material called Reinforced Polyethylene (RPE) has been fabricated to large sizes for winter installations. Projects using RPE included the stream diversion at an Alaska mine site in Figure 1 and many kilometers of irrigation canal installed in Alberta in the winter in Figure 2.

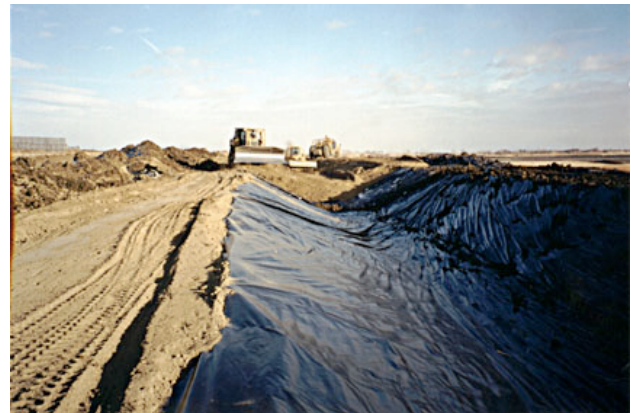
Figure 2. RPE irrigation canals in the winter in Alberta

Seaming of the RPE materials in the winter consisted of overlapping the seams 1.5m and then backfilling. Where additional waterproofing was needed a butyl tape was used in the overlap. For seepage control in fresh water applications these geomembranes were effective for winter installations.

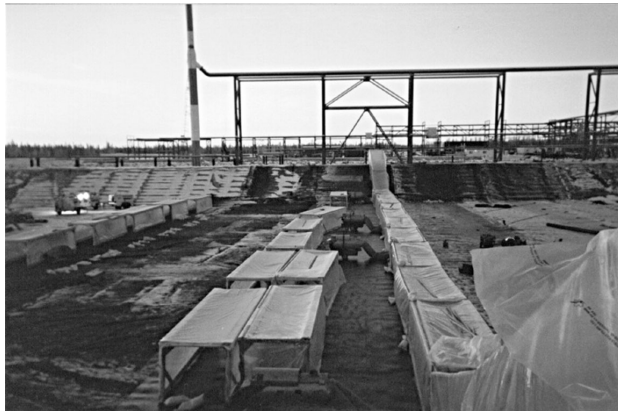
Figure 3. HDPE installation using temporary shelters.

Since 2008 winter installation has become a common practice in Canada. A couple of examples include Figure 3 which is an HDPE installation of a process pond for an oil sands project in northern Alberta. Temporary shelters were used to shelter the welding area. These shelters were helpful under certain conditions however the extra work to move the shelters did not justify their continued use.

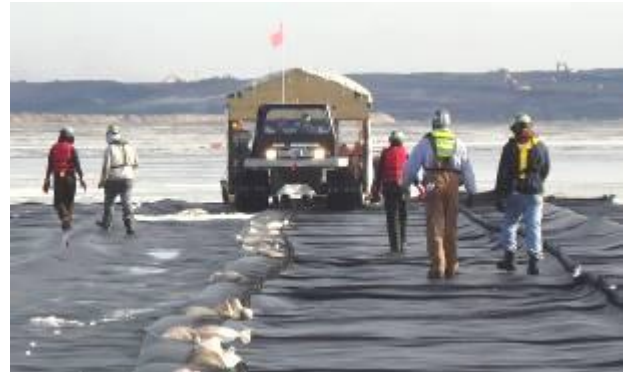
Figure 4. Placement of geotextile on frozen tailings pond.

Another significant winter installation showing the limits of winter weather is in Figure 4. This project was the installation of sewn high strength geotextile on top of a frozen tailings pond. Geotextile sewing machines are sensitive to the cold so this required heating sewing shelters in addition to cold weather deployment. This project was outlined in a paper presented at the Pan-Am CGS conference in 2011 (Mills, 2011).

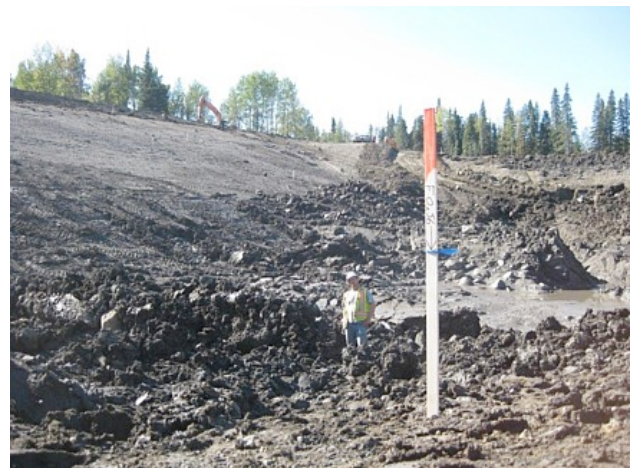
Figure 5. Subgrade preparation in wet conditions.

The project started on October 26th with crews on site to weld the HDPE pipe for the sumps. Because the crews were on site early for this preparatory work there is a good photo record of the site preparation. Figure 5 shows the condition of the subgrade in October and Figure 6 shows the final subgrade preparation. The earthwork crews did an excellent job on this project under difficult conditions.

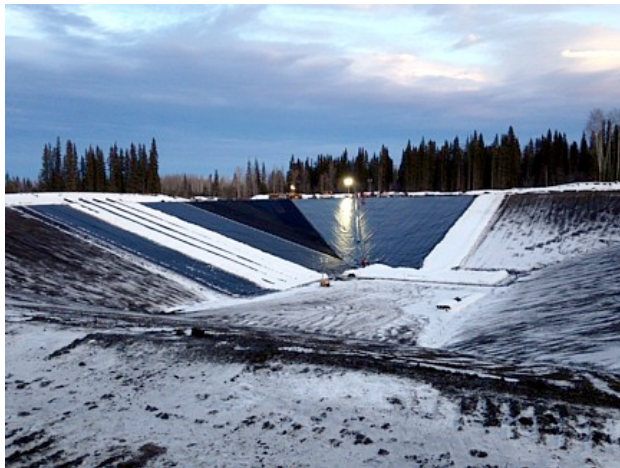
Figure 6. Installation under the lights.

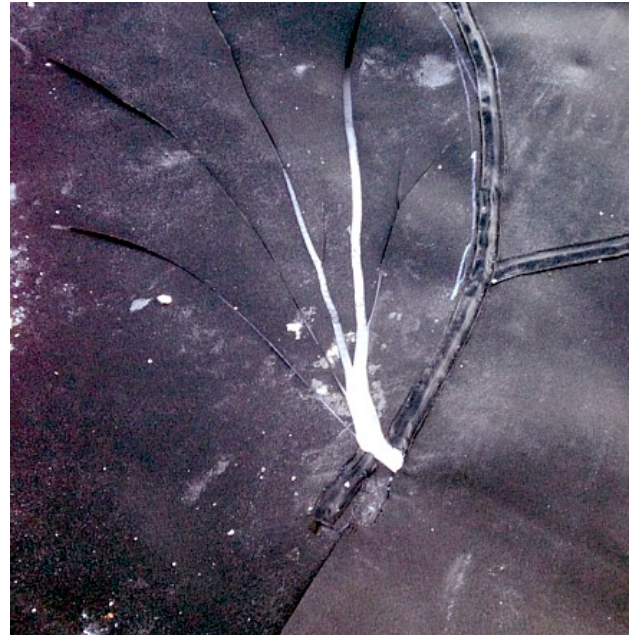
Figure 7. Cracking of the geomembrane.

Again the material was passing the material specifications but problems were occurring during installation. In Figure 7 the cracking is evident next to an extrusion seam. As outlined earlier extrusion seams can develop stresses in the geomembrane especially when cooled quickly. The conclusion was that the extrusion welds were placed at too cold a temperature. Additional temperature monitoring would be put in place to limit problems. Over the following week there were no welding issues as the field crews waited until temperatures warmed to -20C before welding.
