Recent underwater geomembranes solutions for dams and canals

Underwater installation at Studena, Bulgaria 2018

The Kembs embankment, France 2020

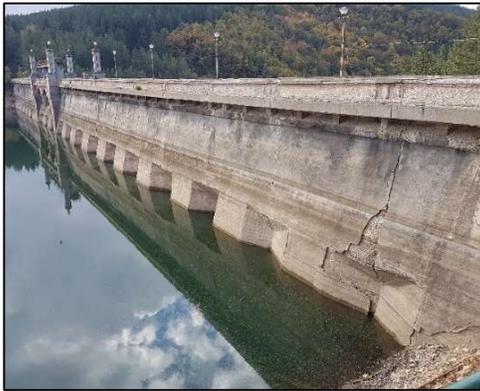
Figure 1. Deteriorated upstream face at Studena dam

Although the dam wall was stable and no significant leakage seemed to be occurring, given the importance of the structure and to prevent a critical situation that could later threaten water supply and require more expensive works, the Bulgarian Government decided to implement a complete rehabilitation project to extend the functional life of the dam by at least 50 years, ensuring water supply and safety of the structure, which is in a seismically active region. The project, financed by the World Bank, had as its most relevant part the rehabilitation works to protect the dam concrete. A tender for the dam rehabilitation was issued by the Ministry of Regional Development and Public Works under the World Bank rules. The tender required as waterproof protection liner a 2.5mm thick polyvinylchloride (PVC) geomembrane heat-bonded at fabrication to a 500g/m² nonwoven needle punched anti-puncture geotextile, to be placed on a 2,000g/m² cushion geotextile protecting the liner against excessively aggressive rough areas. The geomembrane had to be secured to the upstream face with stainless-steel vertical steel shapes and components, clamps and anchors

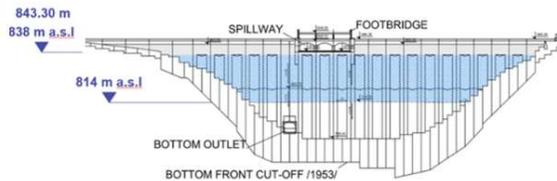
Figure 2. In grey, area lined in the dry, in blue, area lined underwater

The works had to be carried out in such conditions as to guarantee the safety and the proper technical operation of the dam and of its appurtenant structures while providing continuous water supply, which meant that most of the works had to be carried out underwater, and without affecting the quality of the supplied water. During the tender procedure the decision was taken not to extend the waterproofing system down to the entire damaged area (elevation 802m), to avoid working in the sediment layer and creating turbidity. The waterproofing geomembrane system was installed from elevation 843.3m to elevation 814.0m, with underwater works from elevation 838m downwards (Figure 2).

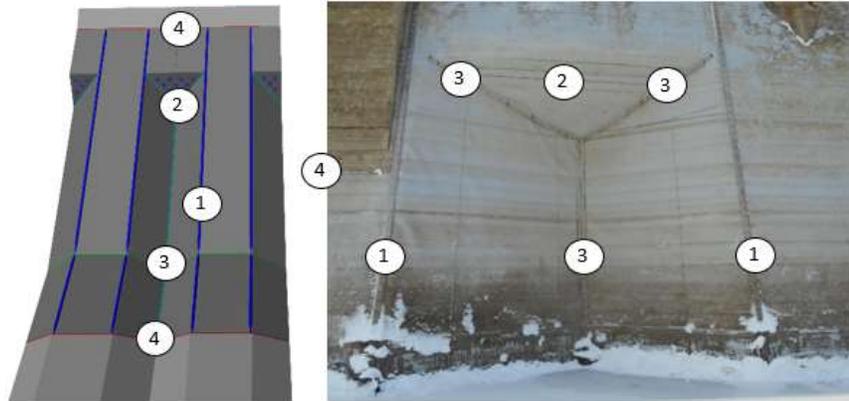
The complex geometry of the dam required a complex face anchorage system, comprising (Figure 3) tensioning profiles (1) in the convex corners, point anchors (2) in the triangular recesses in the buttresses, batten strips (3) in all concave corners, and mechanical peripheral seals watertight against water under pressure (4) at the top and bottom peripheries of the sealing system. All fastening components are stainless-steel.

Figure 3. Tensioning profiles (1, in blue), point anchors (2, in black), batten strips (3, in green), and perimeter seals (4, in red)

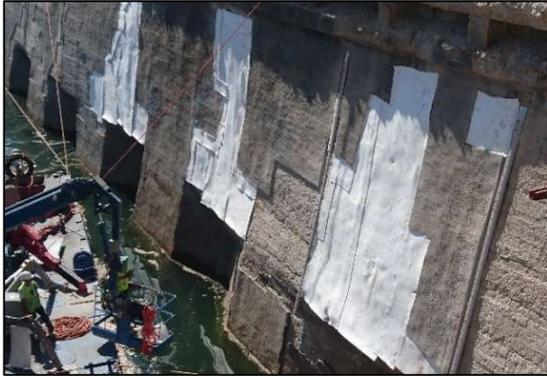
Figure 4. The 2000 g/m² non-woven geotextile is installed on the concrete after removal of the unbonded shotcrete, in the dry and underwater

diamond saw cutting and high-pressure water jetting, followed by cleaning and by levelling of the roughest concrete with mortar. The rough concrete was covered by a 2000g/m² non-woven needle punched polypropylene anti-puncture geotextile fastened with impact anchors (Figure 4). Along the anchorage lines, the concrete surface was levelled with mortar. The same steps were performed underwater, where levelling of the rough concrete was made with resin. The geomembrane sheets/panels were then deployed on the upstream face (Figure 5) and connected and fixed with the Carpi patented face anchorage system described.

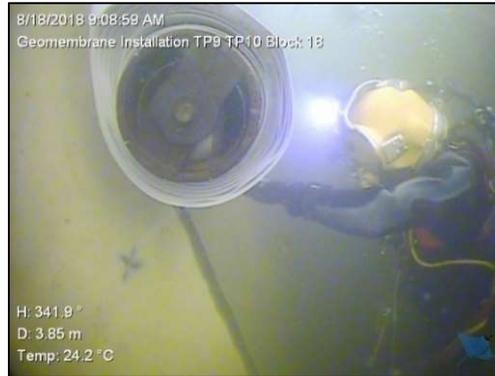
Figure 5. Unrolling of a geomembrane sheet underwater, over the 2000 g/m² non-woven geotextile

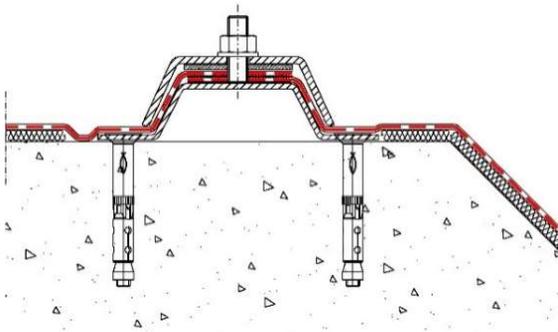
Figures 6 and 7 are related to the tensioning profiles: the first profile is fastened to the concrete with mechanical anchors; the edges of two geomembrane sheets are overlapped at the profile; and the second Omega-shaped profile is positioned over the first one and tightly connected to it, thus forcing the waterproofing liner sheets into a new position that results in a tensioning effect.

Figure 6. Scheme of the underwater tensioning profiles at Studena dam

An efficient tensioning system was essential in view of the heavy snow and ice formation that could exert a dragging effect on the waterproofing liner if it were not perfectly tensioned. The underwater tensioning system used previous projects and presented in ICOLD Bulletin 135 was modified to improve the tensioning effect. The new tensioning profiles (1), intrinsically watertight, are a patented development of the system adopted in previous installations: while previously the tensioning effect was essentially achieved by the installation procedure, at Studena the tensioning effect is achieved by the geometry of the two profiles, as with the tensioning profiles used in dry installation. The point anchors (2) at the triangular recesses consist of long shaft anchors with a thick steel washer to distribute the uplift forces transmitted to the geomembrane liner by wind. Anchors are made watertight by a SIBELON® C 3250 geomembrane washer (the same geomembrane that composes the waterproofing liner, but without geotextile) placed on top of the steel washer and heat-seamed to the underlying waterproofing liner, which was possible because installation of such anchors was carried out in the dry. The batten strips (3) and perimeter seals (4) are made intrinsically watertight: the batten strips using two flat profiles and suitable gaskets to evenly distribute the compression that achieves watertightness, the perimeter seals spreading a resin bedding on the concrete to create a smooth surface and remove possible voids where the seal is placed, and using a rubber gasket under the profiles and splice plates at abutting profiles.

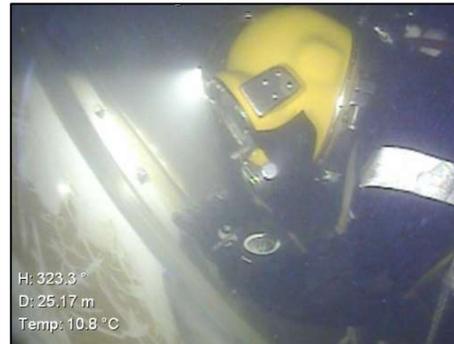
Figure 7. Diver connecting the two tensioning profiles underwater

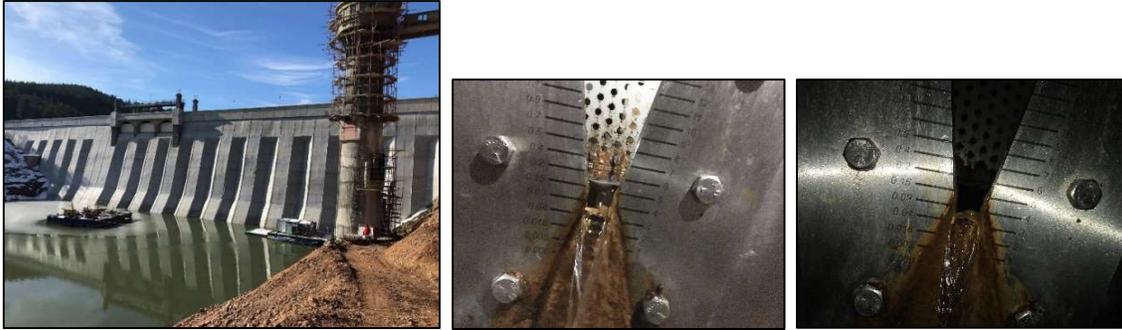
Figure 8. The works during a low water level period, and total leakage from the two drains

At completion of underwater works, the crew horizontally overlapped the geomembrane installed above water over the one installed underwater by the divers and welded on the overlapping a horizontal geomembrane cover strip, to make a watertight junction between the two geomembranes. Waterproofing works were completed within schedule despite difficult climatic conditions, on 27 December 2018. The total surface lined was 5,498m², of which 1,348m² was above water and 4,150m² under water. Total leakage from the geomembrane system, compliant with tender requirements, is shown in Figure 8.

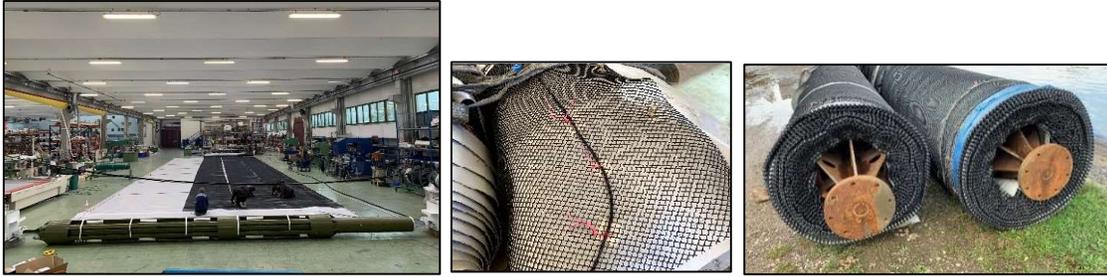
Figure 9. At left and middle, integrating the OFC and drainage layer at the bottom side of a mattress. At right, rolled void mattresses ready for installation at Kembs crest. The drainage geonet is the black material, and the integrated zip can be seen along the edge of the panels

The mattress designed for Kembs has as waterproofing liner a 2.5mm thick Sibelon® C 3250 PVC geomembrane, and as grout confinement layer SIBELON® C 2600 R, a 2.0mm thick scrim-reinforced PVC geomembrane. The monitoring and leak location system comprises a drainage layer, with measurement of flow rate, an inclined piezometer, temperature and pressure sensors, and an optical fibre cable (OFC) system. The innovation for Kembs was to integrate the drainage layer, the OFC system, and the grouting hoses with the mattress at fabrication. The drainage geonet and OFC are attached to the bottom of the waterproofing liner (Figure 9) and the grouting hoses are embedded between the two geomembranes, so that the panels leave the factory incorporating all these elements plus the underwater joining system (the watertight zips). This innovation reduces the diving time, and is consequently a safer installation method, and guarantees there is no loss of cement in the water.

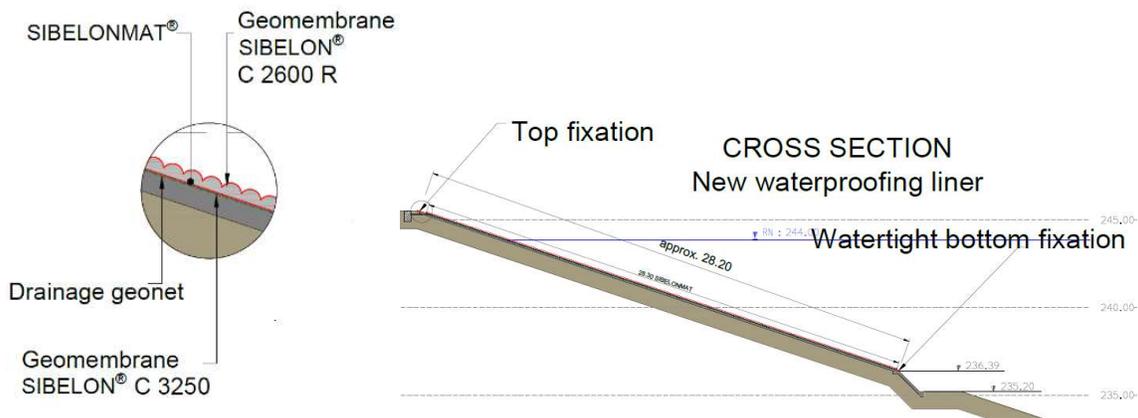
Figure 10. Cross section of the mattress and of the lined slope

The stretch to be lined was about 50m long, spanning the existing deteriorated concrete slabs of one embankment from crest down to about elevation 236.3m, i.e. on about 28m of slope, covering 80 slabs and spanning 26 vertical and horizontal joints. Five mattresses, each 10m wide and 28.4m long, were prefabricated to waterproof the area, in total 1,445m².

The mattress is fixed at the top by a stainless-steel seal, watertight to rain and waves. The side peripheries have a standard watertight stainless-steel perimeter seal, the bottom perimeter seal is an L-shaped stainless-steel profile that also acts as support for the filled mattress. Special details were developed and tested in real scale for the underwater terminations of the zips, in a pressure vessel under water pressure of 40m for 144 hours and 60m for 48 hours.

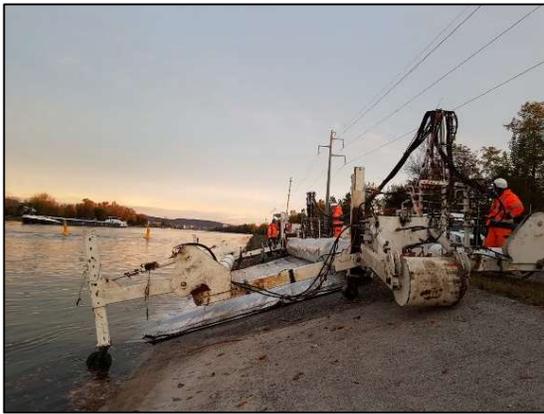
Figure 11. The empty mattress deployed to underwater placement

The divers checked the conditions of the slabs before executing the treatment at joints. As often happens, the real conditions of the subgrade were somewhat different from those anticipated. The thickness of the slabs was not uniform, at some points being only 30mm, which required adopting different types of anchors (mechanical, semi-mechanical, resin based). The vertical joints at the bottom did not exist, therefore joint treatment was necessary only for the horizontal joints, seven upstream and six downstream. The solution envisaged for joint treatment had to be modified, because when drilling started a strong suction was experienced, which indicated that the resin could possibly have been sucked into the holes. The divers treated the joints with a suitable underwater resin. Each rolled mattress was set on a customised unrolling device, temporarily anchored at the crest, and unrolled down to the bottom (Figures 11 and 12). The divers controlled the correct unrolling and joining of the panels, and executed the bottom and side perimeter seals, while at the crest the top fixation was completed by the above-water crew. Adjoining mattresses were joined by pulling the zip from the dry, under the control of the divers.

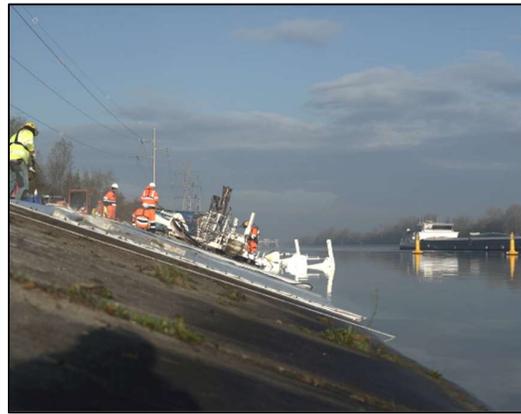
Figure 12. Navigation ongoing during underwater works

Installation was carried out in 2020, from 22 October to the end of November. The high voltage line made it necessary to take customised safety measures, and to adapt the procedure for conveying the rolls to limit the height of the handling equipment. Navigation management was carried out first by providing information to the navigation services, limiting the speed of traffic, then by placing buoys delimiting the work area. Despite these measures, the site suffered repeated wash from the passage of boats, which however did not disturb the smooth running of the waterproofing works. Water speed during installation was variable, with a maximum average speed of 1m/s inside the canal, and a little less along the embankment, which allowed the divers to perform their underwater tasks without shelter.

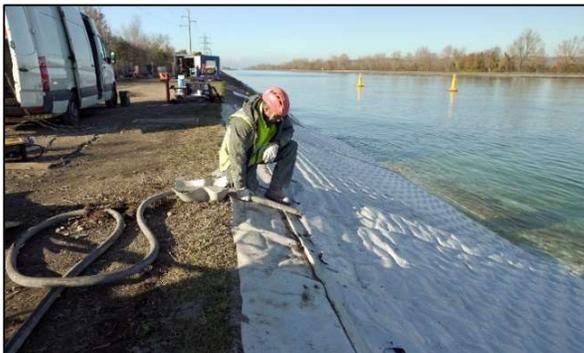
Figure 13. Grouting the mattress

After the panels had been joined, using the integrated grouting hoses the hollow space between the two geomembranes was injected from the crest with cement grout (Figure 13), thus reducing the diving time, increasing the safety of the divers, optimising the cost of the solution and, by preventing loss of cement in the water, providing a solution totally respectful of the environment. Figure 14 shows the completed mattress.

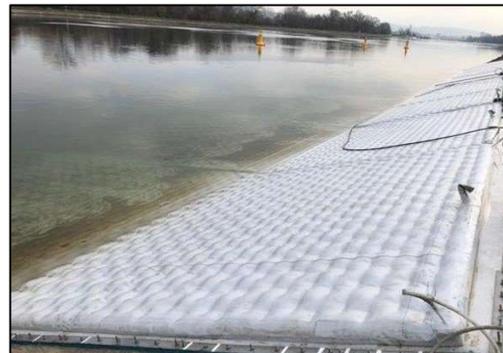
Figure 14. Mattress completed
