# **EXCELPLAS TECHNICAL NOTE: EP93**

## **Title: Heat and UV Degradation of Exposed Bituminous Geomembranes (BGM) and Quantitative Assessment Using Multispectral 3D Imaging**

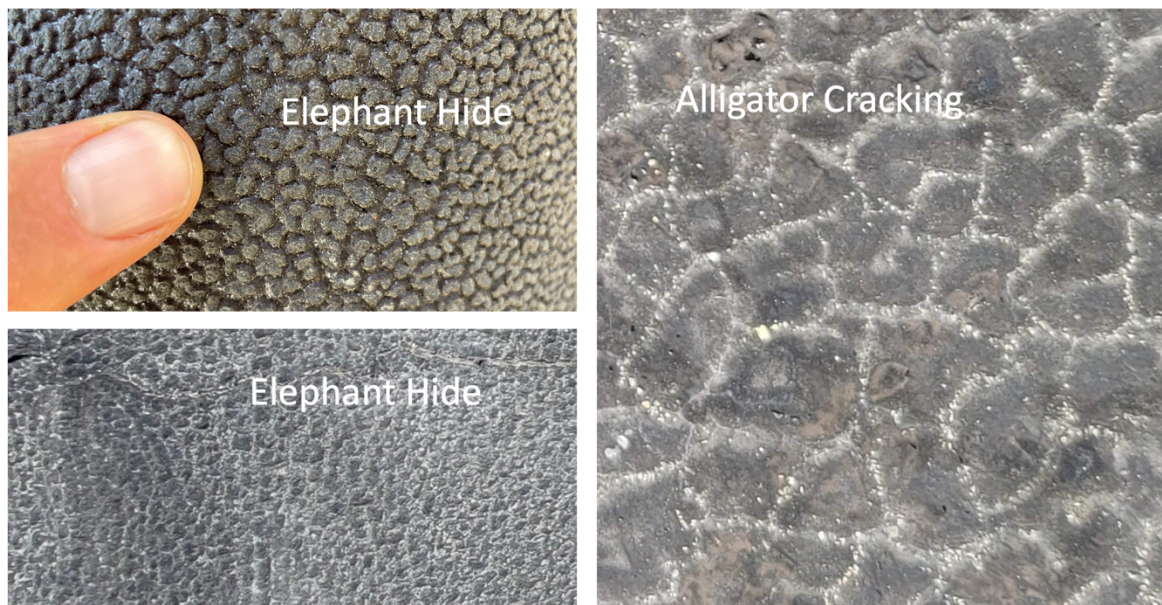
Figure 1. ‘Elephant Hide’ and ‘Alligator Cracking’ of Exposed and Heat Aged BGM

Heat and UV Degradation of BGM: When BGM is exposed to heat and UV radiation, it undergoes a series of crosslinking reactions and surface changes that reflect the degradation of its properties. The first stage of BGM degradation is characterized by fine texturing, which is barely visible to the naked eye. As the degradation progresses, the surface changes become more pronounced and visible. The second stage of BGM degradation is characterized by elephant hide cracking, which appears as a network of fine cracks on the surface of BGM, resembling the texture of an elephant's skin (see Figure 1). The third stage of BGM degradation is characterized by alligator skin cracking, which appears as interconnecting or interlaced cracks on the surface of BGM, resembling the hide of a crocodile (see Figure 2). The fourth stage of BGM degradation is characterized by tortoise shell cracking, which appears as very course interconnecting or interlaced cracks on the surface of BGM, resembling the shell of a tortoise.

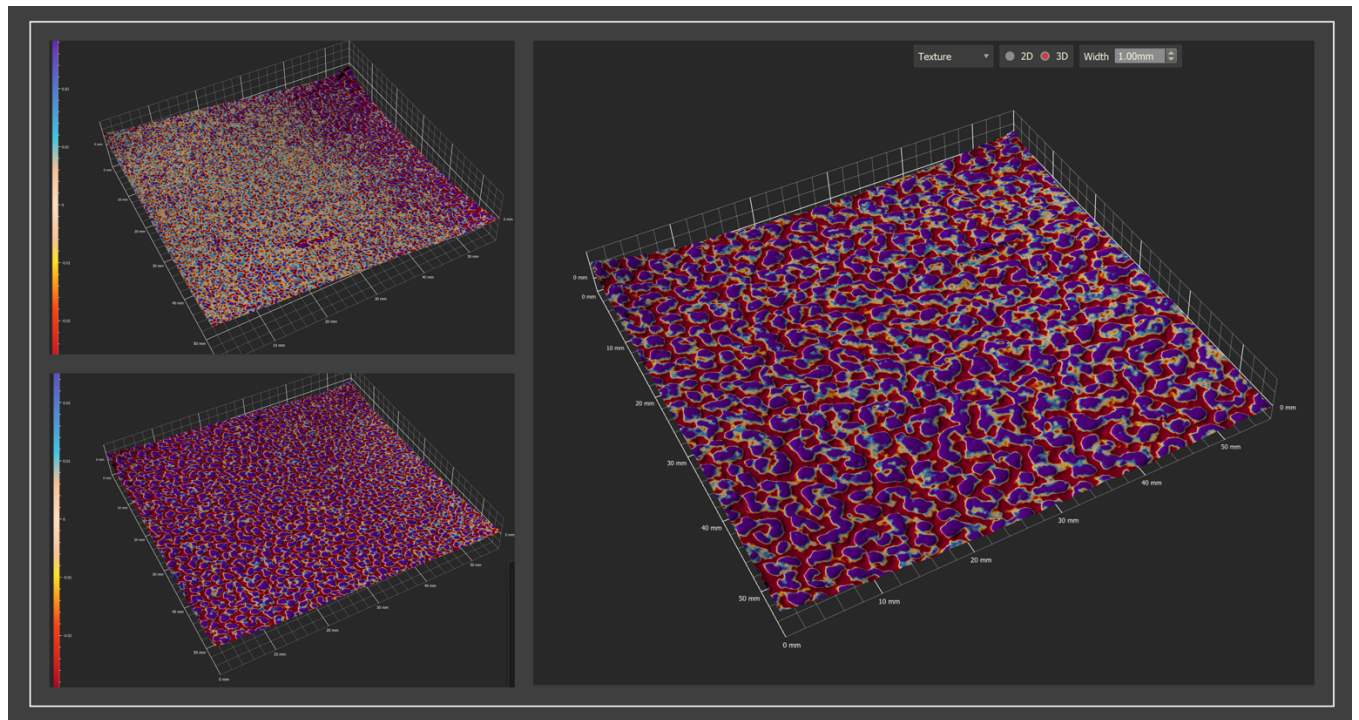
Figure 5. 3D Imaging of Volume of Cracks with Progressive Degradation of BGM Surface

Multispectral 3D imaging provides a non-subjective method of quantitatively assessing BGM degradation. This method involves the use of a multispectral camera that captures images of the surface of exposed BGM at different wavelengths. The captured images are processed to generate a 3D model of the BGM surface, which is used to measure the number and depth of cracks per unit area of BGM. The data obtained from this method can be used to generate a useful index of the level of BGM degradation (see Figures 4 and 5).
