How Geosynthetics have Fast Tracked the Rehabilitation of One of the World's Largest Uranium Mines

Energy Resources of Australia (ERA) is currently undertaking a comprehensive rehabilitation program for the **Ranger Uranium Mine**, located in the Northern Territory. The mine ceased processing operations in 2021, and ERA has committed to restoring the site to its natural state by 2027. The company expects to spend approximately \$1.2 billion on rehabilitation activities up until the end of 2027. This is a bonanza for geosynthetic suppliers and geotechnical engineering consultants.

The recent focus of the rehabilitation works with geosynthetics has been Pit 3. Mining from Pit 3 concluded in November 2012. ERA has been actively rehabilitating Pit 3 at the Ranger Uranium Mine since the conclusion of mining operations in November 2012.

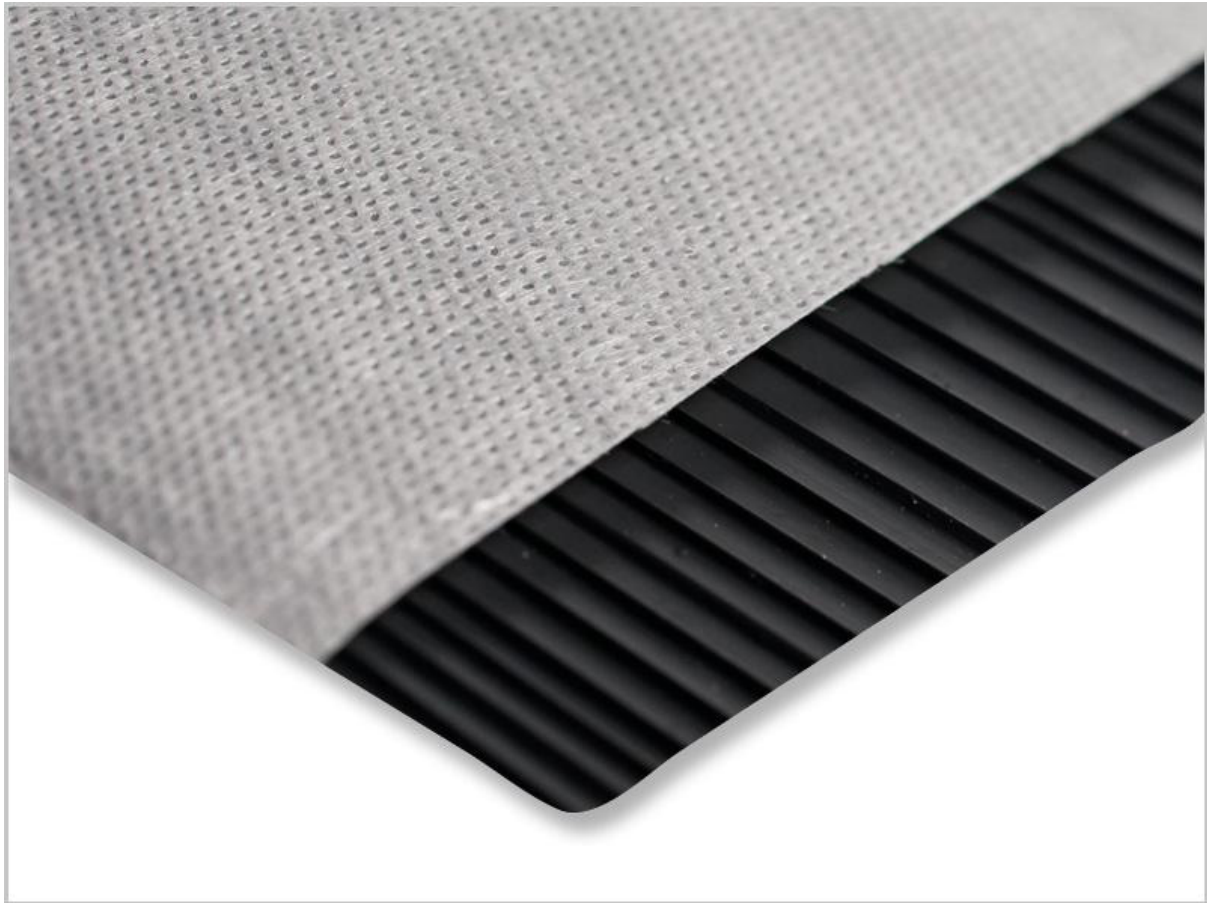
Geosynthetic Wick Drains (GWD), or prefabricated vertical drains (PVDs), are geosynthetic products designed to expedite the consolidation of soft, compressible soils like clay and silt. They consist of a plastic core wrapped in geotextile fabric (see photo below), which allows water to flow while preventing soil particles from clogging the drain.

Figure 2 Composition of a Prefabricated Vertical Drain (PVD)

PVDs are defined in ISO 18325, 2015 as drainage composites with a rectangular cross-section, typically 100 mm wide, installed vertically into soil to provide drainage for accelerated soil consolidation. They usually consist of a central core with a channel system surrounded by a filter jacket or with a filter adhered to it. Sometimes PVDs are also referred to as wick drains, band drains, strip drains, etc.

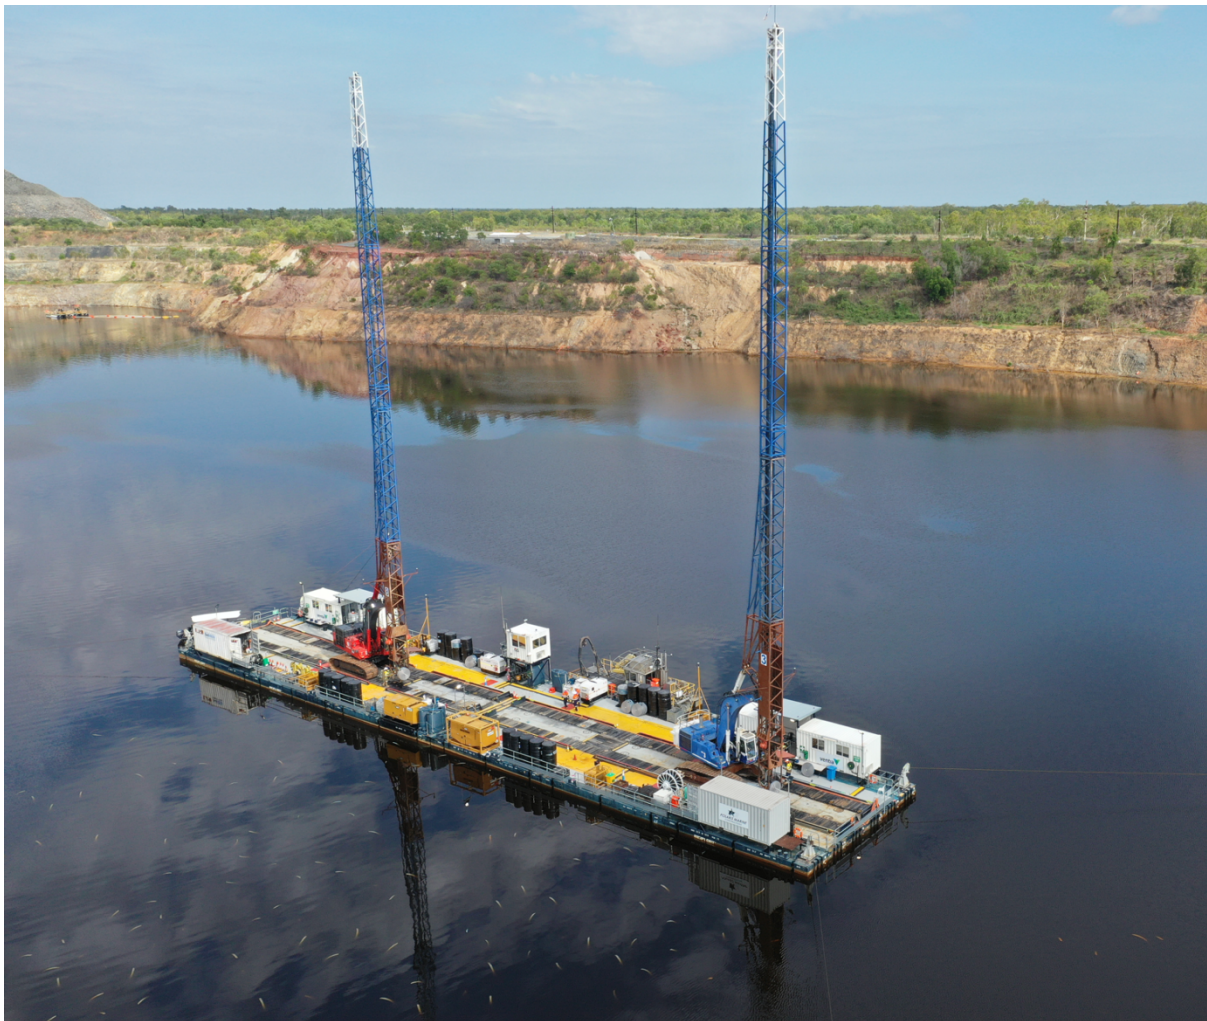
Figure 3. The PVD's were installed from a barge by Ventia <https://www.ventia.com/>

A significant milestone in this process was the completion of the wicking program in March 2023, which involved inserting approximately 41,000 geosynthetic wicks into the tailings of Pit 3. An impressive 1,268,650 LM of PVD material was installed.

The wicks used for Pit 3, each ranging between 25 to 40 meters in length, facilitate the extraction of water from the tailings material, supporting its consolidation and enabling subsequent rehabilitation activities.
