# Acceptance Criteria for Defects in Polyethylene Welds, Coupling Phased Array Ultrasonic Testing and Destructive Tests

Dominique Gueugnaut<sup>1</sup> · Manuel Tessier<sup>2</sup> · Myriam Bechrouri<sup>1</sup> · Aymeric Lopitaux<sup>1</sup>

As a promising reference technique for non-destructive evaluation of both electrowelded and butt-fused polyethylene (PE) assemblies, Phased Array Ultrasonic Testing (PAUT) is still studied extensively in several laboratories worldwide and is supported by the technical standard ISO TS 16943. During the last 10 years, several joint projects have been completed aiming at evaluating the acuity of PAUT applied to both pipes and electrofused assemblies either exhumed from the field or prepared in laboratory. More recently, a focus has been made on fixing some acceptance criteria combining PAUT data and long term resistance of the laboratory joints. This paper presents the updated data obtained on electrofused assemblies—63 mm saddles and 110 mm sockets—containing different types of defects such as: insufficient heating time, pipe under-penetration in the socket, excessive localized scraping, pollutants and calibrated thin strips, in both mass and

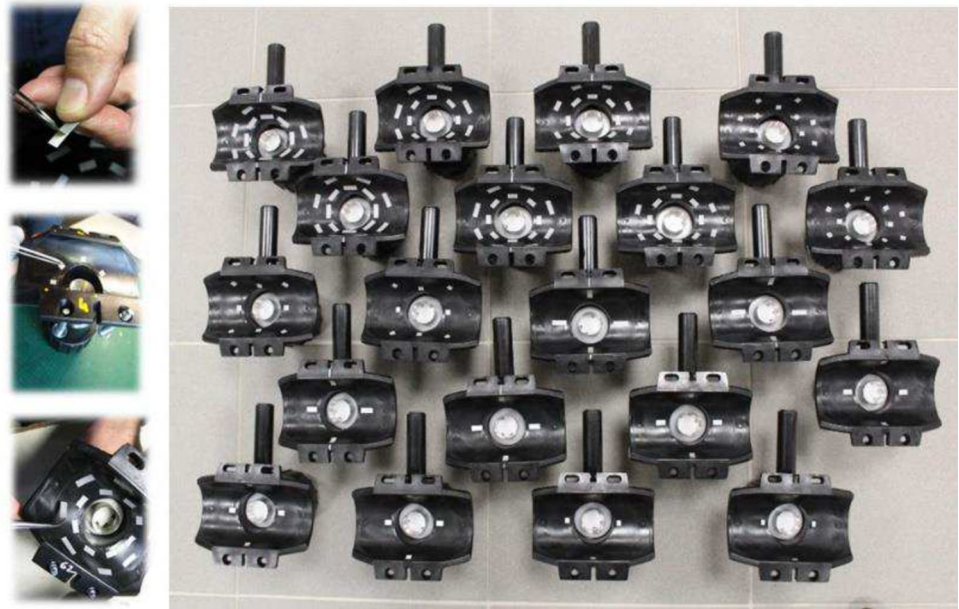
**Fig. 1** Distribution of the strips in the so-called mass and crossing configuration

- 15 assemblies with prior insertion of strips simulating the presence of “mass” defects before welding. The strips—constituted of stickers used generally as optical targets for tensile tests—are around 0.2 mm thick, 5 mm wide, with a length ranging between 5 and 15 mm, with their greatest length oriented parallel to the crown materialized by the heating zone. The surface proportion of the defect relative to that of the fusion zone ranges between 5% and 27.3%, thus lying both below and above the 25% maximum requirement of the ISO 13956 standard dealing with decohesion tests on tapping saddles [26]. In this configuration, the crossing width of the strips accounts for between 22 and 23% of the heating zone of the saddle.

- 15 assemblies with the insertion of strips simulating the presence of “crossing” defects, with their greatest length oriented perpendicular to the crown materialized by the heating zone; The strips are 5 mm wide, with a length ranging between 3 and 14 mm. The percentage represented by the defect lengths relative to the width of the heating zone ranges between 13 and 64%, there again to ensure that the defects are below and above the 50% maximum threshold required by the ISO 13956 standard [26]. In this configuration, the surface distribution of the strips represents between 1.8 and 6.4% of that of the heating zone of the tapping saddle. Figure 1 provides an illustration of the distribution of the strips in the so-called mass and crossing configuration.

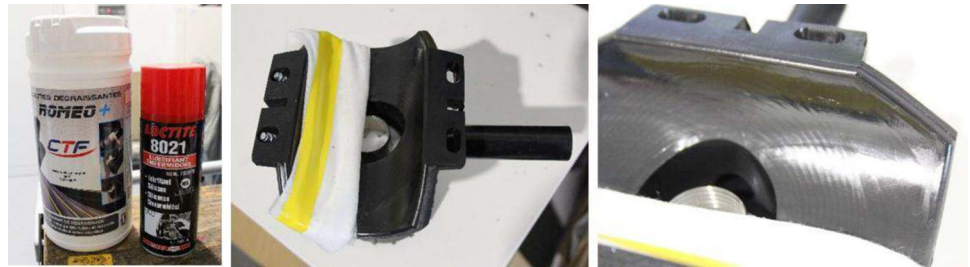
**Fig. 2** Liquid contamination by applying spray on one half of the heating zone of the tapping saddle

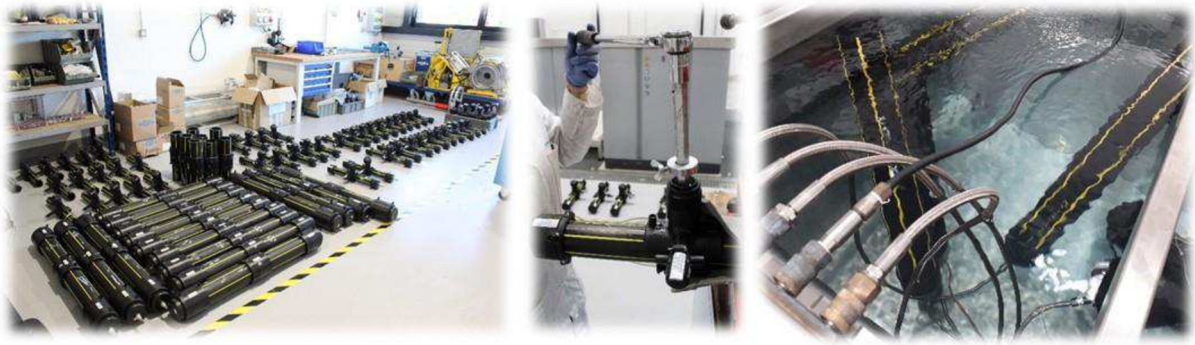
**Fig. 20** Assemblies implemented for the hydrostatic pressure tests

The resistance of the welded assemblies was tested according to the conditions recommended by the NF EN 1555-3 standard, namely, at a temperature of 80 °C for a hoop stress of 5 MPa. Under these conditions, the minimum failure time required is 1000 h. The pipes were pierced using the integrated perforator of the saddle, after a 24 h-minimum cooling time (see Fig. 20).

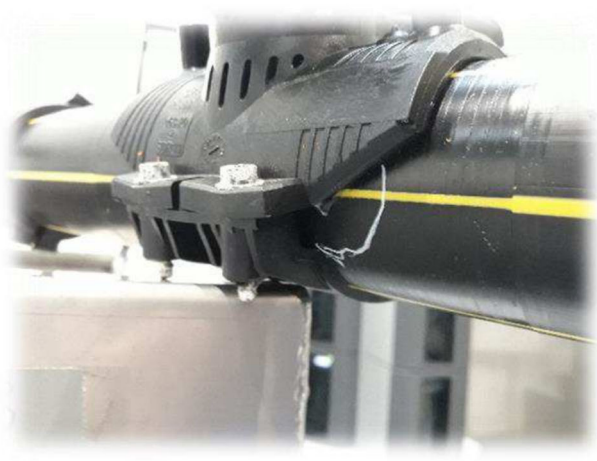
**Fig. 21** Results of the hydrostatic pressure tests performed on the pipe\_saddle assemblies with defects at the interface, welded at nominal time. The photo illustrates a leaking assembly resulting of a failure at the interface

Figure 21 displays the results of the hydrostatic pressure test on pipe\_saddle assemblies with defects, welded at the nominal heating time.

The data show that all the assemblies with defects comply with the minimum requirements of the ISO standard. Based

on this test, no clear trend emerges regarding the impact on the failure time of both the proportion and the type of the implanted defects at the interface.

For the pipe\_saddle assemblies, the failure is located either at the level of the welding interface (diffuse leakage) in 37.5% of cases, at the level of the fusion indicator in 31% of cases, or at the level of the body of the saddle in 28% of cases. Considering the type of assembly shows that leakage occurs:
