Geofoam—20 Years of Experience and Commonly Adopted Practices in NSW, Australia

Damian Mulcahy

Abstract For 20 years, Expanded Polystyrene (EPS), known in civil applications as Geofoam, has been used in New South Wales, Australia as a lightweight fill material for various applications. Pioneered in Norway in the 1970s as a lightweight construction material to minimise settlement, Geofoam was first utilised in NSW for a highway widening on steep ground in 2002. Since then, Geofoam has been used as a lightweight fill to minimise vertical loads on soft ground where excessive settlement was predicted, for emergency and planned slope rehabilitation, as a way of reducing horizontal loading on bridge abutments, and for various other applications. There are several advantages to using Geofoam in construction. It can be more cost-effective than traditional ground improvement techniques; its use can lead to reduced construction time where earthworks' compaction is needed and can reduce the vertical impact on services. Geofoam can be installed by smaller work crews utilising lighter plant and can minimise the excavation footprints for slope remediations. These examples are just some of the

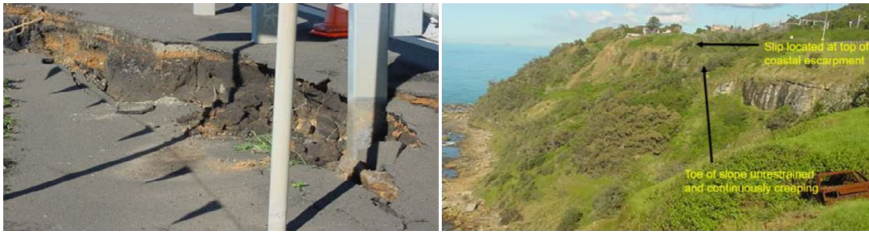
Fig. 2 Left the step in the pavement on the guardrail. Right slope location above cliff

be completed before the grand opening of Sea Cliff Bridge in 2005, however, after commencing the drilling of the top row of soil nails a large tension crack opened up under the excavator. The tension crack approximately 3 m back from the proposed face lined up with the interface between the in-situ weathered sandstone and the embankment fill constructed when the road was built. The existing soil nail design was insufficient to achieve the required FoS and the slope needed to be stabilised urgently to coincide with the bridge opening (Fig. 2).

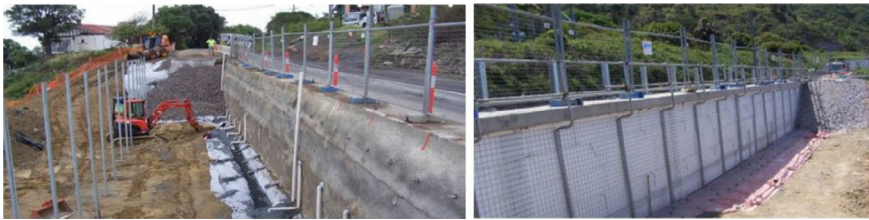
Fig. 3 Left the stabilised excavation with horizontal drain connected to a trench drain. Right the Geofoam remediation prior to shotcreting

The revised remediation consisted of excavating behind the tension crack and applying the same soil nail design to stabilise the excavation face. The resulting 5 m wide void was constructed with Geofoam Blocks. The presence of groundwater seepage from the excavation required the installation of horizontal drains that were connected into drainage trench as shown in Fig. 3.

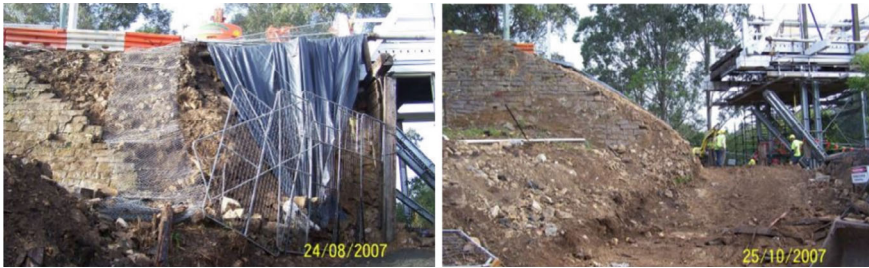
Fig. 4 Left the extent of the collapsed wing wall and drystone wall. Right the excavation and site preparation of placing the Geofram blocks

Movement of a timber wing wall caused the collapse of a section of the northern bridge abutment in 2007 (Fig. 4). Built in 1897, Victoria Bridge is a heritage timber

Conventional earthworks, which would have required a significant amount of further excavation to accommodate benching, was ruled out, as was bored pile options, due to stability and access issues. As the wing walls need to be replaced, it was decided to over-excavate a wedge of the abutment as shown in Fig. 4 (right), and to rebuild it with Geofram. This also allowed space for bridge bracing and repairs to occur concurrently.

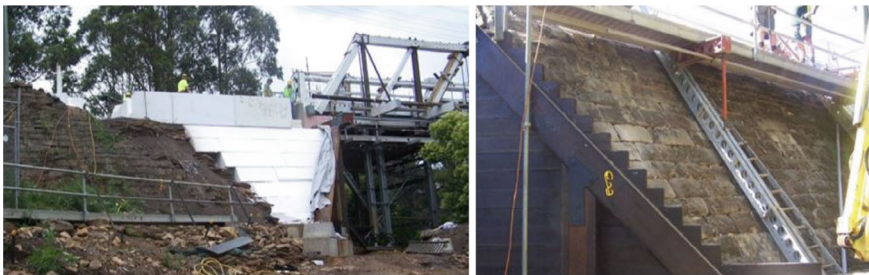
Fig. 5 The Geofram blocks placed prior to shotcrete, and the final remediation with the original drystone blocks reused

Once the wing wall was rebuilt, the Geofram was placed as backfill as shown in Fig. 5. A significant success of this remediation was the ability to reuse all the pre-existing drystone blocks as facing once the Geofram had been shotcreted to reinstate the heritage look (Fig. 5 (right)).

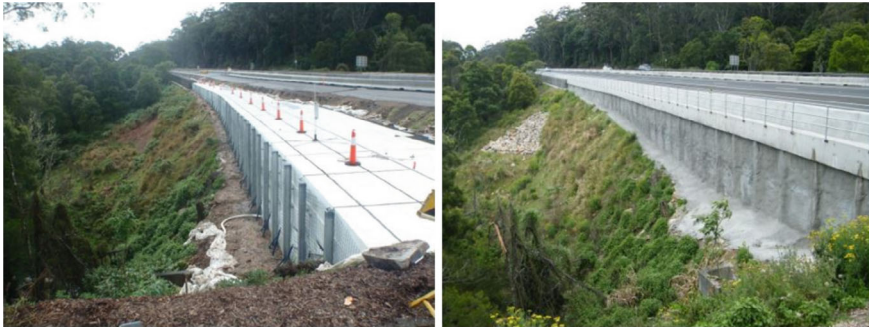
Fig. 6 Construction stages of the Geofoam construction for the acceleration lane

As part of the design process, incorporation of a ridged barrier was required due to the steep grade of the alignment. This resulted in structural “I” beams, with 2–3 m piles as the vertical supports, which were to be incorporated into the structural elements of the concrete slab and the extruded rigid barrier. In this case, the Geofoam blocks were used as a lightweight fill to offset load of the widened pavement and barrier system. As with previous projects, a net reduction in load was achieved. Figure 6 shows the construction stages, left at the top of the Geofoam, and right at the final construction.

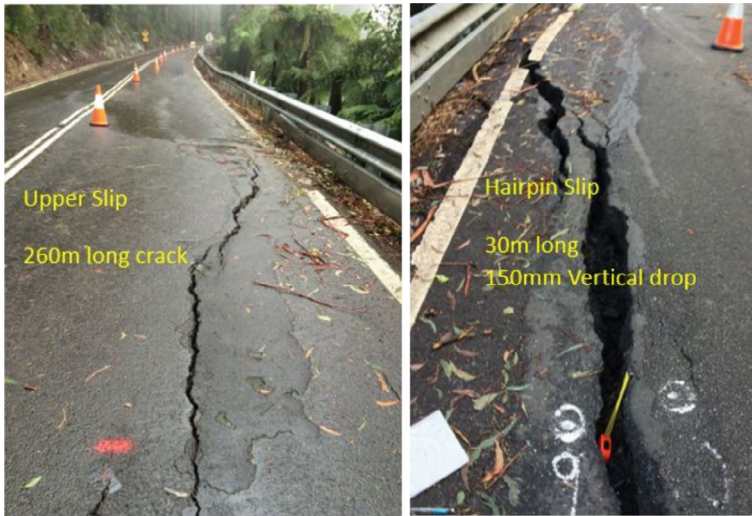
Fig. 7 Two significant slips on Barrengarry Mountain 2015

occurred towards the top of the escarpment (Fig. 7). The upper slip was 260 m long, with a meandering open crack with vertical displacements of 35 mm increasing to 60 mm after 10 days. The second slip 150 m downhill at the hairpin was 30 m long and had a 150 mm vertical displacement that increased to 180 mm. The road was closed while investigations, monitoring, and options assessments were conducted.
