New Water Tank Lining: Passing the Taste Test

From JPCL, August 2021

By Murray Heywood and John Sierzega, Sherwin-Williams Protective & Marine

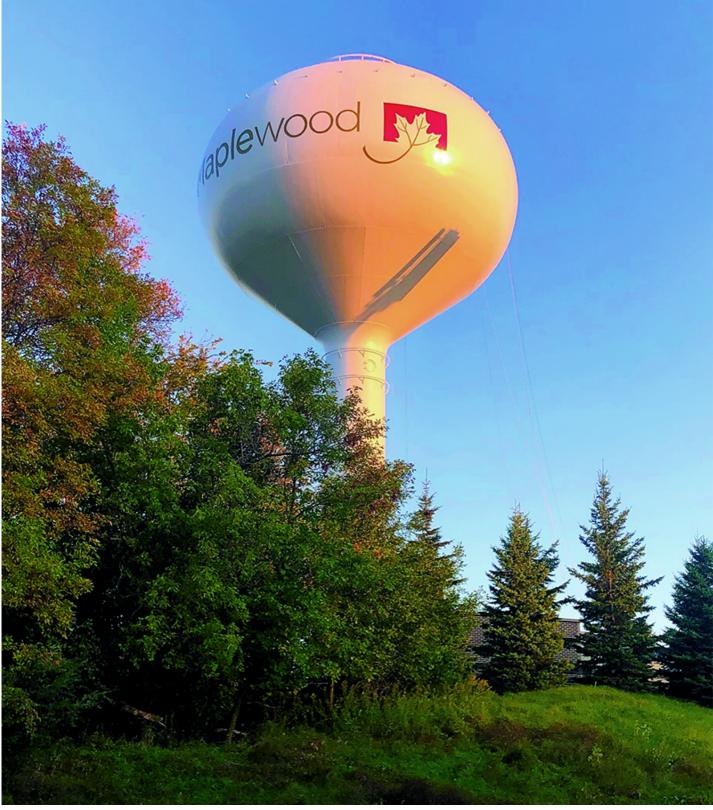
Figure 1: SPRWS selected a newly NSF/ANSI/CAN 600-approved, 100%-solids lining system for its 500,000-gallon Sterling Avenue water tower that helped the restored tank pass a discriminating water panel taste test on the first try. *Courtesy of Sherwin-Williams Protective & Marine*

That costly drain and refill scenario is exactly what Saint Paul Regional Water Services in St. Paul, Minnesota was trying to avoid when the utility provider selected a new 100%-solids glass-flake reinforced epoxy lining system for the restoration of its 500,000-gallon Sterling Avenue water tower in fall 2019 (**Fig. 1**). Nearly every water tank that SPRWS had relined in the region during the past 15 years or so had not passed a taste ?test on its first try. Each failure naturally meant a delay in restoring water service, but it also carried the cost of losing an entire tank's worth of water, with those municipal budget dollars literally going down the drain. The 100%-solids epoxy would hopefully prevent that scenario.

The new next-generation, advanced technology, 100%-solids glass-flake reinforced lining system that SPRWS chose had recently secured NSF/ANSI/CAN 600 approval for potable water storage, making the Sterling Avenue tower the first to feature it. In selecting this system, the utility provider hoped to fill the tank just once before restoring water service, thereby realizing a timely, and less costly, return to service. The choice paid off with the water panel approving the first samples from the freshly filled tower, enabling immediate approval for service. The return to service was also accelerated by fast curing times for both the lining system and the tower's exterior coatings.

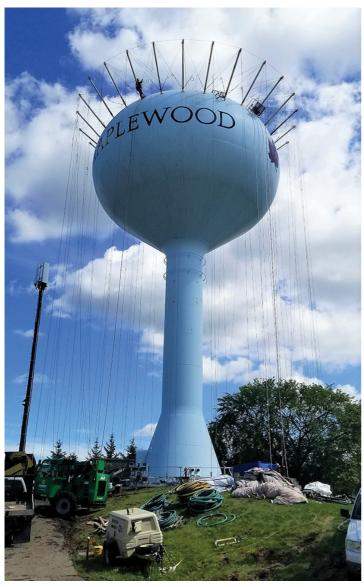
Serving the Maplewood, Minnesota, community, the Sterling Ave. water tower was due for a restoration following about 15 years of service since its last coatings work. The tank's exterior had faded and was in need of a refresh **(Fig. 2)**, and its interior was showing signs of minimal corrosion. Touchups and repairs were a possibility, but they would have taken longer to perform than a full restoration. With time of the essence to minimize the tower's time offline and stay ahead of the rapidly approaching Minnesota winter, SPRWS decided on a full rehabilitation using fast-curing coating systems, including the new 100%-solids lining system.

Figure 2: The water tower's exterior had faded and was in need of a refresh to liven up the image of the Maplewood, Minnesota, community. *Courtesy of Sherwin-Williams Protective & Marine*

Applicators first prepared the tank's exterior to the SSPC SP-6/NACE No. 3 Commercial blast-cleaning standard. They then applied a 2–4mil DFT primer coat using the same moisture-curing urethane zinc-rich primer used on the tank's interior to resist corrosion and damage.

Crew members next spray-applied an intermediate coat of a two-component, high-solids polyamide epoxy mastic to the tank's exterior at 4–6 mils DFT. With its high solids content, this protective coating layer ensured adequate protection of sharp edges, corners and welds on the tank. The epoxy is also fast-drying, helping the crew move quickly from the intermediate layer to the topcoat.

For the topcoat, the coating contractor used a two-component, high-performance acrylic polyurethane that will provide long-term UV protection for the high visibility structure. The coating offers exceptional long-term color and gloss retention, as well as excellent resistance to corrosion and weathering. Saving time on the application, crew members were able to apply the coating at thinner DFTs of just 2–3 mils compared to the 3–5-mil DFTs typically required for conventional polyurethanes.

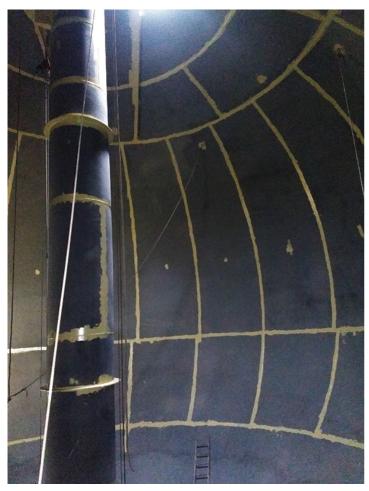
Figure 3: Applicators blasted the tower's interior to a Near White Metal standard, applied a zinc primer to the entire interior and then applied a stripe coat of the lining system to weld seams and edges to ensure full coverage of these hard-to-coat areas. A full coat of the 100%-solids, glass flake-reinforced lining followed. *Courtesy of Sherwin-Williams Protective & Marine*

To install the lining system inside the spheroidal tower, a crew of applicators first prepared the interior tank surfaces to the SSPC SP-10/NACE No. 2 Near-White Metal blast-cleaning standard. Next, crew members spray-applied a full coat of a single-component, moisturecuring urethane zinc-rich primer on the interior surfaces at 2–4 mils dry film thickness. The primer provides resistance to corrosion, abrasions and chemicals to help protect the tank's steel from deteriorating. It also allows for cathodic protection inside the tank.

Applicators then brushed and rolled a stripe coat of the 100%-solids, glass-flake reinforced lining to welded areas (Fig. 3) before spray applying the lining at 30–40 mils DFT in a single coat using plural spray equipment. Due to the coating's high-build capabilities, applicators could spray the material up to 125 mils DFT where needed to fill in any pits. The lining's glass-flake reinforcements give it extremely low permeability and excellent abrasion and chemical resistance, helping to deliver a life expectancy greater than that of a conventional three-coat zinc/epoxy/epoxy system. Best of all for the Sterling Avenue tank project's accelerated timeline, the lining offered a return-to-service time of just 10 hours following the final application.
