PRESS RELEASE

Water Infiltration Barrier & Ground Surface Erosion Control Protection to a Reinforced Earth Wall – STAGE 2

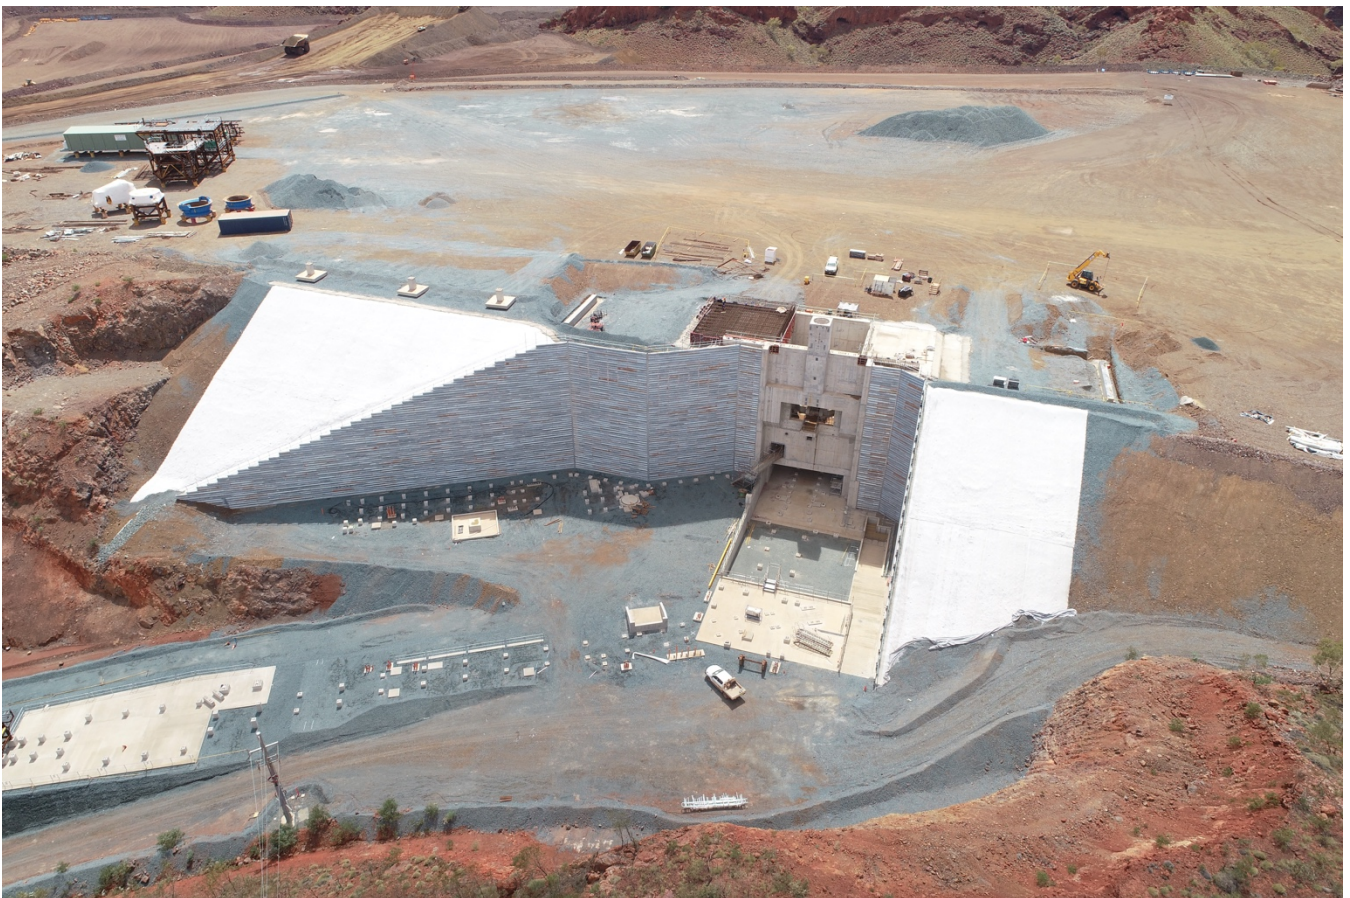
To continue on from a successful 1st Stage installation in December, 2022, Tiltex Australia's installation team have just completed Stage 2 of a major water infiltration barrier and ground surface erosion control to the ROM Wall Crusher project in Pilbara, Western Australia.

Our Tiltex team installed over 50 metre+ long steep batters at 1V:1.6H, secured with our soil/rock anchor grid system designed to withstand cyclonic wind conditions. Approximately 900 x 1m long cable anchors were installed to a 2m x 2m grid pattern across the entire batter face with perimeter anchors spaced at 0.50m centres.

Tiltex 12B was specified over traditional erosion control material options, such as revetment mattress and shotcrete, due to Tiltex 12B's superior performance (80MPa compressive strength with 16.1MPa flexural strength*), with a faster installation time

Tiltex 12B was also specified to replace concrete spoon drains due to the cost savings and a superior termination to stop water infiltration behind the wall.

The Tiltex team installed over 2300m² of Tiltex 12B ahead of schedule, even though the project presented difficult conditions with steep batters and high summer temperatures.
